**Site and Reach Assessment  
Evaluation of Treatment Alternatives**

**SR 530/Sauk River Chronic Environmental Deficiency Site**

**April 21, 2004**

**Washington State Department of Transportation**  
Environmental and Engineering Service Center  
Environmental Services Office

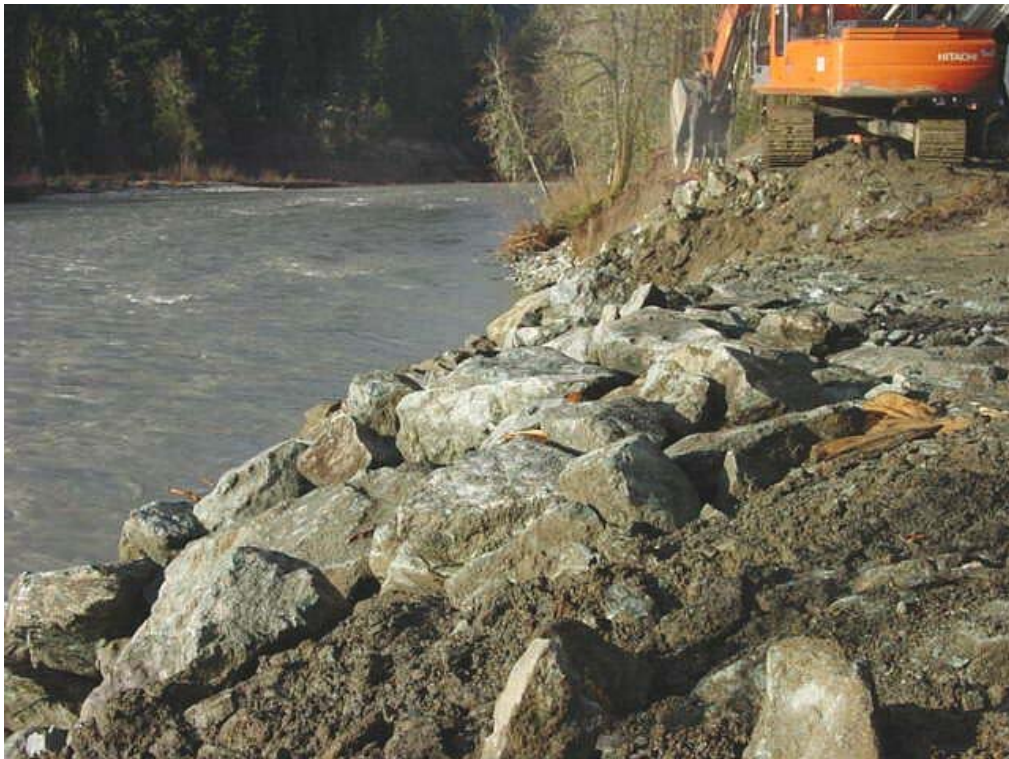
**Figure 2.** Installation of riprap at SR 530 CED site (November 2003).

This CED site is approximately 300 feet in length and consists of the SR 530 roadway and a hardened (riprapped) embankment which extends at a 1:1 slope to the Sauk River approximately 20 ft below the roadbed elevation (Figure 3). Before the fall of 1993 the top of the river bank was 50 feet from the road at the upstream end of the site, and 110 feet from the road at the downstream end. In October 2003 an early season flood eroded the bank to a near-vertical bluff extending to within one to three feet of the paved portion of the roadway (Figure 4).

This portion of SR 530 is constructed on an alluvial terrace that is currently exposed along the outer bend of a river meander. The current embankment hardening was constructed at two different times; the upstream half was constructed in the early 1990's in response to channel changes that occurred during the November, 1990 third-highest flood-of-record, and the downstream half in response to channel changes that occurred during the October, 2003 flood-of-record.

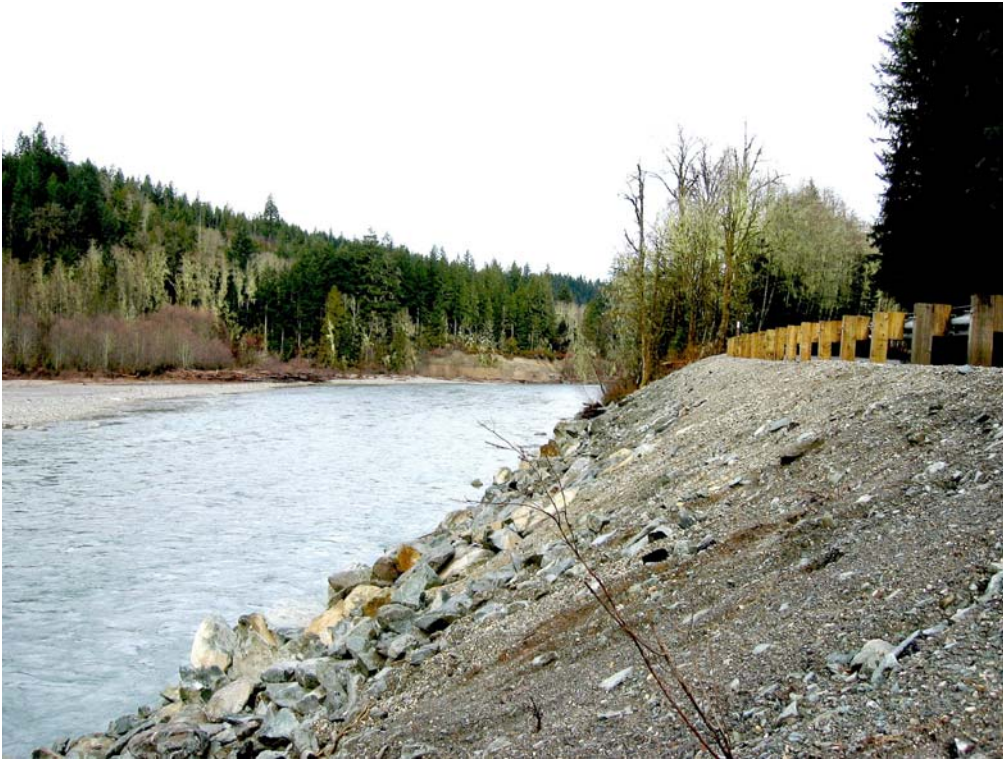
**Figure 3.** SR 530 CED site looking downstream.

The primary site-based mechanism of bank/roadway failure is most likely toe erosion caused by impinging flows occurring during last fall's peak flow event (see the Reach Assessment for more detail). The location of the site along the outside of the meander bend and smoothing of the channel by the original riprap installed immediately upstream are also likely to be contributing factors.

A shift in the channel alignment induced by last fall's event has caused the main thread of the river to impinge on the bank at a 45° angle of attack (the previous channel alignment had been nearly parallel to the bank) along the outside of a meander bend (Figure 5). This particular configuration guarantees that the largest erosional forces (shear stress and fluid momentum) in this reach will be exerted on the site. Two potential adverse outcomes for the streambank and roadway prism may be foreseen:

- (1) Impinging flow will tend to spiral downward and in a downstream direction after it contacts the bank, forming a scour hole and possible undercutting of the bank. Visual evidence of scour hole formation (flow deceleration, "boiling" from upwelling currents) was seen at the time of the site visit, but no estimation of the depth of the hole could be made because of turbidity.
- (2) The inability of the flow energy to dissipate along the bend because of the lack of roughness and deformability of the hardened bank will tend to cause the erosional forces to propagate immediately downstream, with the potential for an increase in bank erosion at the downstream transition from riprap to unarmored bank.

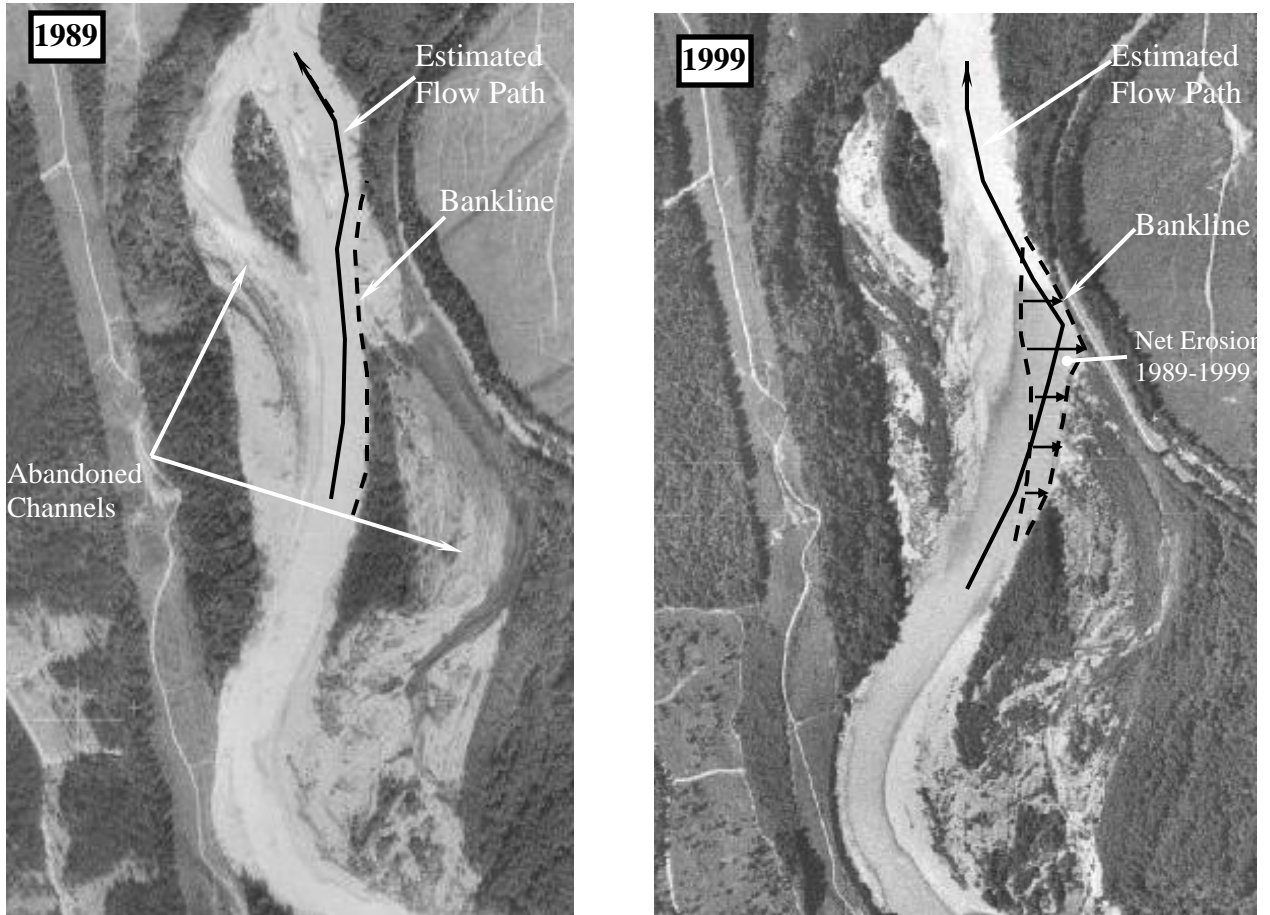
**Figure 8.** Aerial view of assessment site and reach showing channel changes and abandoned channels.

Abandoned channels exist on either side of the river both immediately above and below the site (Figure 8), and the relatively young age of riparian vegetation within and along the margins of these channels indicate that abandonment was recent. This avulsion is confirmed by the most recent 1:24K USGS topographic map (Rockport quadrangle, 1979), which shows the main thread of the channel occupying the alignment of the current relic channels in the vicinity of the CED site. A review of aerial photos since 1989 indicate a lateral advance in the outer meander bend toward the CED site. In addition, the channel planform has shifted such that main thread of

the channel, which previously had run nearly parallel to the project site, is now impinging more directly on the site (angle of attack approximately 45°). Several wide, shallow lateral bars were observed in the assessment reach immediately above the CED site; these, along with the aforementioned evidence of recent avulsion and lateral migration of the main channel, suggest a moderate degree of horizontal and vertical instability within this reach. Relative to its geomorphic setting within the watershed (high sediment supply, low gradient, moderate confinement), the assessment reach is tending toward equilibrium. However, the reach immediately upstream of the site is a depositional zone subject to rapid channel changes and avulsions into abandoned channels during high flow events. These avulsions can change the angle at which the river impinges on the CED site, and increase the risk of future bank erosion. The observed lateral migration and potential for avulsion during large peak flow events are considered to be reach-based mechanisms for bank failure at the CED site.
