**Technical Memorandum:  
River Bank Erosion at SR 7, Milepost 4.75,  
Tilton River, Lewis County, WA**

**Work Order MT0265**

**Ed Molash, Hydrologist  
WSDOT Environmental Services  
Hydrology Program**

**July 2010**

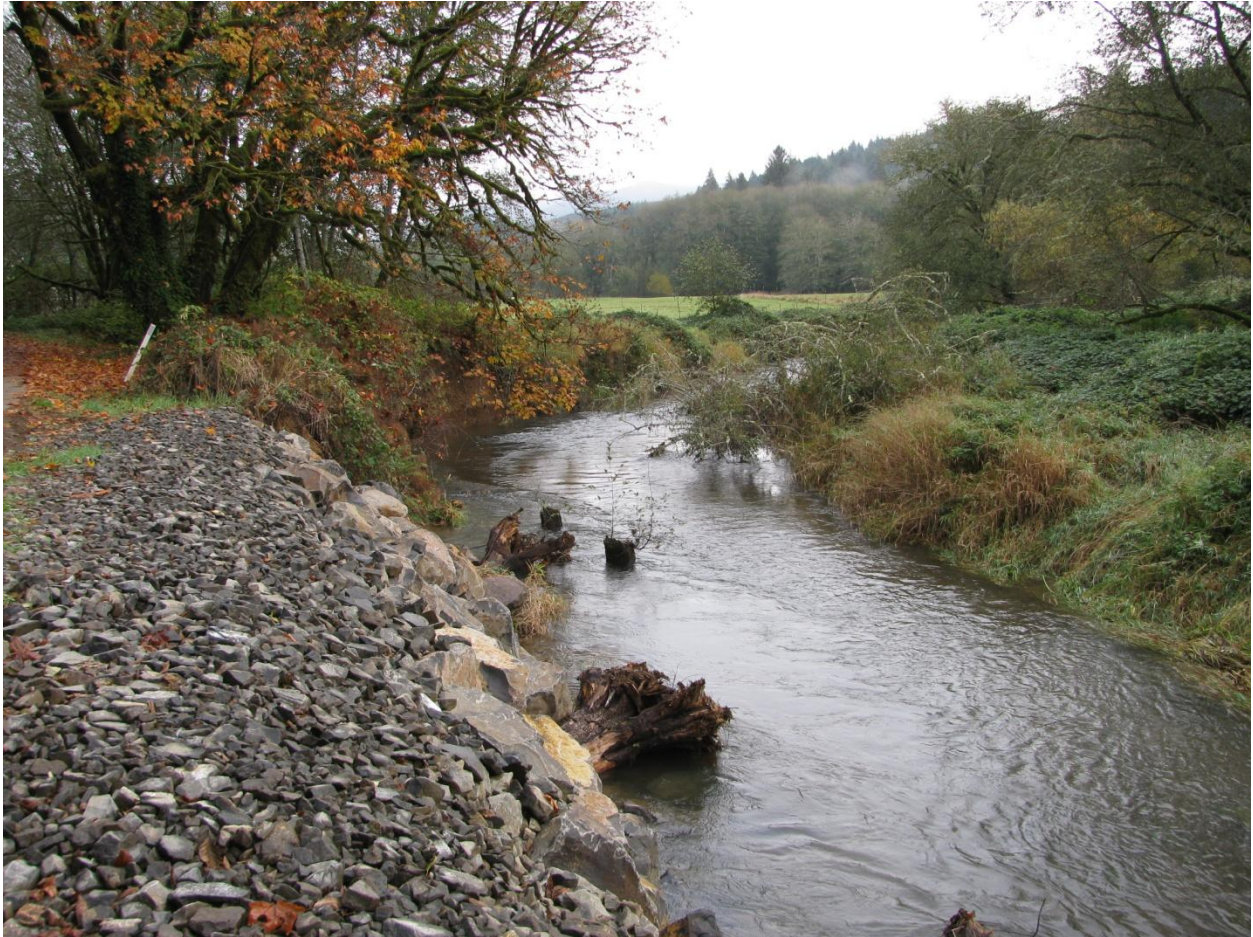
**Figure 2. Bank repair on Nelson Creek, Wahkiakum County, looking north.**

A prime example of this type of bank repair was constructed in 2009 by Wahkiakum County Public Works on Nelson Creek. Photos of the completed bank repair are shown in Figures 2, 3, and 4.

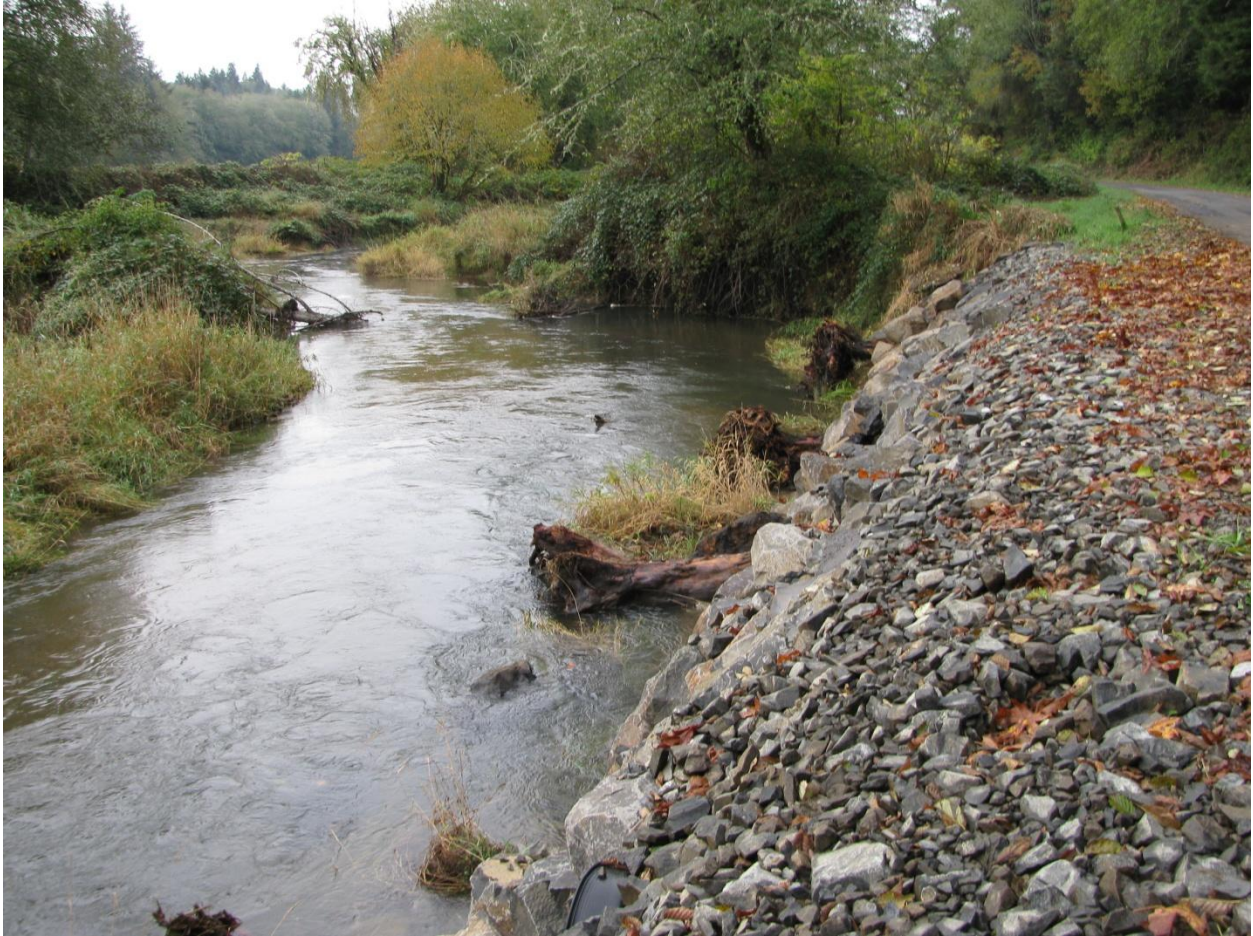
**Figure 3. Bank repair on Nelson Creek, Wahkiakum County, looking south.**

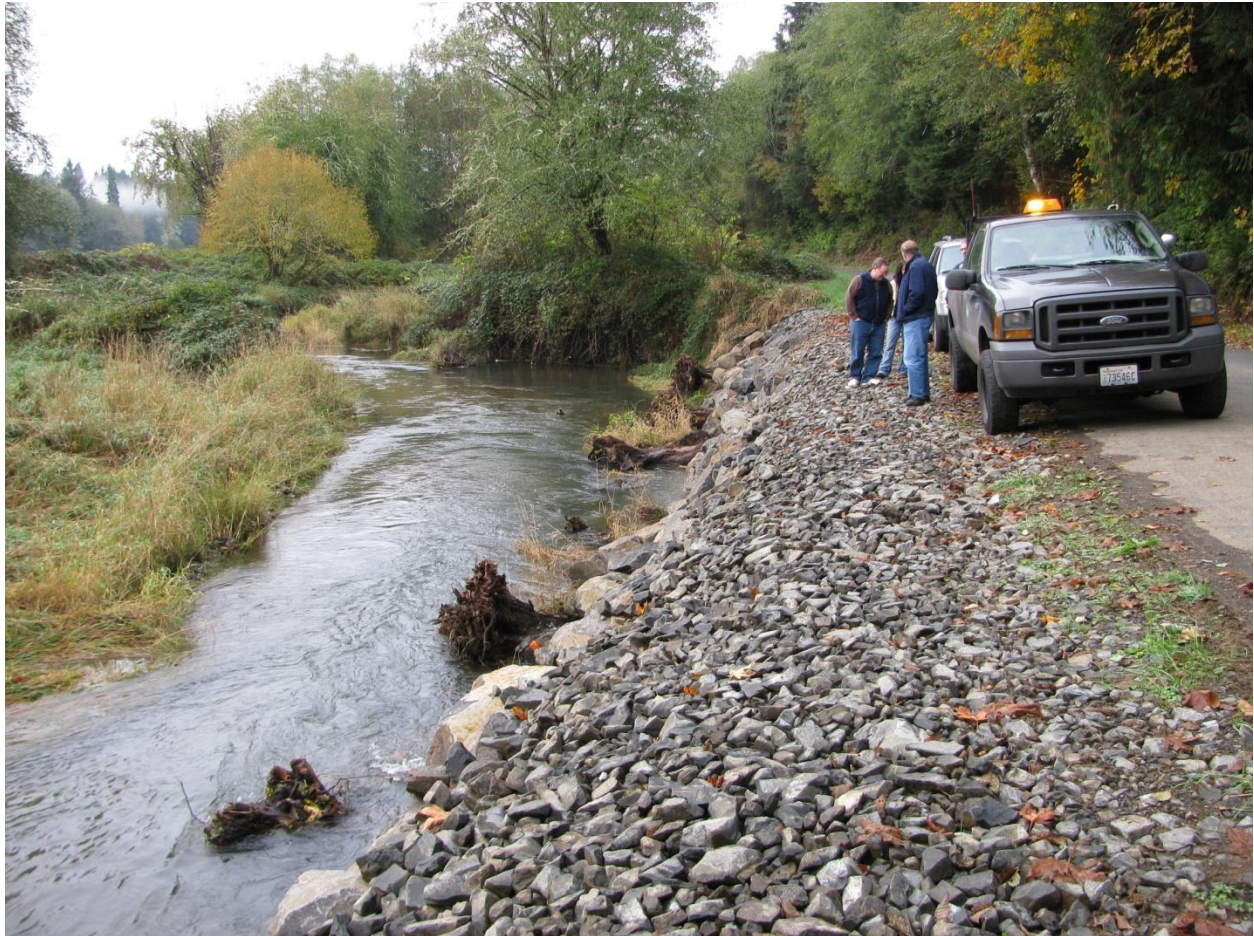
**Figure 4. Bank repair on Nelson Creek, Wahkiakum County, people for scale.**
