**Site and Reach Assessment
Middle Fork Wildcat Creek
At SR 8, MP 5.01
Bridge No. 8/13**

Work Order MS 5454

**Rob Schanz, Hydrologist
WSDOT Environmental Services
Watershed Management Program**

October 2007

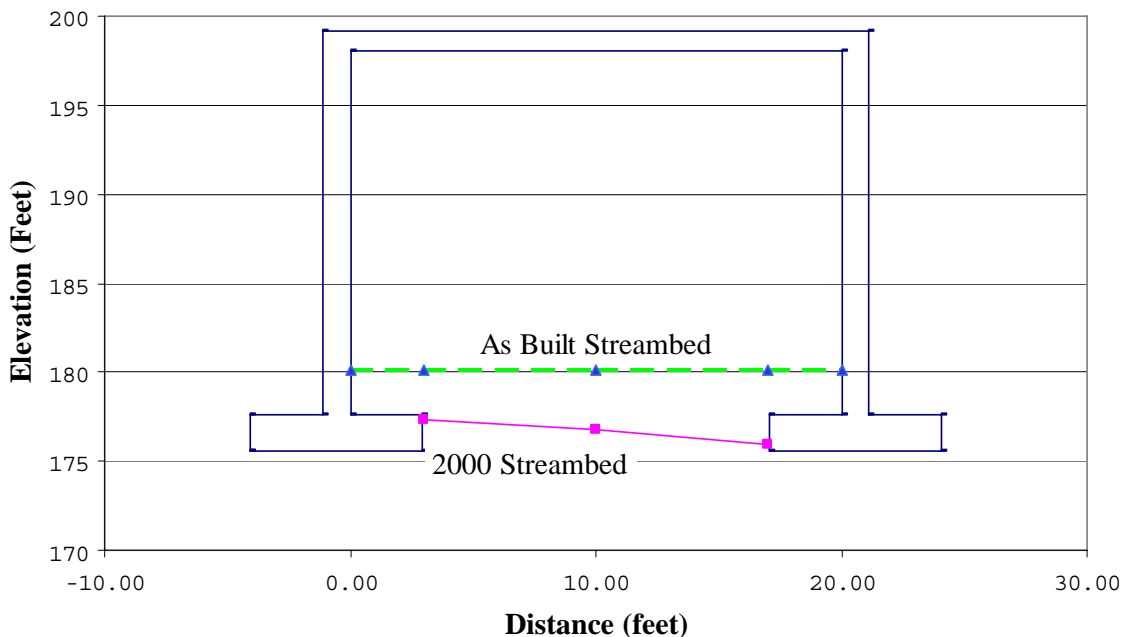
Figure 2. Historical Cross Section Surveys of the SR 8 Wildcat Creek Culvert

Washington State Department of Transportation (WSDOT) Bridge Inspection Reports from 1995-2005 show a history of problems at the culvert associated with streambed erosion (WSDOT, 2007). The 1995-2003 reports note increasing exposure of the culvert and wing wall footings. Wing walls were tipping out one to two inches at the top. In the winter of 2005 the southeast outlet wingwall failed and tipped into the creek.

An emergency repair was completed in September 2005 to replace the failed wing wall. The southeast wingwall is now on deeper footings, but the other wingwall foundations are still shallow and vulnerable to undermining. During this repair WSDOT covered all footings with heavy loose riprap, and installed nine boulder drop structures in the culvert and at the exit to control erosion and maintain fish passage (Figure 3). These boulder drop structures were designed to create a series of pools, with a maximum drop of about one foot between pools. The first structure (A-4) is located just upstream of the inlet, and was not visible in April 2007. The next four structures (A-3, A-2, A-1, and A) control the gradient within the culvert. The last four structures step flow down from the outlet to a deep pool near the WSDOT right-of-way boundary. Two rootwads are anchored into heavy loose riprap on each bank at the bottom drop structure (Figure 4).

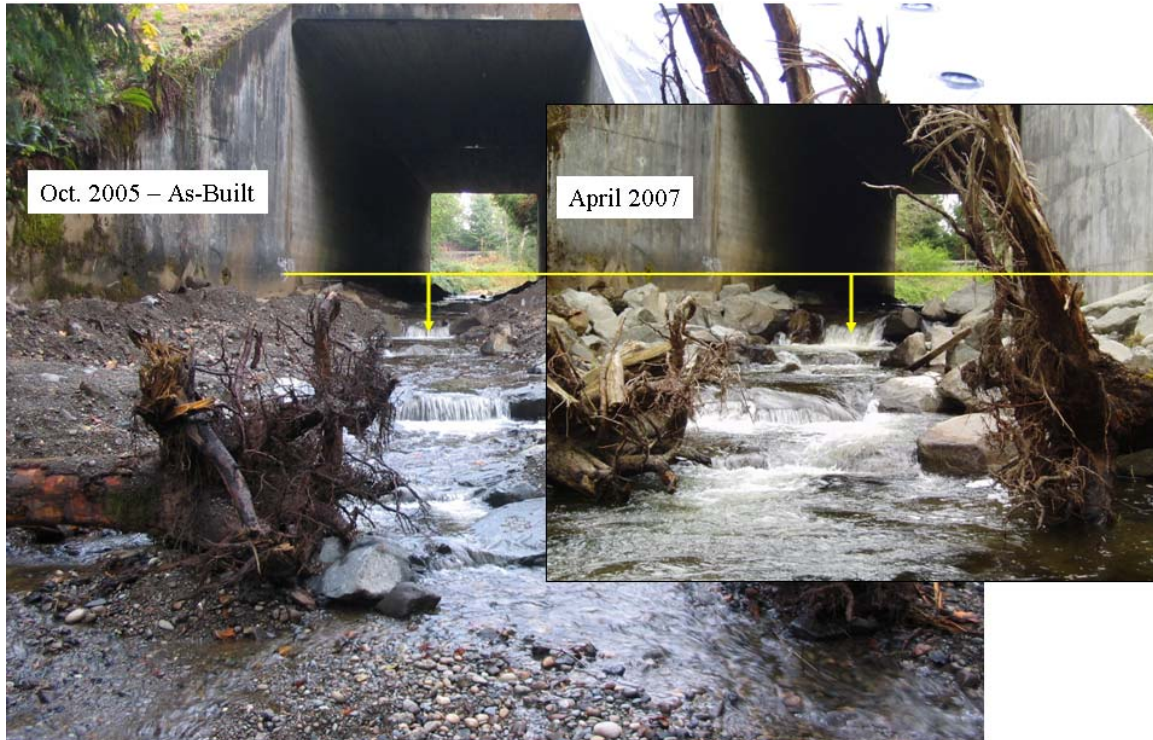
Figure 4. Photos of As-Built and Current Conditions at the Culvert Outlet

The boulder structures were originally covered with fine streambed material to provide substrate and fill interstitial spaces (Figure 4). High flow energy at the outlet removed most of this fine material in the 2005-06 rainy season. WSDOT replaced the lost streambed material in the summer of 2006 with cobbles of 10 inches or less and gravels (Bob Barnard, personal communication). Much of this washed out again in the winter of 2007. This loss of fine material causes leakage and lowering of water levels in the pools behind the boulder structures.

Pool dewatering and boulder settling combine to create elevation drops that impede fish passage. The water surface now drops two to three feet between the B and C pools, depending on flow levels.

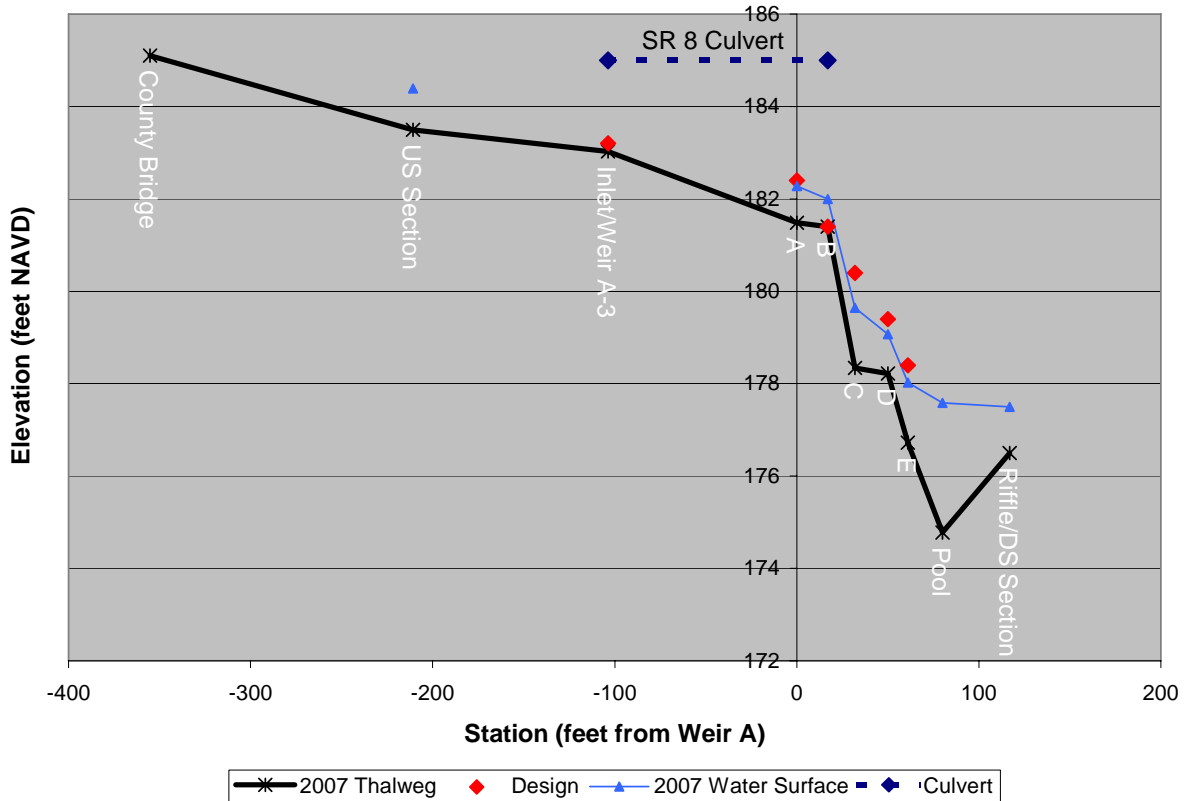
Figure 5. Streambed Profile of Wildcat Creek near SR 8

Figure 5 compares the design profile to drop structure elevations surveyed in 2007. The channel bed slopes at about 1.4 percent between the inlet and outlet. Drop Structure B at the culvert outlet is relatively stable, with a minimum elevation close to the design level. The downstream structures have settled substantially, dropping one to two feet relative to the design profile. The low point in Structure C is now about two feet lower than designed.

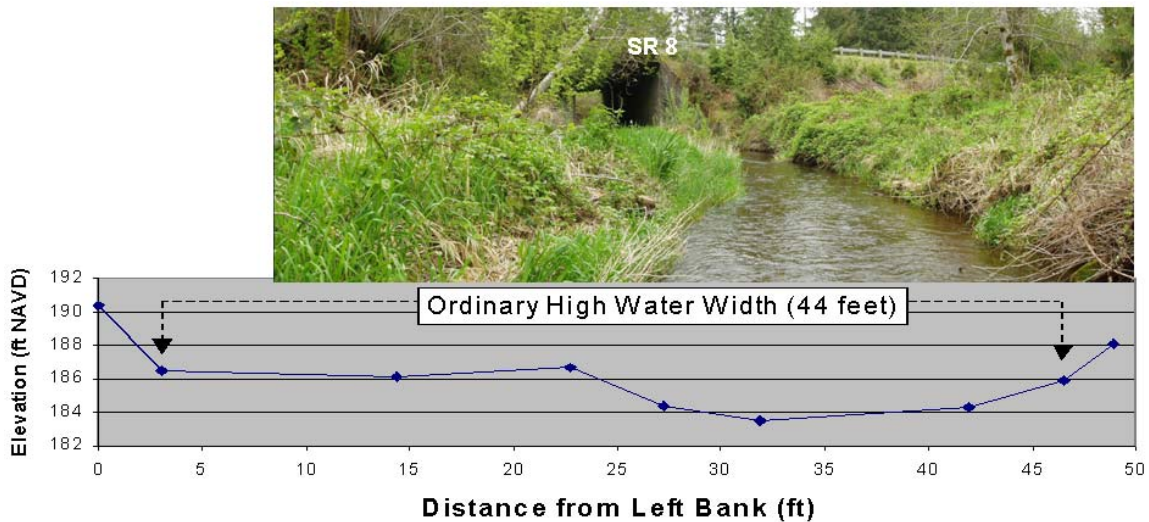
Figure 6. Cross Section of Wildcat Creek upstream of SR 8

Figure 6 shows a typical cross-section of the channel and floodplain in the segment upstream of SR 8. The active channel is about 25 feet wide. A 20-foot wide floodplain bench lies about three feet above the channel bottom on the left bank. Scour marks and surface deposition indicate that this bench is frequently flooded. Ordinary High Water is indicated by a scour line on the slope above the left bank floodplain, and by an erosion scarp at the transition between canary grass and Himalayan blackberry on the right bank. The total channel and floodplain width is about 44 feet at Ordinary High Water.

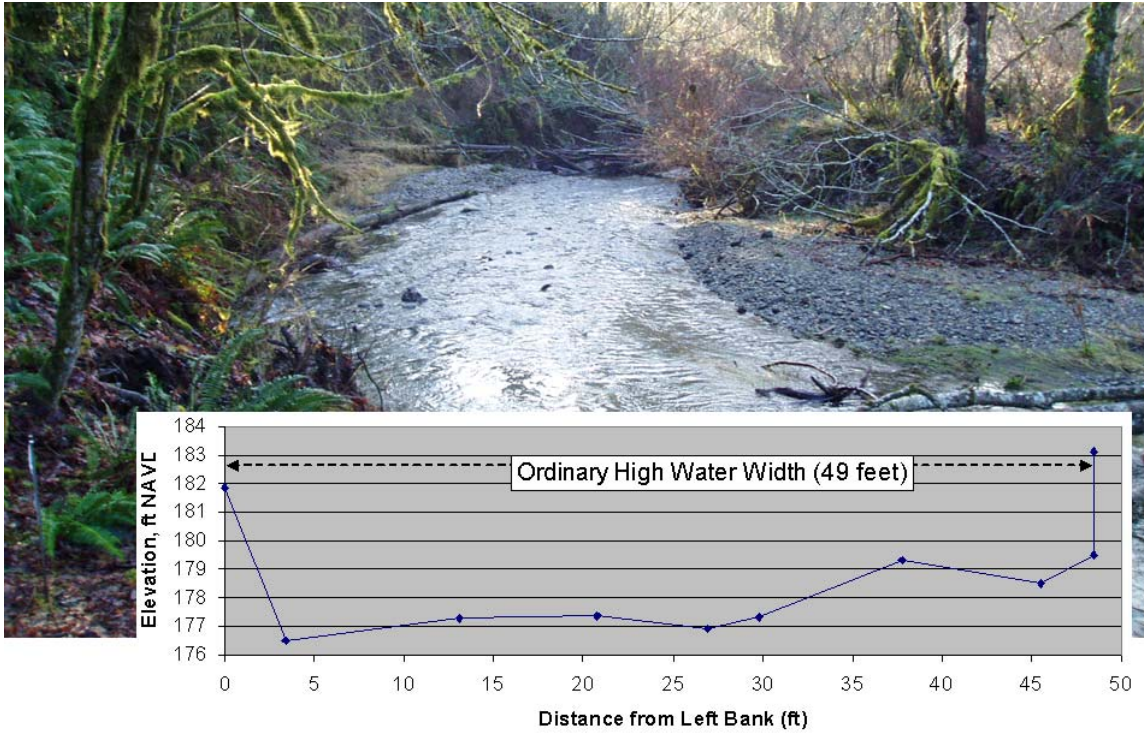
Figure 7. Cross Section of Wildcat Creek downstream of SR 8

Figure 7 shows a cross section of Wildcat Creek at the top of the riffle (just below the pool tail out). Low flows spread shallowly across a 26-foot-wide bed of gravel and cobble. The channel is deepest along the toe of the curving left bank. On the right bank the channel transitions onto a 19-foot-wide gravel bar. The right bank above the gravel bar is nearly vertical, and transitions onto an upland terrace that may flood during extreme events. The left bank consists of a steep scarp that transitions into a forested slope. Distinct scour marks and undercut tree roots mark Ordinary High Water on each bank. The total width at Ordinary High Water is about 49 feet, including the low flow channel and adjacent gravel bar.

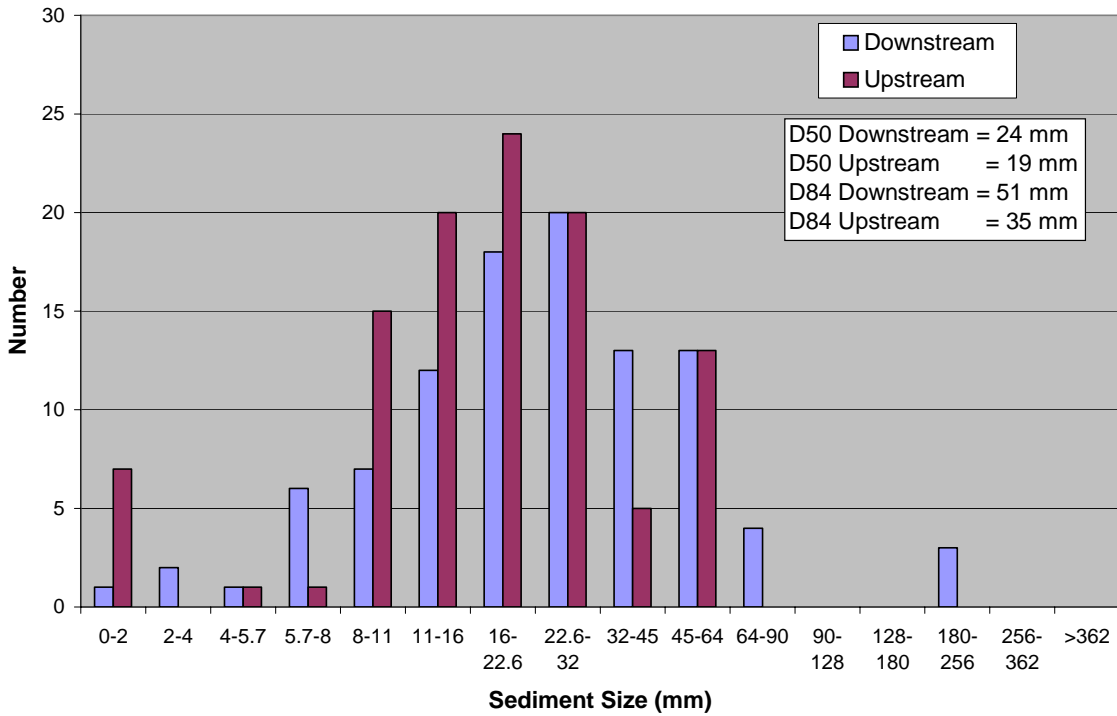
Figure 8. Sediment Size Distributions in the Wildcat Creek Channel

Figure 8 compares typical sediment size distributions in the upstream and downstream cross sections. These were derived from bank-to-bank Wolman pebble counts taken in April 2007 at the two surveyed cross-sections. The upstream channel had a D50 of about 19 mm. All sampled material fell in the sand and gravel size classes. The downstream riffle was coarser, with a D50 of 24 mm and a broader range of size classes (from sands to large cobbles). The riffle becomes coarser downstream of the sampled section, with more cobbles and large gravels.

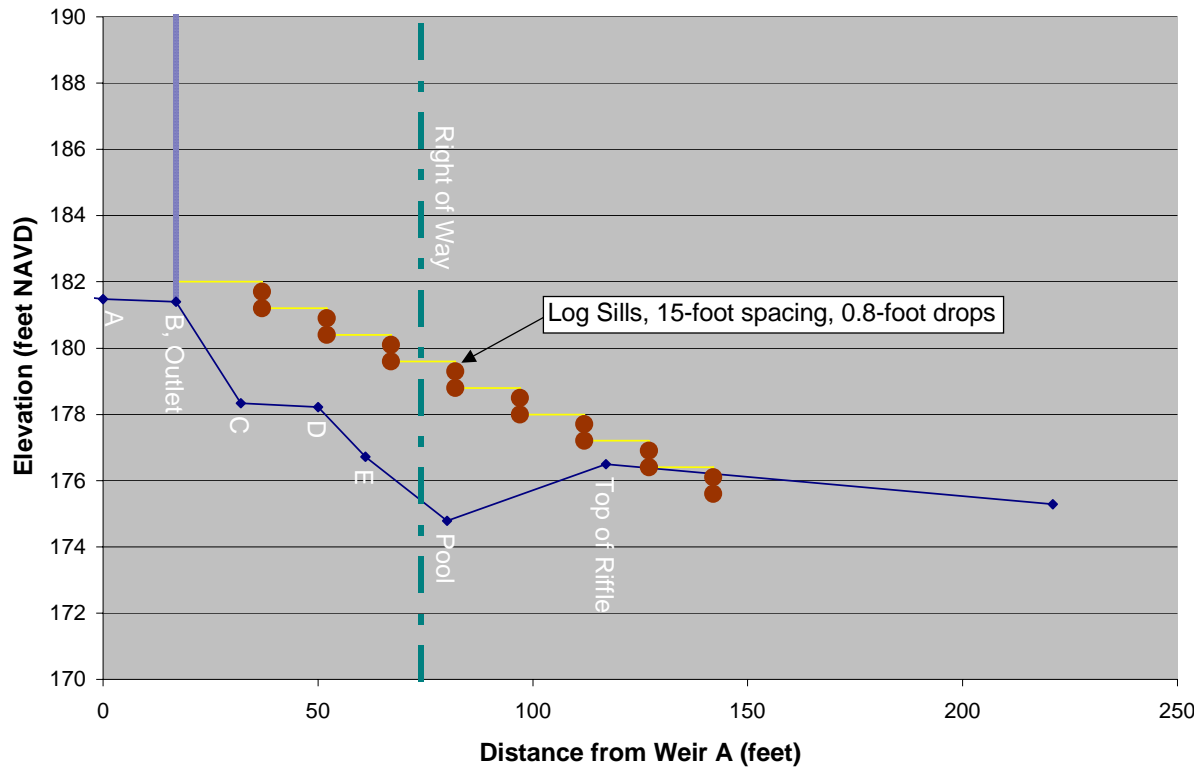
Figure 15. Streambed Profile for Log Sills (Alternative 2)

Performance and Risk: This alternative would require extensive construction work outside of the WSDOT right-of-way, both in-channel and on adjacent upland areas to anchor logs. The last structure would end at least 53 feet beyond the right-of-way boundary.

This alternative would probably require some future channel maintenance work inside and outside of the WSDOT right-of-way. Log sill structures work best with channels less than 30 feet wide (WDFW, 2003); in this case the channel toe width at the downstream riffle is about 45 feet. The widths of structures and the high energy of flow at the culvert outlet indicate a moderate risk of flanking or undermining of log sills. Flanking of the structures could cause bank erosion and damage to adjacent properties.

Description: The existing boulder structures below the outlet (structures C-E) would be removed and replaced by a series of log sills/weirs designed to specifications described in the WDFW culvert manual (WDFW, 2003). The sills would each create a drop of less than 0.8 feet.

The top pool would backwater and tie into a grade control structure at the culvert outlet. This grade control structure is needed to prevent erosion from progressing up the culvert bed if the downstream logs fail. The existing rock Structure B could provide this grade control, or could be replaced with a buried concrete sill to provide higher reliability. The outlet control structure should be submerged by the backwater from the first downstream log sill.

The ends of the first two log sills would be buried in heavy, loose riprap placed along the base of the culvert wingwalls and anchored to concrete blocks. This riprap would help anchor logs, and would also protect the walls if the weirs are flanked or undermined. Below the wingwall, logs would be placed in trenches in the adjacent streambanks, anchored to concrete blocks, and covered with rock and soil. Bank protection would also be needed between structures to discourage flanking.

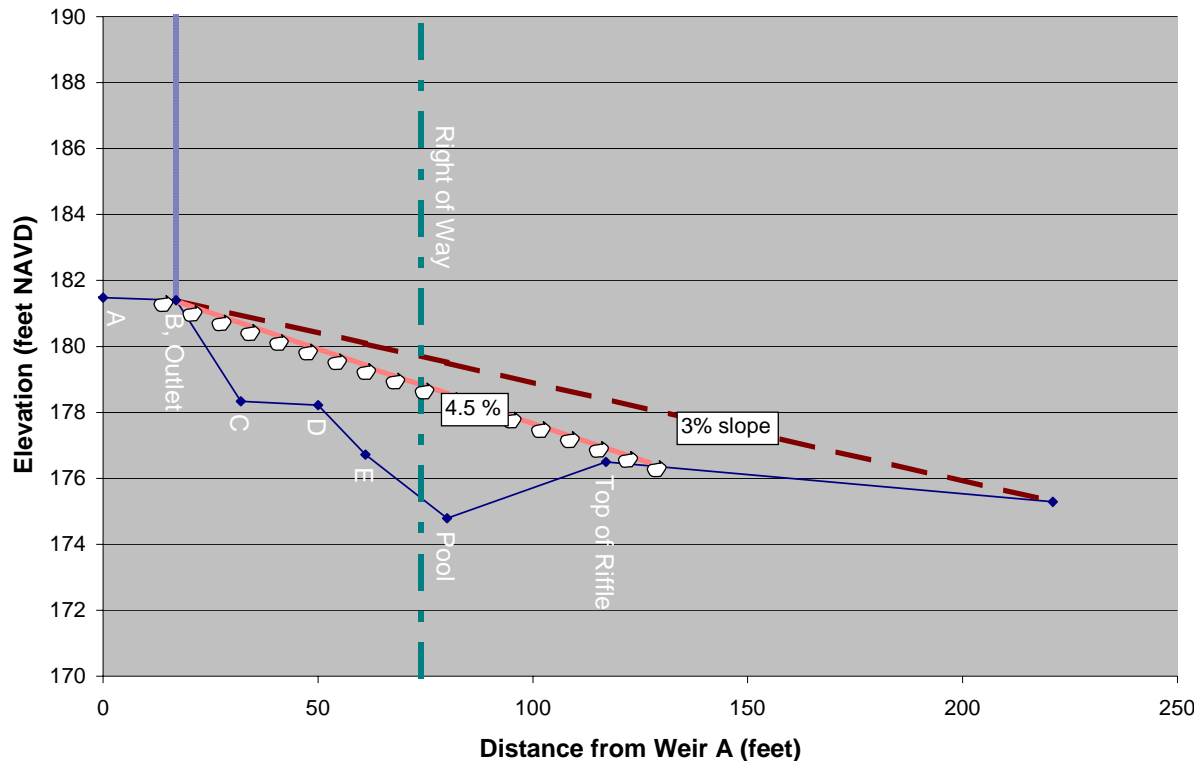
Figure 16. Streambed Profiles for a Roughened Channel (Alternative 3)

Figure 16 shows two alternative roughened channel profiles. The WDFW culvert manual recommends a maximum slope of three percent as a general guideline. However, this slope would extend the channel more than 200 feet below the culvert outlet, and would cover almost all of the next downstream riffle. Much of the roughened channel would be within a sharp bend, where flow curvature would increase risks of failure and damage to downstream properties. A steeper channel at 4.5 percent slope would end at the top of the downstream riffle and avoid the downstream bend in the channel. However, this would require a very coarse substrate (D84 of 1.3 feet) to reduce scour. The average velocity during January fish passage flows would be about 3.5 feet per second. Projecting boulders would create resting areas with significantly lower velocities.

Roughened channels are less prone to flanking and bank erosion than log sills. To avoid the downstream bend the channel would have to slope steeper than recommended by WDFW guidelines, and would therefore have a higher risk of scour and removal of bed material. Proper design of roughened channels depends on accurate estimates of stream hydrology, hydraulics, and sediment properties. If the large elements of the channel bed are not sized properly, erosion could progress upstream and re-create the headcut that currently causes fish passage problems. Fine material could also be washed away, leading to dewatering problems similar to those that occur with the existing boulder structures.

Description: A new channel bed would be constructed with a linear slope from the culvert outlet to the downstream riffle. The bed would be constructed of a coarse mix of sediment that includes large rock sized to resist scour and provide hydraulic diversity. Scattered boulders would project above the streambed to create hydraulic shadows and resting places for fish as they negotiate the higher velocities in the steepened channel segment. The new channel would raise the streambed by about three to four feet in the scour pool at the right-of-way boundary. It would also bury the foundations of the culvert wingwalls. The heavy loose riprap that covers these foundations would be left in place, and could be further reinforced as long as the angular riprap is buried by new streambed material.

The top of the new channel would tie into a grade control structure at the culvert outlet that protects the culvert bed from erosion if the roughened channel fails. This grade control structure could consist of either the existing rock structure B, or a buried concrete sill tied into the culvert walls for higher reliability.

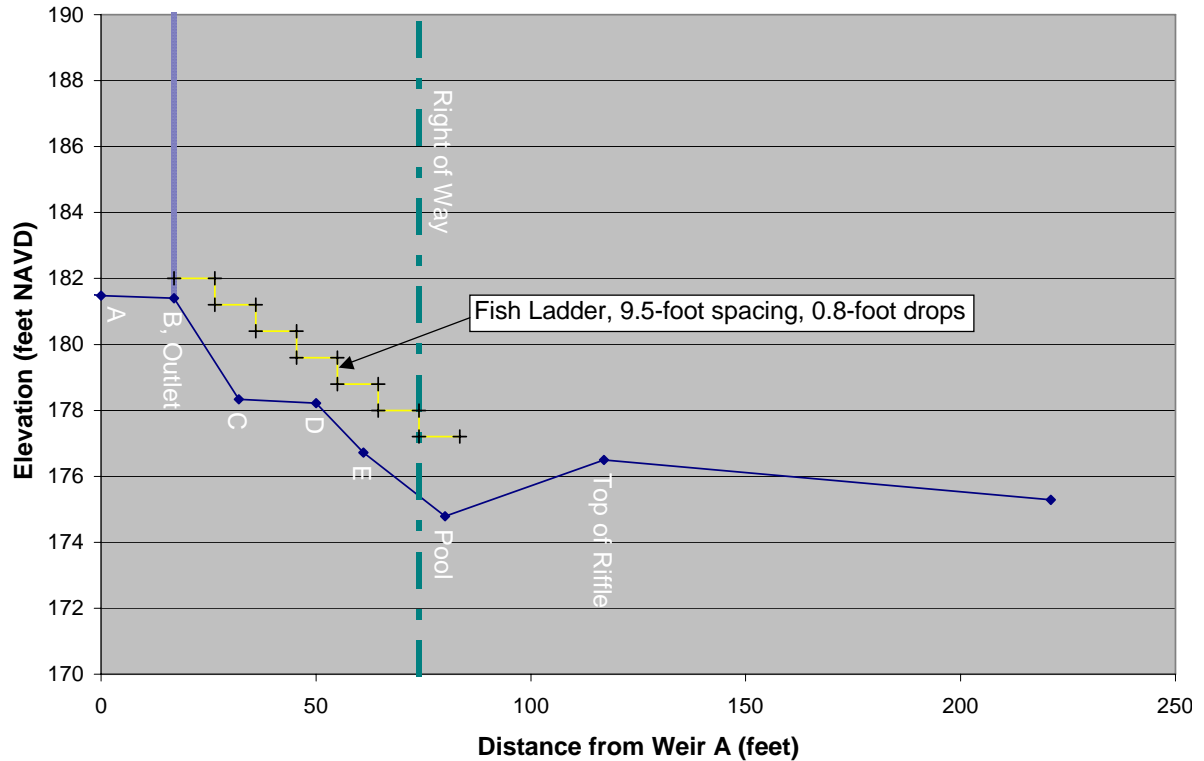
Figure 18. Streambed Profile for an Outlet Fish Ladder (Alternative 4)

Each pool would have to have enough volume to dissipate energy and discourage the formation of whitewater. WDFW recommends a maximum Energy Dissipation Factor (EDF) of about 4 ft-lbs/ft³/s for fish ladders. A 20-foot-wide pool with a hydraulic drop of 0.8 feet would have to be 8.5 feet deep to meet this criterion for the January fish passage flow. Pools this deep could compromise the integrity of adjacent foundations, and would tend to fill with sediment after each storm event. This alternative is therefore not likely to meet energy dissipation requirements for fish passage without almost constant maintenance.

Fish ladders function best in controlled systems with low ranges of flows. The weir control structures and pools have narrow operating ranges, and are difficult to design for optimal fish passage conditions under the wide range of flows that occur in natural streams. As discussed above, the short distance from the culvert outlet to the right-of-way boundary limits the pool area available for energy dissipation. This leads to pool depth requirements that will be difficult to construct and impractical to maintain.

Description: The boulder structures at the outlet would be removed and replaced with a concrete fish ladder, consisting of a series of lined pools and notched concrete weirs that step flow down to the natural streambed elevation near the WSDOT right-of-way boundary, 57 feet downstream of the culvert outlet. Stepping down with a maximum drop of 0.8 feet would require 6 pools with weirs spaced about 9.5 feet apart. Figure 18 shows how this alternative would alter the streambed profile.

The upstream pool would be 20 feet wide to match the existing culvert, and subsequent pools would flair out downstream to tie in to the channel banks at the right-of-way boundary. The last weir would discharge into the deep pool at the right-of-way boundary.

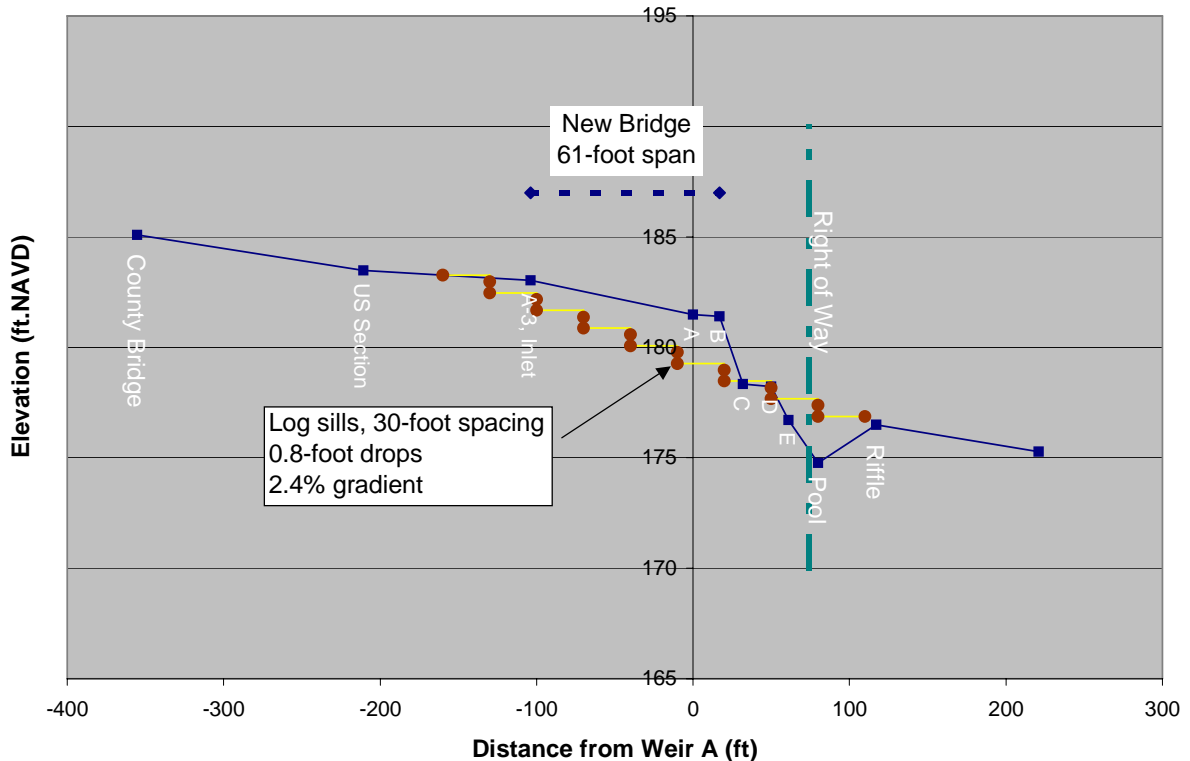
Figure 19. Streambed Profile for a New Bridge (Alternative 5)

Performance and Risks: This alternative would reduce flow confinement and allow the natural movement of sediment and wood through the system. Without grade control, it could also allow downstream channel incision to progress and threaten upstream bridges and properties. Figure 19 shows how grade control structures could be used to control the streambed profile in this reach. Log sills spaced 30 feet apart would control the gradient within the WSDOT Right-of-Way at about 2.4 percent, and limit the risk of progressive incision that would harm upstream properties. This relatively long spacing and a more gradual profile would considerably reduce erosion and flanking risks for these log structures (in comparison to the log sills used in Alternative 2 above).

Description: The entire SR8 culvert would be replaced with bridges that meet WDFW stream simulation criteria. The streambed would be re-graded beneath the structures to create a stable gradient that allows fish passage. Bridge footings would be placed below anticipated scour depths.

The existing culvert is functionally obsolete, and will eventually need to be replaced. We therefore recommend a new bridge (Alternative 5) as the long-term solution to erosion and fish passage problems. This is the only alternative that fully addresses flow constriction and high velocities caused by the culvert, and restores natural movement of wood, water, sediment, and fish beneath the highway. Footings for the new bridge would be placed well below the potential scour depth, greatly reducing risks to the structure. Grade control structures may be needed beneath the bridge to reduce the risk of progressive streambed erosion and damage to upstream structures and properties.
