# **Reach Assessment for Norris Slough at SR 105**

**Robert W. Schanz, PE, LHG**  
**Jim Park, Hydrologist**  
**WSDOT Environmental Services**  
**Watershed Management Program**  
**June 2006**

**Washington State Department of Transportation**  
Environmental and Engineering Service Center  
Environmental Services Office

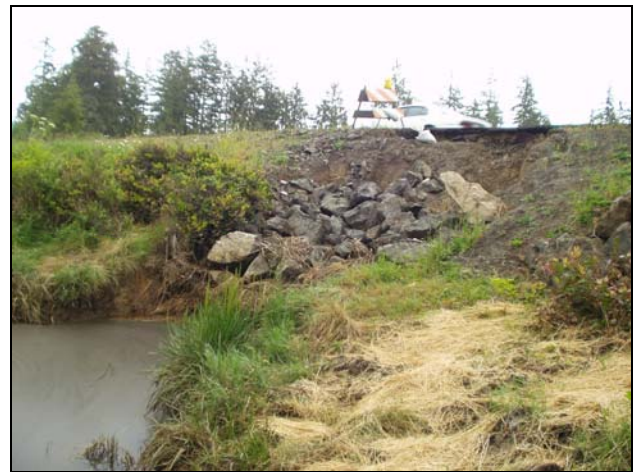
**Figure 2. 2003 photo of collapsing shoulder at the culvert inlet.**

The culvert is undersized relative to the volume of tidal and flood flows conveyed by Norris Slough. Contraction and acceleration of flows at the inlet and outlet have created deep scour holes that undermine the culvert and the road embankment. The culvert was installed without

wingwalls or bed armoring, and has rusted with exposure to saltwater. Unless it is replaced, it will eventually collapse and undermine the SR 105 roadbed.

The mechanisms of failure are undermining of the culvert and surrounding road embankment by scour, and structural collapse of the culvert. This is caused by excessive contraction of flows at the culvert inlet, and by deterioration of the metal culvert by exposure to saltwater.

We examined two alternatives for replacing the culvert. Replacing the culvert with a bridge provides greater environmental benefits, and costs less than replacement with a three-sided structure. We therefore recommend the bridge alternative (Alternative 1) as the long-term solution for SR 105 at Norris Slough.

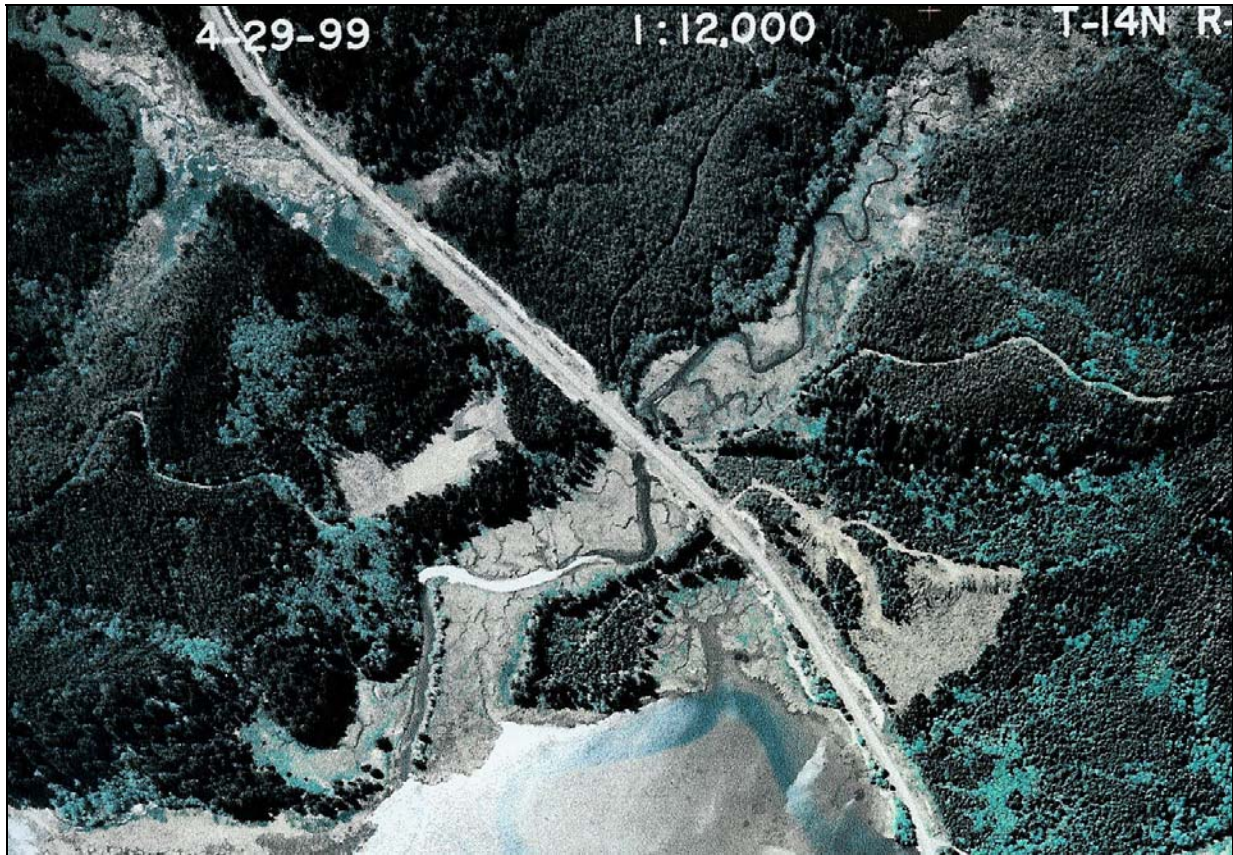
The tidal portion of Norris Slough upstream of the culvert is about 2600 feet long, and meanders across a 200- to 550-foot wide marshplain (Figure 3). Near SR 105 the channel is a deep slough lined with tidal mud. The upper bank within the root zone is nearly vertical, but transitions to sloping mud that extends from the bottom of the root zone to the channel invert (Figure 4). WSDOT field surveys measured an average channel top width of 50 feet at the Mean Higher High Water elevation (8.1 feet NAVD). In many locations the active channel contains a 10-20 foot wide terrace at about +5.5 to +6.0 feet NAVD. These terraces are inundated by most high tides, and are typically colonized by Lyngby sedge.

**Figure 3. Aerial Photo of the Norris Slough Valley**

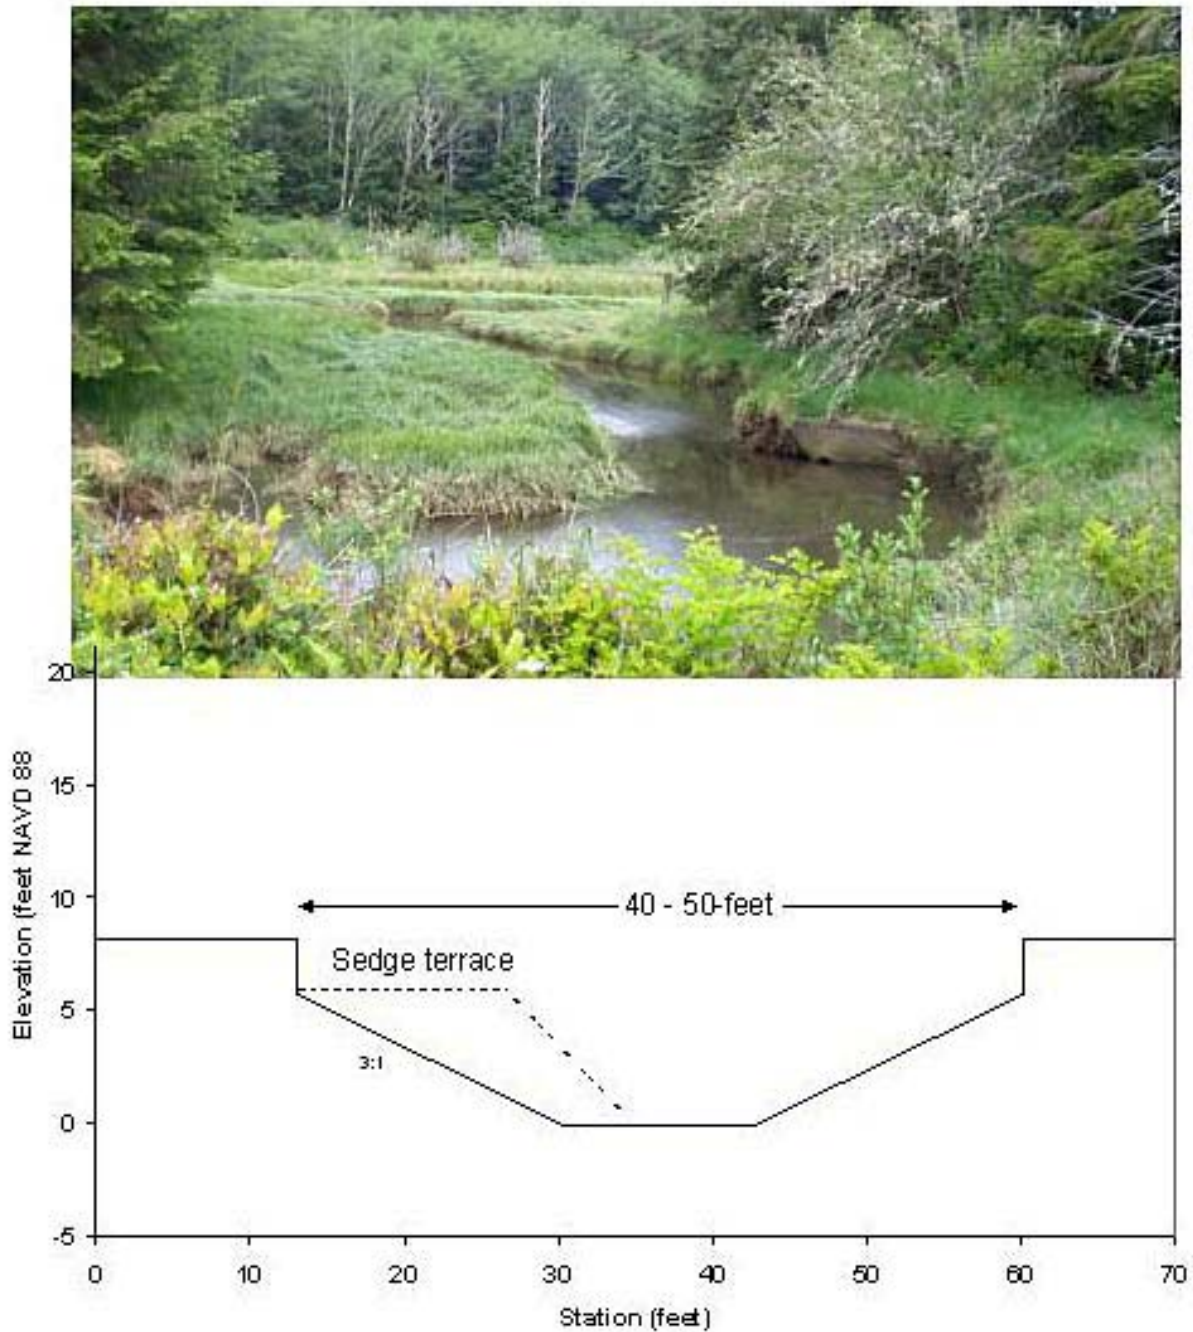
Applying these relationships to Norris Slough (Marsh Area = 16 acres) yields a channel cross-section area of 285 square feet and a depth of 8.2 feet. Assuming a section shape similar to that shown in Figure 4, this corresponds to a channel top width of about 50 feet at MHHW. This is remarkably consistent with widths surveyed by WSDOT at Norris Slough.

**Figure 4. Typical Cross Section of Norris Slough near SR 105**
