Reach Assessment for the South Fork Newaukum River at SR 508 Milepost 7.3

Work Order MS 5404

July 2006

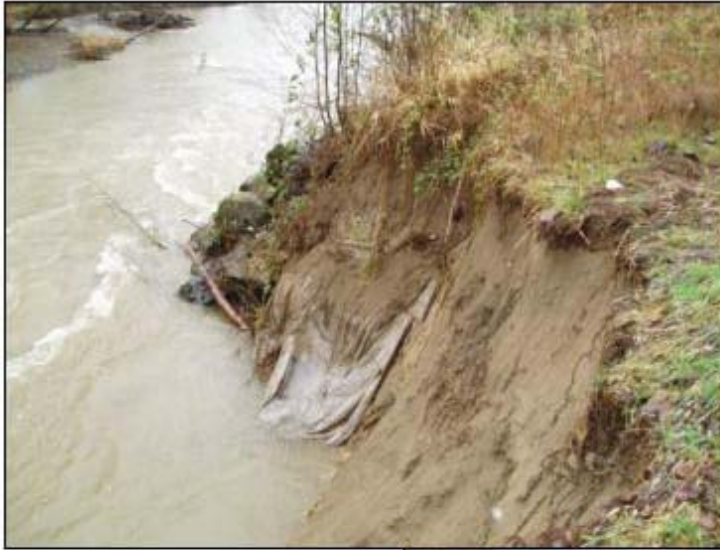
The South Fork Newaukum River removed 8-10 feet of bank during this storm, leaving less than 15-feet of terrace between the roadbed and the riverbank. Erosion was concentrated in a 40-foot scalloped section of bank between the second and third river barbs. Large fissures opened up on the terrace, and the road settled several inches overnight. WSDOT closed the road on January 13, and SR 508 was included in the Governor's declaration of emergency for the January 2006 storms. A rock buttress was installed as an emergency repair between the second and third barbs, filling in the scallop and stabilizing the slumping terrace (*see cover photo*). This buttress has

stabilized a 140-foot section of bank, but erosion scallops continue to develop upstream and downstream of the installed rock.

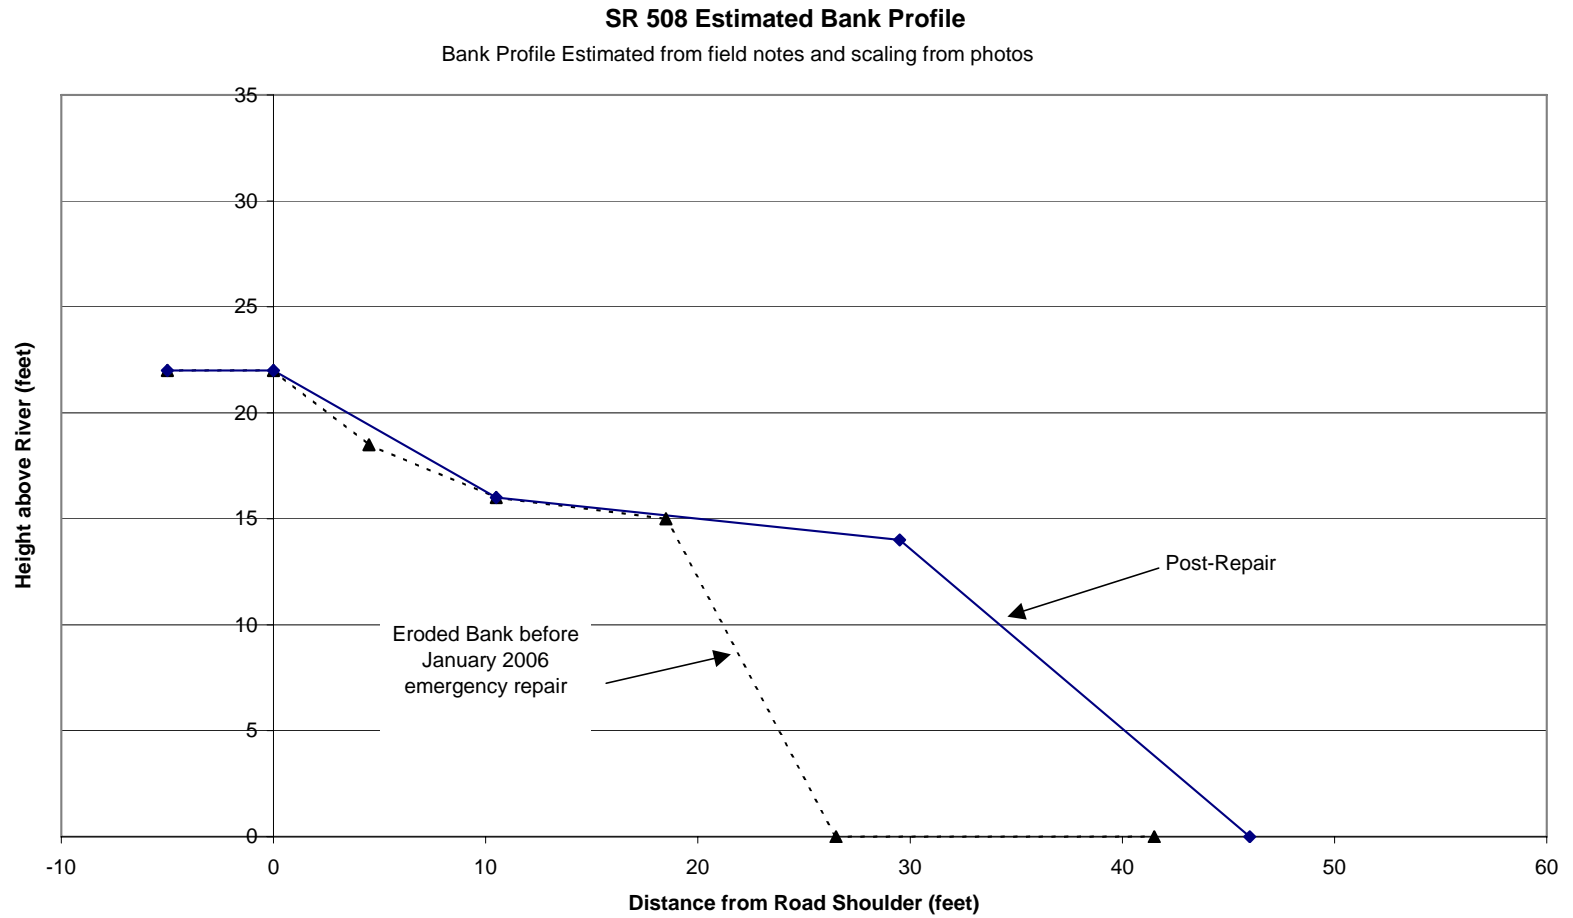
Figure 2. Estimated Riverbank Profiles at the Erosion Site

Figure 2 shows typical sections of the bank before and after the emergency repair. On January 12 (before the repair) the river had dropped below its peak flood level, and was flowing at about 1350 cfs at the project site. The eroded bank was about 15 feet high, and consisted of loose sandy silt. Sandy siltstone was exposed at the base of the slope, just above the river water level. Seepage was emerging from subsurface drainage pipes and from the eroded bank along the top of exposed geotextile fabric (*see cover photo*).

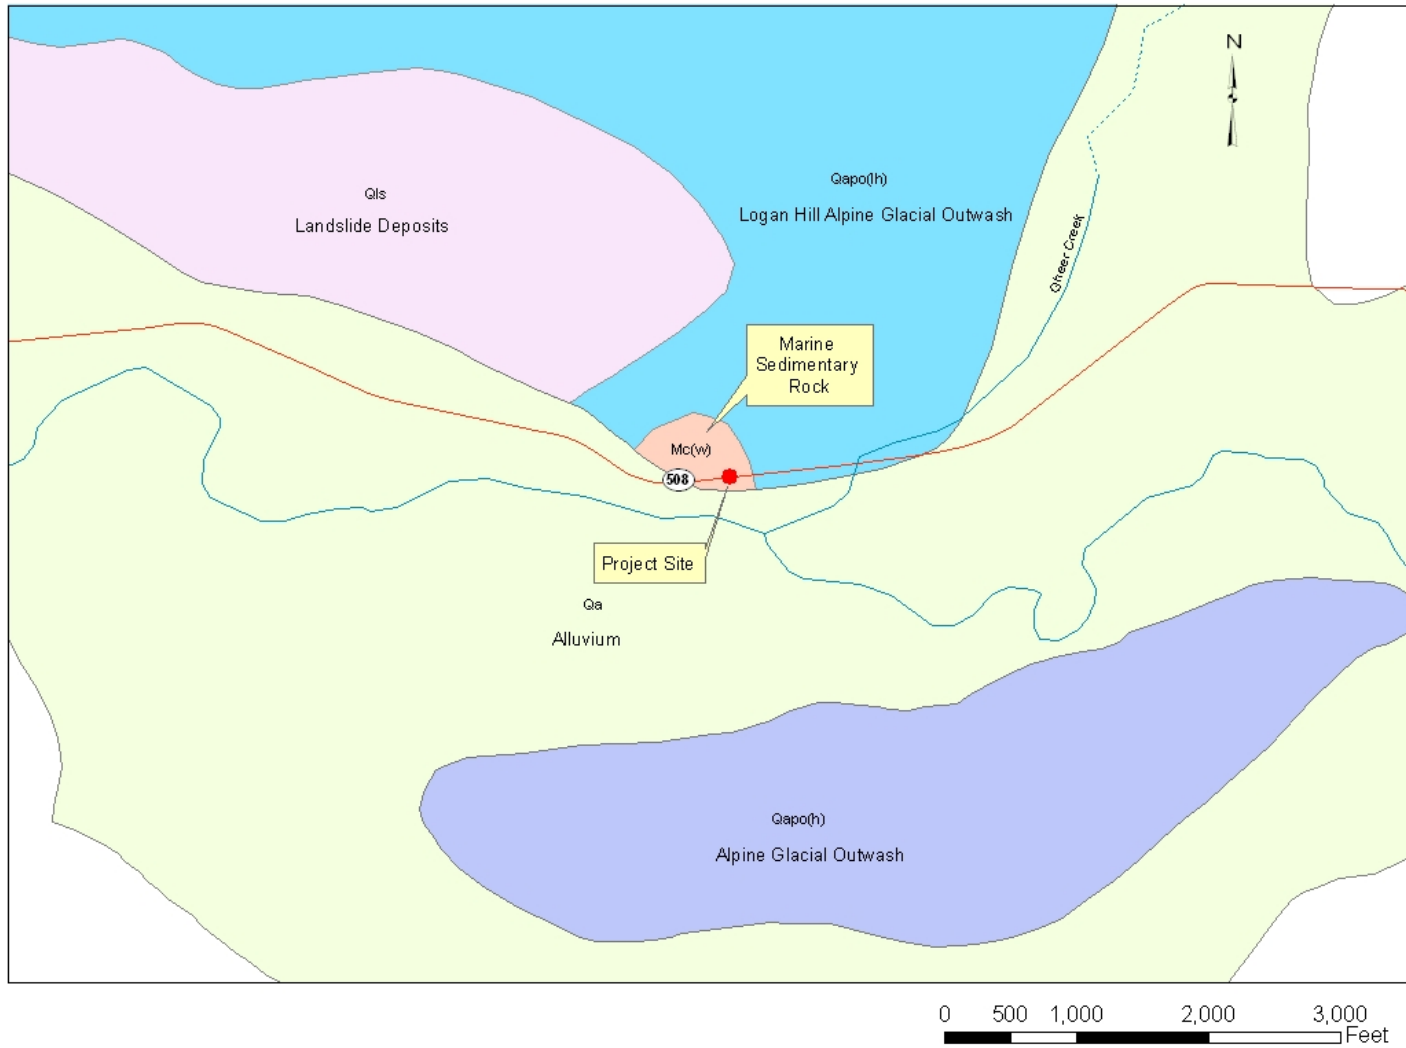
Figure 3. Surficial Geology near the Project Site

Figure 3 shows the surficial geology in the vicinity of the project site, based on 100K Department of Natural Resources (DNR) mapping. Low areas next to the river are covered by coarse alluvial soils found in floodplains that are frequently dissected by channels (USDA, 1979). Cloquato silt loam and Chehalis silty clay soils cover the higher floodplains on the south side of the valley.

SR 508 is built on landslide deposits at the base of a slope on the southern edge of the terrace, about 60 feet below the top of the terrace. This slope exposes Miocene sedimentary rock that underlies the Logan Hill glacial outwash (Figure 3). Geotechnical reports for the Onalaska slide describe this material as a very weak, highly weathered sandy siltstone. A shelf of this rock is exposed at the base of the eroding riverbank, at about the Ordinary High Water level of the river. A mantle of loose sandy xerothent soils covers the bedrock and makes up most of the eroding riverbank. These soils often form in colluvium derived from marine siltstone, sandstone, and pyroclastic breccia (USDA, 1979).

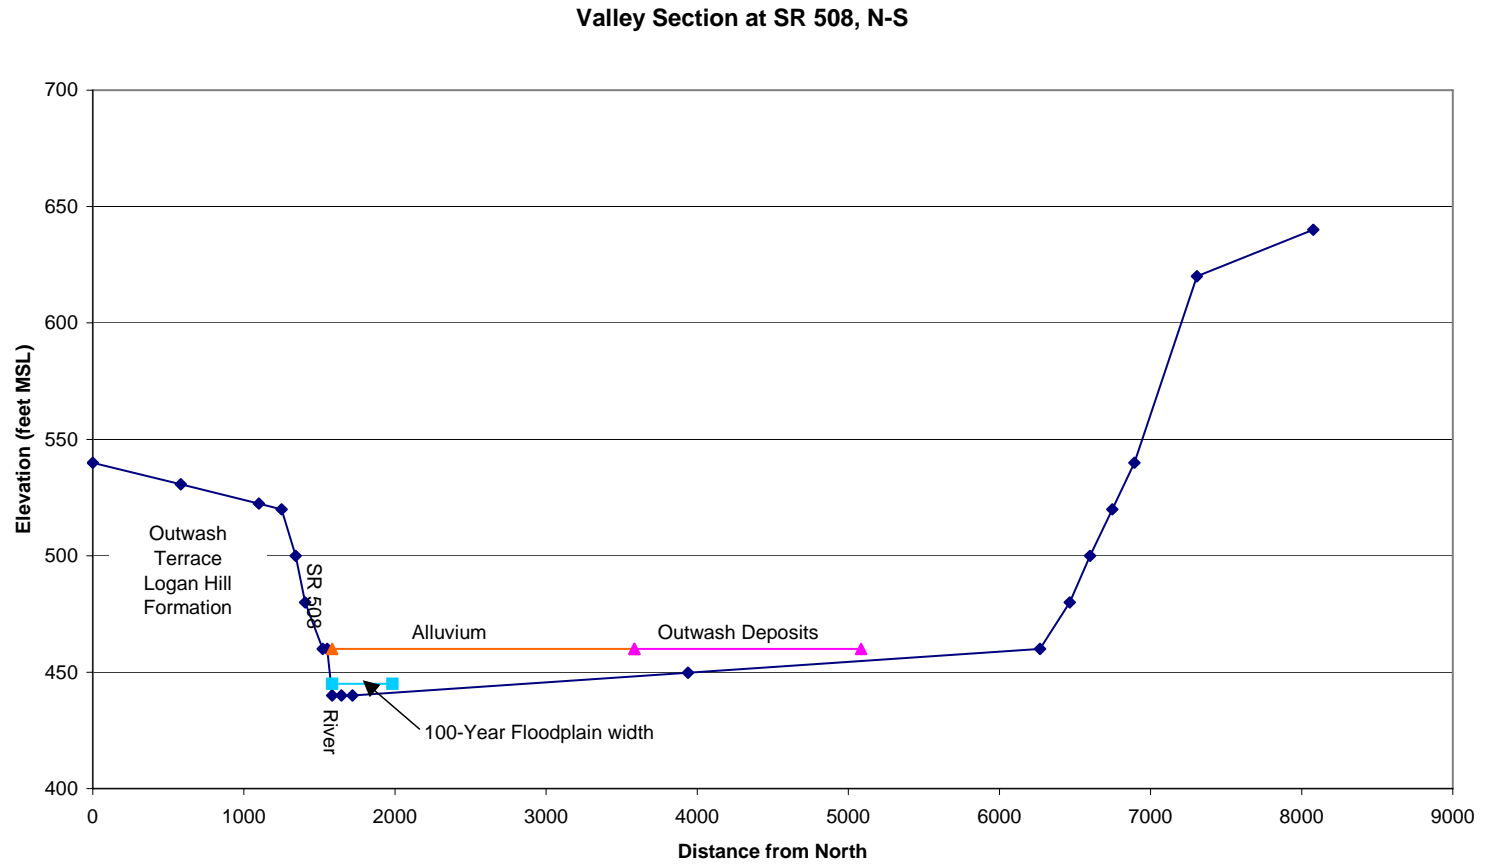
Figure 4. Cross Section of the South Fork Newaukum River Valley at the Project Site

Figure 4 shows a valley cross-section at the project site, measured from USGS 1:24K topography. At the project site the South Fork Newaukum River has migrated to the northern margin of its floodplain where it is jammed against a glacial terrace. The 100-year floodplain covers a 400-foot wide band that generally lies within low alder-covered areas next to the channel. The southern side of the valley contains a higher floodplain terrace of alluvial deposits that only floods during extreme events.

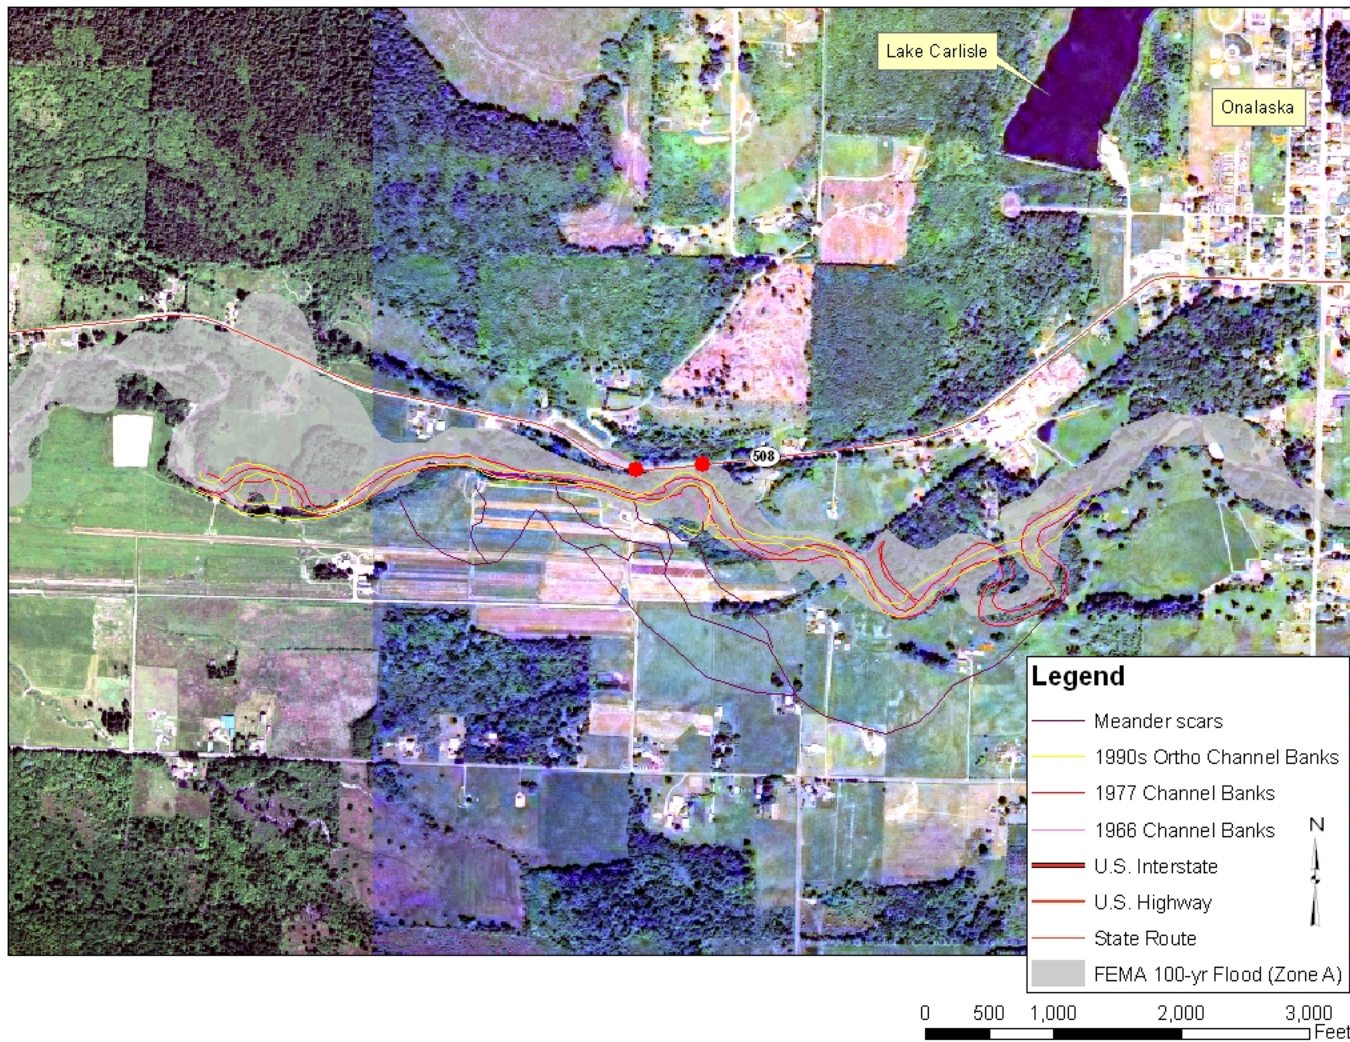
Figure 5. Channel Migration Patterns Observed in Historical Aerial Photographs

2002 aerial photos show three major meander bends in the project reach, including the bend that contains the project site (Figure 5). These bends typically contain a 25- to 30-foot wide wetted channel and 30- to 80-foot wide sediment bars. The meander bends are separated by relatively straight 1000- to 1500-foot pool segments with 40- to 60-foot wide channels and few large sediment bars.

Figure 5 compares channel configurations shown in 1966, 1977, early 1990's, and 2002 aerial photos. The channel stays to the north side of the valley throughout this period, with no major avulsions or channel changes into the southern side of the valley floor. Two major chute cutoffs of meander bends upstream and downstream of the site simplified and straightened the channel

The 1966 and 1977 photos show numerous channel scars lacing across the southern side of the alluvial valley (Figure 5). These indicate the river historically migrated across the floodplain on the southern side of the valley. They currently function as shallow overflow swales that only carry water across the high floodplain terrace during very large flood events. Farm tilling has obscured these features in the early 1990s and 2002 photos.

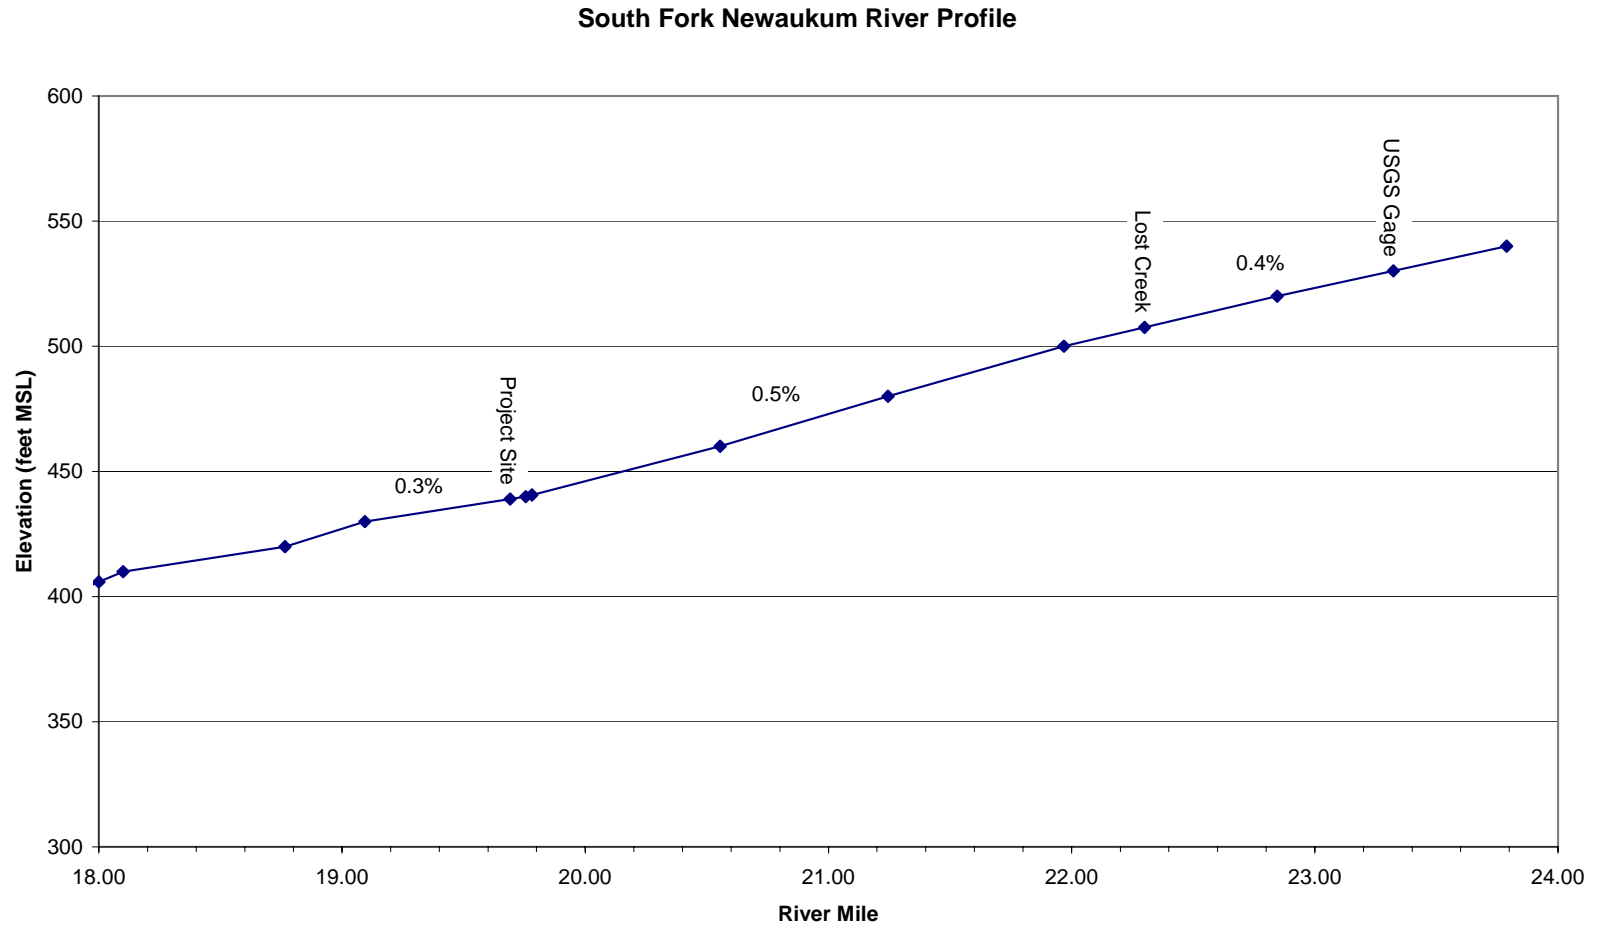
Figure 6. Profile of the South Fork Newaukum River Bed in the Project Reach

Figure 6 shows the profile of the riverbed in the project reach, derived from USGS 1:24K topography. The river gradient is fairly uniform at about 0.5 percent between the project site and the USGS gage upstream of Onalaska. At the project site the gradient drops to about 0.3 percent.
