YAKIMA AIR TERMINAL 2005 PAVEMENT MANAGEMENT REPORT

2005 PAVEMENT MANAGEMENT REPORT

February 2006

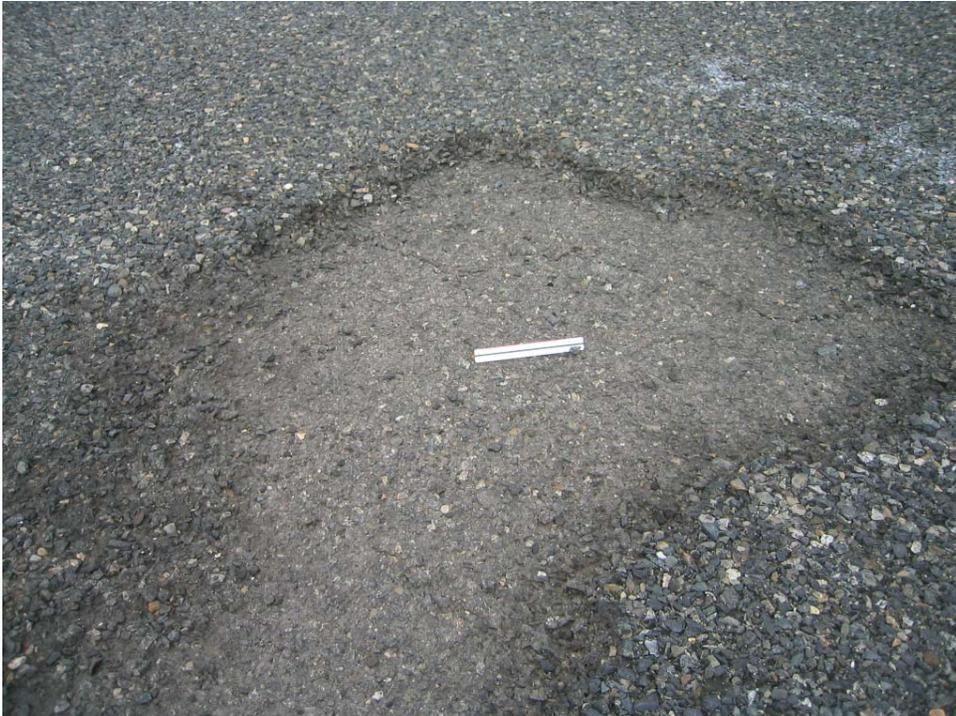
R04YK-06. Raveling and weathering.

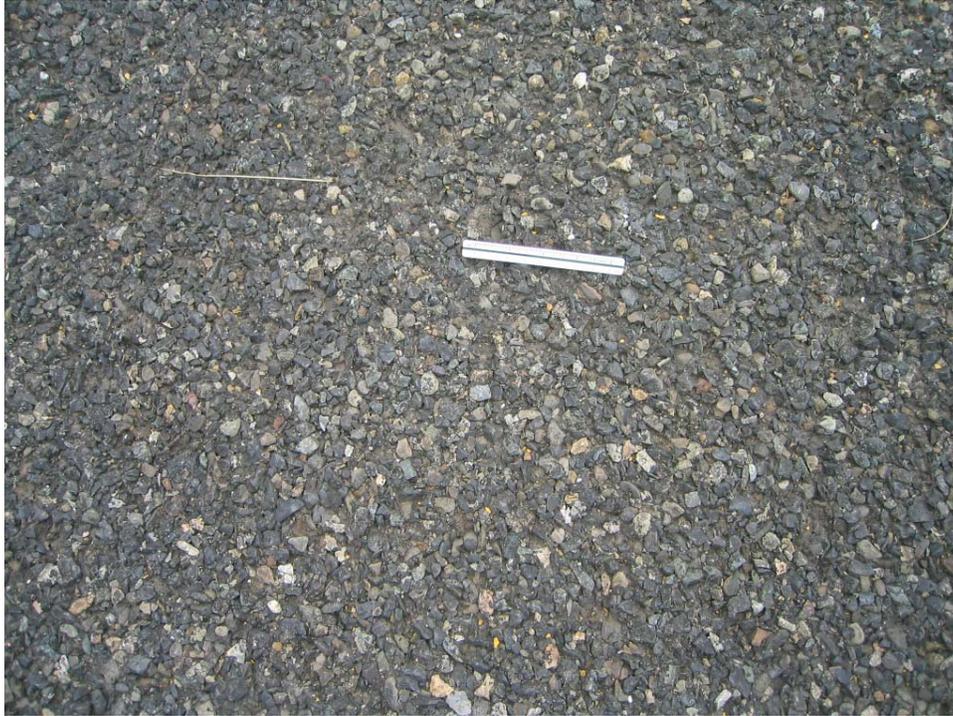
R04YK-08. Raveling and weathering.

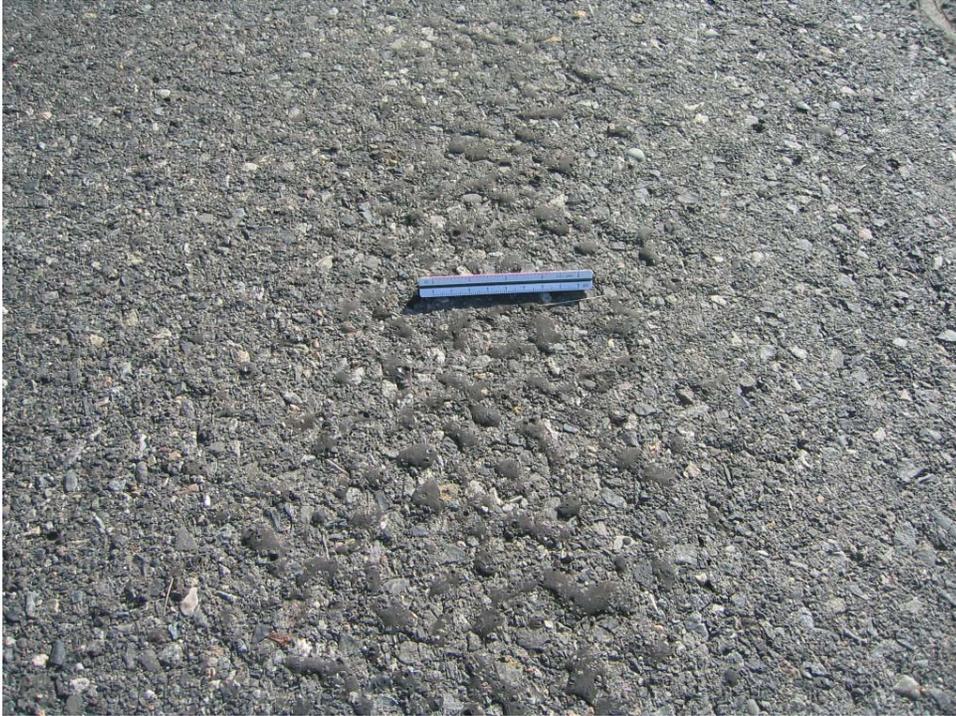
TBYK-01. Bleeding.

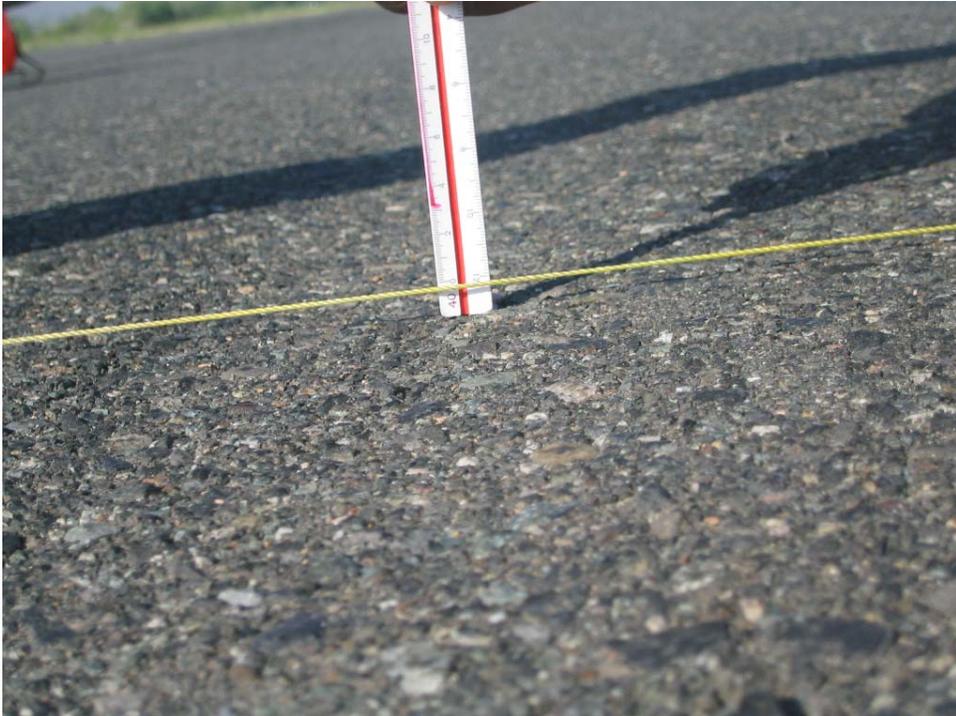
TBYK-01. Rutting.

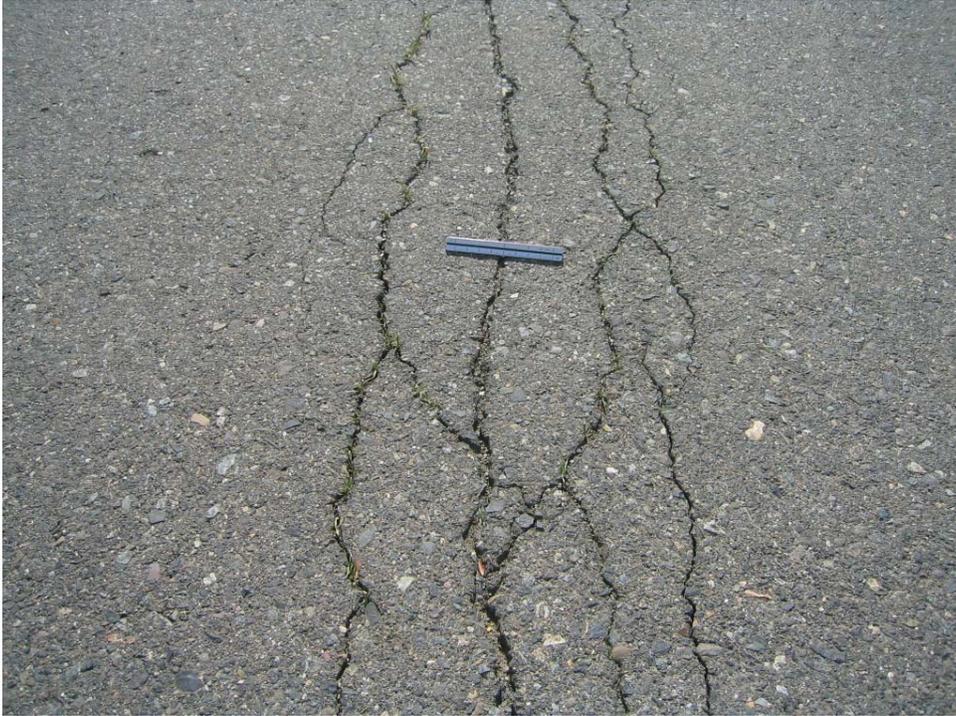
TBYK-04. Alligator cracking.

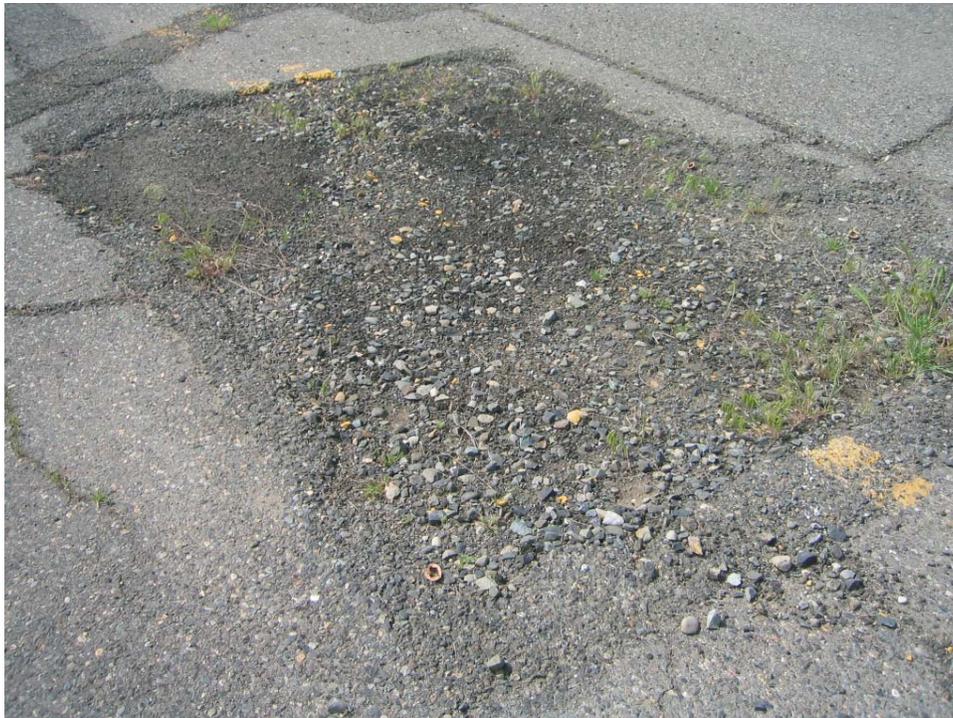
ACAPYK-01. Raveling and weathering.

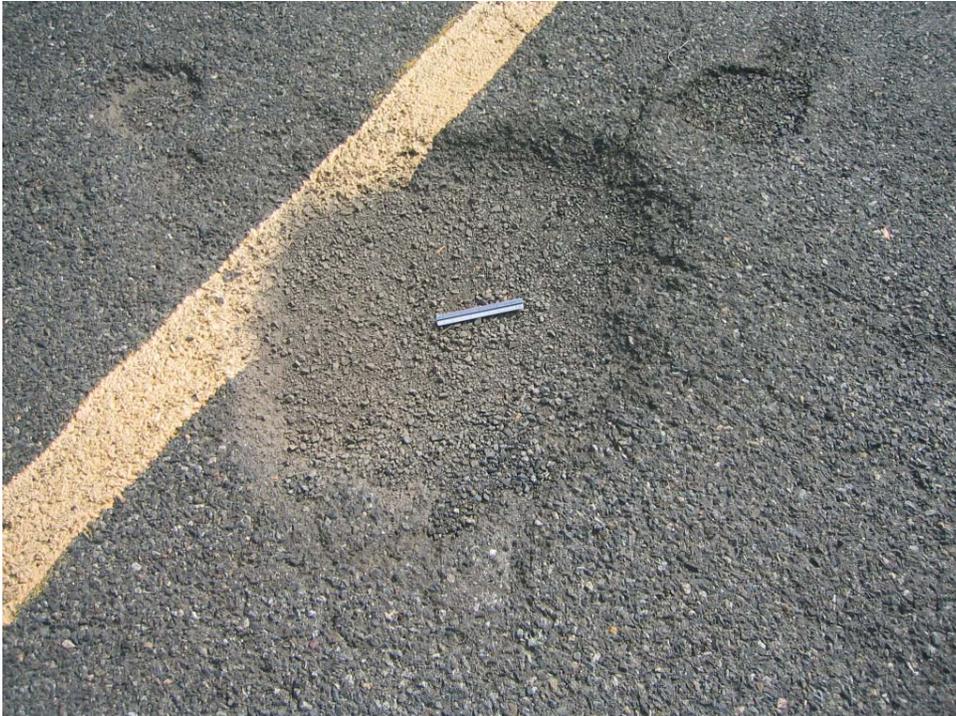
ACUSTYK-01. Raveling and weathering.
