Memorandum

Subject **Flood risk assessment and emergency response measures for State Route 410 near Crystal Mountain Boulevard, MP 57-60**

SR 410 Emergency Memorandum Site Photographs

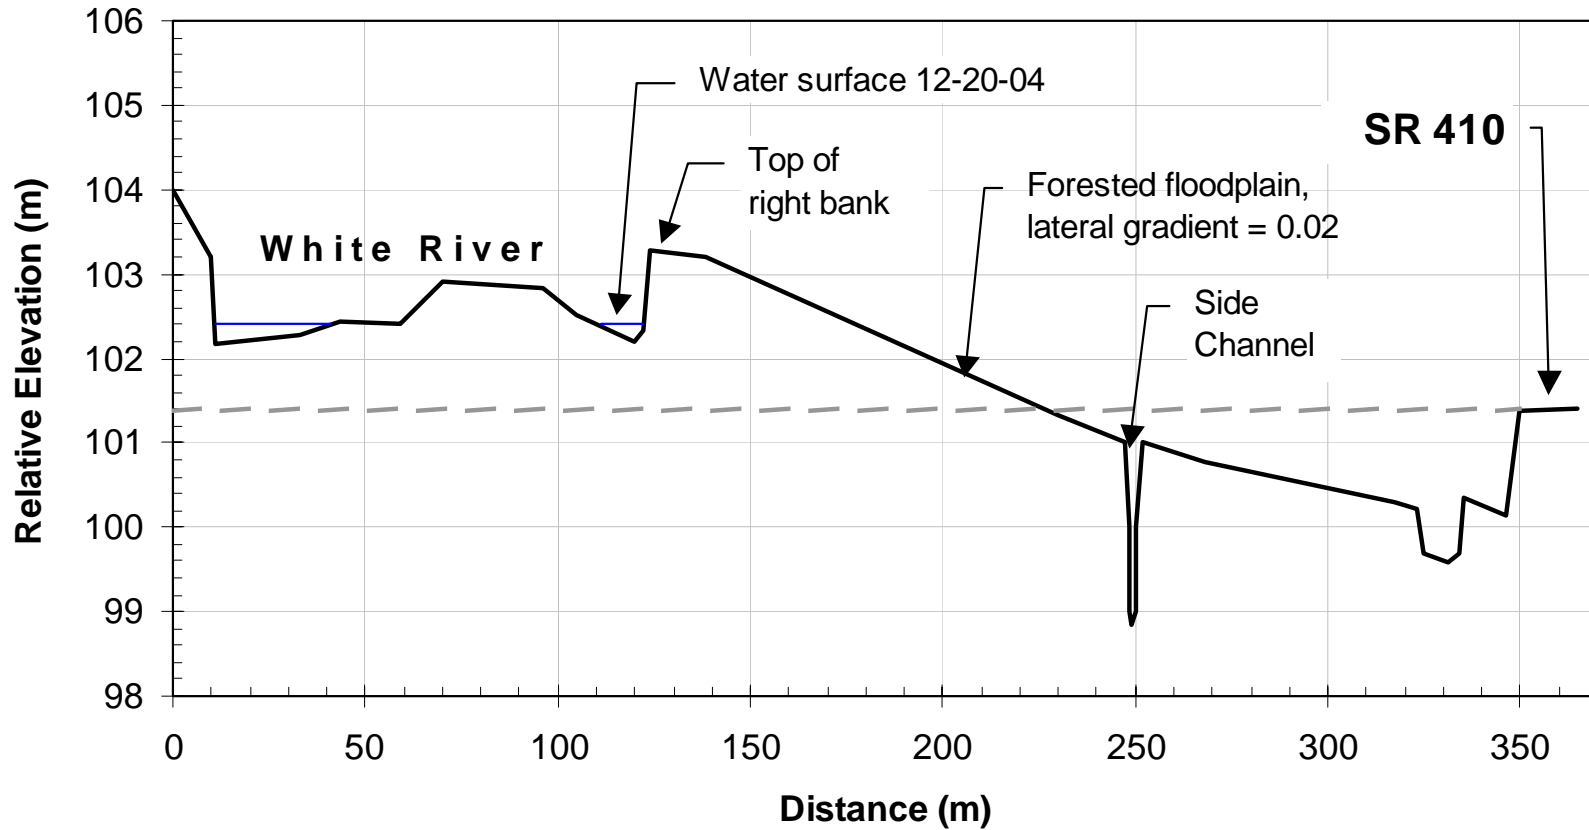
Cross Section 4 (MP 58.42)

The valley cross-section Herrera surveyed at MP 58.42 on December 20 clearly documents a convex cross-section across the Upper White River valley with the surface of SR 410 situated about 2 meters (6 feet) below the active river channel (Figure 3a). The floodplain in this locale has a lateral gradient from west to east of about 2 percent. Channel avulsions such as occurred upstream of this cross-section in October 2003 would have a gradient of over 2 percent and result in extremely high velocities without substantial flow resistance. The potential for erosion is clearly illustrated in the cross-section by the presence of a deeply incised side channel about halfway between SR 410 and the river (Figure 3a). Because the grade of SR 410 diverges from the general grade of the White River and its valley, sections of the highway in vicinity of MP 58 end up well below the grade of the river bed (Figure 4). Three short transects were measured perpendicular to the highway north (downstream) of the valley cross-section (Figure 2). These transects (Figures 3b-3d) illustrate that the elevation of the highway relative to the river grade diminishes north of cross-section no. 4 (Figure 3a). The energy of flow impinging on the highway at cross-sections 1-3 (Figures 3b-3d) is reflected in the deposition of large cobbles on the highway and adjacent floodplain surfaces at elevations equal or greater than the highway (Appendix A). Assuming the floodplain has a similar lateral gradient as found in the valley cross-section, the road lies as much as 3 meters (9 feet) below the river. The relatively low area along the eastern margin of the river's floodplain between MP 57.5 and MP 59 will continue to pose significant risk of flooding and erosion along SR 410. Inspections on December 20 and 21 indicate the temporary ELJ constructed in October 2003 is still effectively deflecting flow away from east floodplain. But the ELJ was constructed only as a temporary emergency measure. Failure of the ELJ or a change in channel conditions (location and bed elevation) could re-introduce a significant portion of the river's flow into the channel network that damaged SR 410 in October 2003.

Figure 3a. Valley cross-section no. 4 surveyed on Monday December 20, 2004. River channel is situated 1 meter above surface of SR 410. Bankfull elevation in channel is 2 meters above highway surface.

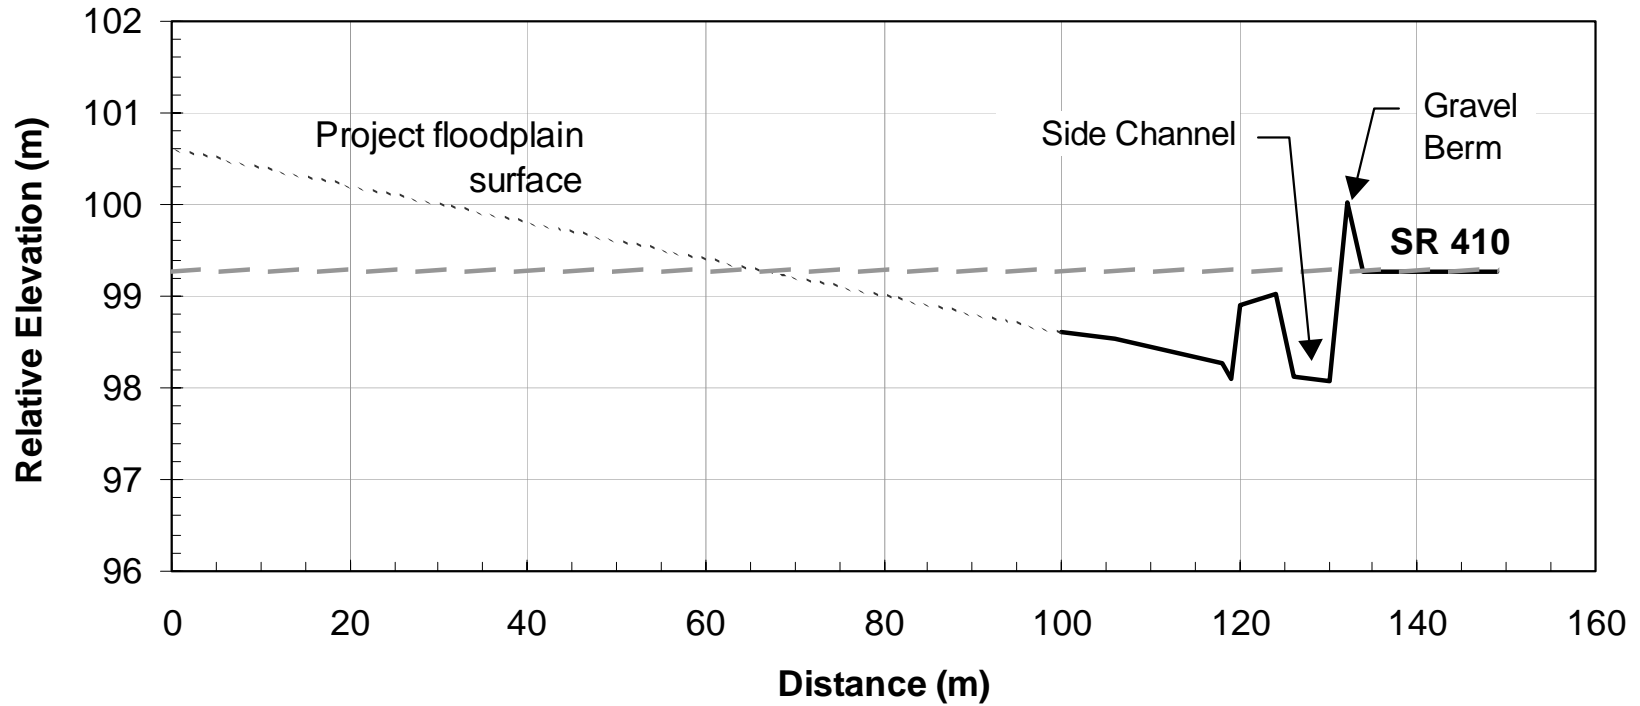
Cross Section 3 (MP 58.38)

Figure 3b. Cross-section transect no. 3 surveyed Tuesday December 21, 2004. Projected floodplain surface (short dashed line) based on floodplain gradient in cross-section no. 4. Thick dashed line is projected elevation of SR 410 road surface.

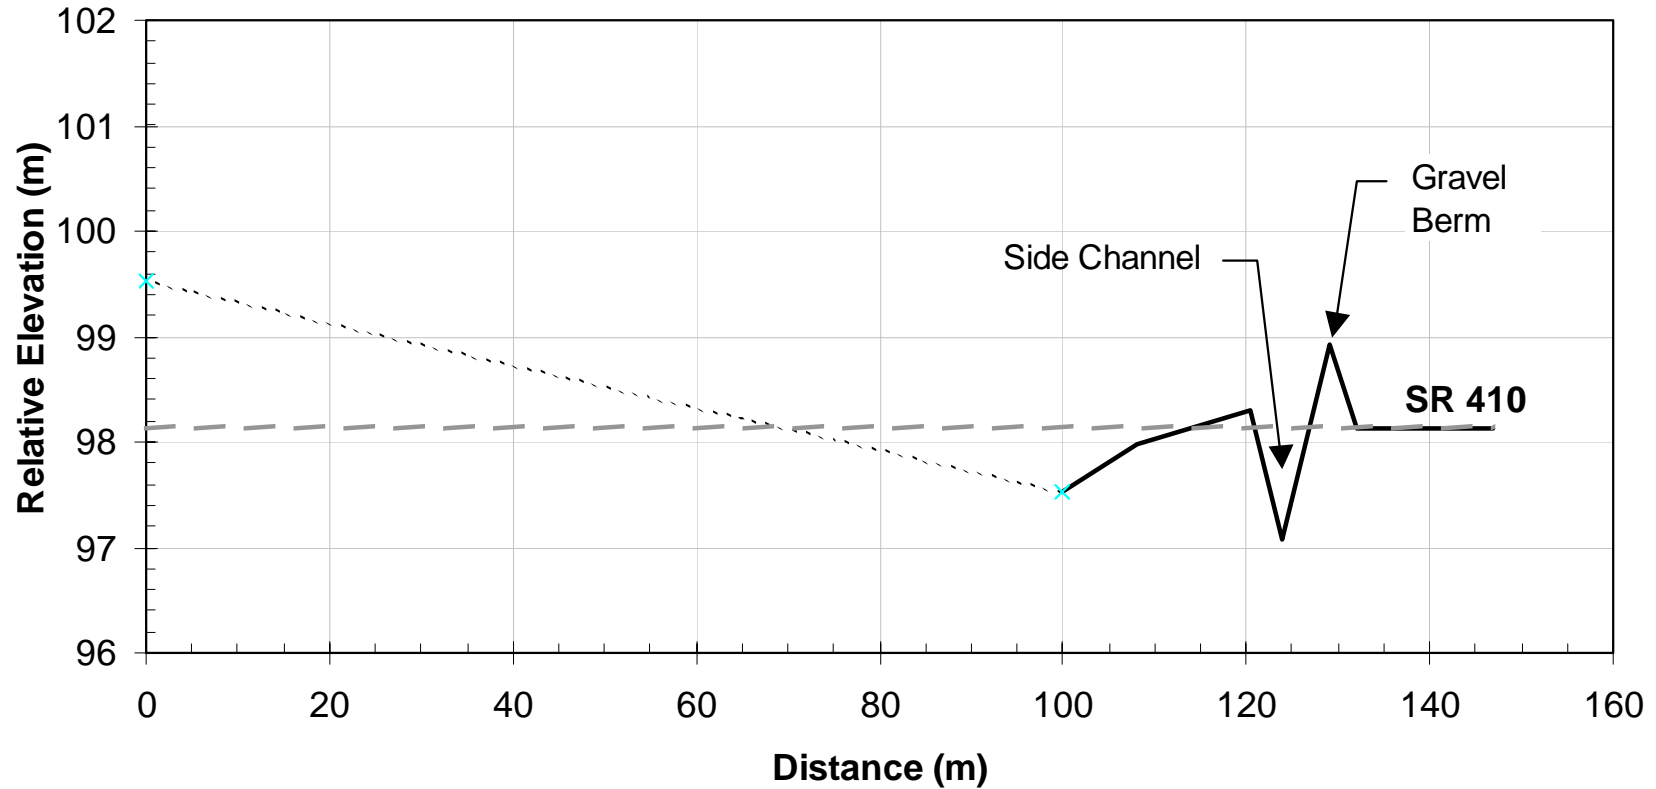
Cross Section 2 (MP 58.35)

Figure 3c. Cross-section transect no. 2 surveyed Tuesday December 21, 2004. Projected floodplain surface (short dashed line) based on floodplain gradient in cross-section no. 4. Thick dashed line is projected elevation of SR 410 road surface.

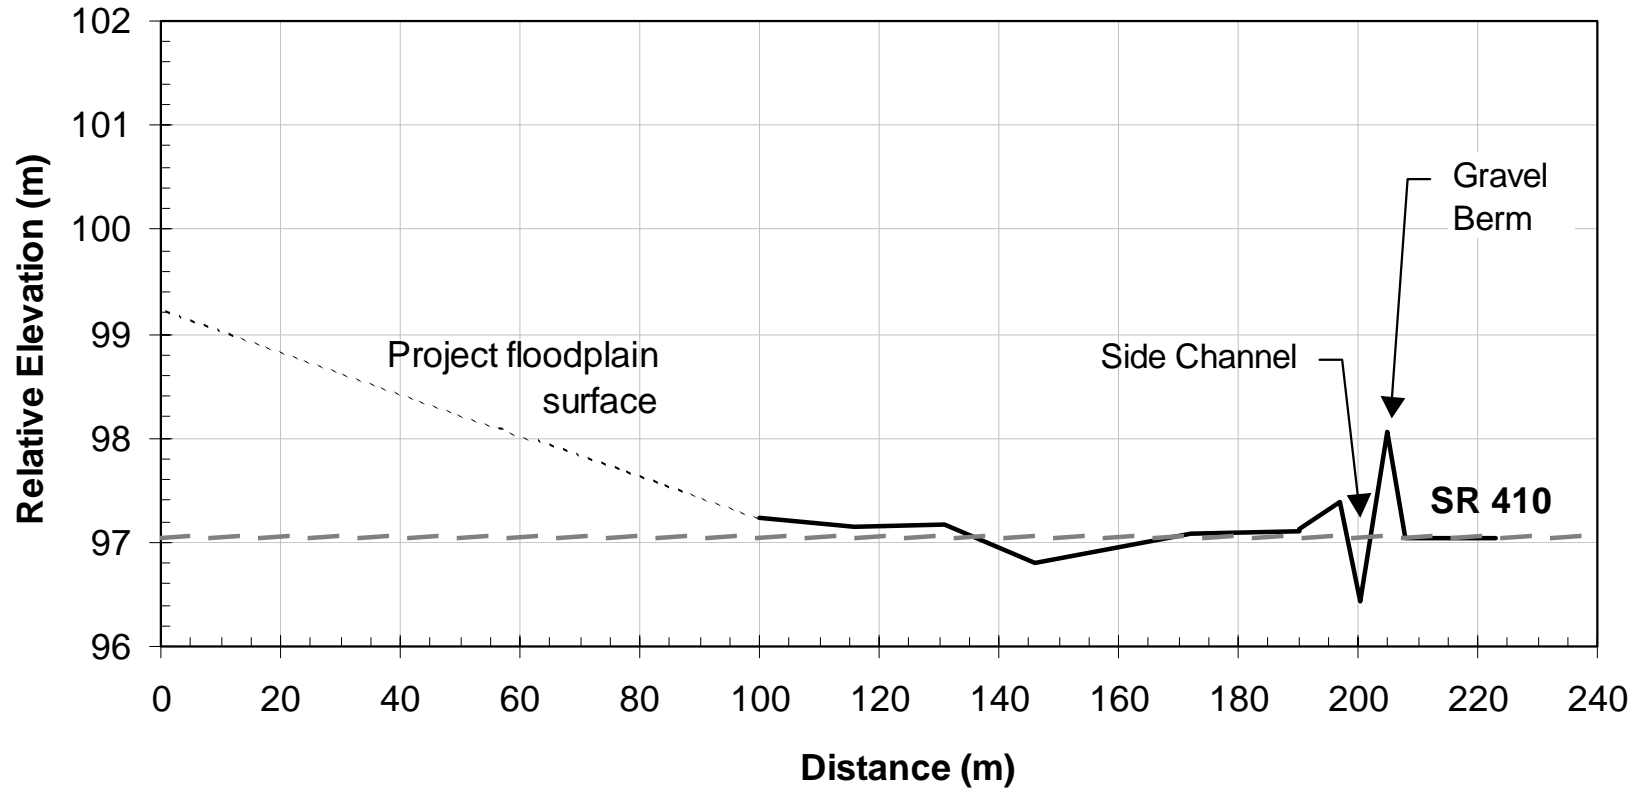
Cross Section 1 (MP 58.31)

Figure 3d. Cross-section transect no. 1 surveyed Tuesday December 21, 2004. Projected floodplain surface (short dashed line) based on floodplain gradient in cross-section no. 4. Thick dashed line is projected elevation of SR 410 road surface.

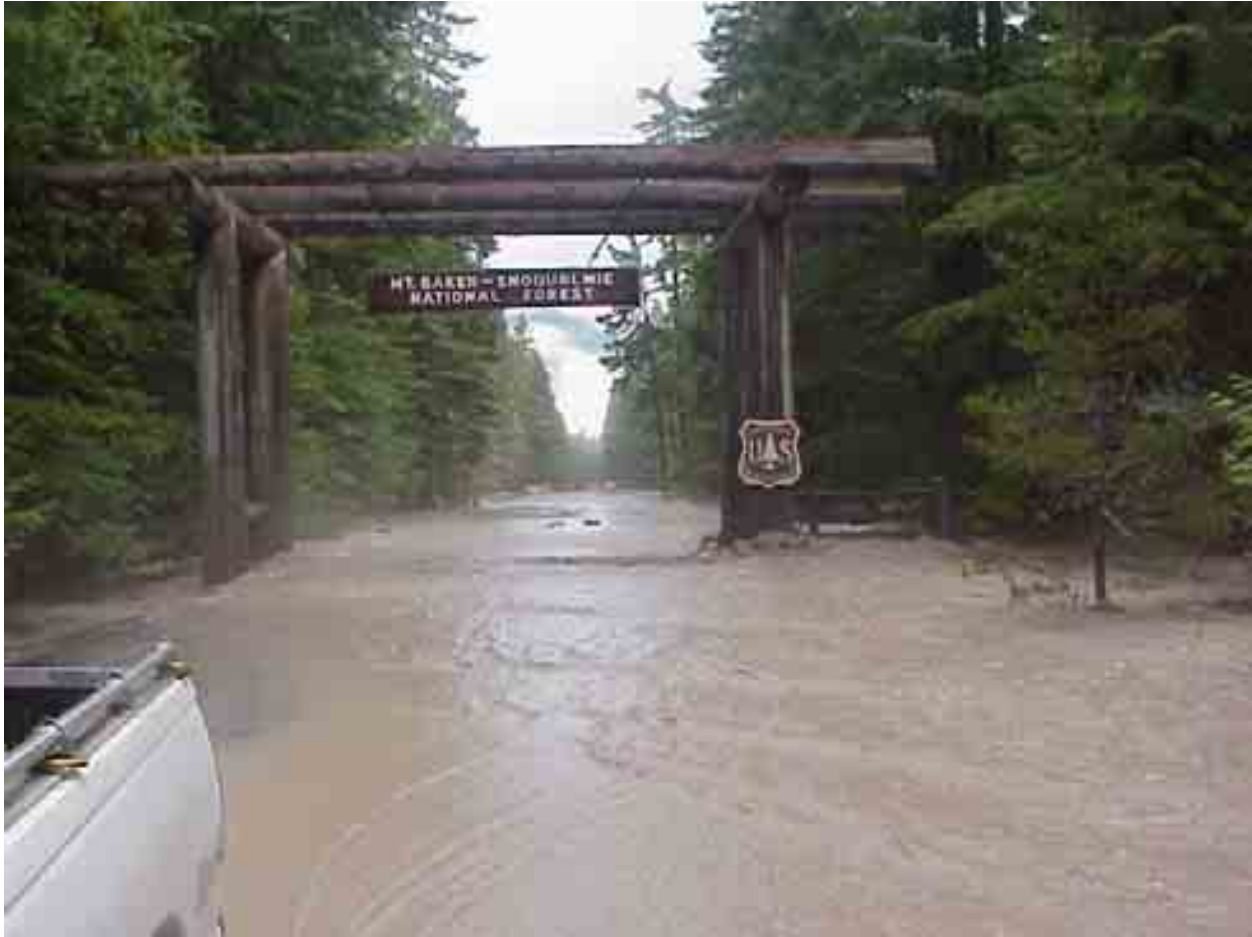
MP 57.45

Photo taken standing in Mount Rainier National Park (MRNP) looking north (downstream) along SR 410 during October 2003 flood at boundary with Mt. Baker-Snoqualmie National Forest (MBSNF). Crystal Mountain Boulevard is just beyond park boundary on the right (east). Photo by Ed Burnside, WSDOT.

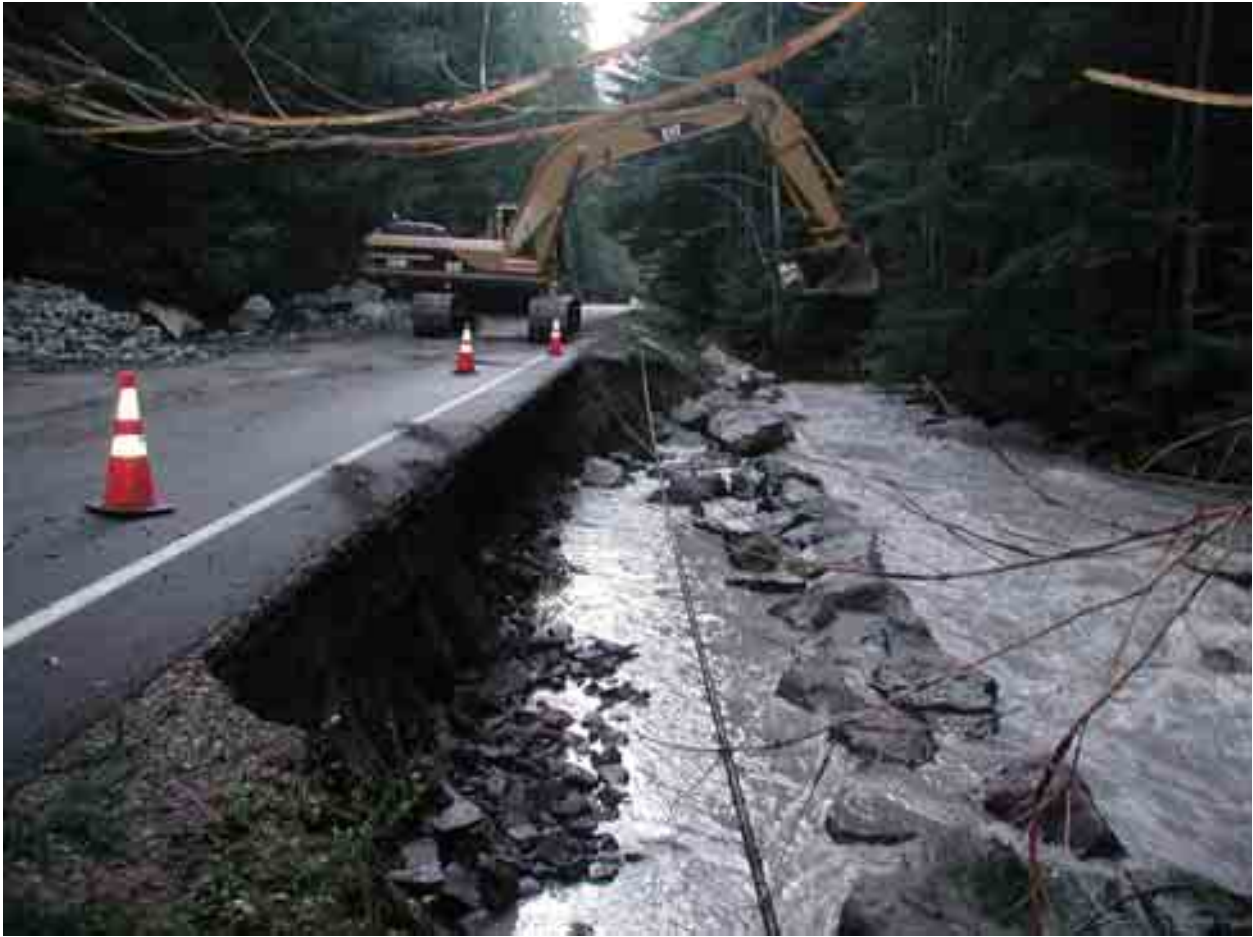
~MP 58.05

Erosion undercutting highway embankment of SR 410, October 24, 2003. Photo looking south (upstream).

Reconstruction and hardening (rock wall) of highway embankment undercut by erosion.

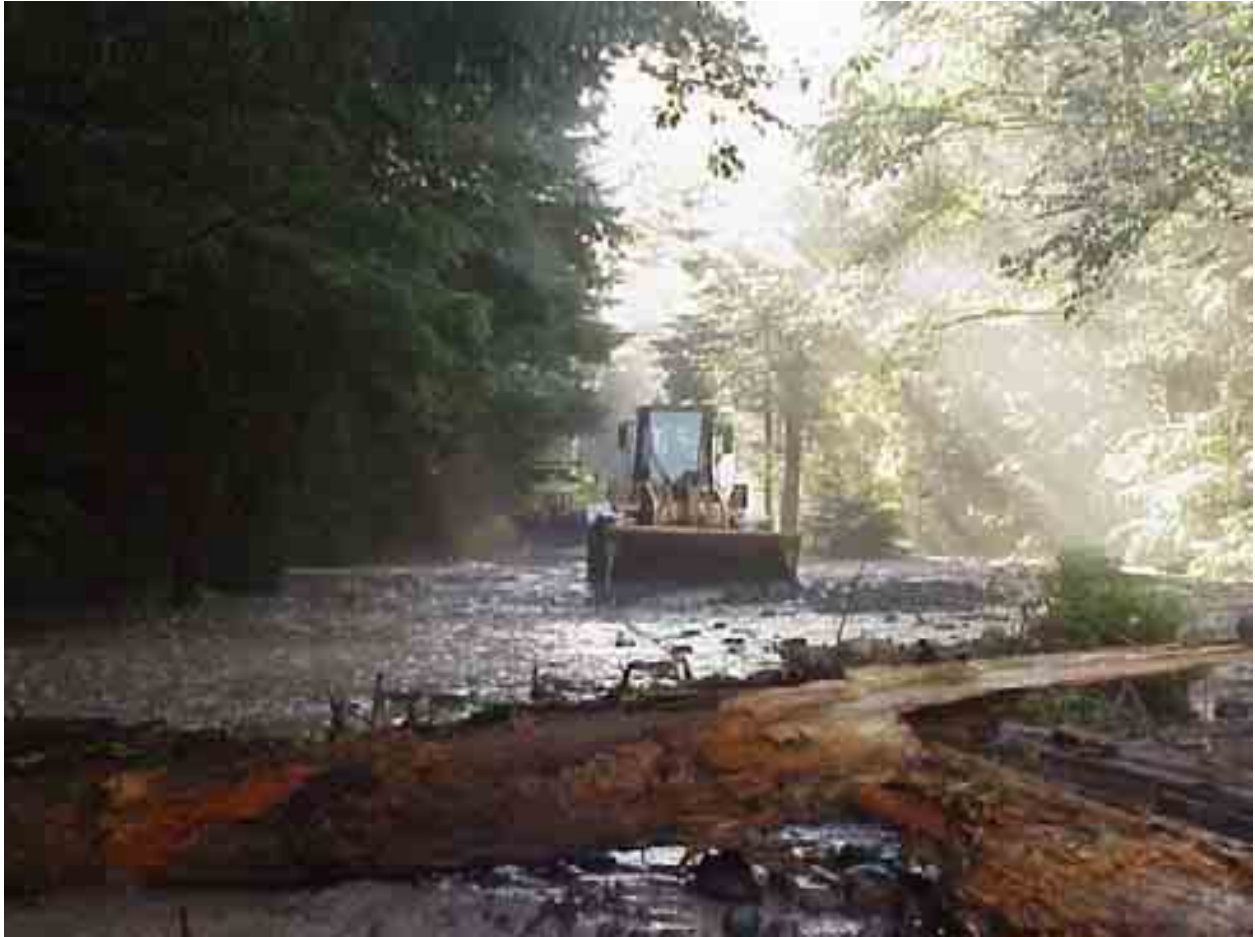
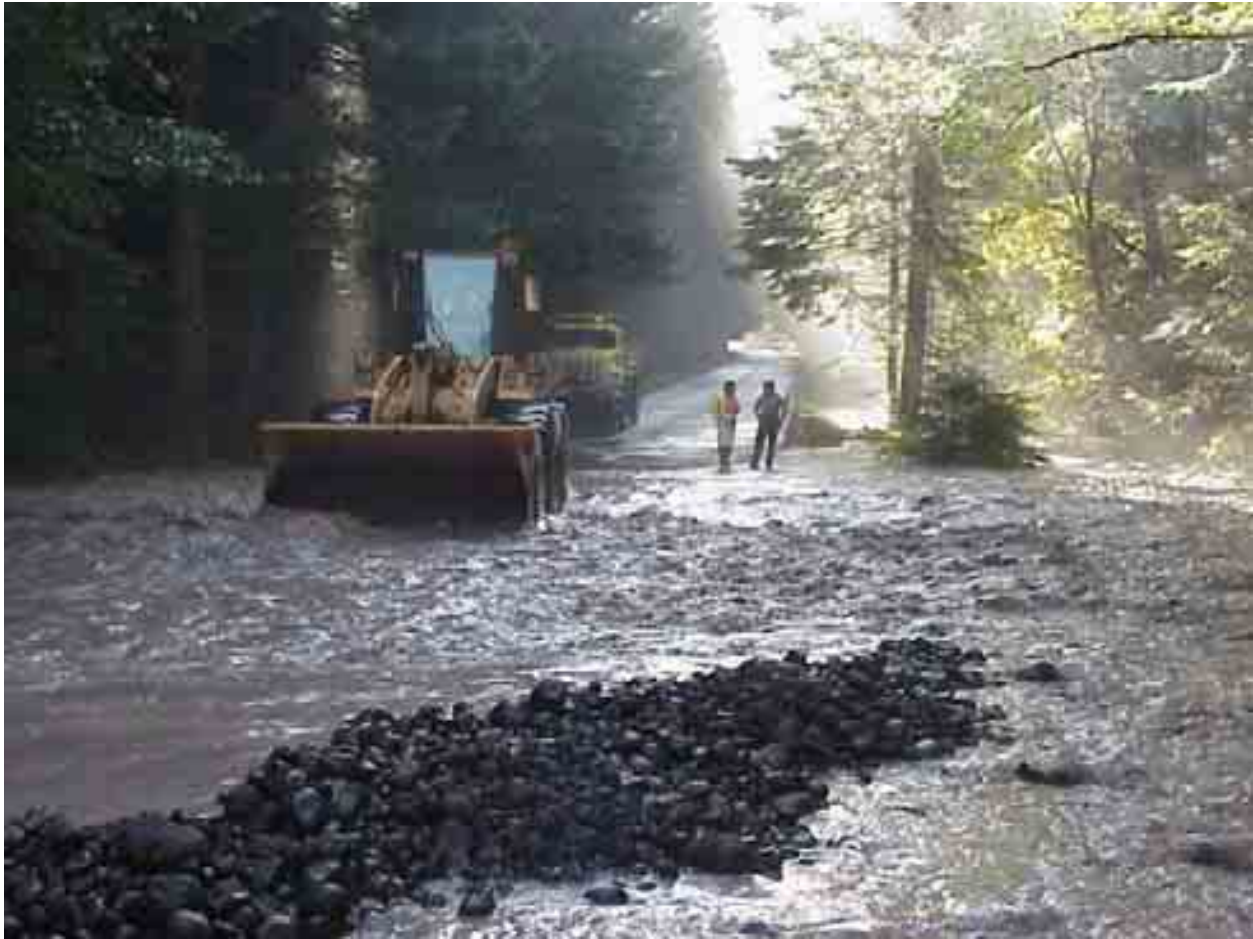
~MP 58.30

WSDOT maintenance crews clearing sediment and debris from SR 410 during October 2003 flooding. Photo looking south (upstream). Photo by Ed Burnside, WSDOT.

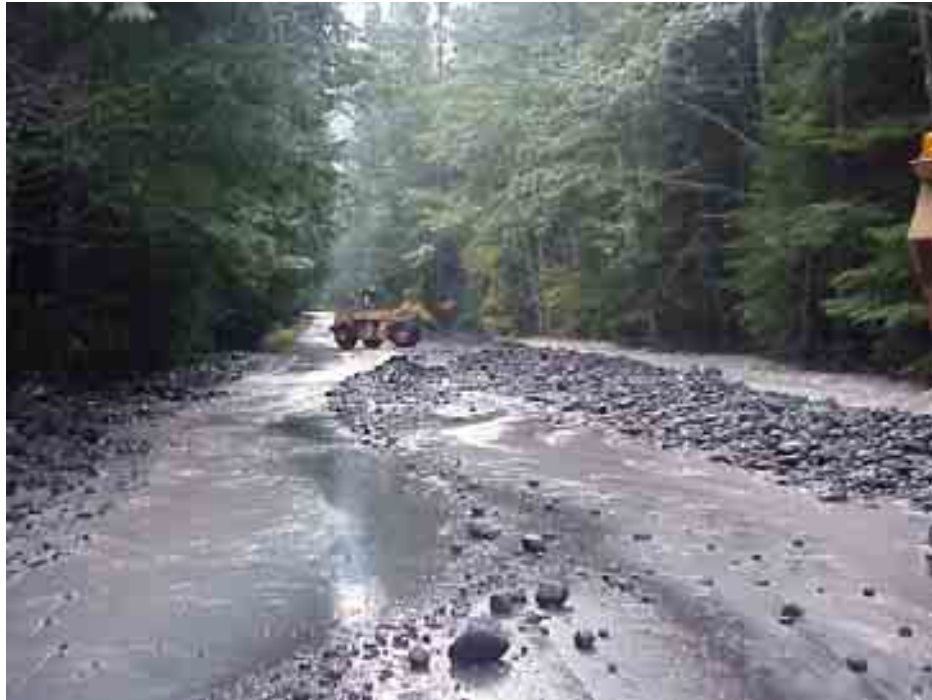
~MP 58.30

WSDOT maintenance crews constructing temporary gravel berm to contain flow to west margin of SR 410 during October 2003 flooding. Photo looking south (upstream). Photo by Ed Burnside, WSDOT.

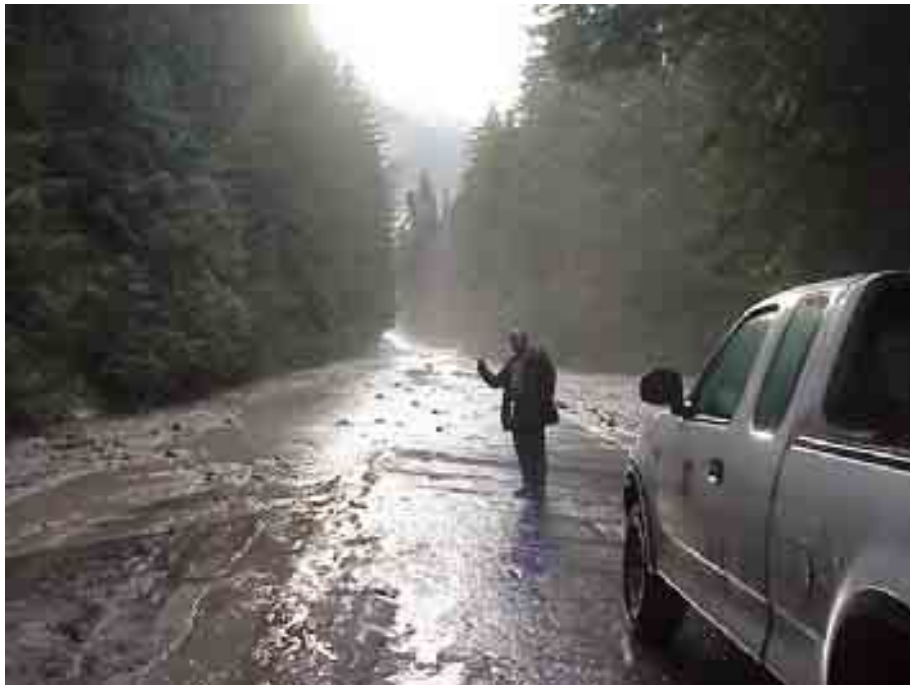
Similar view of site on January 18, 2005.

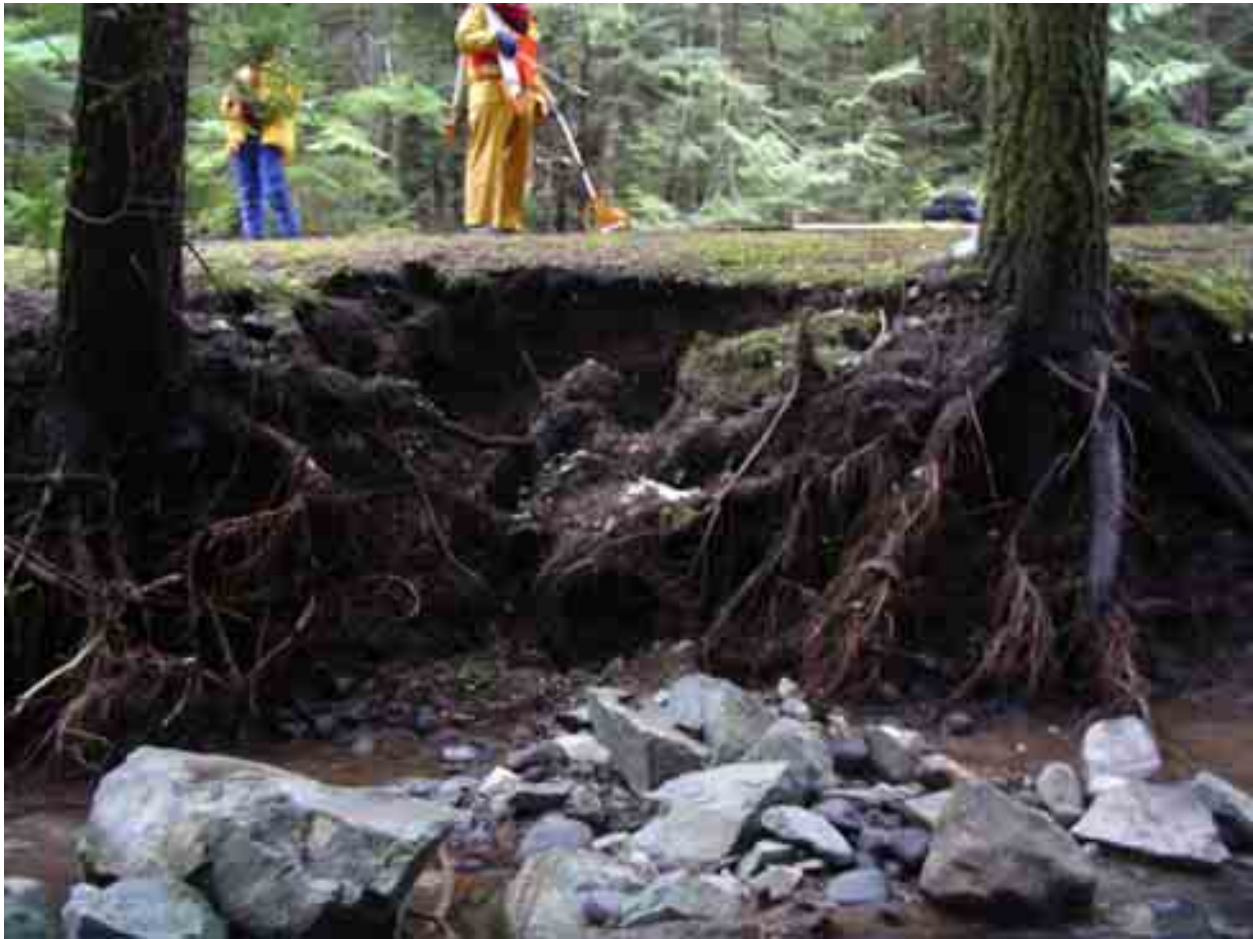
MP 57.92

Eroding bank along SR 410 at culvert crossing, MP 57.92, 12-20-04. Lower section of concrete culvert pipe was transported about 50 feet downstream. Construction of an armored toe to embankment is recommended for this site.

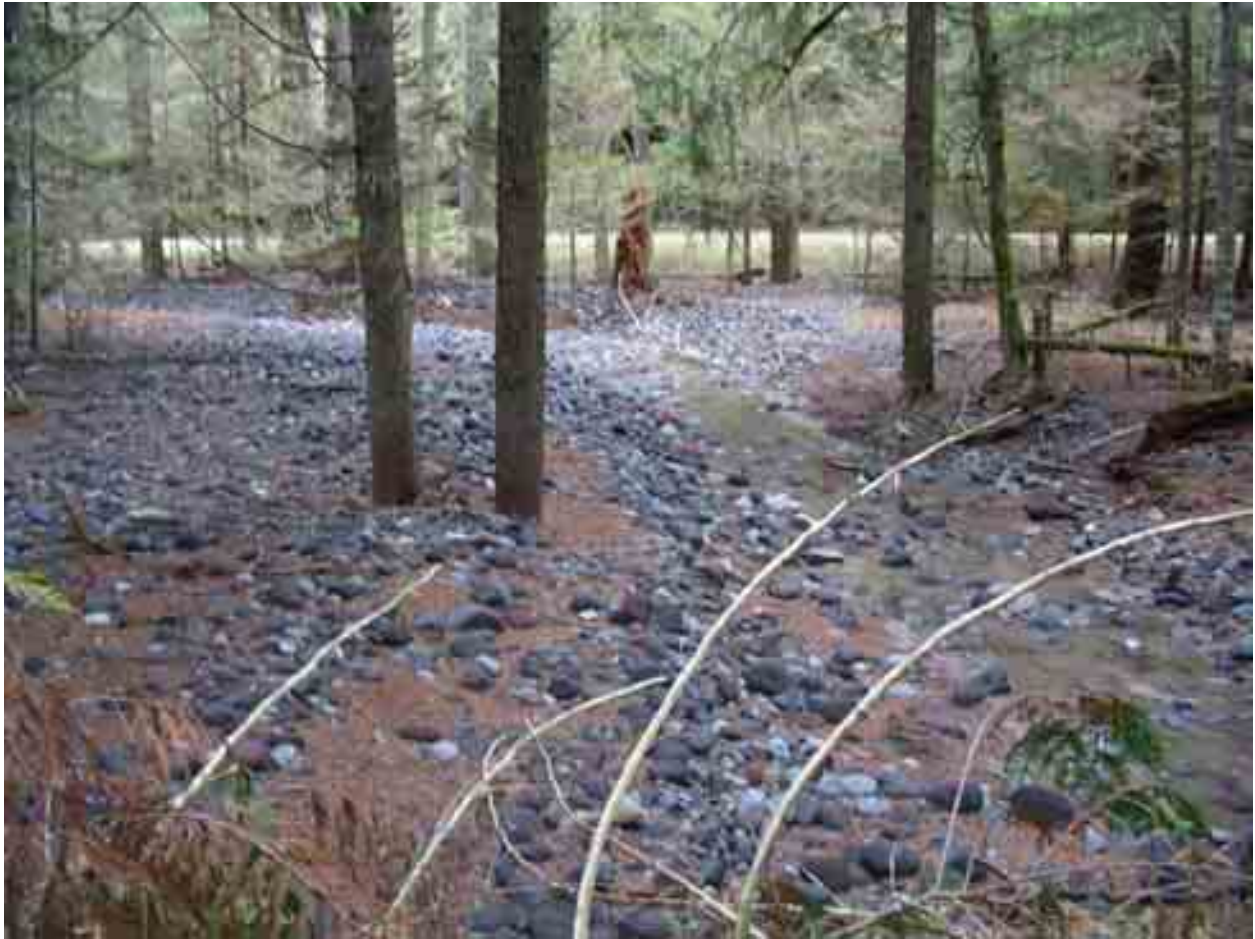
MP 57.42

Photograph taken 12-20-04 looking north-northeast (downstream) at SR 410 directly downstream of valley cross-section (no. 4) at MP 58.42. Floodplain forest is buried in cobble delivered in October 2003 flood. Construction of roughness elements (embedded logs and snags) to dissipate energy are recommended for this site.

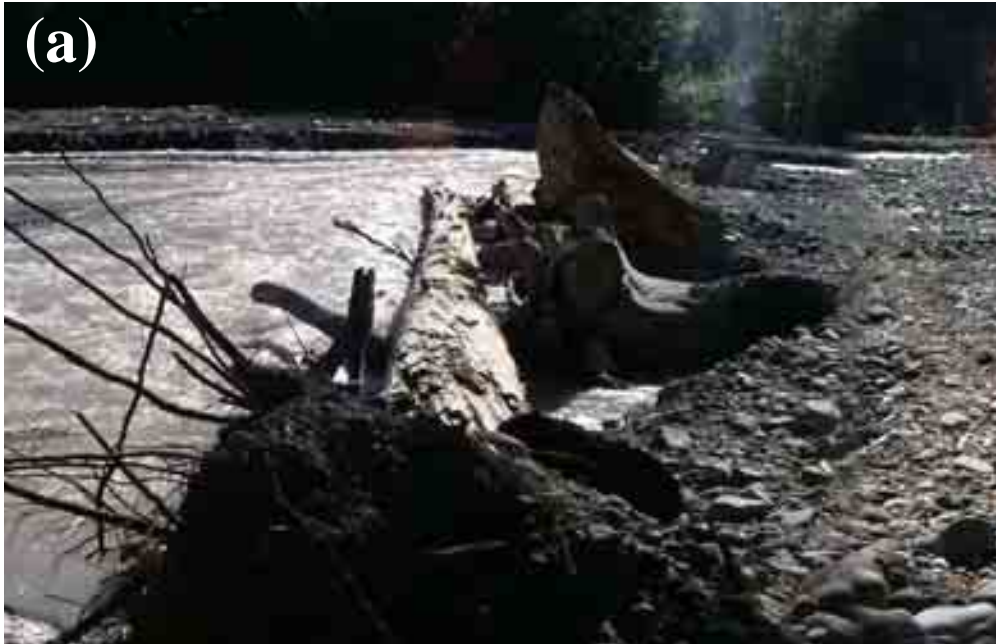
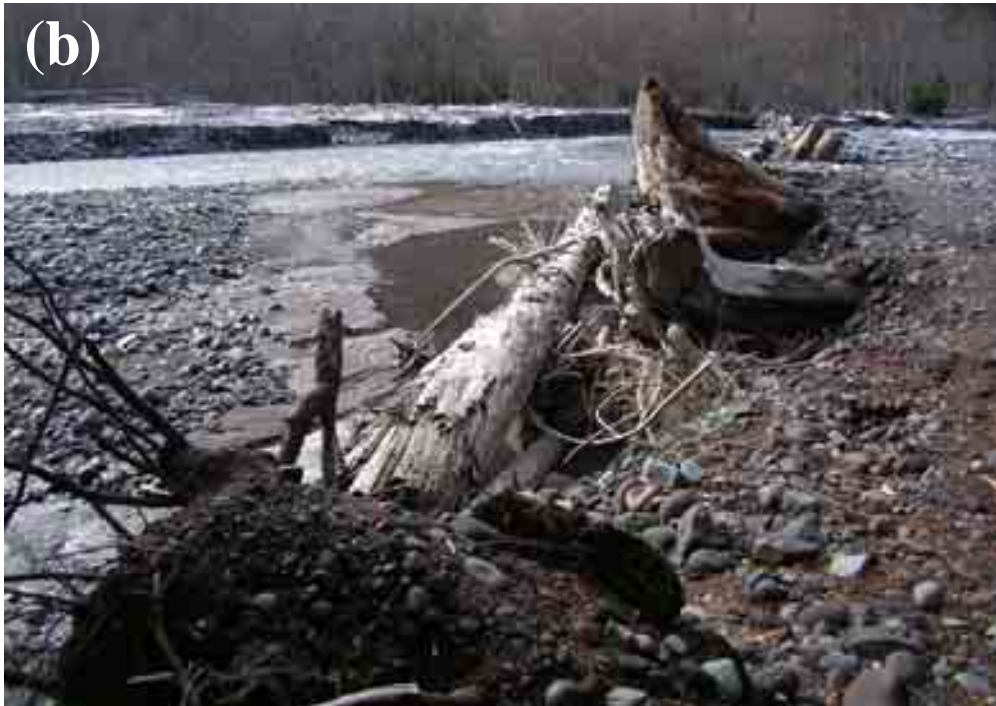
MP 58.62

Upstream margin of Emergency ELJ on 08-07-04 (a) and 12-20-04 (b), looking west toward left bank of river. River flow is from left to right. ELJ has experienced some erosion. Placement of additional wood debris at upstream end of structure is recommended.

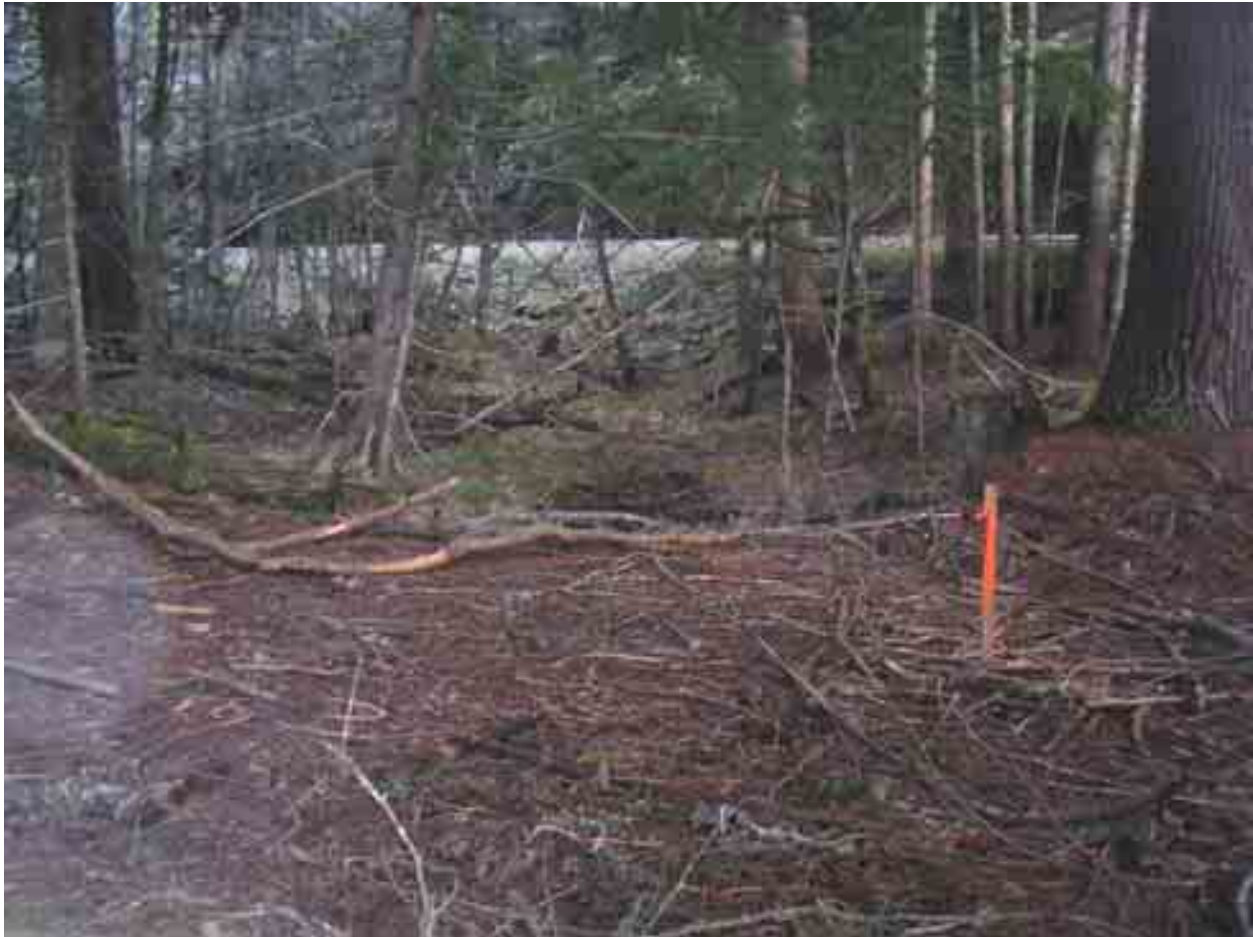
MP 58.75

Standing on old road grade and looking north-northeast toward SR 410 down side channel directed at highway embankment, 12-20-04. Construction of roughness elements (embedded logs and snags) within channel and at toe of road embankment to dissipate energy are recommended for this site.

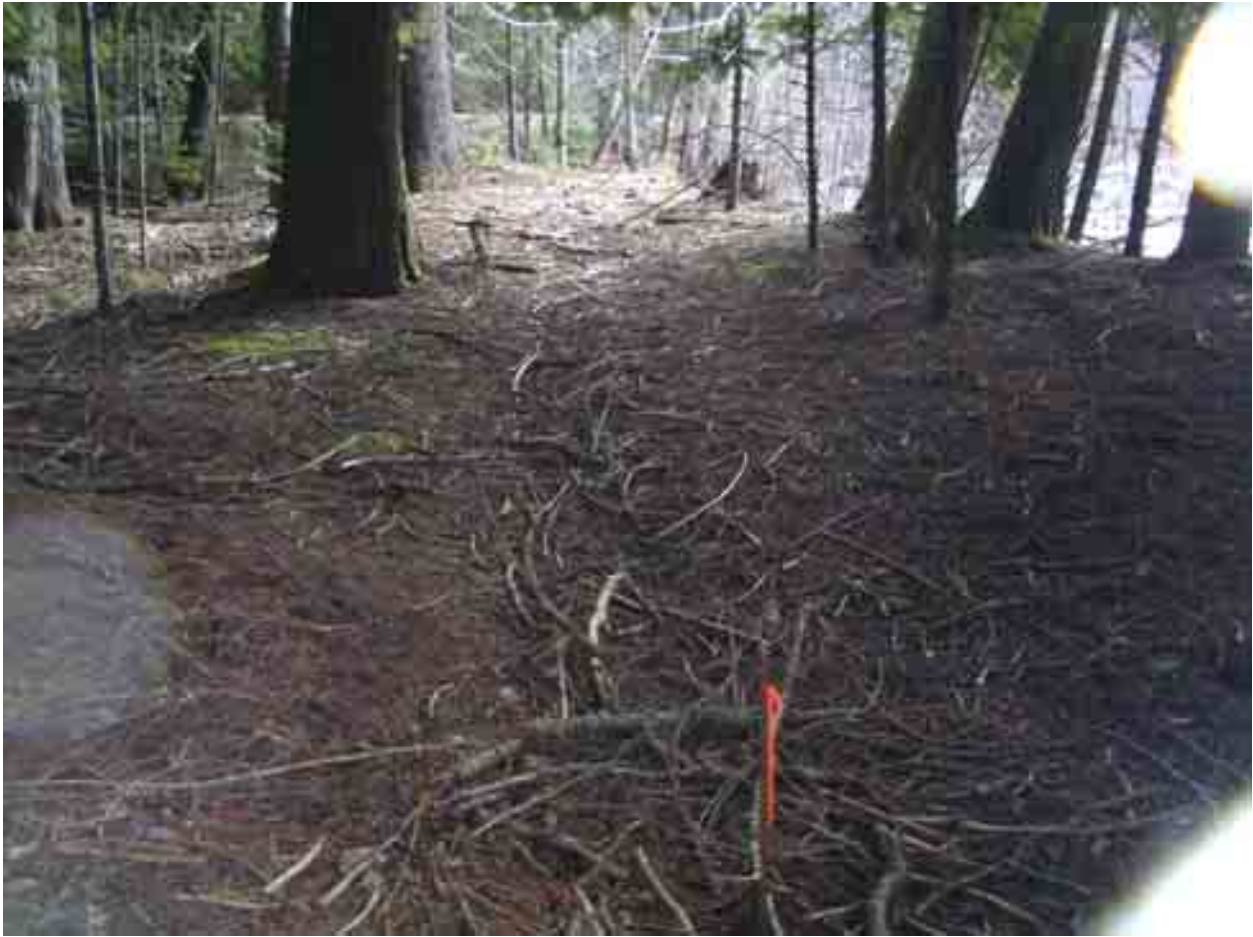
MP 58.76

Standing on old road grade and looking upstream (south-southeast) toward SR 410 and White River, 12-20-04. Construction of roughness elements (embedded logs and snags) along old road grade to dissipate energy are recommended. Reinforcement of natural logjam along right bank of river (upper right of photo) is also recommended.

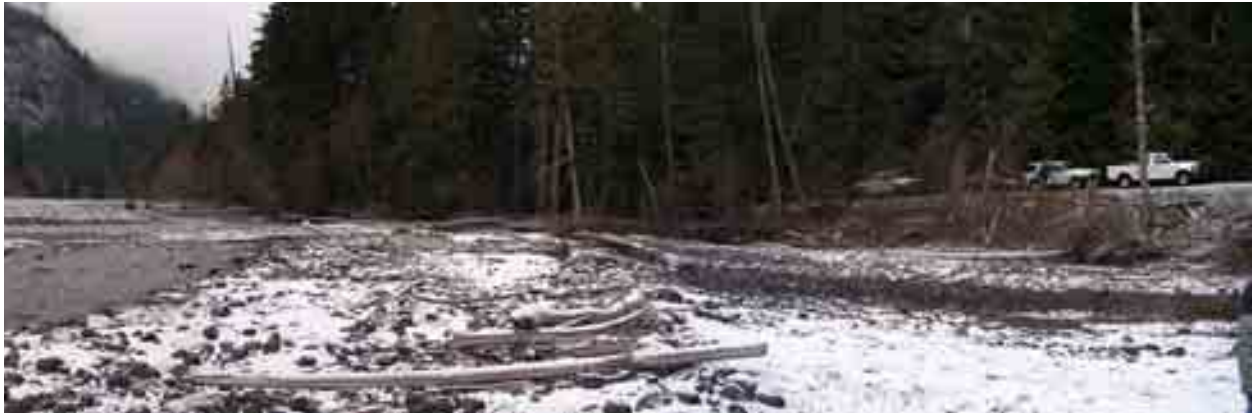
MP 58.82

Looking downstream along right bank, 12-21-04. Temporary ELJ constructed in October 2003 is at center left of photo (i) and SR 410 to far right. Natural logjam recommended for reinforcement is at right center of photo where old road grade emerges from floodplain forest (ii). Construction of one to two additional ELJ structures is recommended directly adjacent to right bank at far right.

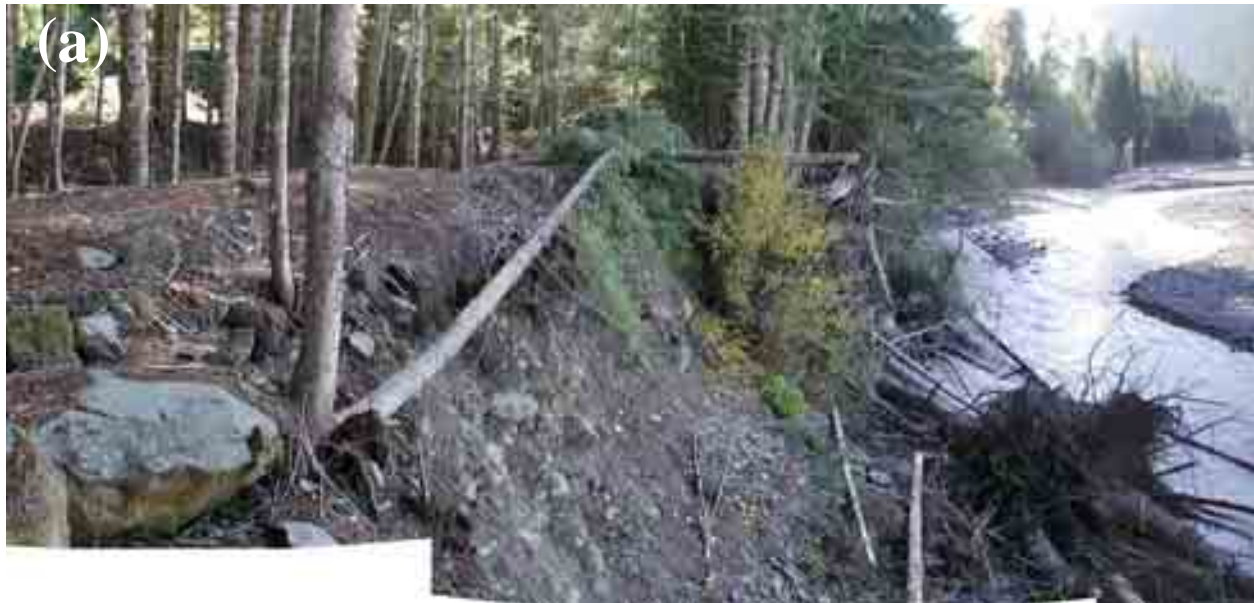
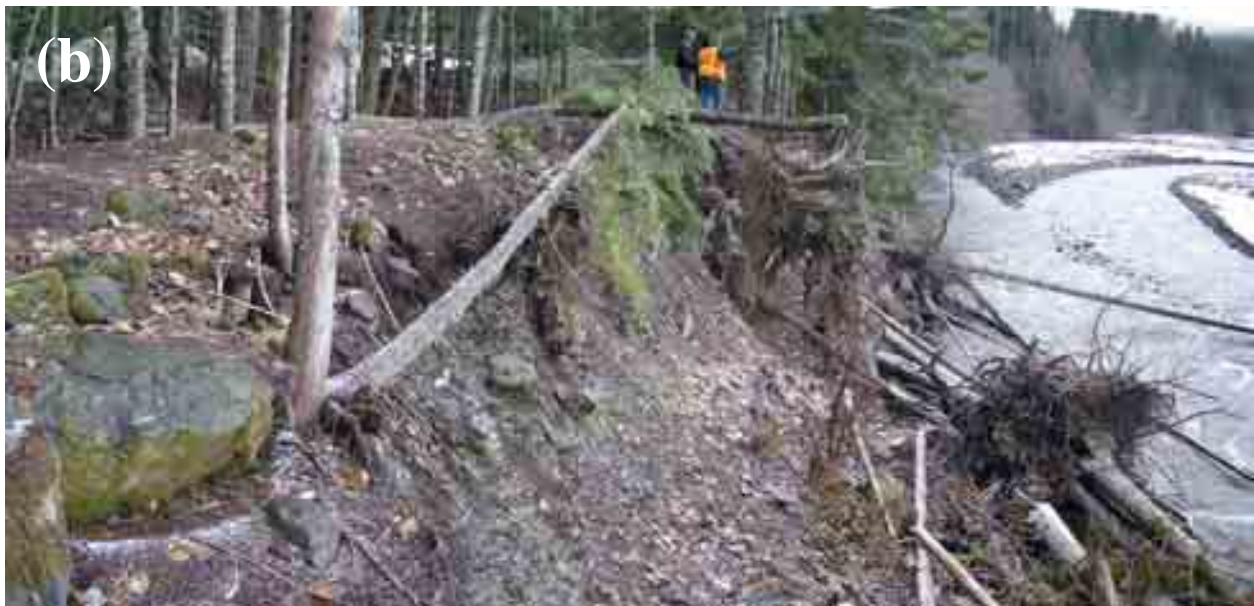
MP 59.20

High eroding bank at stockpile site, MP 59.2 looking upstream along old road grade, 10-31-03 (a) and 12-21-04 (b). Bank here has eroded approximately 3 feet between October 2003 and December 2004 (undercut stump in right center of photo). Based on planform of the river, erosion is likely to continue at this site and poses a significant threat to stockpile site. Construction of an armored toe to embankment and engineered logjams to deflect flow away from bank are recommended for this site.

5. MP 59.2: Two to three ELJ structures along eroding embankment adjacent to Foothills Creek Stockpile.
