APPENDIX A

Site Photographs

Reach Analysis—Hoko, Clallam, Pysht Rivers Photographic Log

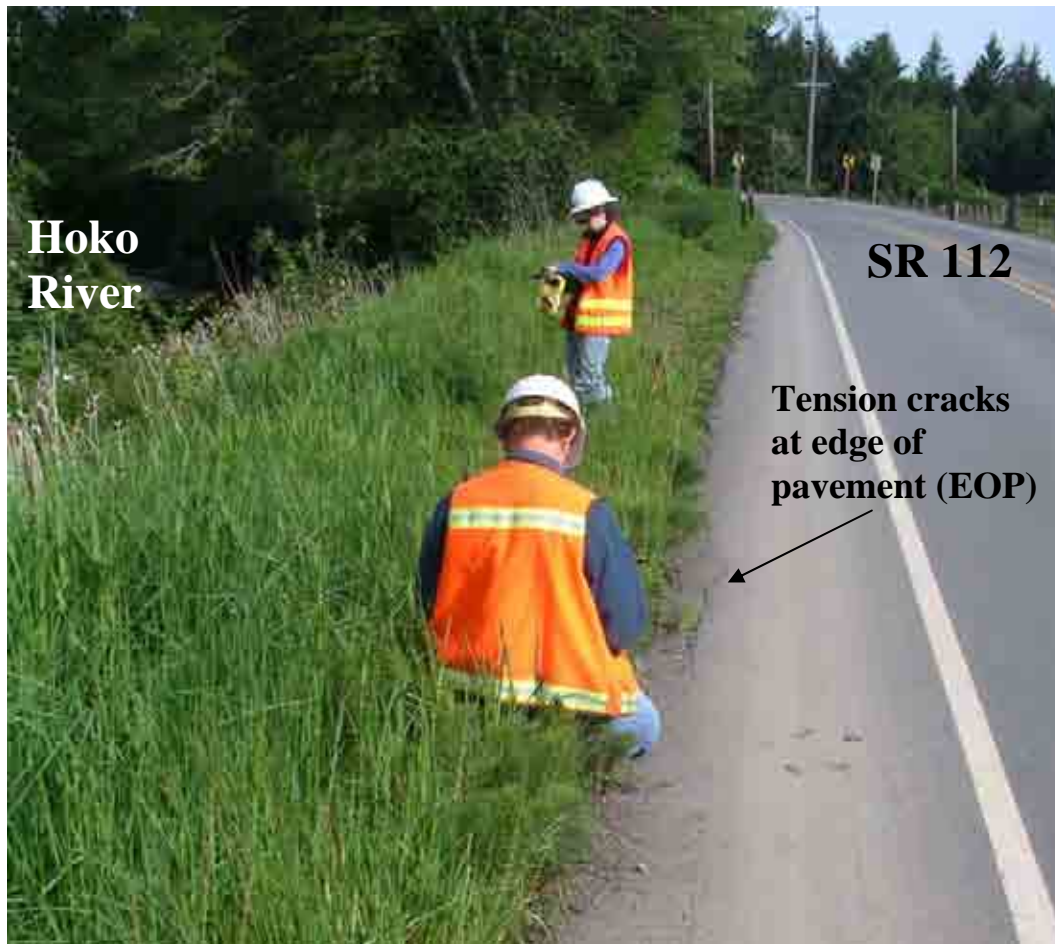
Photo A-1. Hoko River Site ID H-1. (May 12, 2005). Looking west at tension cracks in SR 112 pavement due to bank slumping along Hoko River. Cracks are approximately one foot from the edge of pavement extending 25 feet along the road at MP 11.5. (Photo 2537)

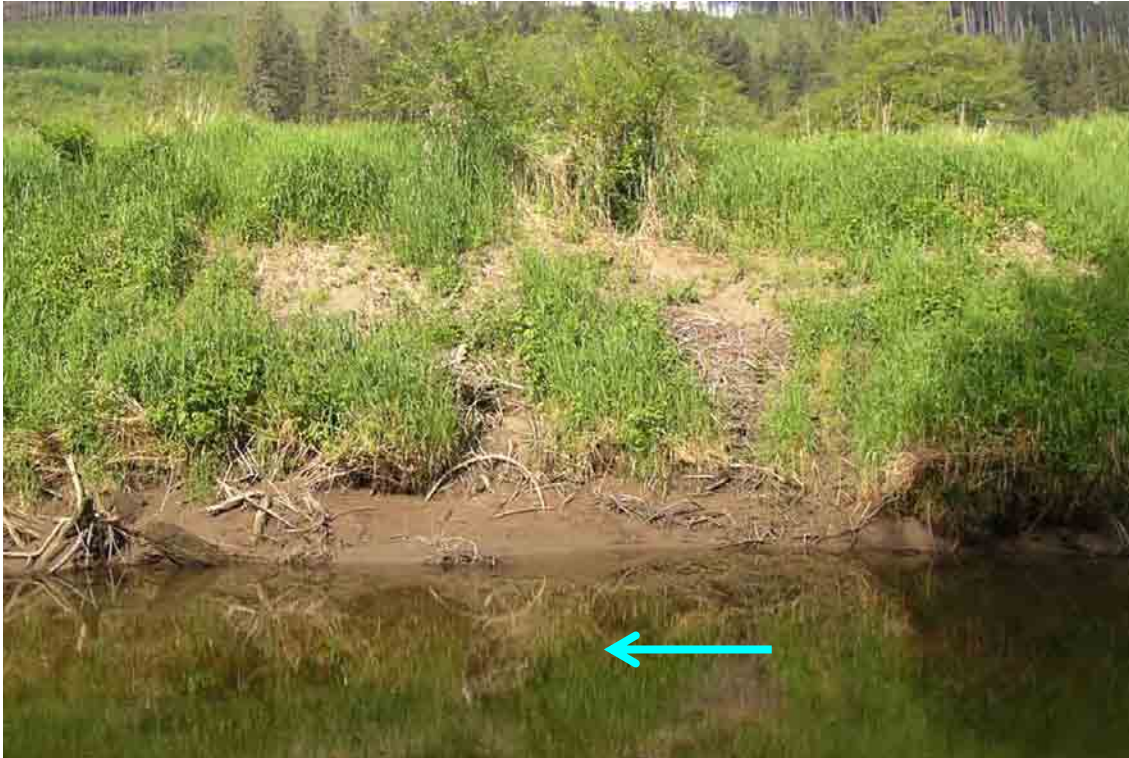
Photo A-2. Hoko River Site ID H-1 (May 12, 2005). Representative unforested bank of Lower Hoko River consisting of silty sand 20 feet high. (Photo Pan 2538-2539)

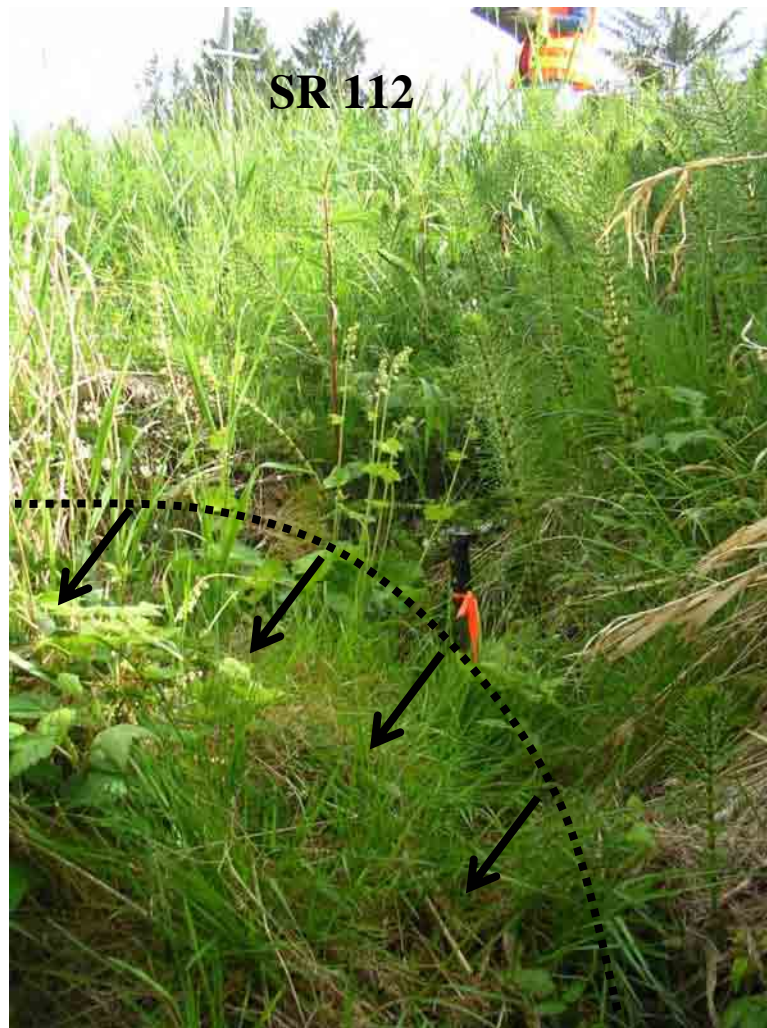
Photo A-3. Hoko River Site ID H-1.(May 12, 2005). Machete in expansion crack of slump head scarp in left bank adjacent to SR 112. Area left of machete is likely to collapse in near future. (Photo 2540)

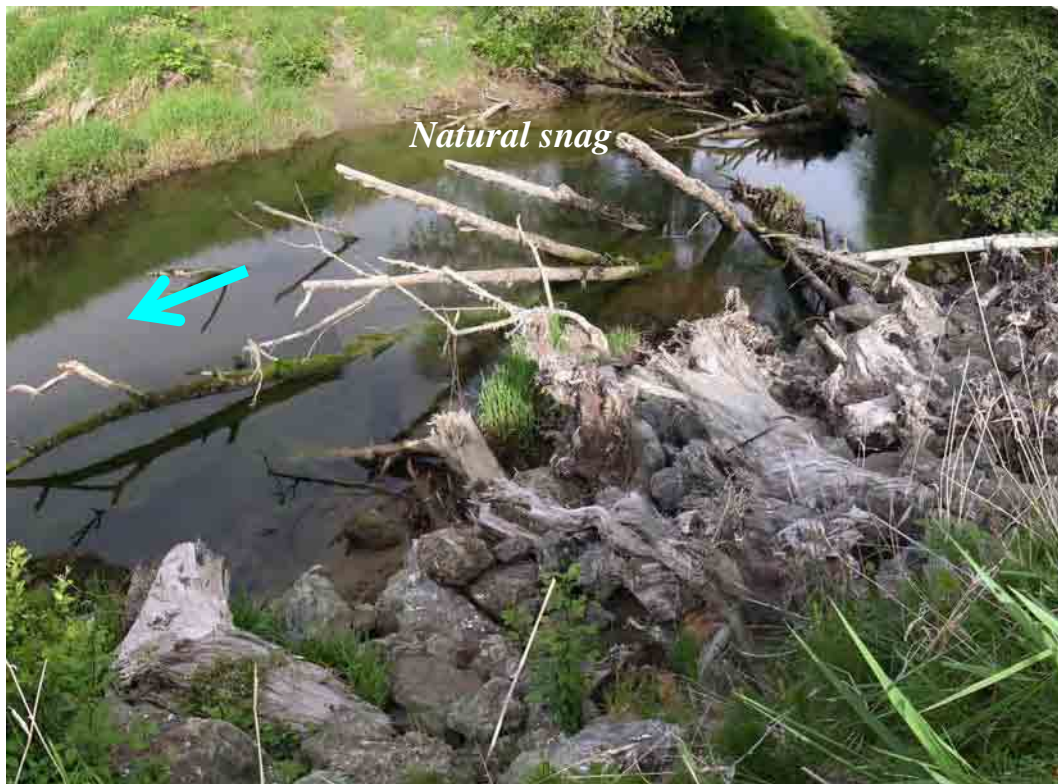
Figure A-4. Hoko River Site ID H-1 (May 12, 2005). Natural snag adjacent to bank protection work done in 2003(?) using rip and cabled stumps to stabilize left bank along SR 112. (Photo Pan 2541-2550)

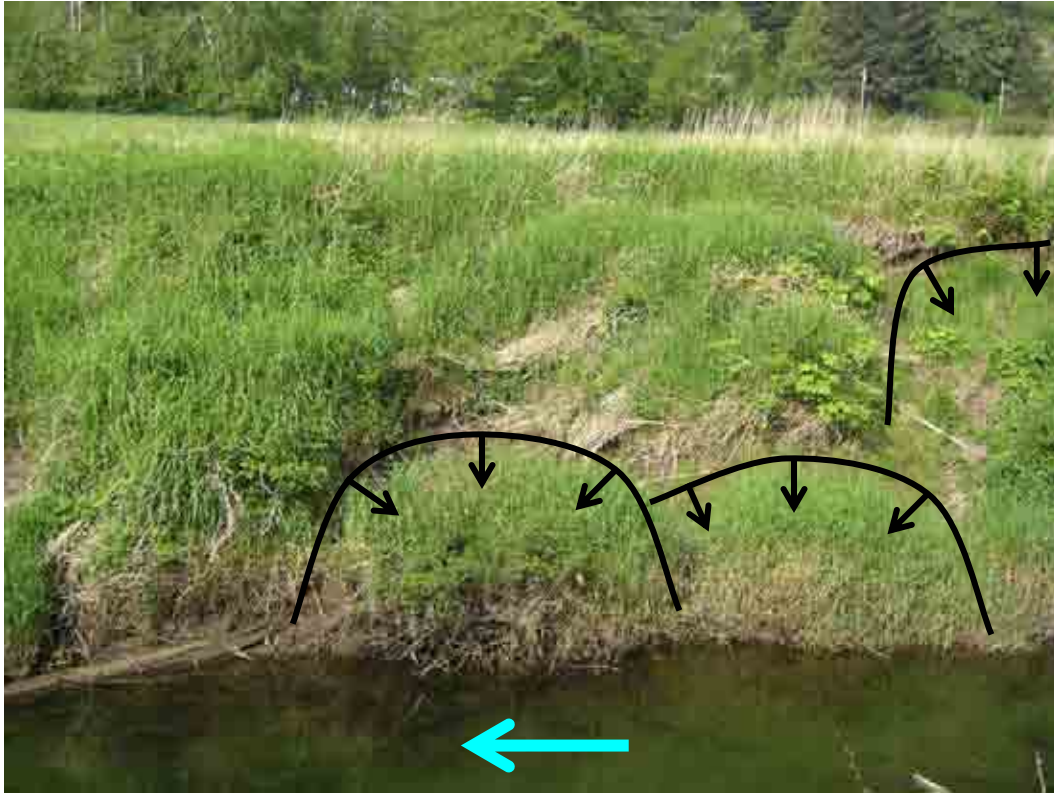
Photo A-5. Hoko River Site ID H-1 (May 12, 2005). Slumping along right bank. (Photo 2551)

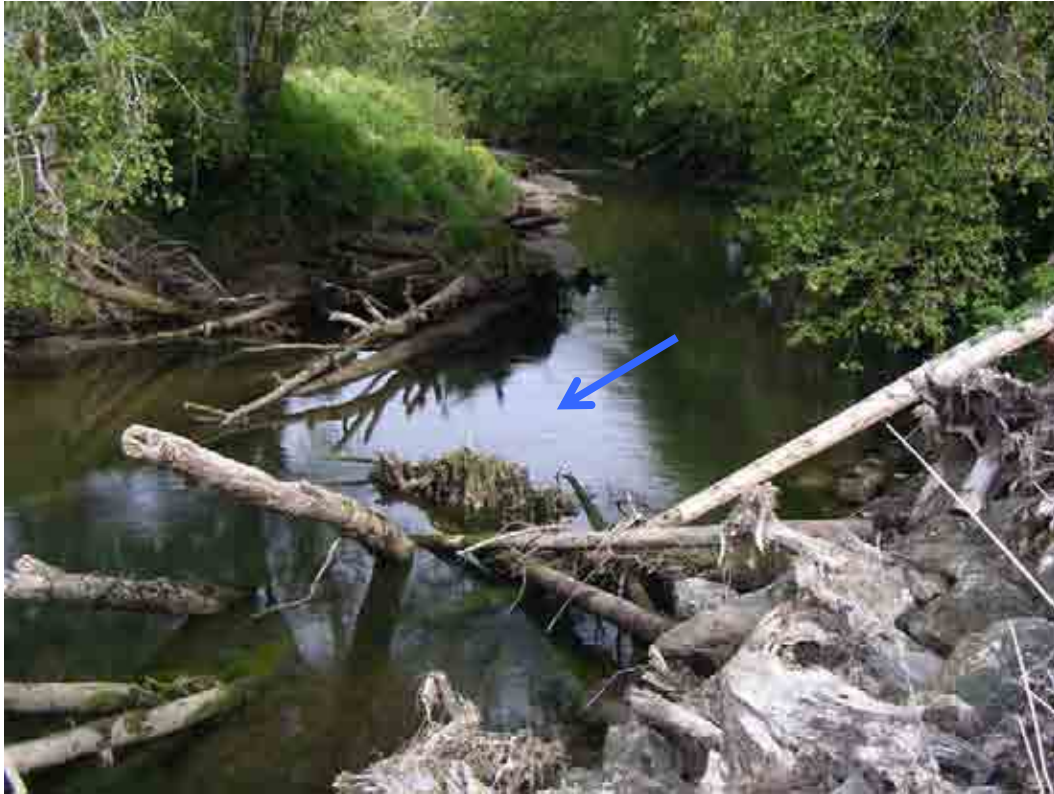
Photo A-6 Hoko River Site ID H-1 (May 12, 2005). Looking upstream natural snags may have contributed to bank erosion problem. Site looks stable now. (Photo Pan 2553)

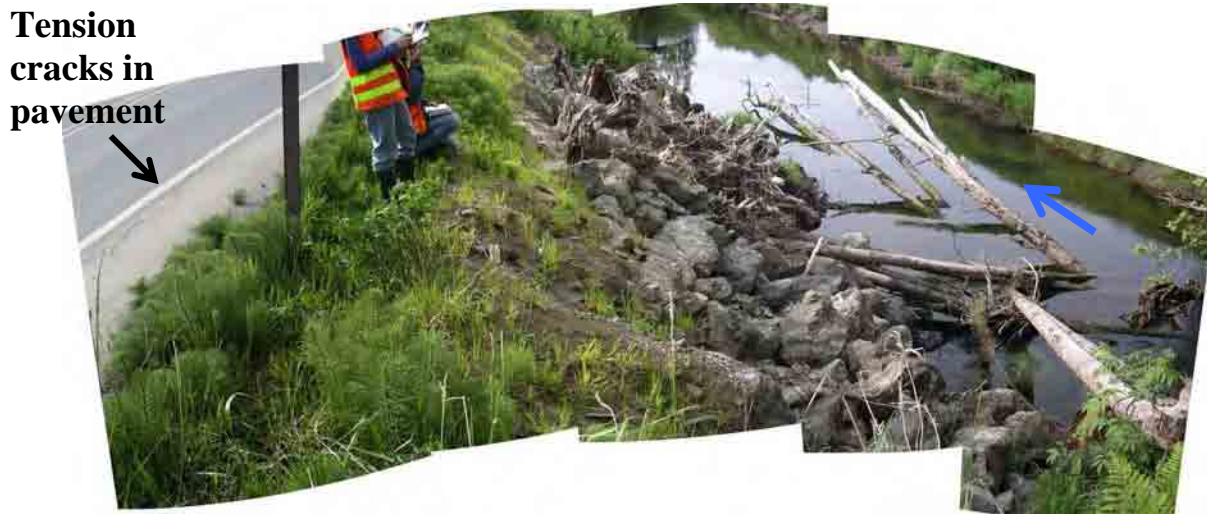
Photo A-7 Hoko River Site ID H-1 (May 12, 2005). Site of 2004(?) bank protection work MP 11.5(?), looking downstream. Tension cracks in pavement visible far left of image. (Photo Pan 2555-2559)

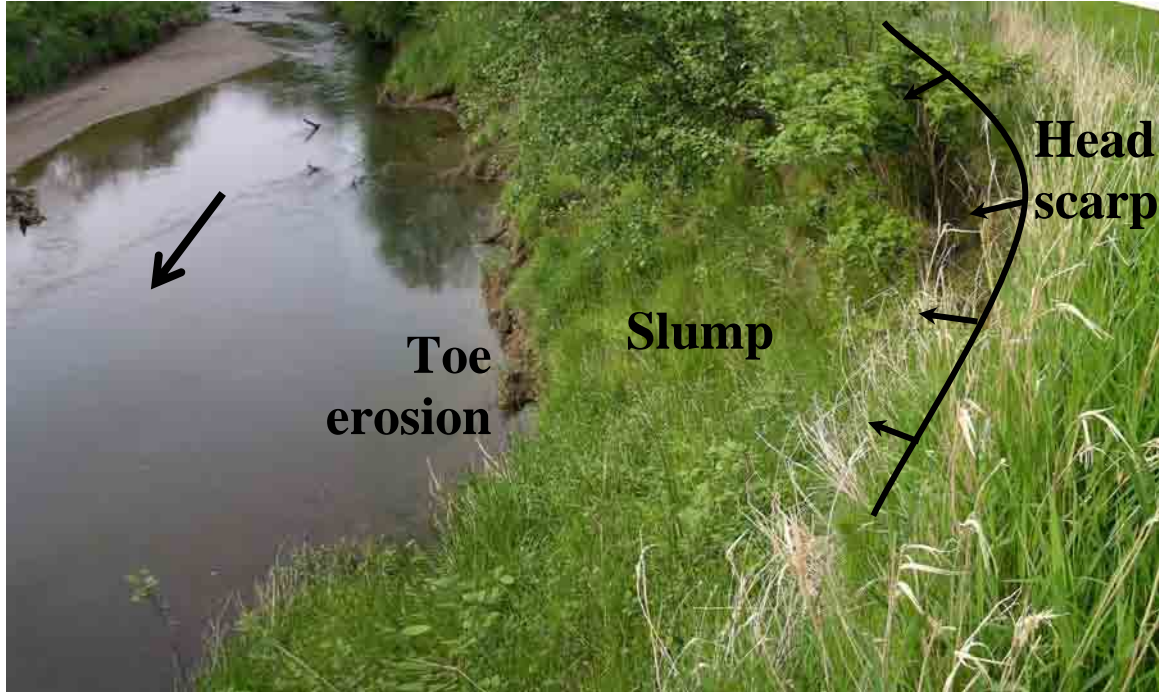
Photo A-8. Hoko River Site ID H-1 (May 12, 2005). Looking upstream. Slump block (Photo Pan 2563-2565)

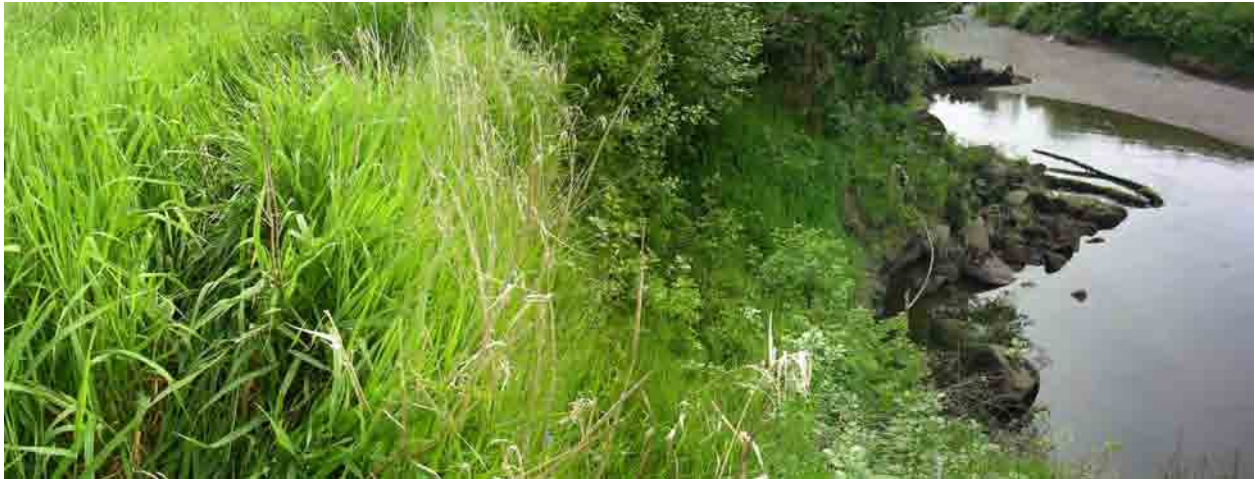
Photo A-9. Hoko River Site ID H-1 (May 12, 2005). Looking downstream at undercutting of gravel sand toe of bank, apex of meander at MP 11.42. (Photo Pan 2571-2574)

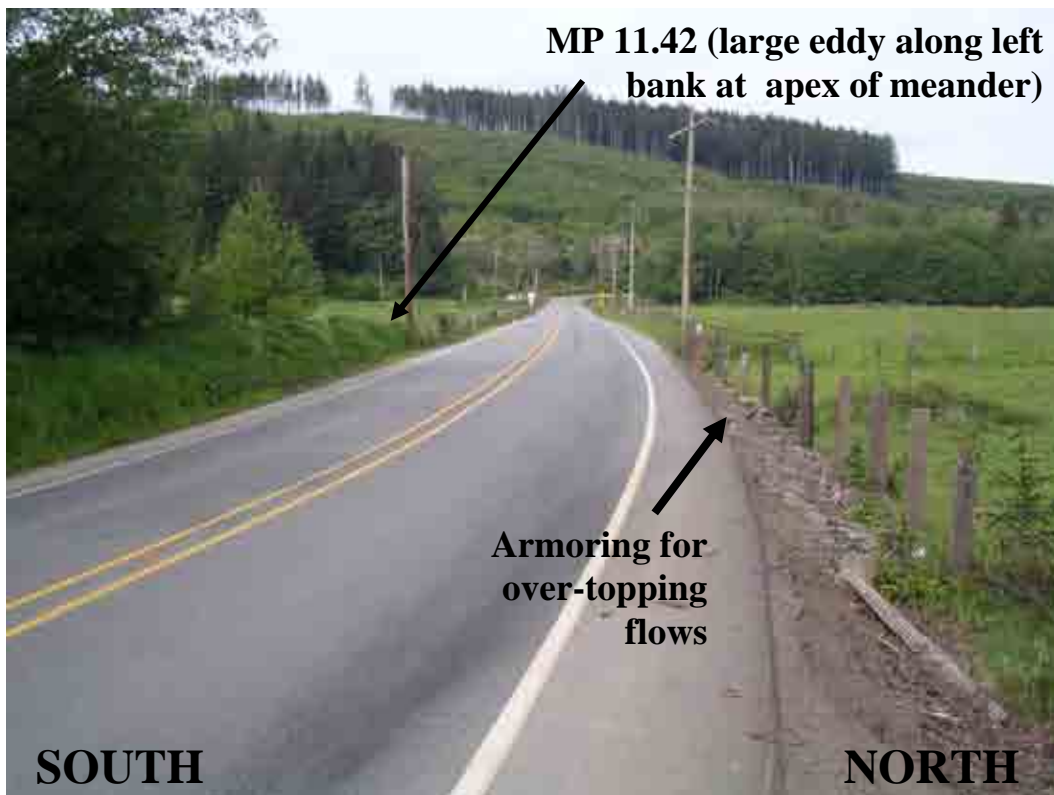
Photo A-10. Hoko River Site ID H-1 (May 12, 2005). Looking west at upstream end of H-1, MP 11.42. Road is raised about 4 feet above floodplain and still susceptible to overtopping flows (note armoring along downstream or north (right) side of road. (Photo 2575)

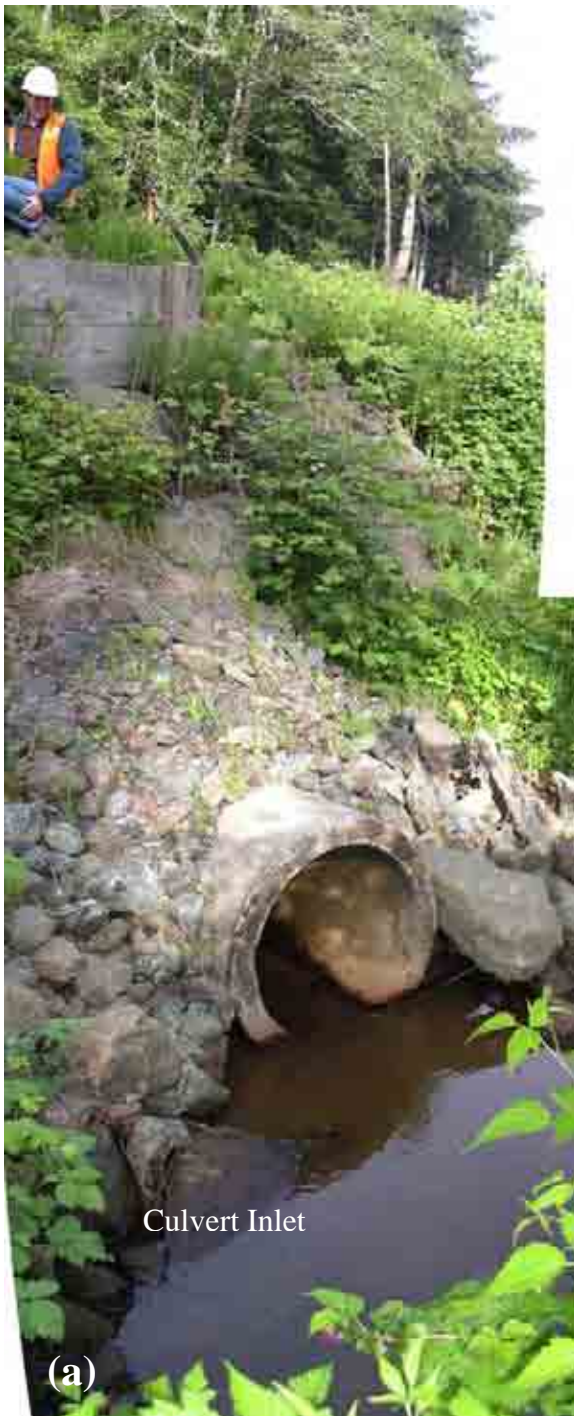
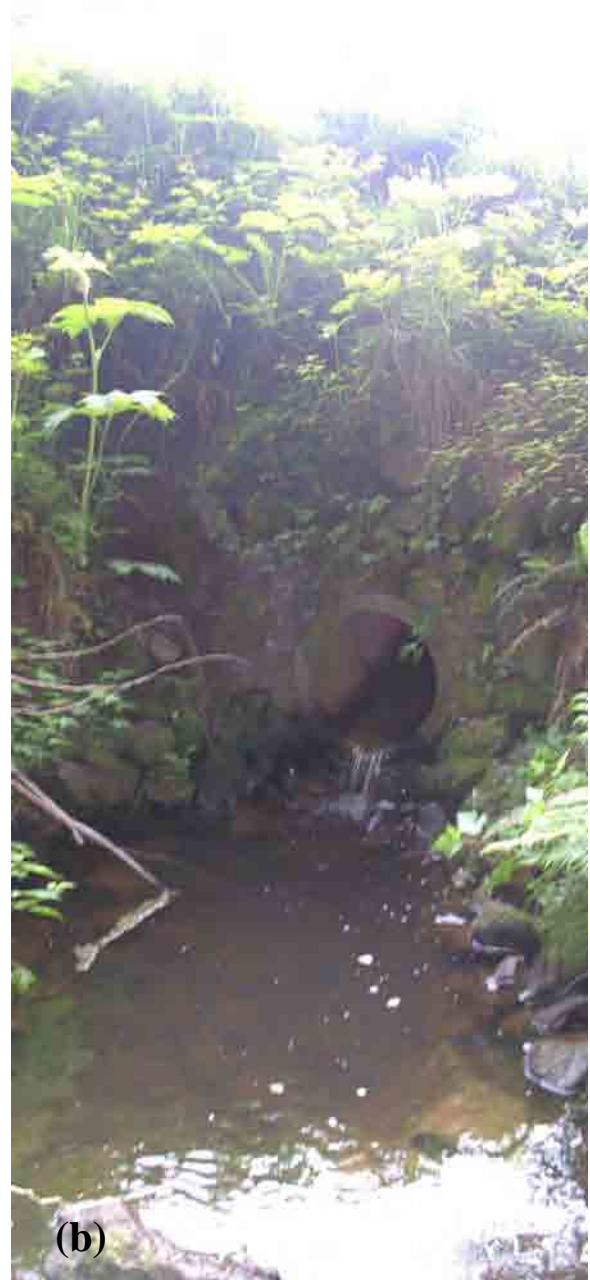
Photo A-11. Hoko River Site ID H-2 (May 12, 2005) (a) Upstream side of undersized culvert. (b) downstream side of culvert. Culvert is 24 inches in diameter. (Photo Pan 2528-2529 and Pan 2525-2526)

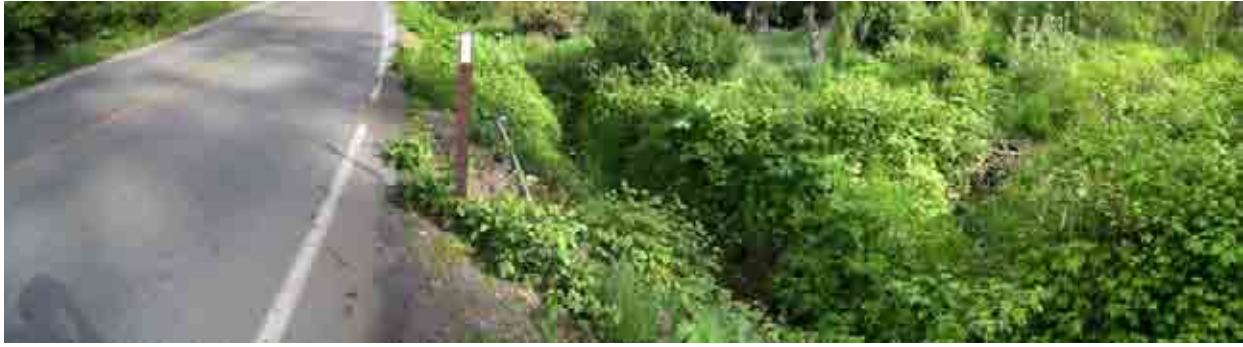
Photo A-12. Hoko River Site ID H-2 (May 12, 2005). Looking west along SR112 and upstream of culvert. Tension cracks in pavement are visible for 25 feet along the right shoulder. (Photo Pan 2530-2532)

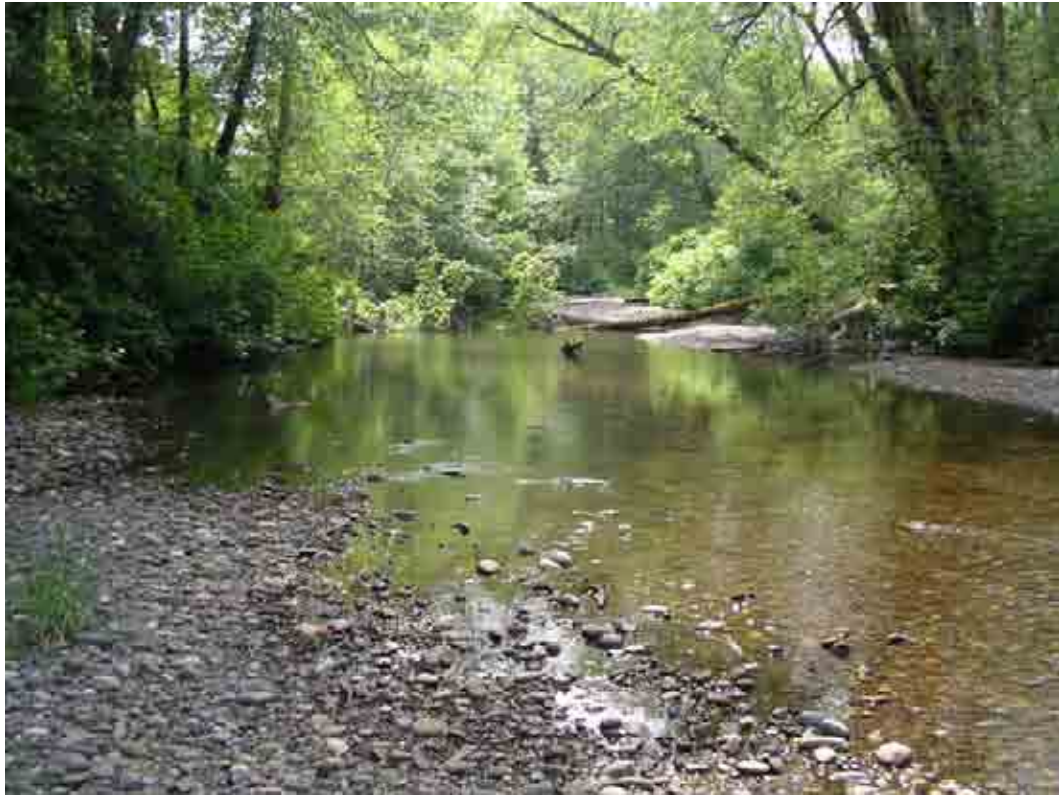
Photo A-13. Clallam River Site ID C-1 (May 12, 2005). Looking upstream of “Corp Site” of large (greater than 4 foot) rock rip rap that is situated along the right bank where alder has fallen across the channel. (Photo 2643)

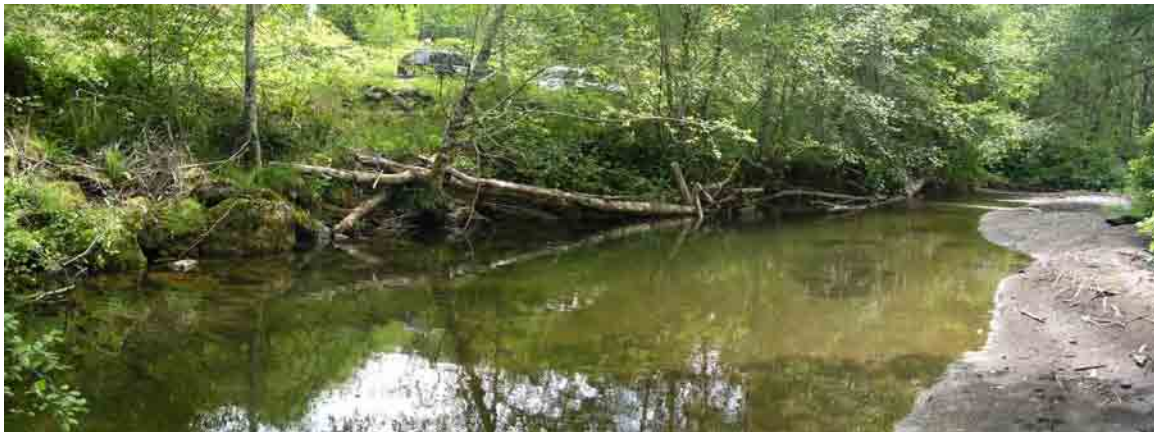
Photo A-14. Clallam River Site ID C-1 (May 12, 2005). Looking upstream at right bank of rip rap at corp site. (Photo Pan 2644-2645)

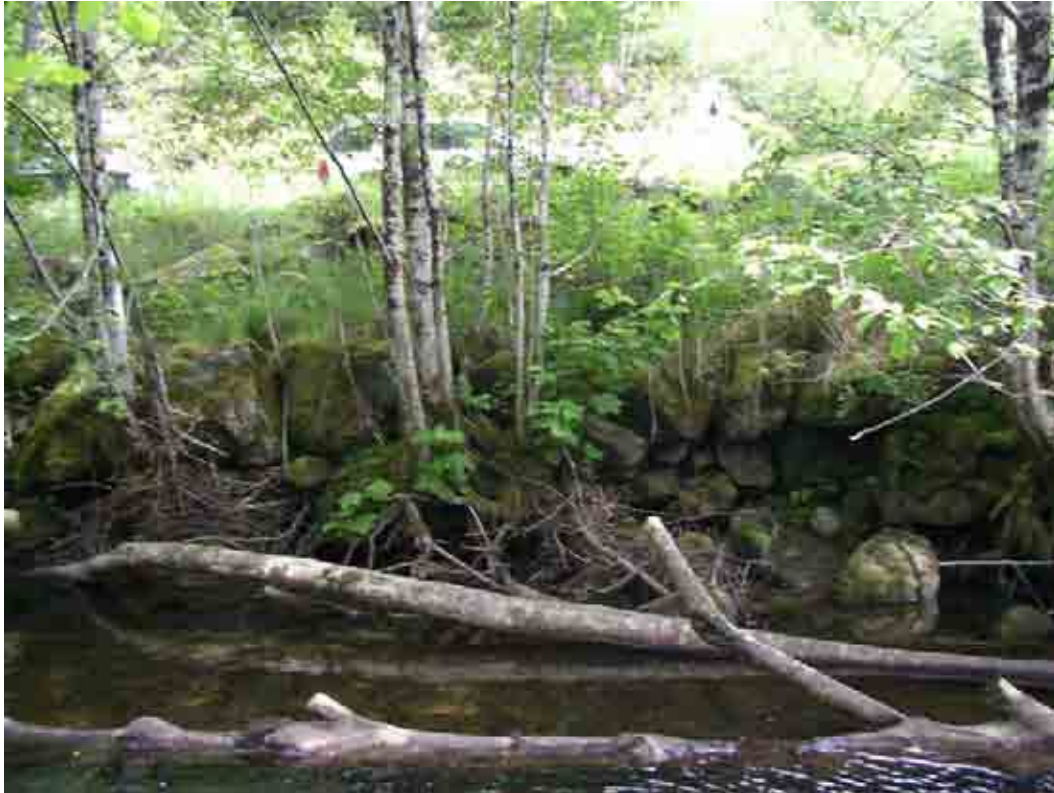
Photo A-15. Clallam River Site ID C-1 (May 12, 2005). Bank at Corp Site is vertical for the first 8 ft above channel. Total hang height is 15 feet. (Photo 2646)

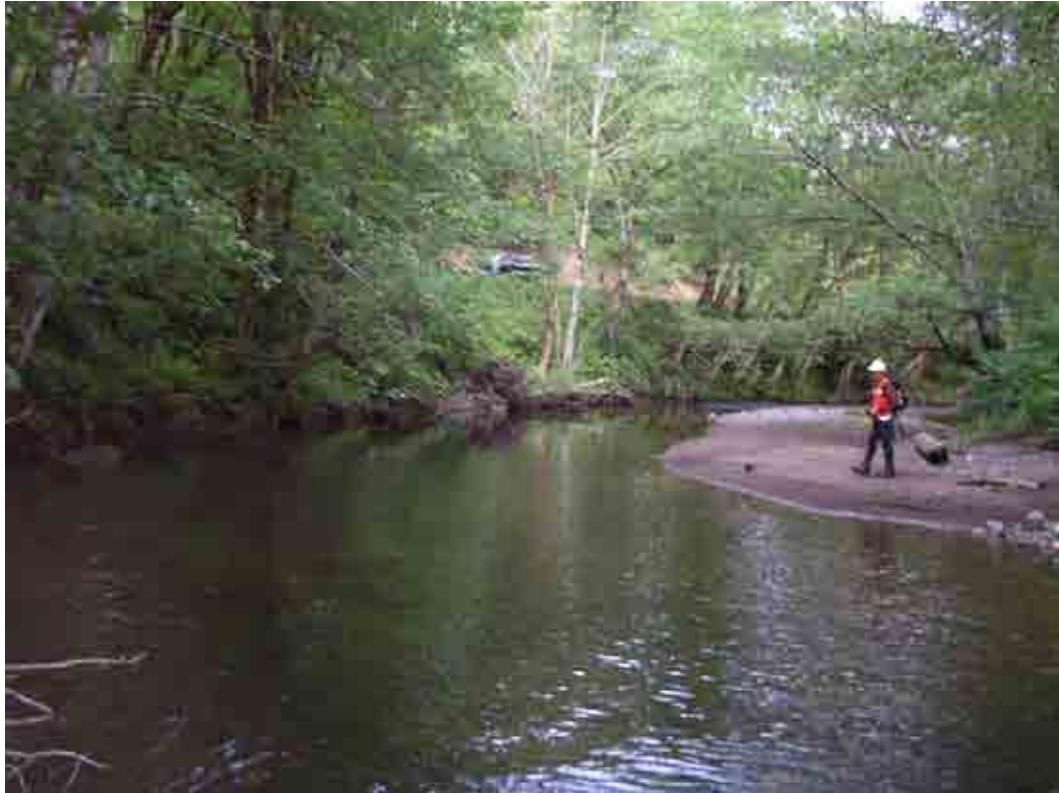
Photo A-25. Pysht River Site ID P-1 (May 12, 2005). Looking downstream along rip rap. Bruce Carpenter on point bar of right bank. Beyond this bend in the river the right bank floodplain is three feet. (Photo Pan 2777)

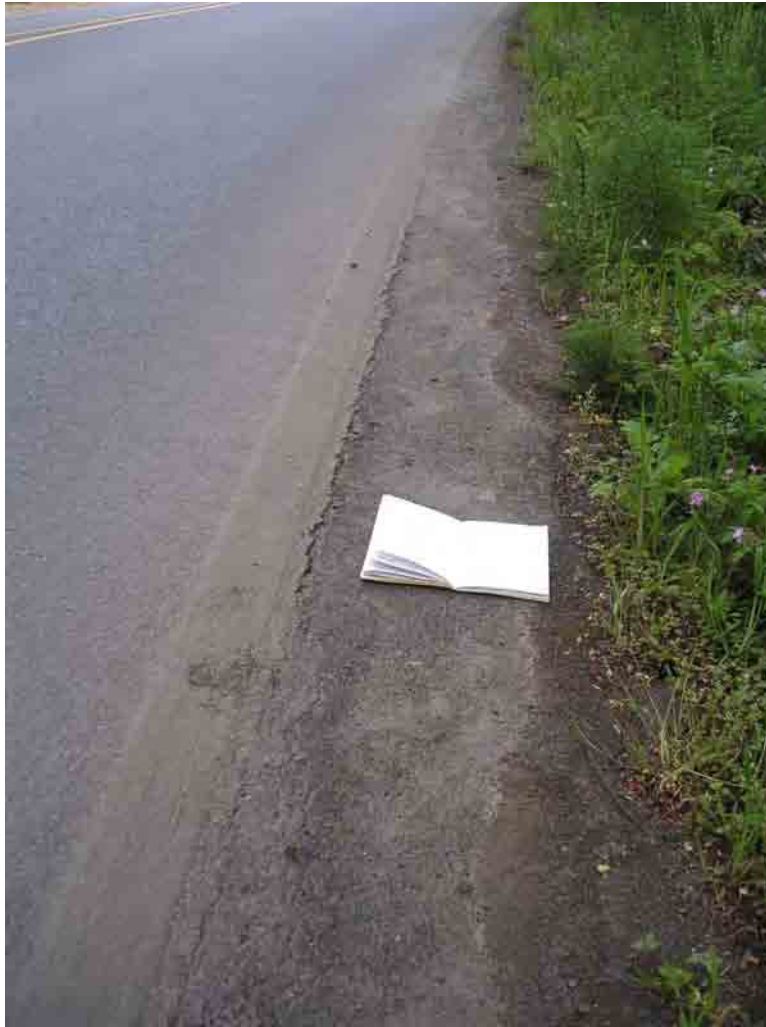
Photo A-26. Pysht River Site ID P-1 (May 12, 2005). Cracked pavement. (Photo 2778)

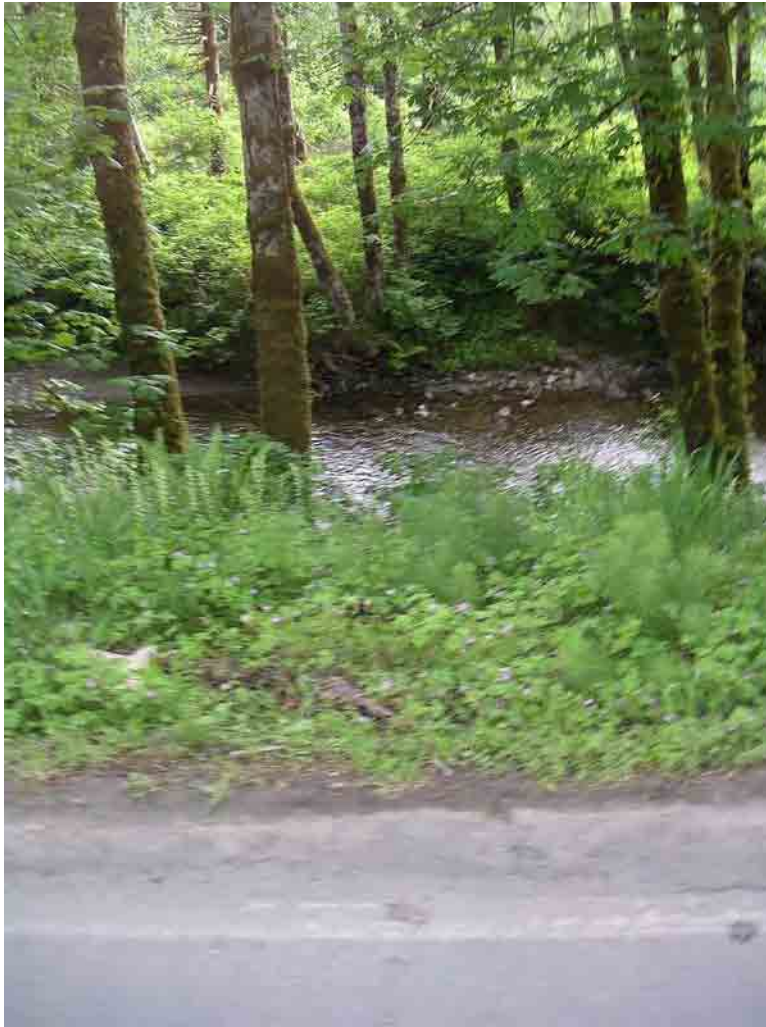
Photo A-27. Pysht River Site ID P-1 (May 12, 2005). Looking south across the river to far bank. Bank height from river is approximately 3 feet. (Photo 2779)

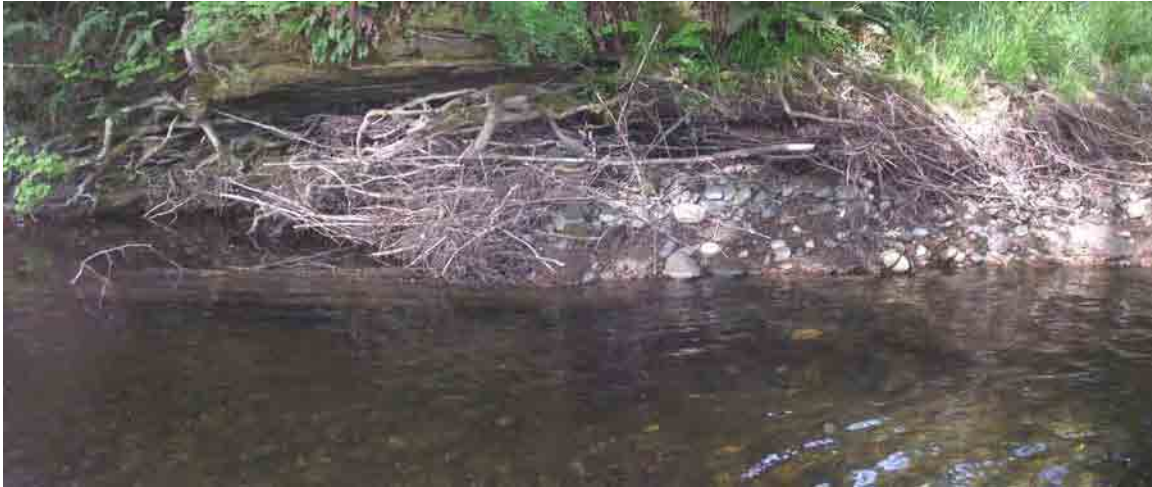
Photo A-26. Pysht River Site ID P-1 (May 12, 2005). Buried log (Photo Pan 2789-2790)

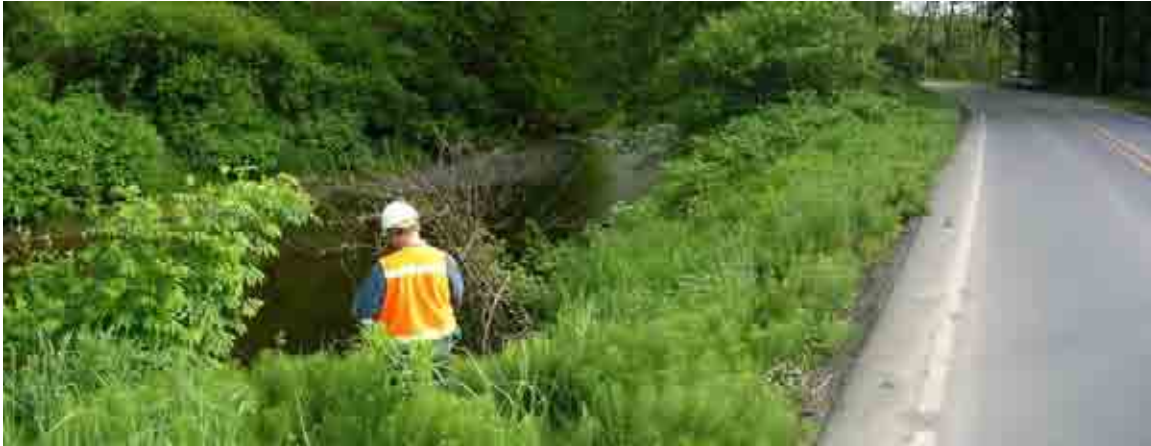
Photo A-29. Pysht River Site ID P-03 (May 11, 2005). Looking upstream . Bank height is approximately 15 feet. Top of bank is 9 feet from the edge of the pavement. Bank erosion – 40 feet. Limited riparian vegetation. (Photo Pan 2497-2498)

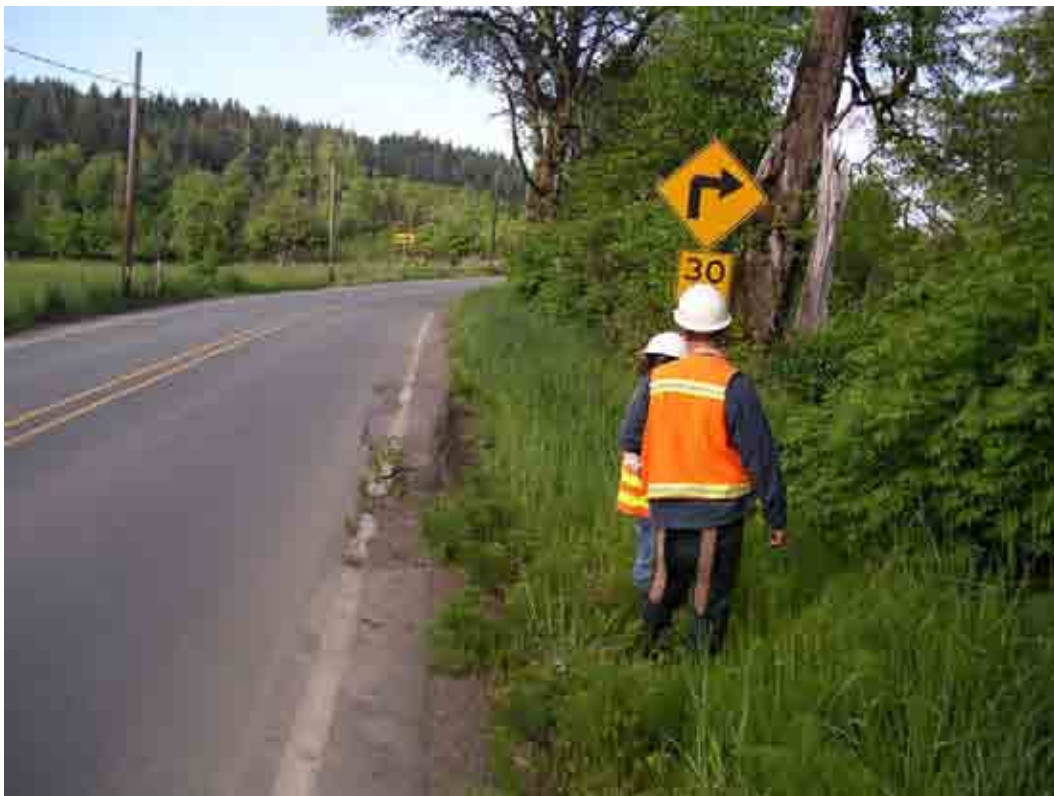
Photo A-30. Pysht River Site ID P-3 (May 11, 2005). Looking downstream. Bank erosion, cracked pavement, top of bank is 10 feet from the edge of pavement. (Photo 2499)

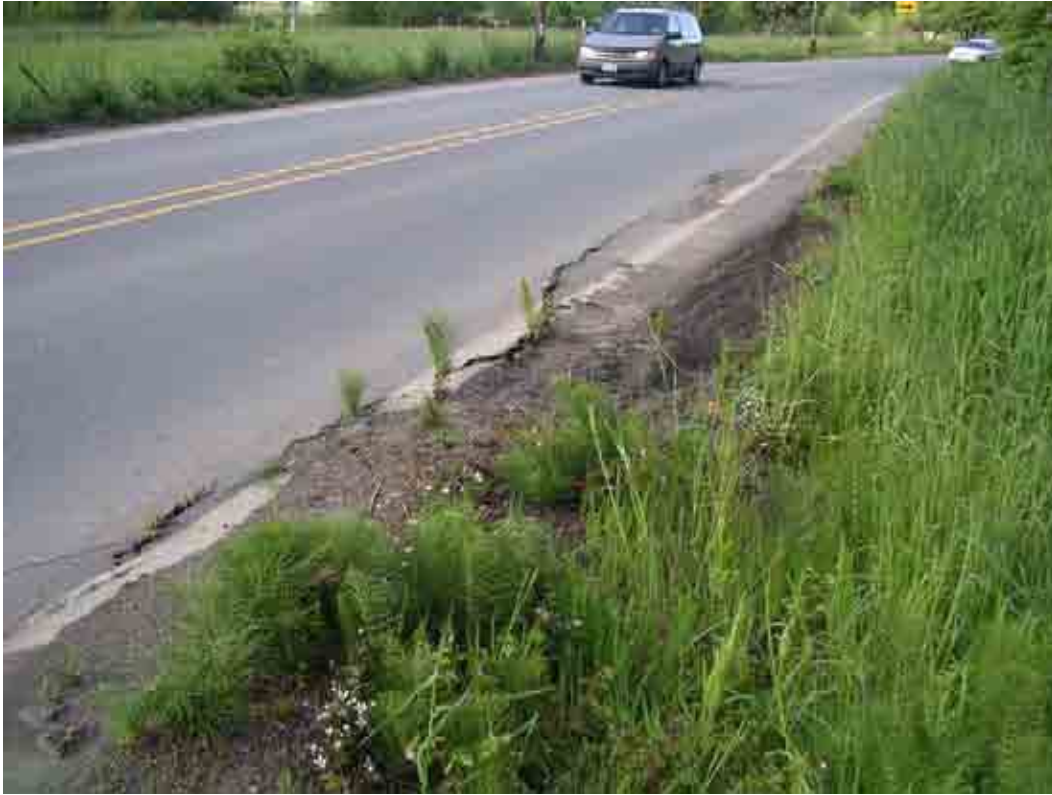
Photo A-31. Pysht River Site ID P-3 (May 11, 2005). Detailed view of cracked pavement. Area where road cracks are exhibited is approximately 55 feet in length. End of cracking downstream is coincident with the start of rip rap (41 feet downstream of 30MPH sign). (Photo 2500)

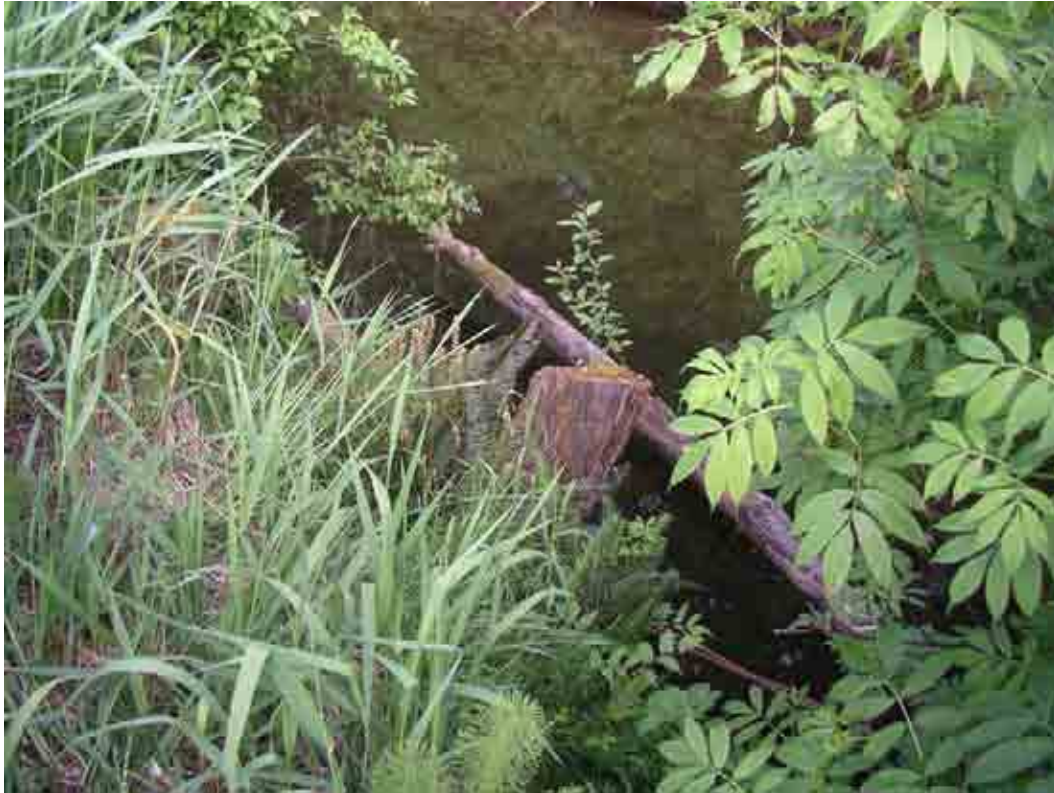
Photo A-32. Pysht River Site ID P-3 (May 11, 2005). Looking down the bank towards channel. Bank is vegetated (Photo 2501)

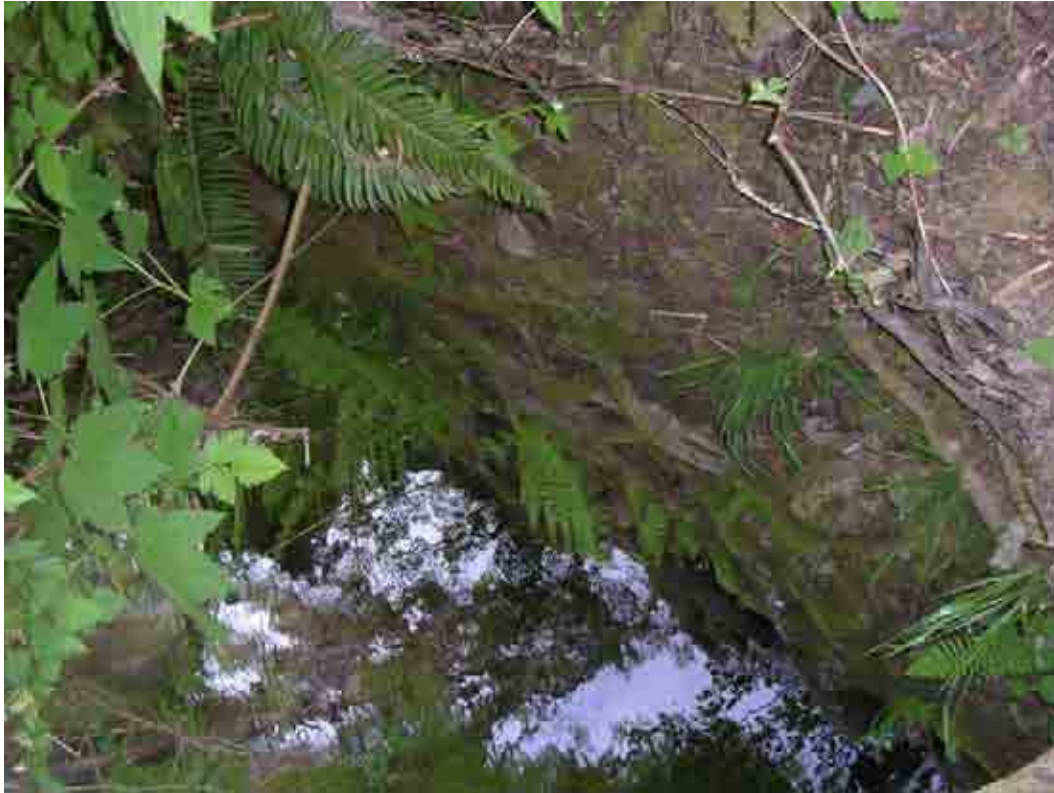
Photo A-33. Pysht River Site ID P-3 (May 11, 2005). Left bank alder root cohesion. Upstream of milepost 26. (Photo 2502.)

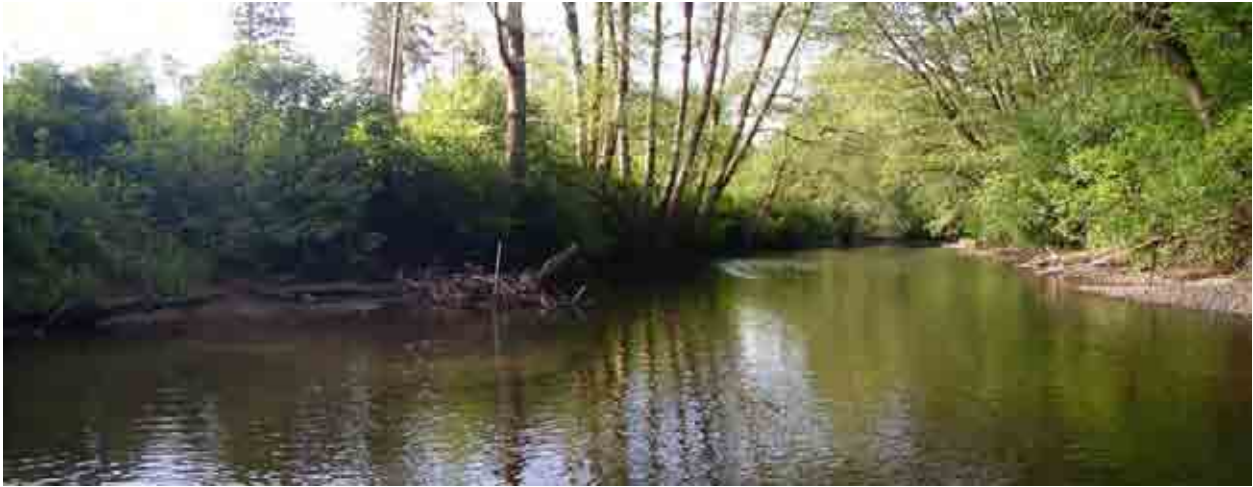
Photo A-34. Pysht River Site ID P-3 (May 11, 2005). Looking downstream. Just upstream of Mile post 26. Wetted channel is approximately 60 feet, bank height is approximately 12 feet. Bankfull depth is ~3 feet. Channel is plane bed devoid of wood and habitat. (Photo Pan 2503-2504)

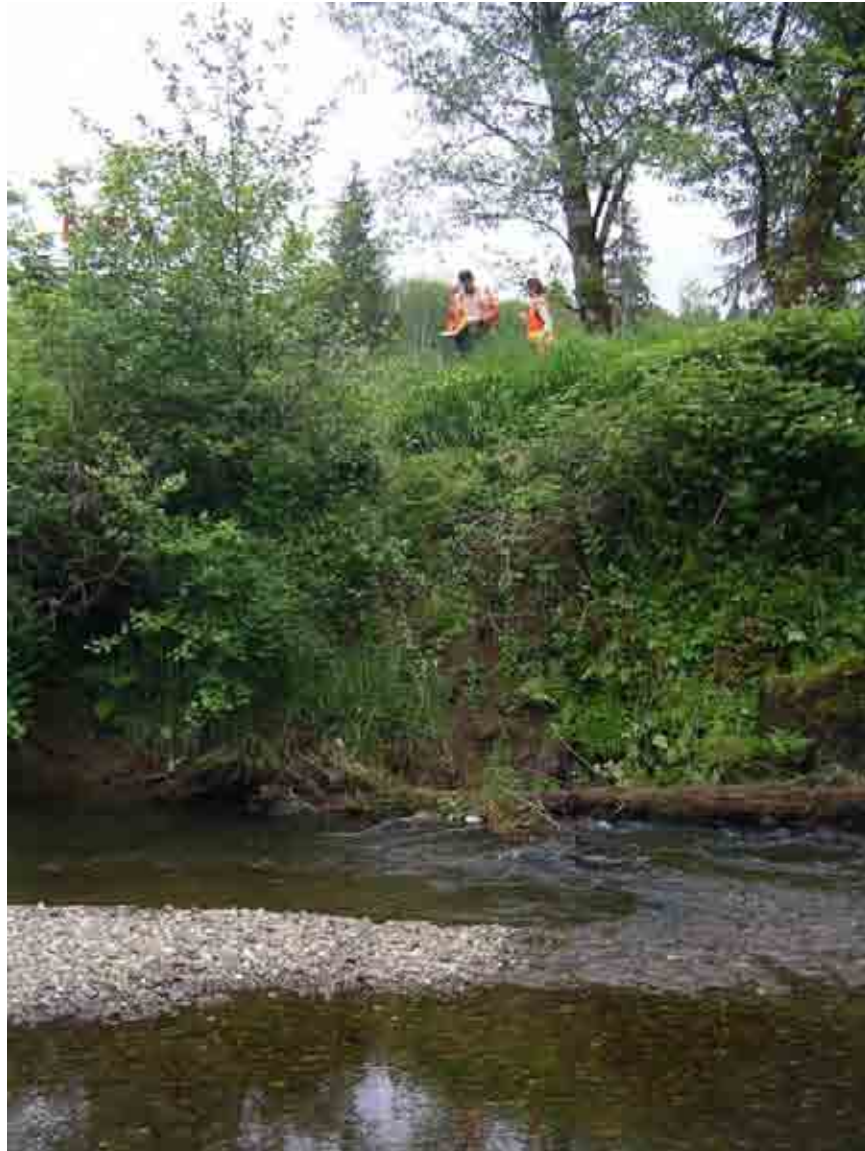
Photo A-39. Pysht River Site ID P-4 (May 10, 2005). Large coarse gravel bar – distinct armor layer. (Photo 2296)

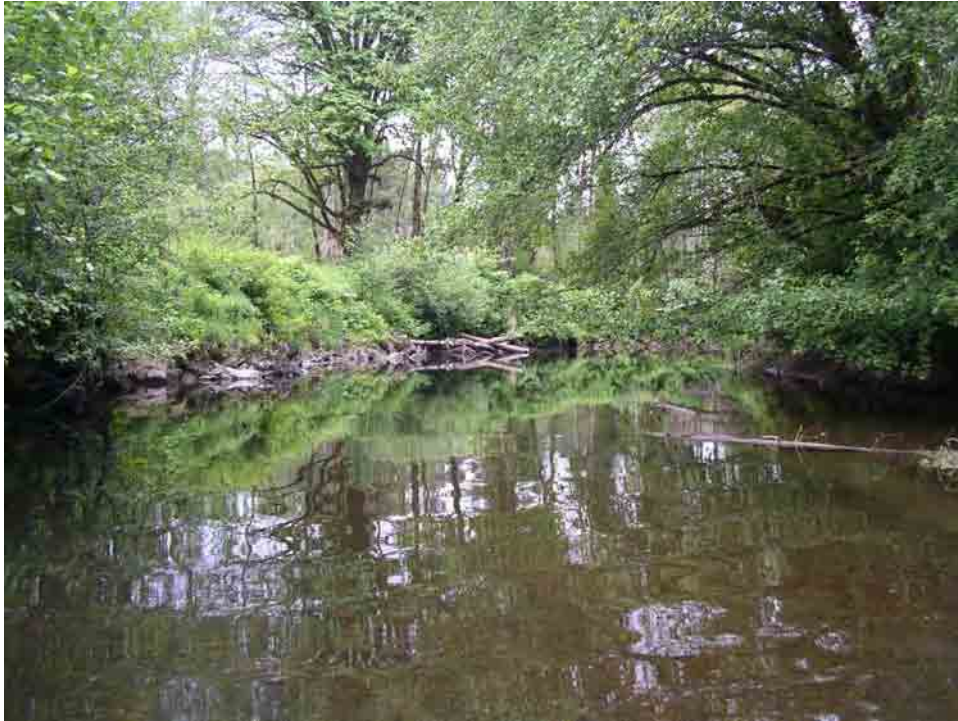
Photo A-42 Pysht River Site ID P-4 (May 10, 2005). Looking upstream above redds – plane bed channel along rip rap – no wood. (Photo 2300)
