APPENDIX A

Site Photographs

Reach Analysis—Hoko, Clallam, Pysht Rivers Photographic Log

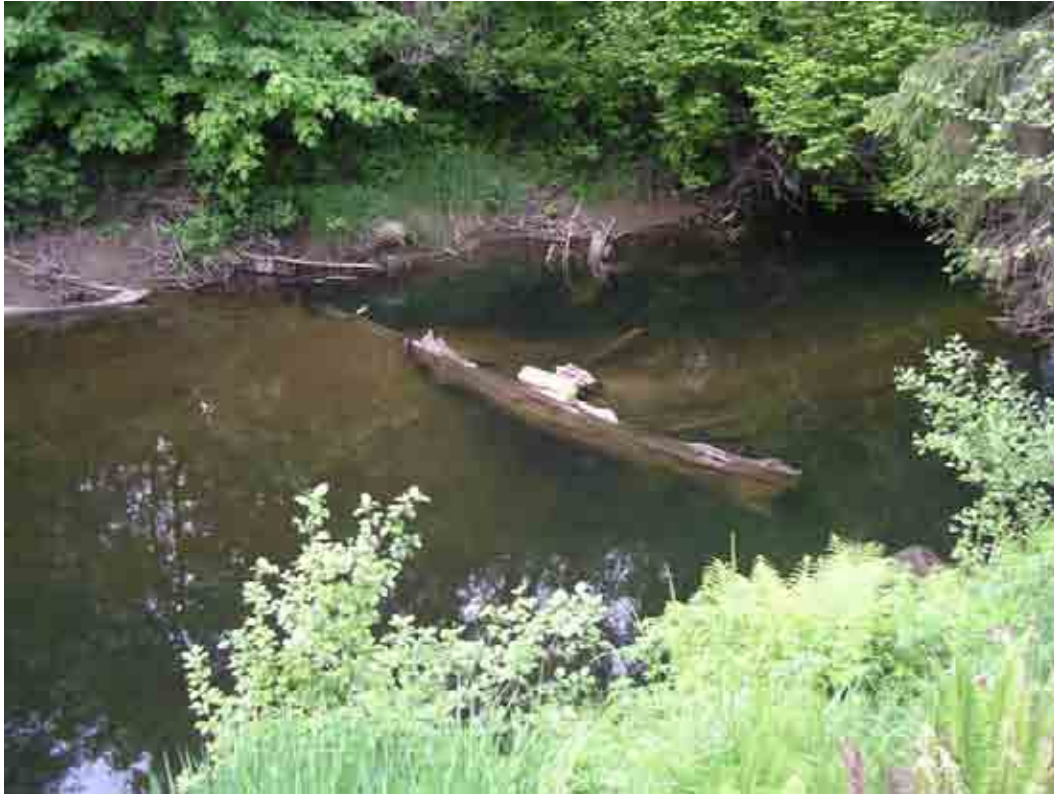
Photo A-45. Pysht River Site ID P-4 (May 11, 2005). Submerged log across Pysht channel about 25ft downstream of mile post 27 sign. (Photo 2448)

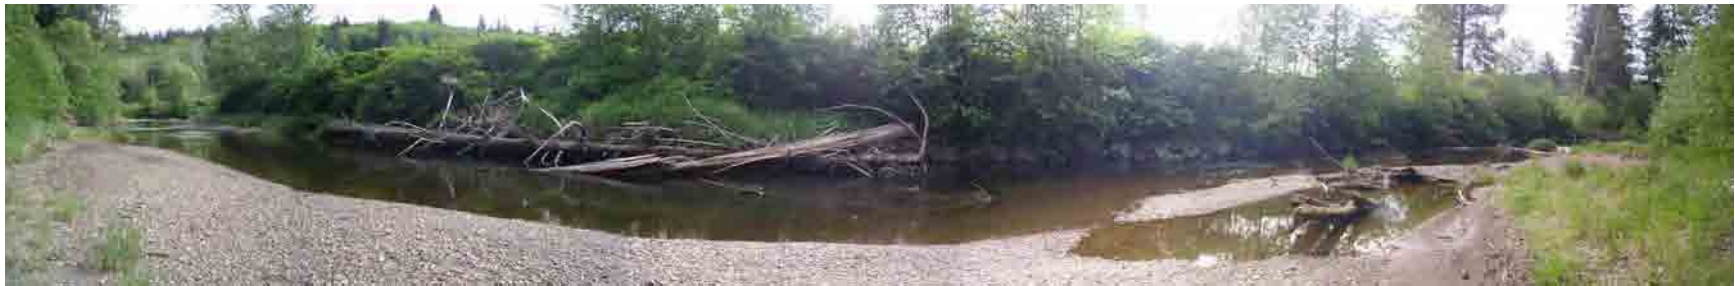
Photo A-50. Pysht River Site ID P-4 (May 11, 2005). Panoramic image from the left point bar opposite cabled logs along toe of right bank. Rip rap (Photo Pan 2453-2458)

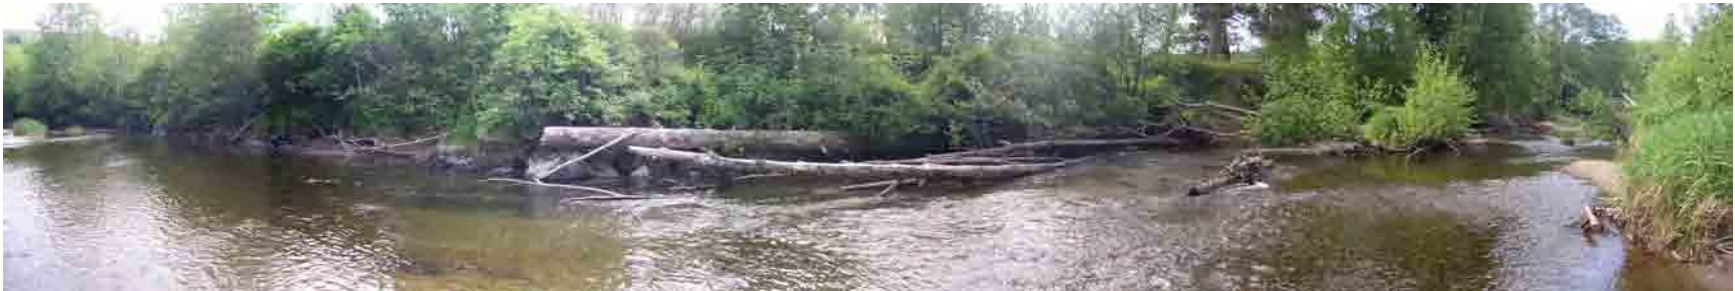
Photo A-51. Pysht River Site ID P-4 (May 11, 2005). Panoramic image of right bank rip rap. (Photo Pan 2461-2467)

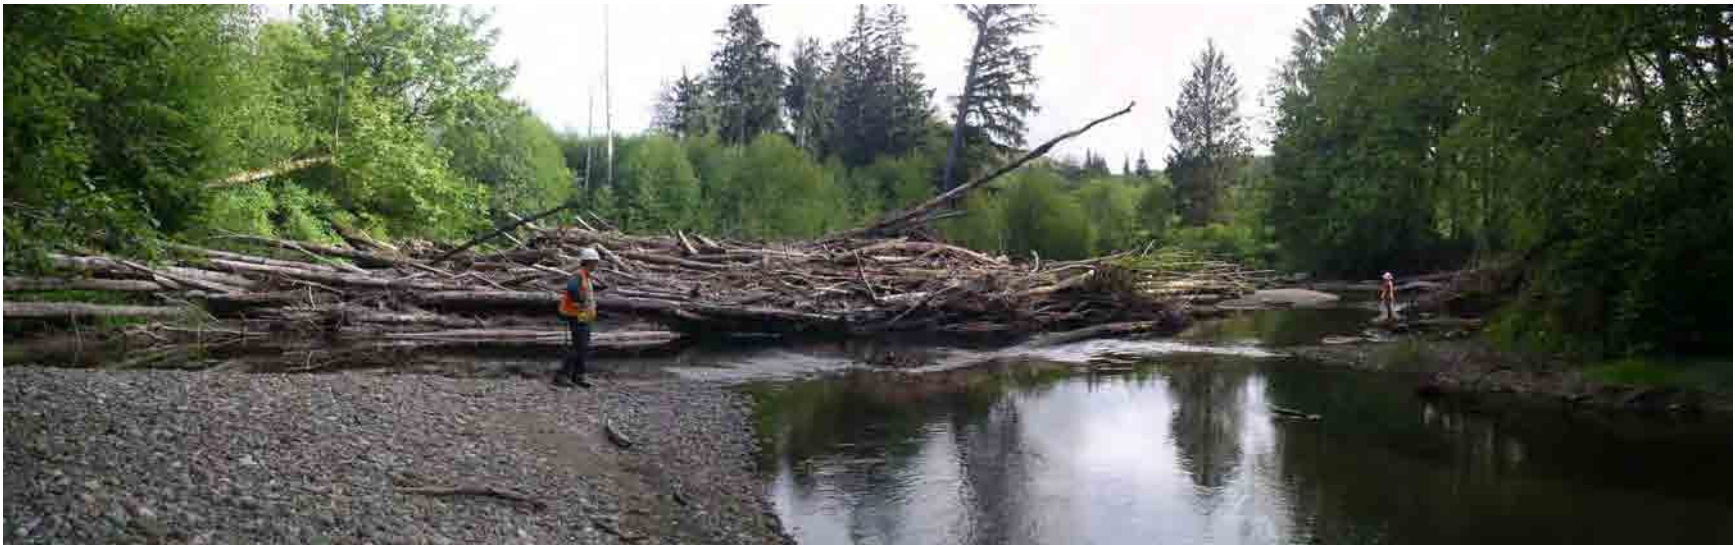
Photo A-55. Site ID P-4 (May 11, 2005). Channel spanning logjam. (Photo Pan 2494-2496)

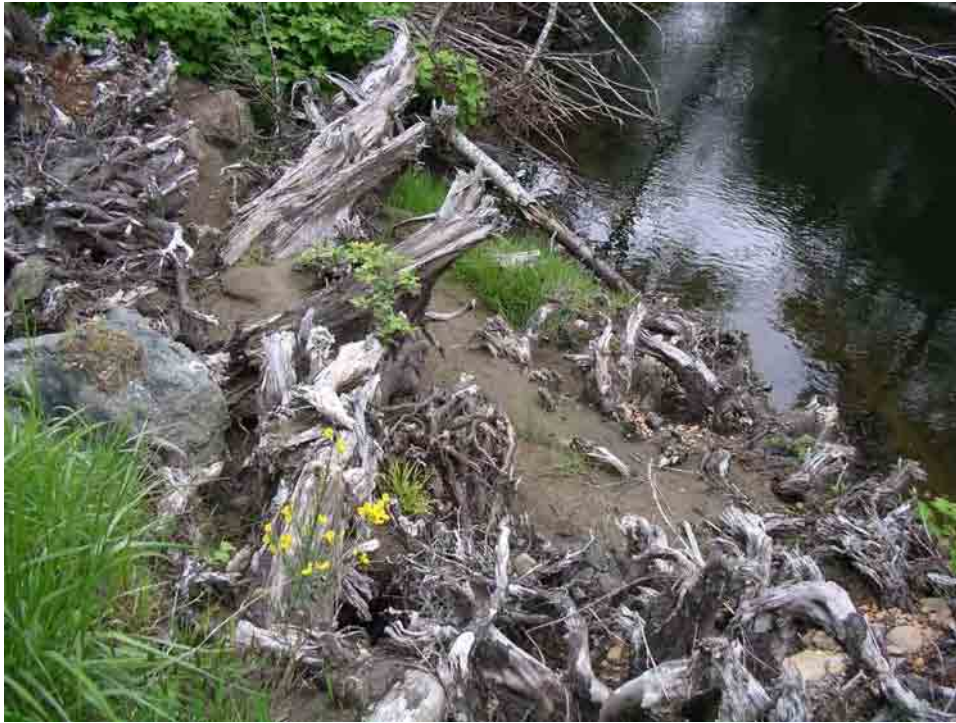
Photo A-58. Pysht River Site ID P-5 (May 10, 2005). Sand deposition in rock and wood of bank. Large gravel bar on left side of channel. (Photo 2312)

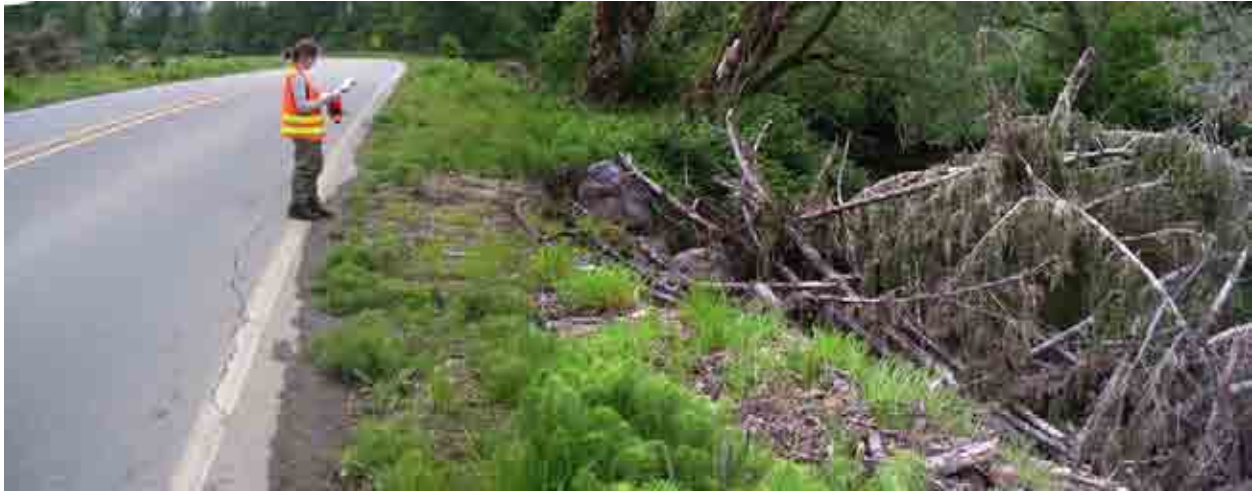
Photo A-59. Pysht River Site ID P-5 (May 10, 2005) 48 feet of cracked pavement just downstream of P24 (Photo Pan 2313-2314)

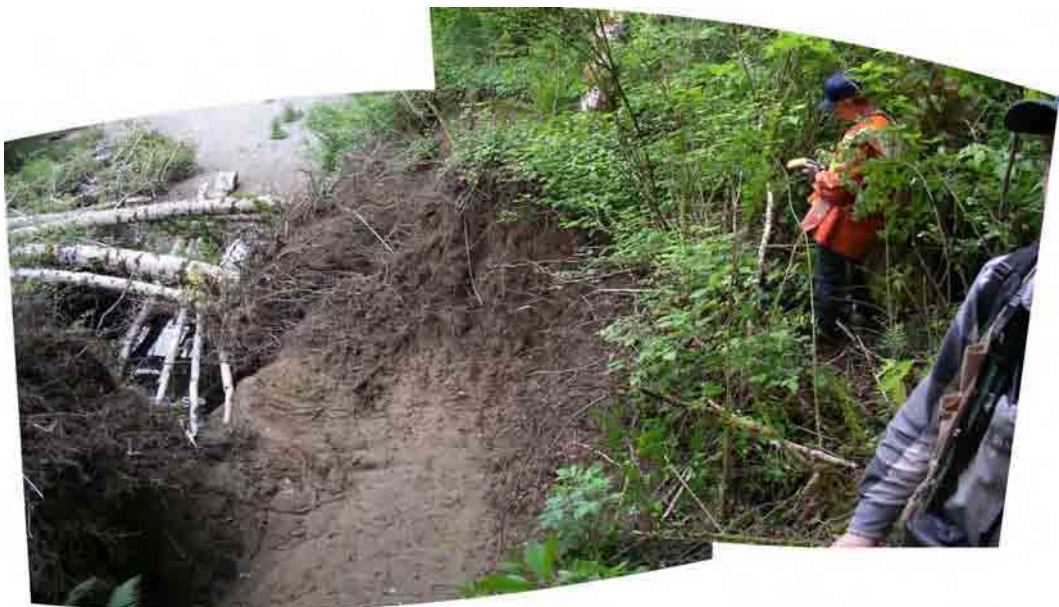
Photo A-62 Pysht River Site ID P-5. (May 10, 2005) top of right bank. Pt. 132m to PISI at end of gravel bar where large logjam has formed (see photo Pan 2318-2319). Large alder ~24" dbh is undercut. Tip of bank is 40 feet to highway edge of pavement. (Photo Pan 2320-2321)

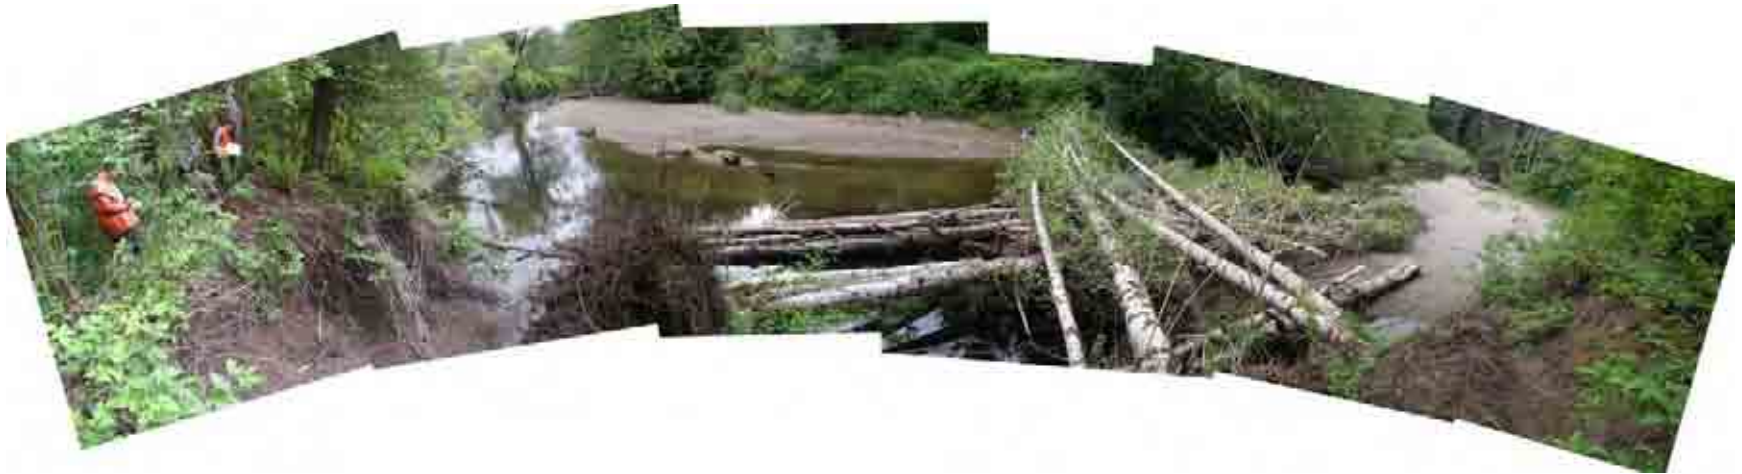
Photo A-64. Pysht River Site ID P-5 (May 10, 2005). Panoramic from top of right bank downstream of P25 looking at undercut alder logjam and downstream. (Photo Pan 2323-2328.)

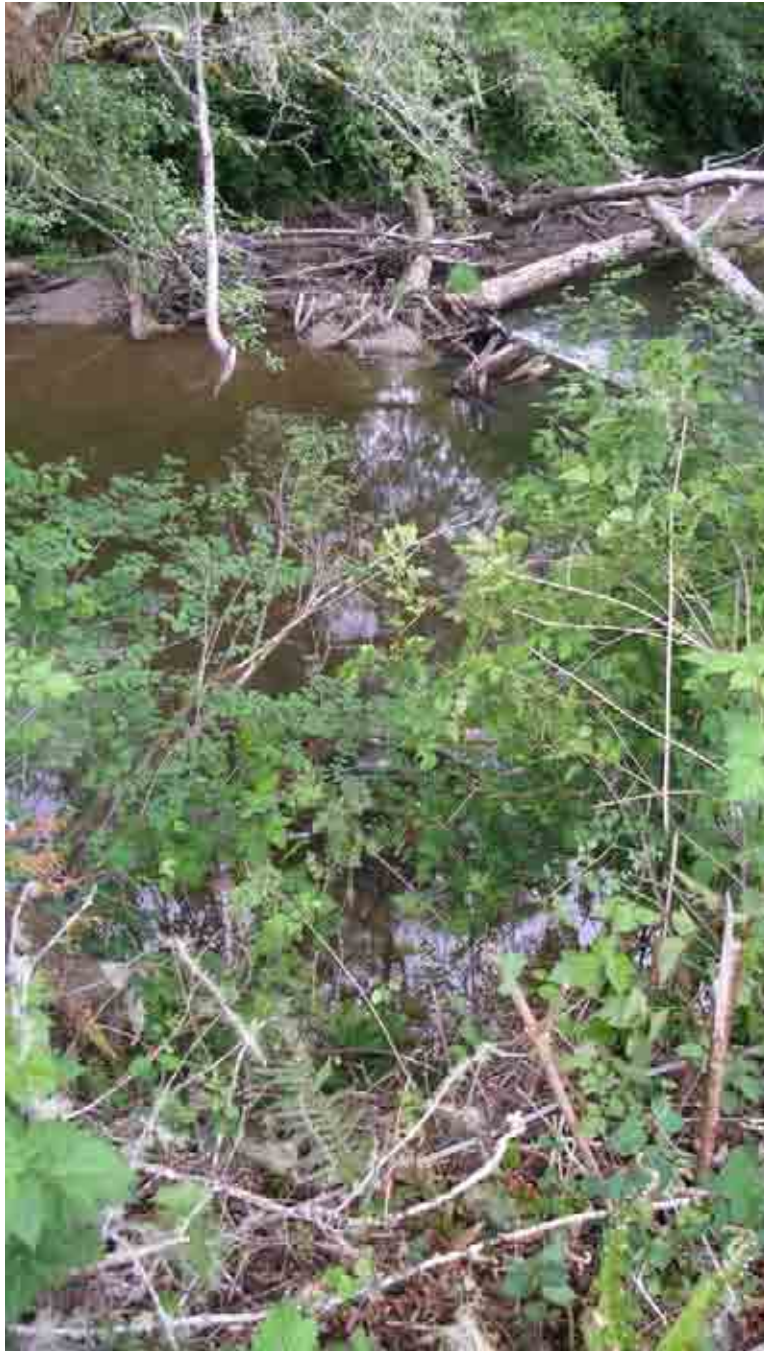
Photo A-66. Pysht River Site ID P-5 (May 10, 2005). Vertical panoramic of top edge of right bank with steel cable (to log downstream along recent repair site) immediately downstream of alder clumps leaning into river. Upstream of alder clump is rock rip rap. (Photo Pan 2330-2332.)

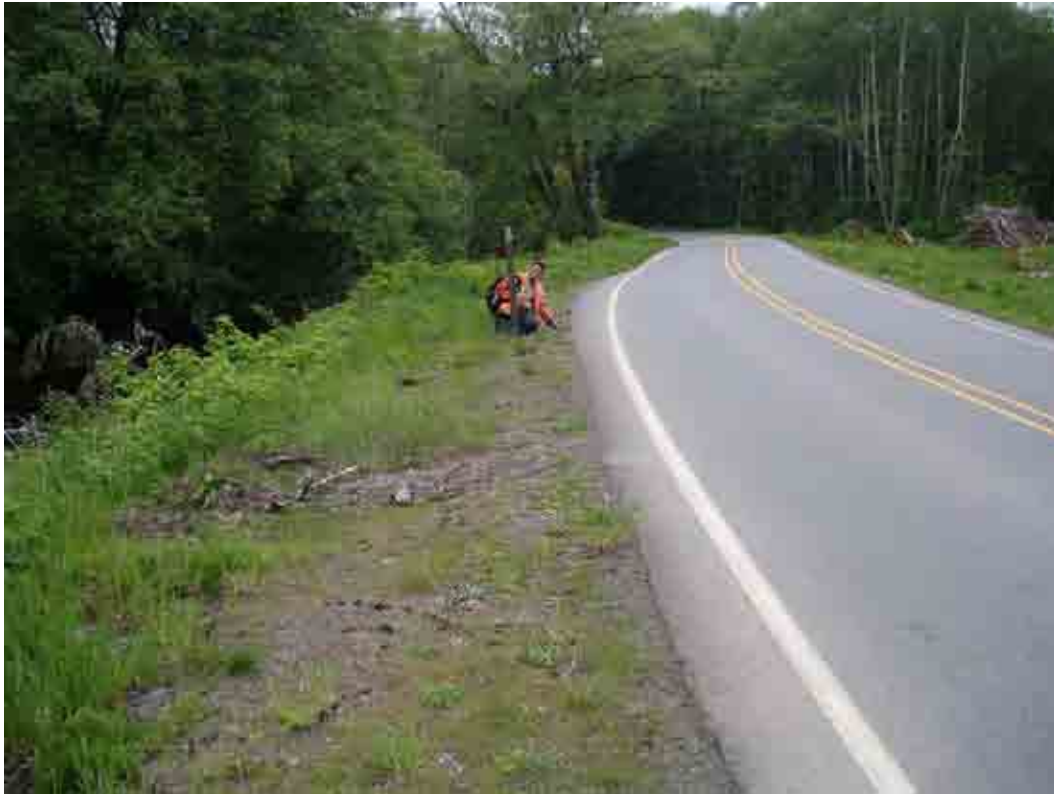
Photo A-67. Pysht River Site P-5 (May 10, 2005) Looking downstream along right bank edge of pavement; rills of runoff along highway. (Photo 2333)

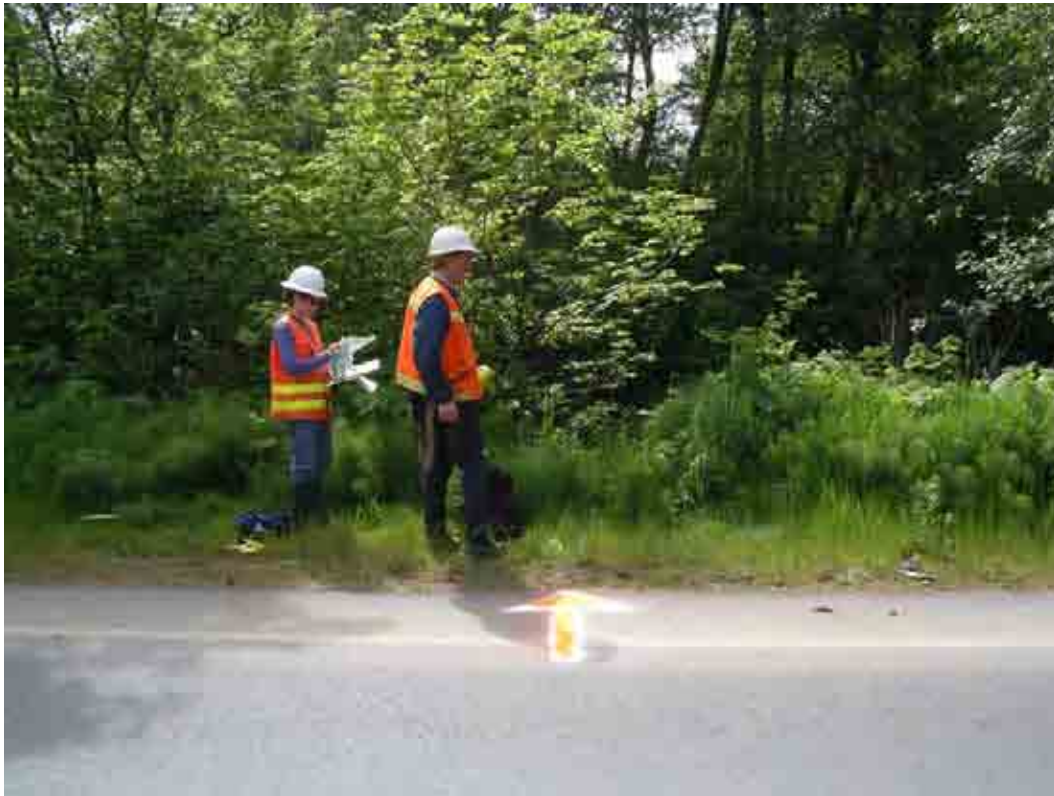
Photo A-68. Pysht River Site ID P-7 Bank erosion (right bank) 42 year extent. 13 feet to edge of pavement. (Photo 2422)

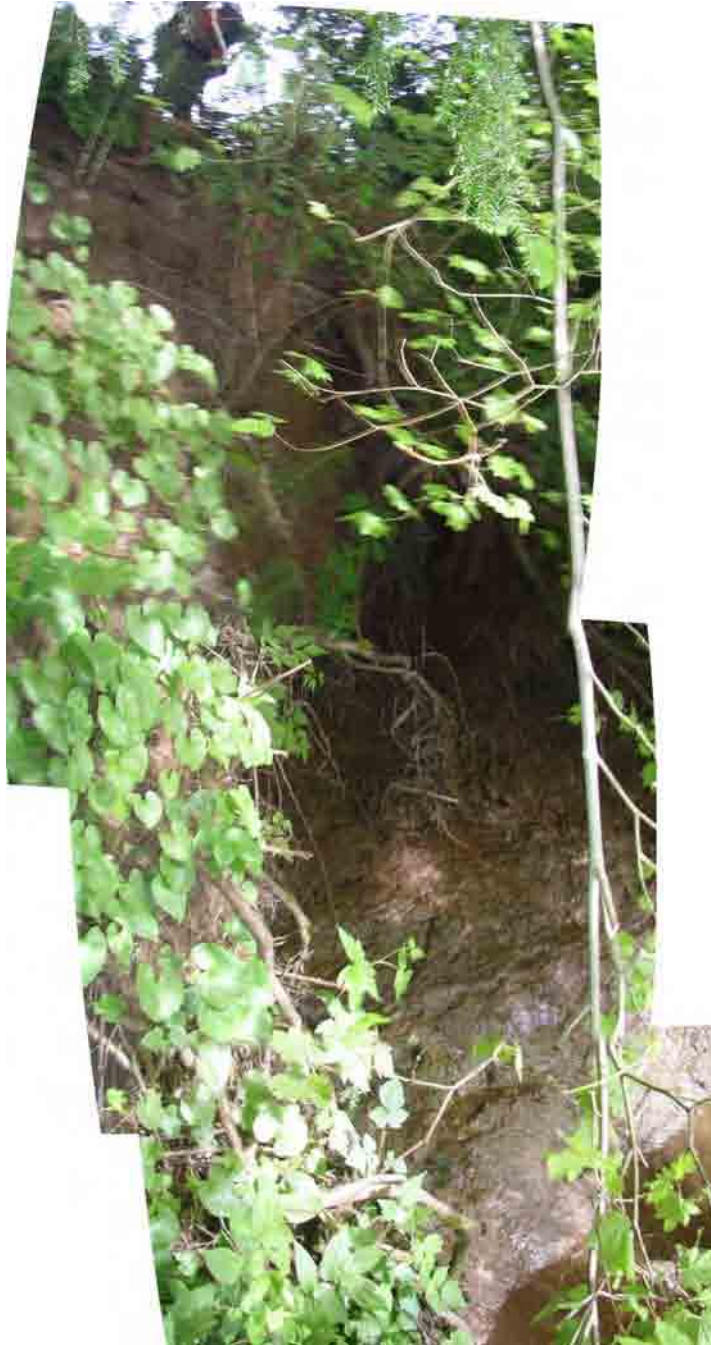
Photo A-69. Pysht River Site ID P-7 Bank erosion. Near MP 28 (108 yards downstream) right bank is 18 feet high (sand). Photo above illustrates bank calving. (Photo Pan 2424-2426)

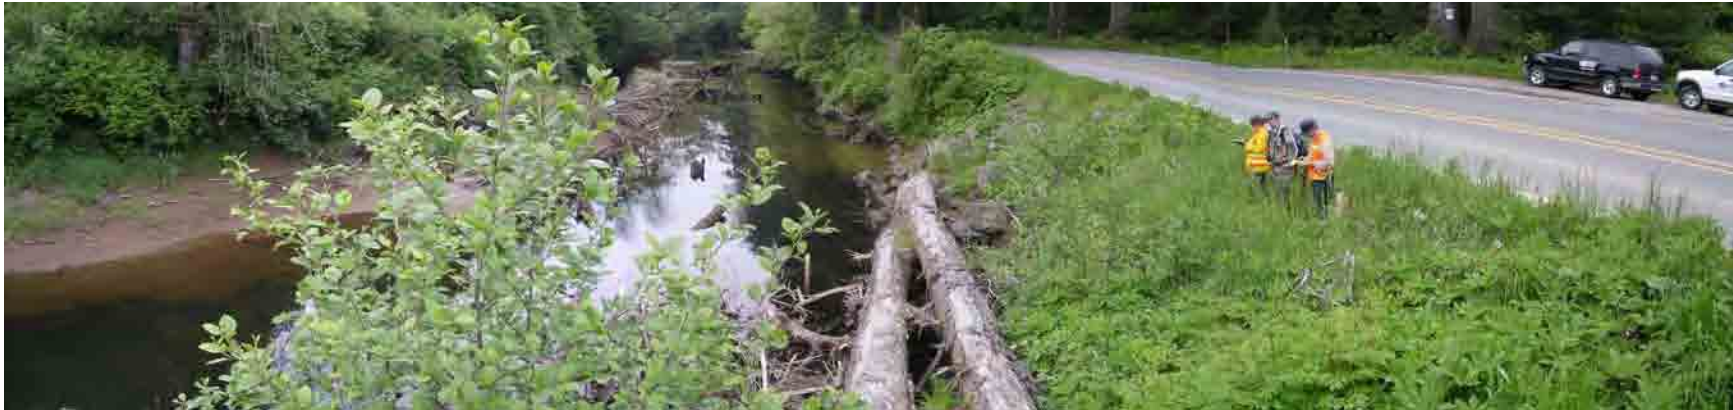
Photo A-70 Pysht River Site ID P-8 (May 10, 2005). Bank erosion (RB), rip rap at site (some falling), 75-foot rip rap launching, 27-feet of bank slumping, and less than 10 feet EOP. TA notes: From sitka stump u/s end of site. Functional rip-rap is ~95 feet long about 40 feet beyond rip rap is at risk. (Photo Pan 2267-70)

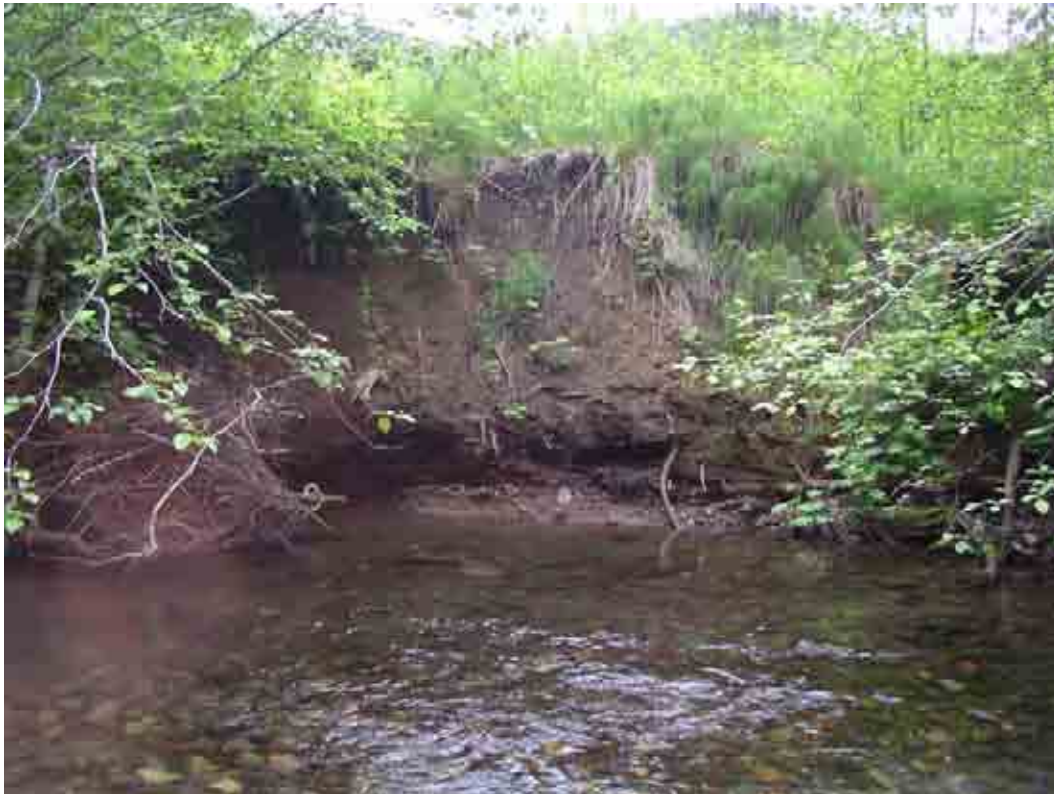
.Photo A-73 Bank erosion into fill material within the road prism of the historical alignment of State Route 112 at RM 5.9 on the Clallam River (May 11, 2005). The bank height is 10 feet and the banks consists of sand and gravel fill material over alluvial cobble, gravel and sand that typically makes up unmodified stream banks in the study reach. The flow direction is from right to left. (Photo-2368)

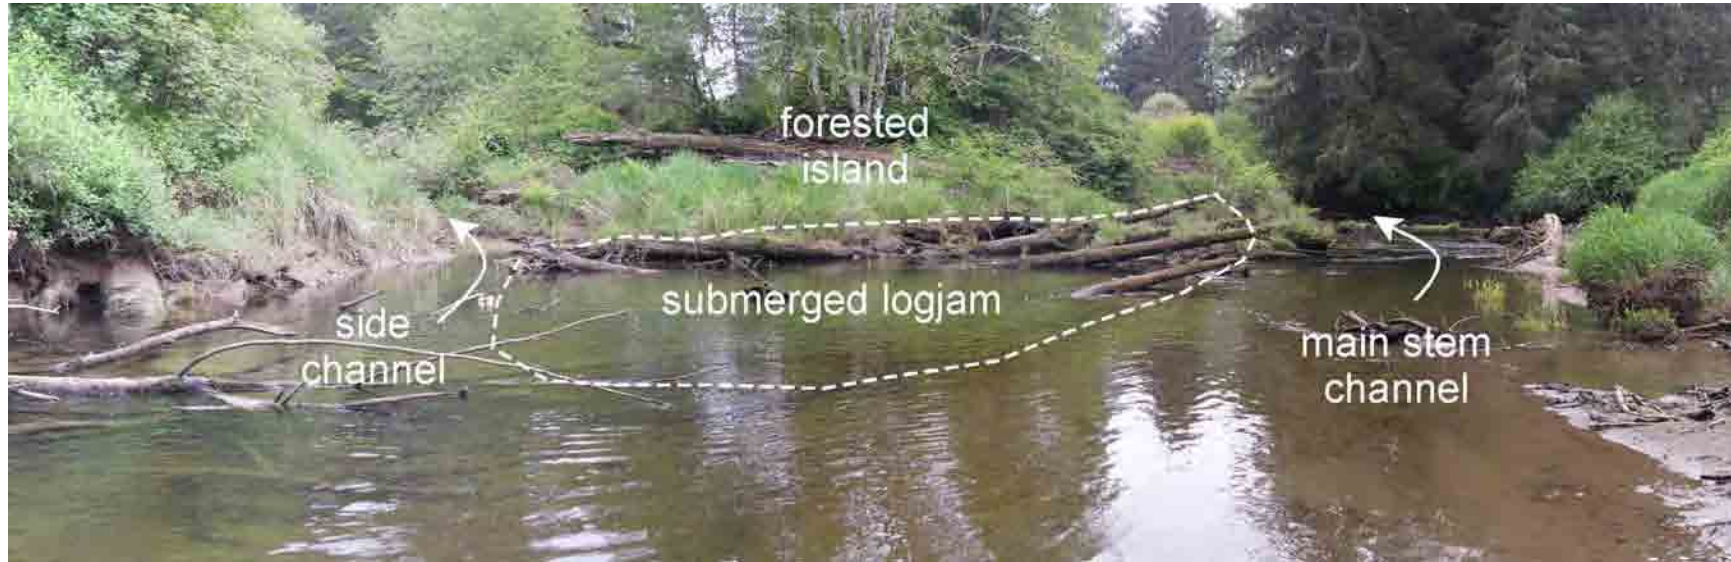
Photo A-78. Looking downstream at a submerged logjam on the Pysht River at RM 3.2 (May 10, 2005). A side-channel formed due to flow deflected through the forested floodplain forming a forested island downstream of the logjam. The main stem now conveys a smaller proportion of the total discharge due to conveyance provided by the side-channel. (Photo Pan 2228-2232)
