WASHINGTON STATE FERRIES

Investigation into the Loss of

Propulsion on the

M/V TACOMA

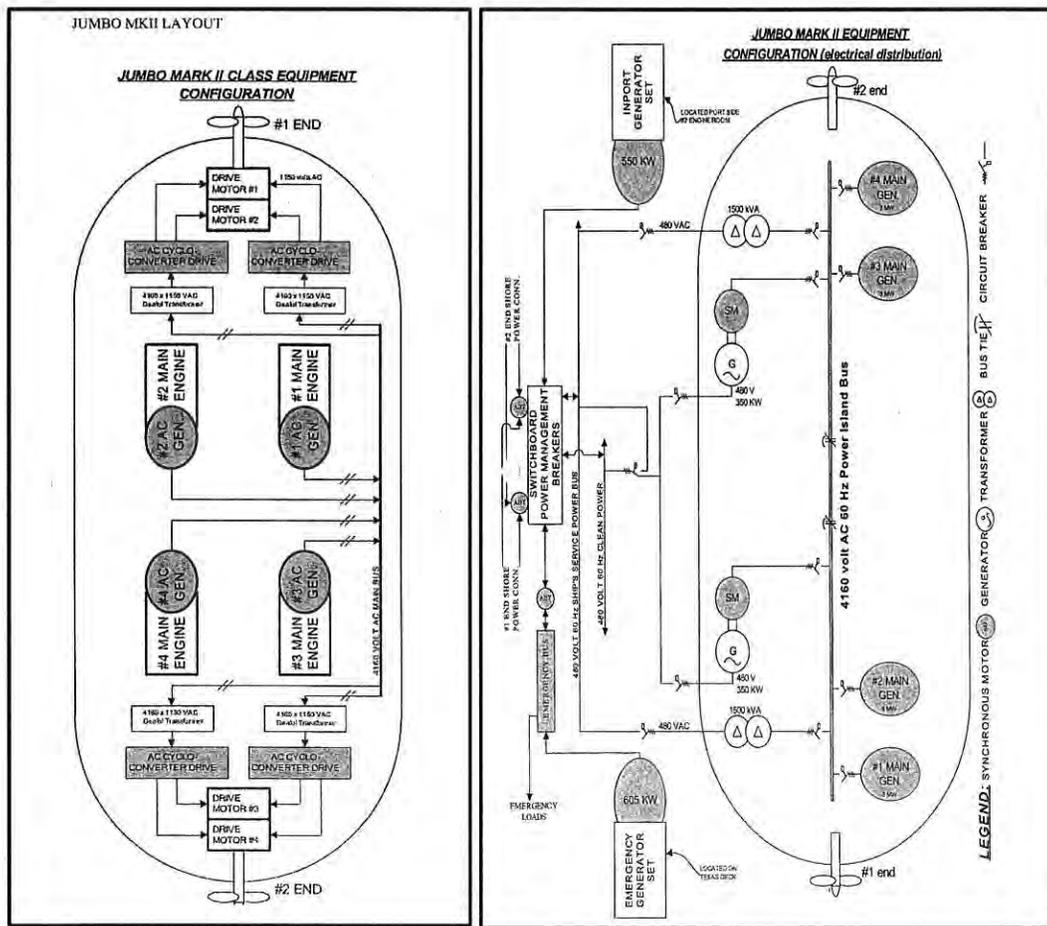
The M/V TACOMA has five electrical switchboards. There are the two 4.16 kilovolt (kV) main propulsion switchboards and three 480 volt (V) switchboards; ships service, clean power and the emergency switchboard. The ship's service switchboard was being powered by the main propulsion switchboards through the #2 ship's service transformer. The clean power switchboard was being energized by the main propulsion switchboard through the #1 motor-generator set. Both clean power and ship's service switchboards were feeding power to various sections of the emergency switchboard.
