**Site and Reach Assessment
Evaluation of Treatment Alternatives
SR 20 MP 100.7 (Skagit River)**

Work Order MT0100

December 14, 2007

Washington State Department of Transportation
Environmental and Engineering Service Center
Environmental Services Office

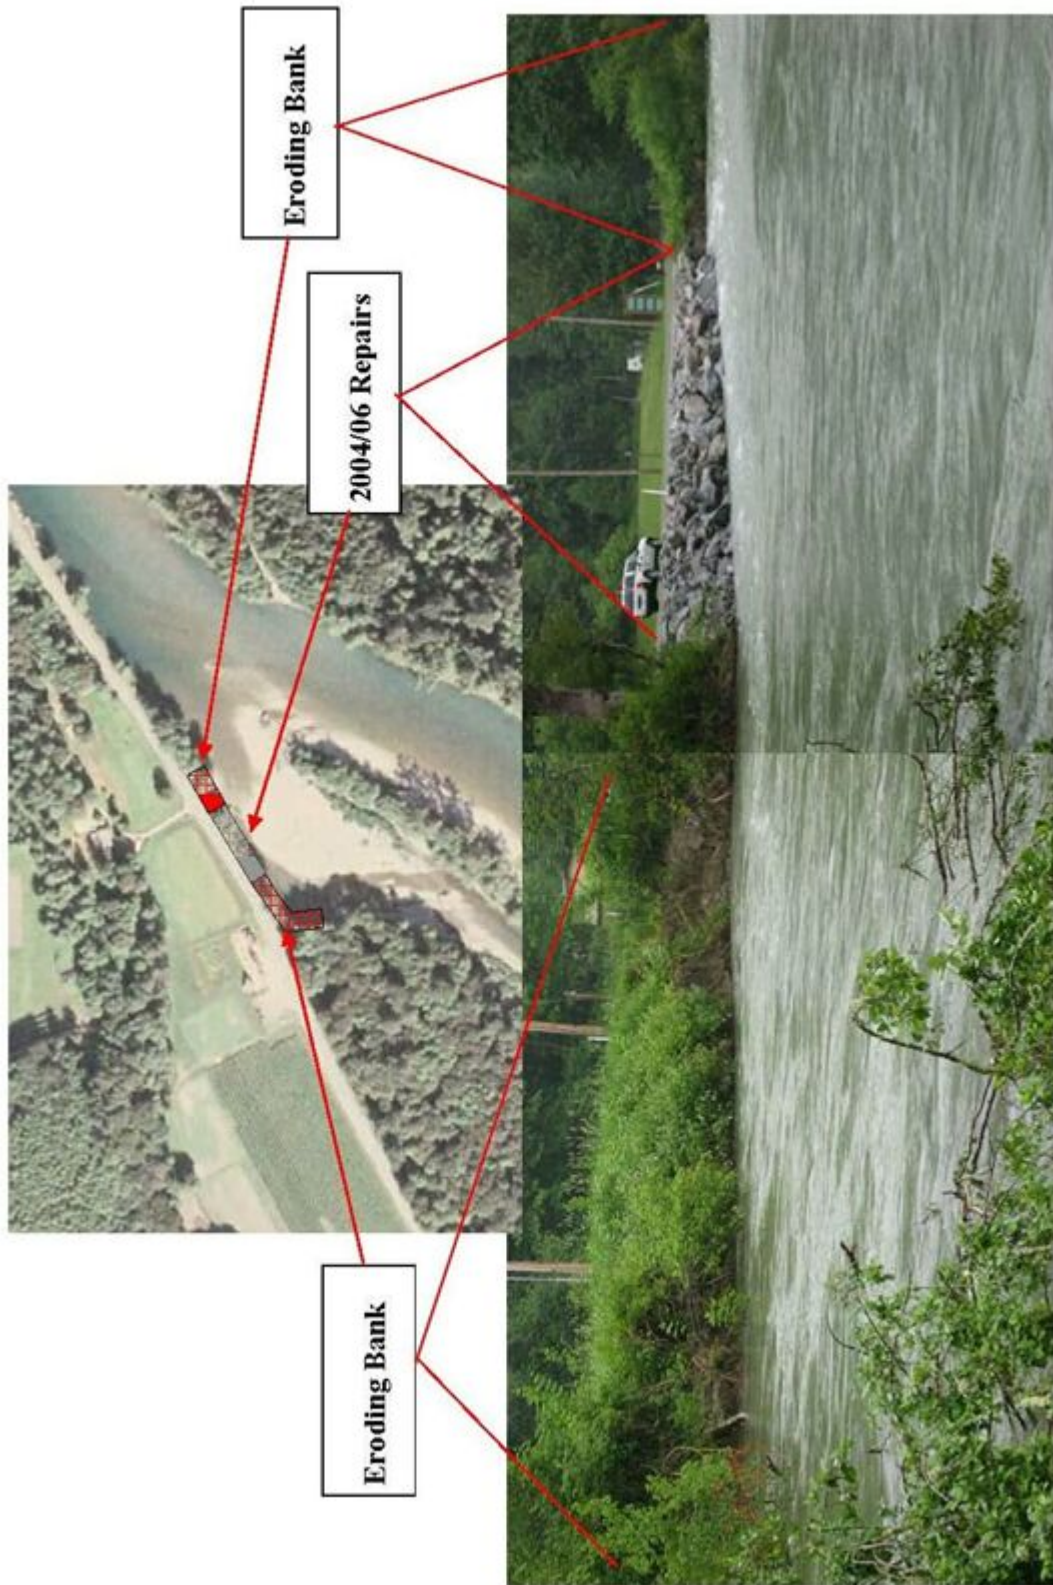
Figure 2. Aerial and ground view of SR 100.7 CED Site.

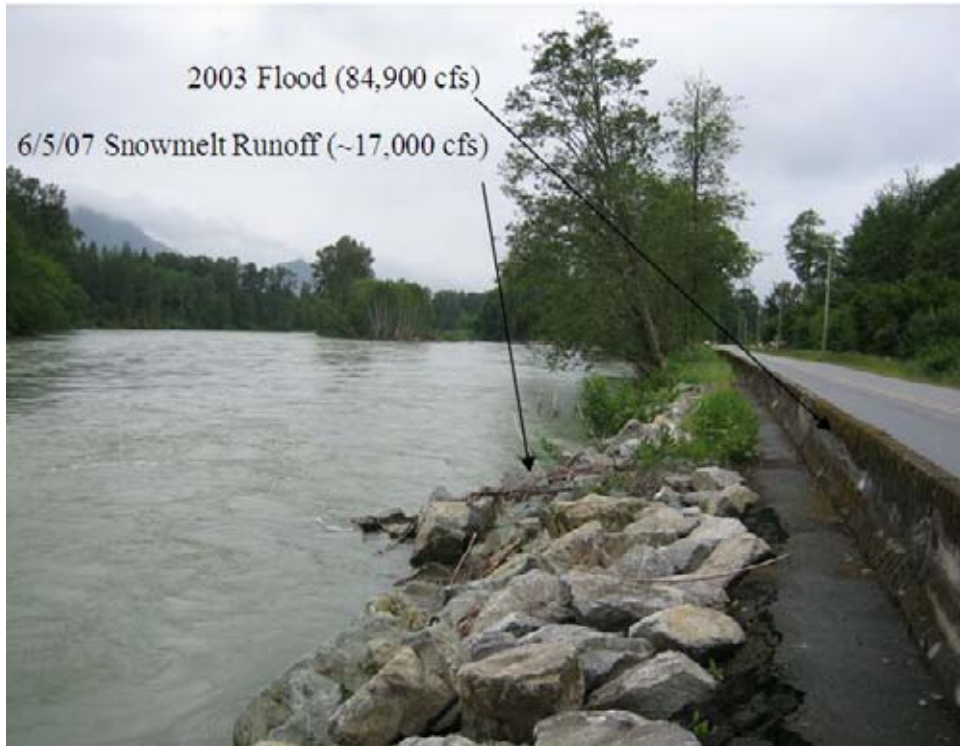
Figure 3. Bank section upstream of CED site showing comparative river stage .

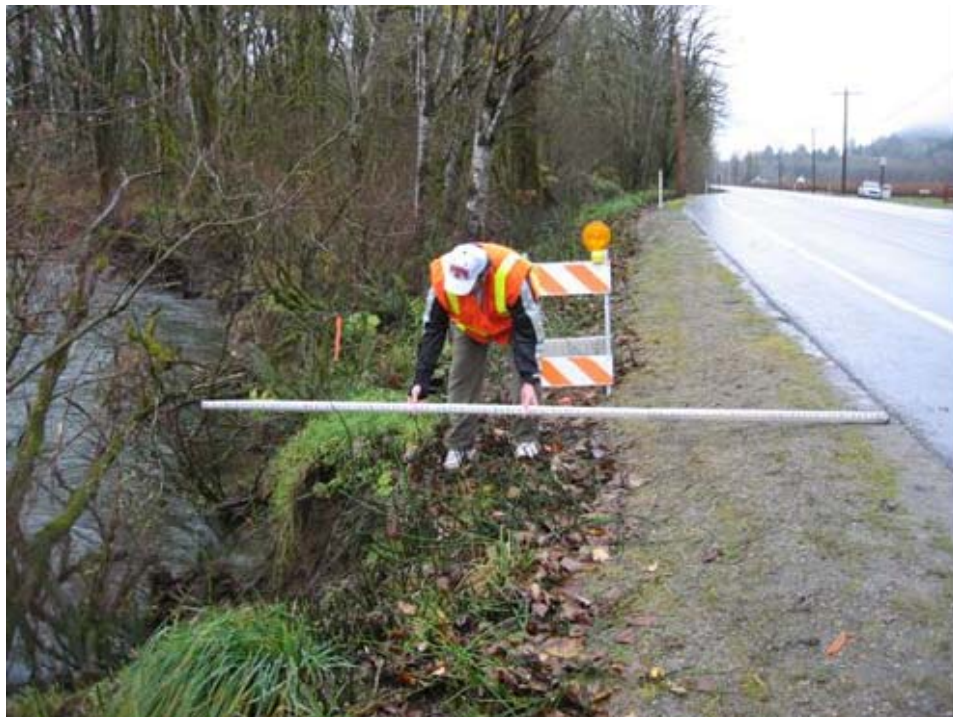
Figure 4. Bank erosion progressing to within eight feet of the roadway (11/23/04).

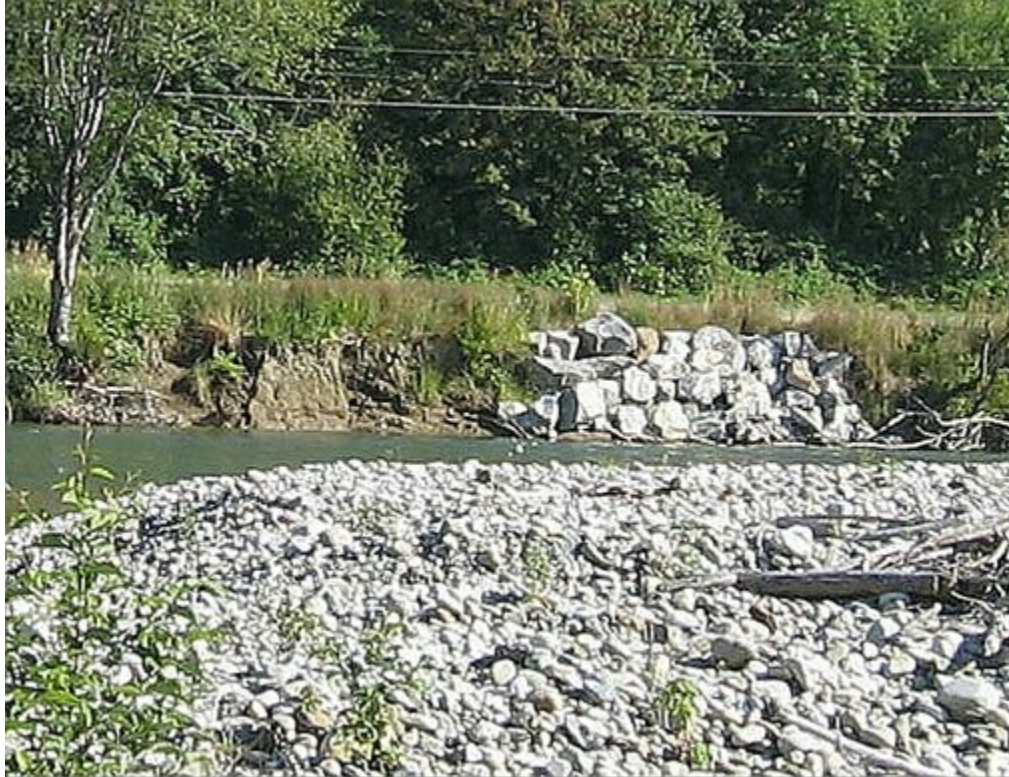
Figure 5. Bank erosion downstream of 2004 repair.

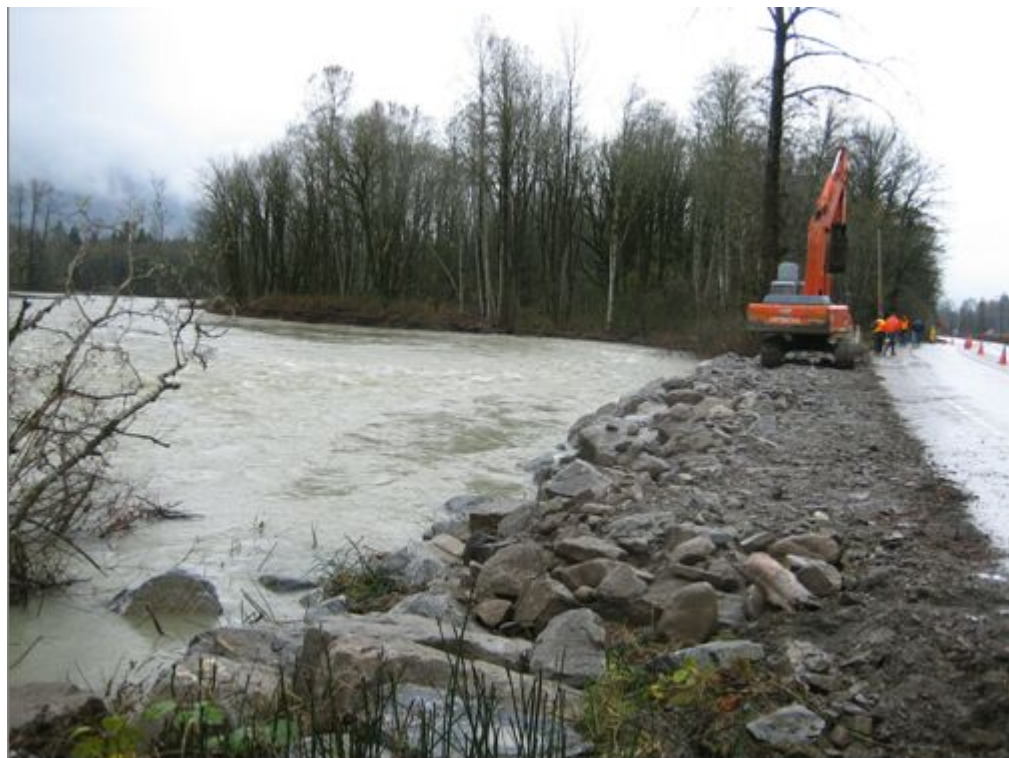
Figure 6. 2006 repair, looking downstream.

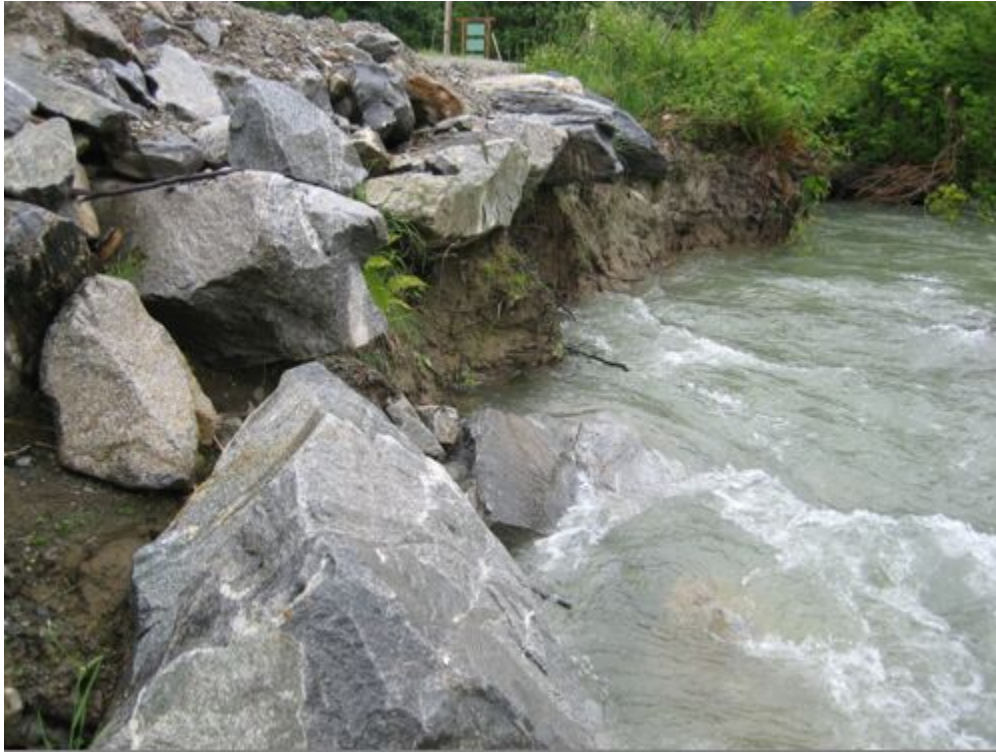
In October of 2003, a 100-year flood occurred in the upper Skagit. The peak water surface elevation at the CED site extended nearly to the top of a line of Jersey barriers which were installed at the pavement edge to prevent inundation of the roadway (Figure 3). Small areas of the existing riprap protection were damaged, but further downstream the unprotected bank was stripped of its vegetation, and bank erosion is presumed to have begun at the site. Erosion continued through the winter of 2003 and into the fall of 2004 until the top of the bank came to within eight feet horizontally of the edge of pavement (Figure 4). WSDOT-NWR maintenance personnel performed an emergency repair of this damage in late November of 2004, installing riprap along 40 feet of bank. Additional bank erosion occurred immediately downstream during the winters of 2004 and 2005 (Figure 5), requiring construction in November, 2006 of an additional 150 feet of riprap immediately upstream and downstream of the 2004 repair. Since then, additional erosion occurred over approximately 100 feet of bankline immediately upstream and downstream (Figure 2), and a portion of the 2006 repair was undermined by a scour hole forming at the toe of the bank (Figure 7).

Figure 7. Undermining of 2006 repair.

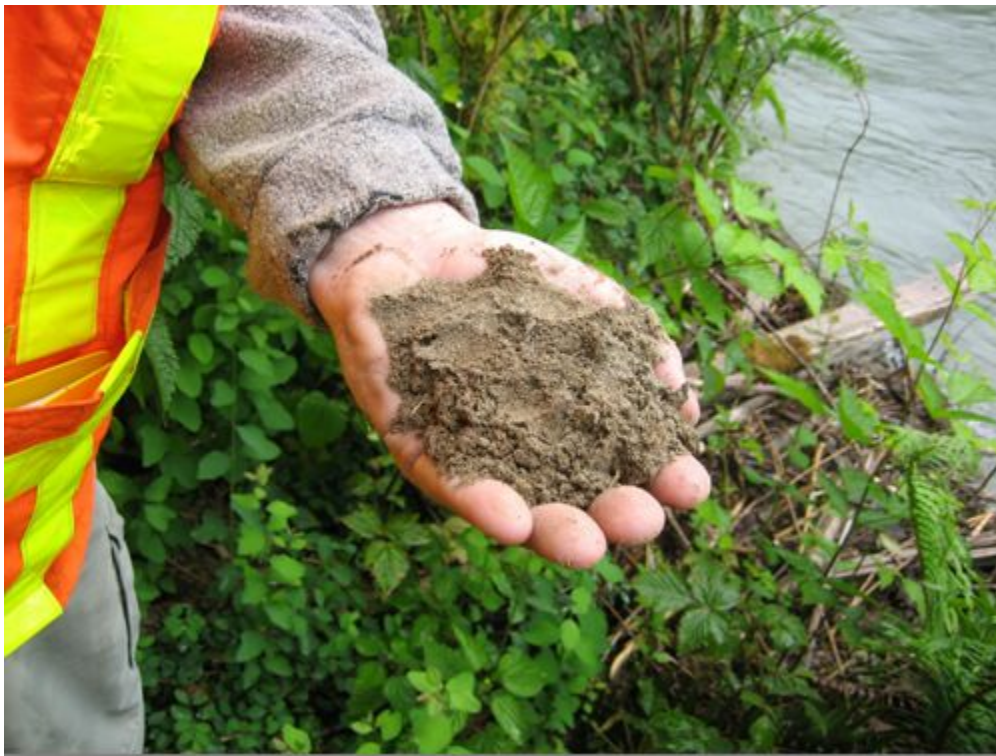
Bank material at and downstream of the site consists of alluvial fine sand and silt (Figure 8) with a few lenses of coarser sand and gravel. Resistance to erosion is provided primarily by any vegetation growing on the bank. The undisturbed bank downstream is well-vegetated, and there is a dense root mat extending to a depth of about 24 inches. Along SR 20, the rooting density and strength of the bank vegetation (particularly trees) may be limited by the steep slopes, the presence of riprap, and the narrowness of the buffer. Below the root mat the bank material is highly erodible, and the bank is susceptible to toe erosion, undercutting, and subsequent bank failure.

Figure 8. Bank material (alluvial fine sand and silt).

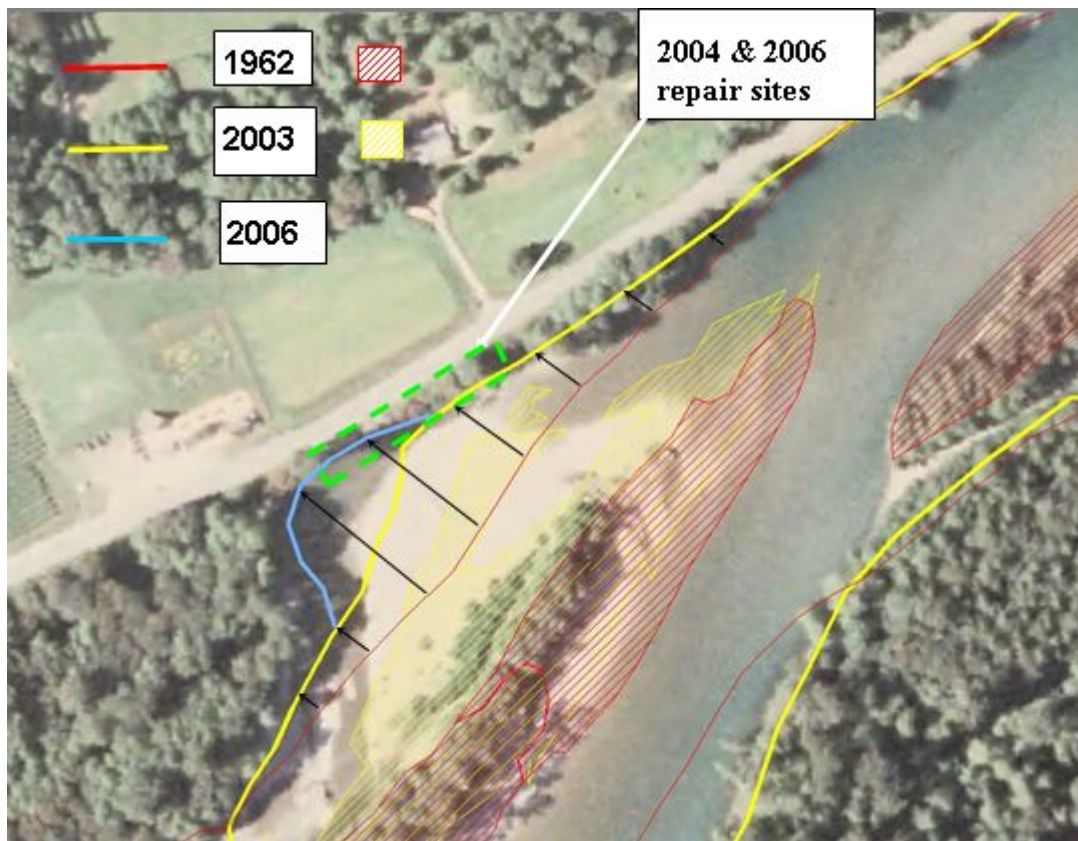
A review of historical aerial photos (1962 , 1969, 1978, 1987, 1991, 1998, 2003, 2006) shows the progression of bank erosion over the last 44 years (figures 9 and 10). During this period, the bankline has migrated both directly towards the road, and along the road in a downstream direction. Maximum migration distance since 1962 is approximately 300 feet.

In the photo sequence, the erosion of the bank line appears to follow the migration downstream of the island opposite the assessment site. At larger, higher-velocity discharges, a lateral bar formed in front of the bank directs flows directly at the bank line (Figure 11), which results in toe erosion, undermining, and eventual failure of the bank. Placement of riprap protects the bank face on which it is placed, but the smoothed bank line transfers erosive energy downstream, resulting in erosion of unprotected banks. In addition, impingement of the directed flow against the riprap face directs a portion of the flow downward, creating a scour hole, which undermines the toe of the riprap and may result in slumping and eventual failure of the riprap.

Figure 9. Migration of bank line and island near assessment site.

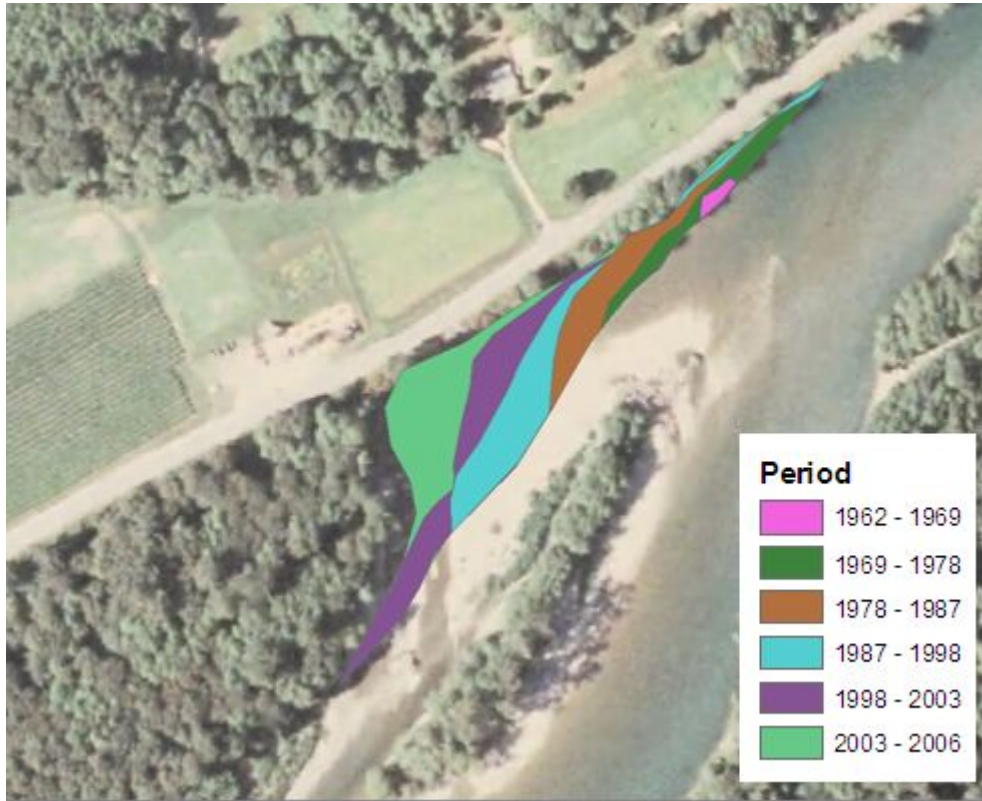
Figure 10. Area of eroded bank in period between successive air photos.

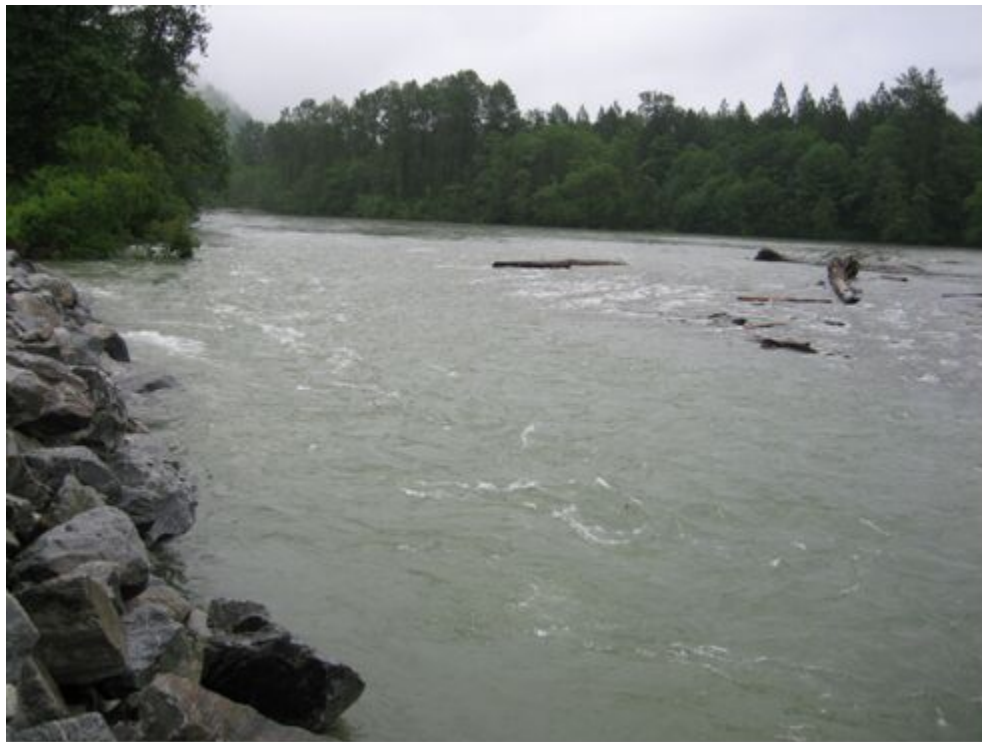
Figure 11. Lateral bar directing flow towards the bankline at the CED site.

- *Jet scour* caused by the lateral bar opposite the CED site.
- *Toe erosion* caused by reduction in bank roughness associated with recent repairs and reduction or elimination of bank vegetation by recent floods.
- *Constriction scour* caused by sediment accumulation in the side channel opposite and downstream from the site, which acts to hold the thalweg against the bank.

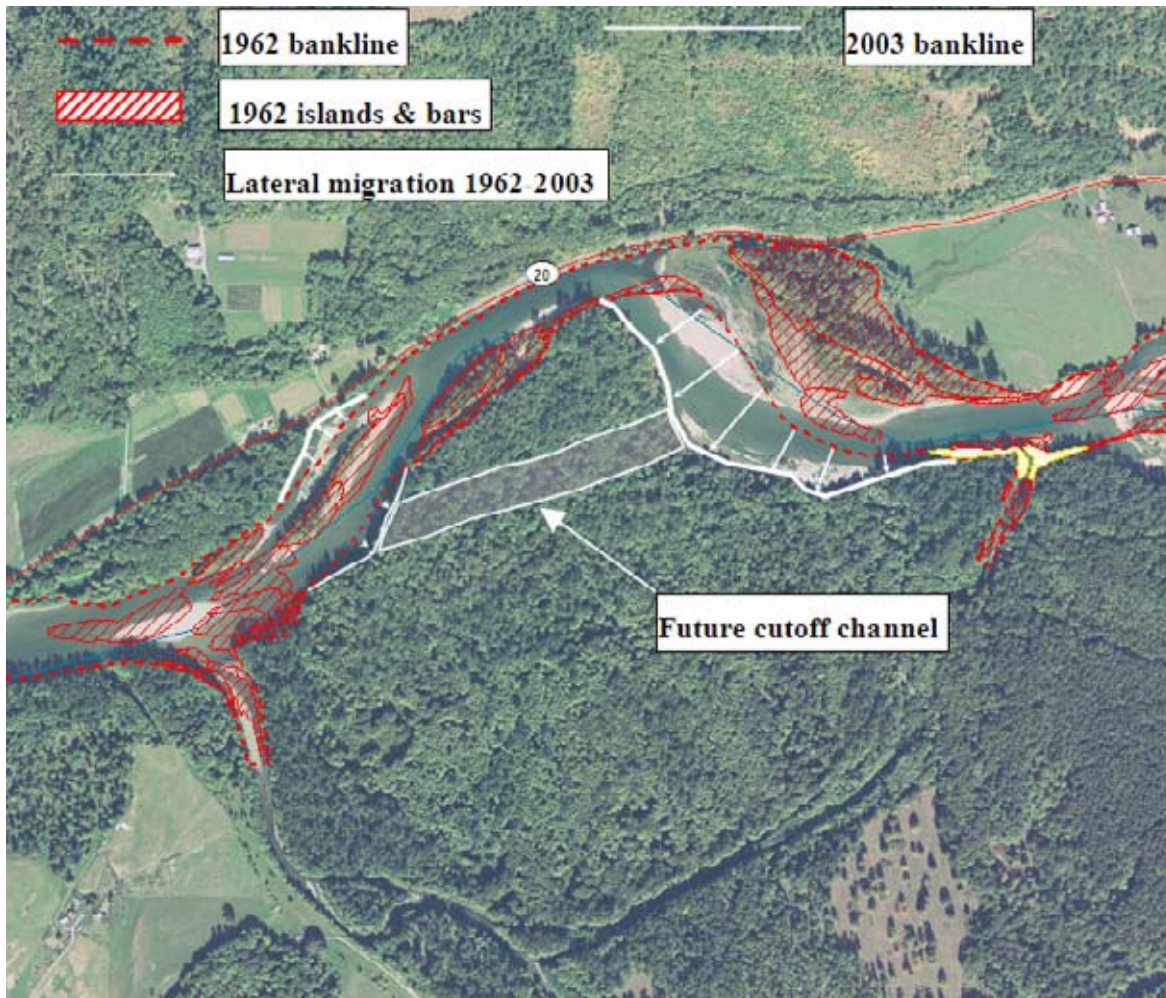
At the scale of the assessment reach, the channel appears to be more or less stable vertically; there is no evidence of large-scale aggradation or degradation. Lateral migration is constrained over the middle third of the reach (including the CED site) by riprap placement along SR 20. This enforced lateral stability results in reduced bank roughness and transfer of erosive shear forces from the bank to the channel bed, resulting in a deepening of the thalweg and extension of the meander apex downstream along the base of the riprap. The lateral bar just upstream of the site (see site-based mechanisms of failure) appears to represent the point at which excess stream power is expended, resulting in sediment deposition. Consequently, the riprap contributes to bank failure at the site by creating the geomorphic features associated with the site-based failure mechanisms.

Figure 15. Aerial view of assessment reach showing lateral migration of meander and in-channel bars and islands (1962 – 2003).
