WSDOT/WASHINGTON STATE FERRIES

**Investigation into the collision between the
M/VHYAK and the M/YTASYA
on September 13, 2013 at the confluence of
Harney Channel and Upright Channels
in the San Juan Islands**

Board Of Inquiry
10/25/2013

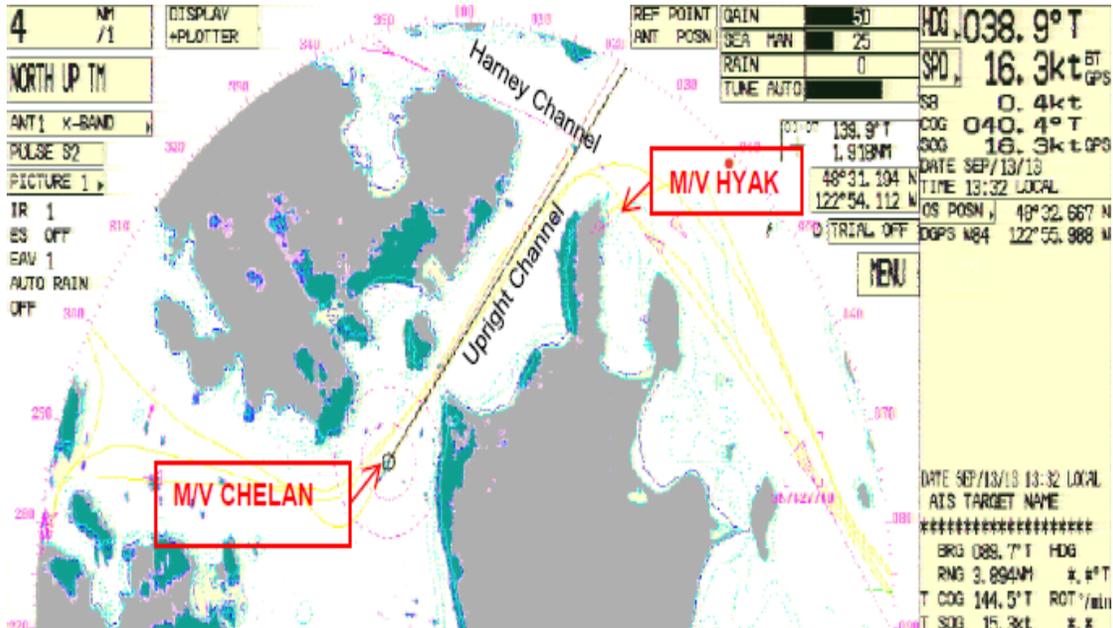
Voyage Data Record Screen Shot From M/V CHELAN, 13:32 Local Time

13:32:39: The M/V HYAK begins to back out of the Lopez Island dock and begins the "V" maneuver. The M/V CHELAN was proceeding northward in Upright Channel at the time of the M/V HYAK was completing the "V" maneuver and departing from Lopez Terminal. The M/V CHELAN is equipped with a Vessel Data Recorder (VDR). The VDR is a data recording system designed for vessels required to comply with the IMO's International Convention SOLAS Requirements. The VDR collects data from various sensors on board a vessel, then digitizes, compresses and stores this information in a protective storage unit. The protective storage unit is tamper-proof and designed to withstand extreme shock, impact, pressure and heat, which could be associated with a marine incident (fire, explosion, collision, sinking, etc.). There are only two WSF ferries equipped with VDR, the M/V CHELAN and M/V ELWHA. The installation of VDRs is a requirement for any vessel engaged in an international voyage, and currently only the M/V CHELAN and M/V ELWHA are assigned to the Sidney, British Columbia Canada international route. The M/V HYAK is not equipped with a VDR. However, all WSF ferries are equipped the Automatic Identification Systems (Fleet Track) which records the latitude,

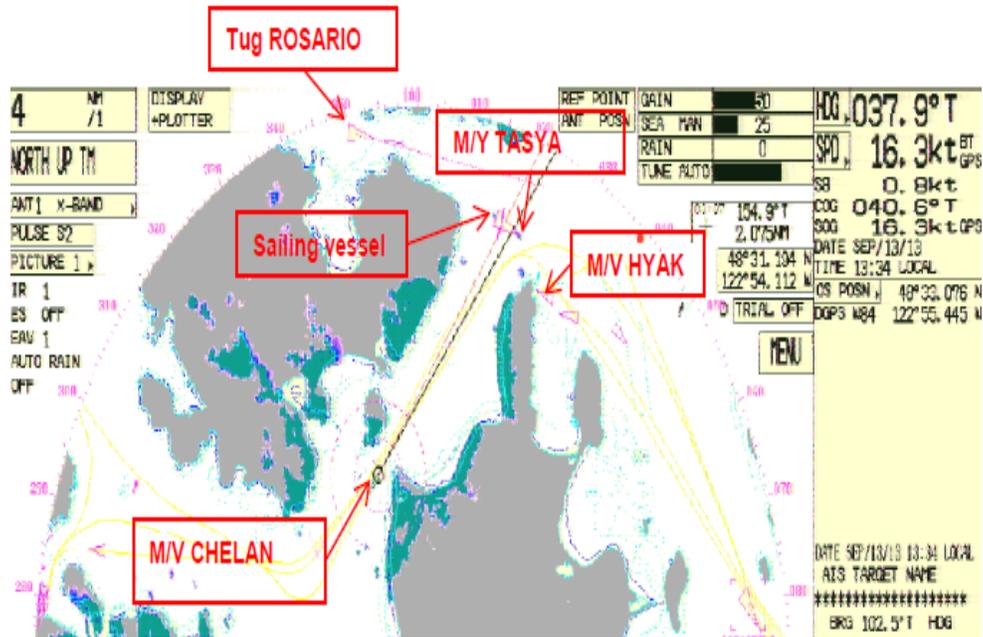
Voyage Data Record Screen Shot From M/V CHELAN, 13:34 Local Time

13:34:41: The M/V HYAK completed the “V” maneuver and the Number 1 end was in command and was now pointed in northwesterly direction enroute Orcas Island Terminal. Captain Whaley puts the Engine Order Telegraph (EOT) to Full Ahead. The M/V HYAK eventually built to a speed of 18 knots just prior to the collision. This time is verified by a security camera which captures the propeller wash from the stern of the M/V HYAK. In her interview Captain Whaley said that she saw a tug and tow, and two small vessels directly in front of, and on the M/V HYAK's intended route to the Orcas Island Terminal.

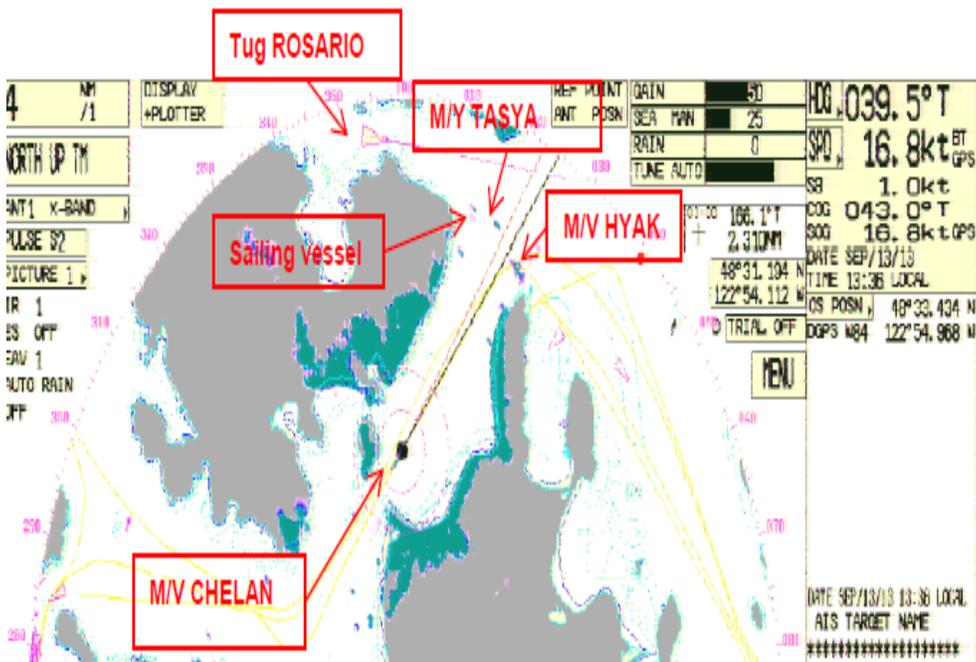
Voyage Data Record Screen Shot From M/V CHELAN, 13:36 Local Time

At approximately the same time the M/V CHELAN acquires the M/Y TASYA on the M/V CHELAN's radar as depicted in the VDR image below.

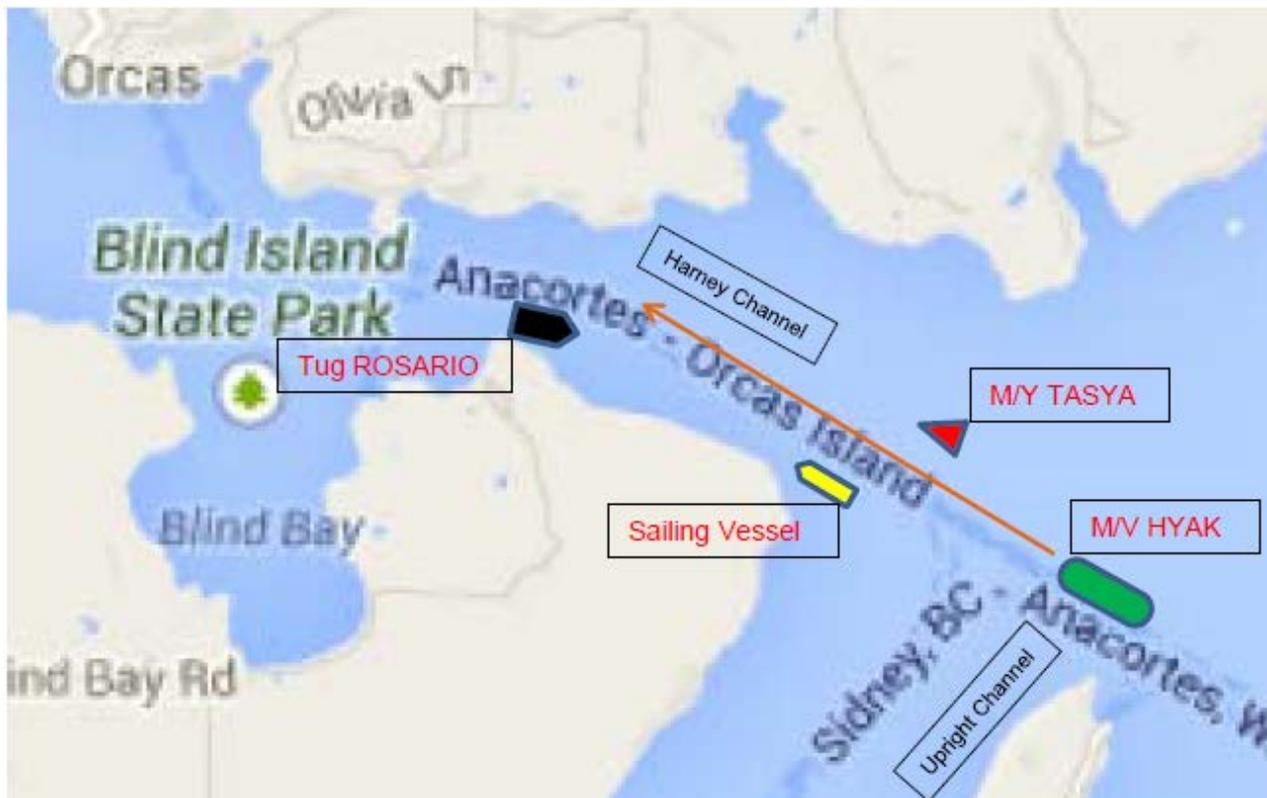
Graphical Representation of Captain Whaley's Transit Voyage Plan

Captain Whaley stated that one of the two small vessels was under sail and the other was under power. Captain Whaley stated that her plan was to go between the two small vessels and keep the tug and tow on the port side. She instructed the Second Mate Hervey to leave the M/Y TASYA to starboard while putting the other small vessel and tug and tow to port of the M/V HYAK. The M/Y TASYA was underway at a speed of approximately 6.5 knots. The picture below is graphical representation of the Captain Whaley's transit plan. This picture is not drawn to scale and is provided to orient the reader to the relative positions of the vessels in relationship to each other.

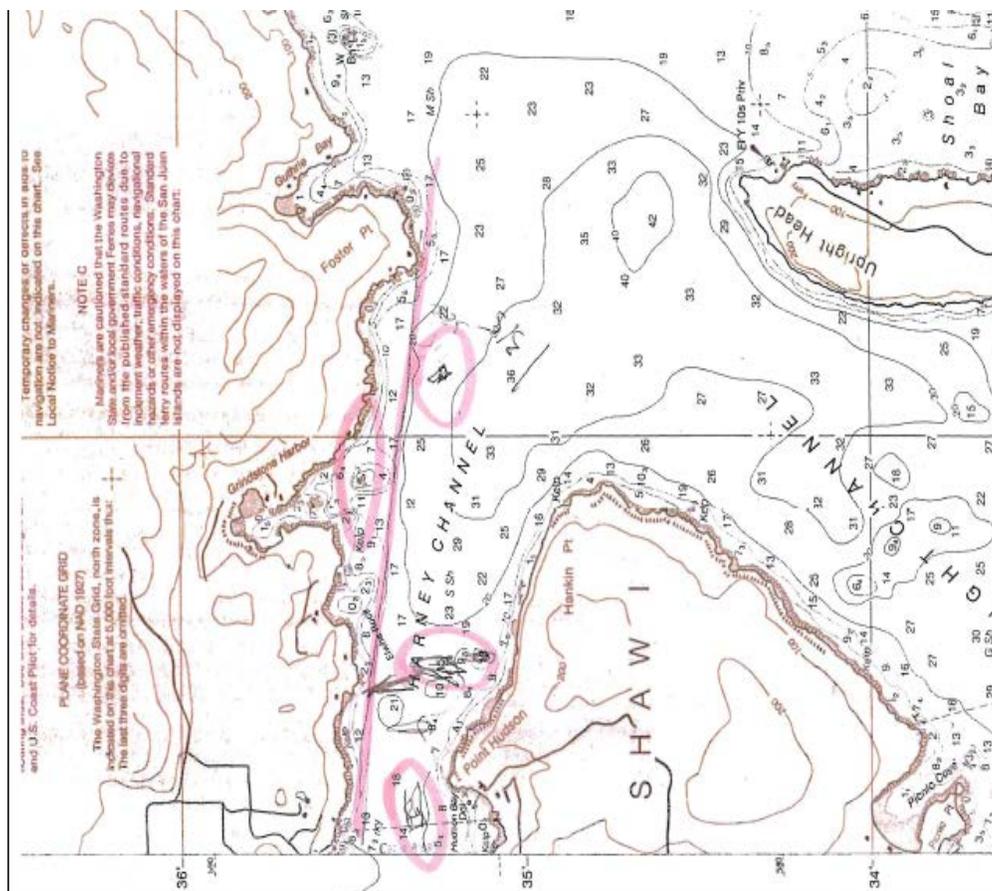
Attachment 14, Captain Whaley's Hand Drawn Representation of the Location of the Incident

13:38:14: [REDACTED] The M/Y TASYA was impacted on its port quarter. The M/V HYAK continued to back full astern and the bow fell off to port. Captain Whaley made written and verbal statements to the U.S. Coast Guard and the Board of Inquiry that placed the location of the collision farther north and west in Harney Channel than has been identified by objective evidence. In her statements to the board of inquiry, Captain Whaley indicated that the M/Y TASYA was West of Foster Point, closer to Grindstone Harbor. However, VDR images from the M/V CHELAN and data from Fleet Track clearly indicate that the collision actually occurred farther South and East in the less restrictive waters in the middle of the confluence of Harney and Upright Channels.

6. When developing her transit plan the Captain placed the M/Y TASYA farther north and west than where the vessel actually was.	<ul style="list-style-type: none"> • Human (4) • Permanent Crew (10) • Human Factor (143) • Situational Awareness (150) • Information Inaccurate (152) • Inappropriate Standard Applied (270) 	The Captain relied solely on the radar. The Captain had a transit plan but did not adequately monitor the changing situation The Captain did not comply with Navigation Rule 6 (Safe Speed), Rule 7 (Risk of Collision), and Rule 13 (Overtaking).
