# Manette Bridge

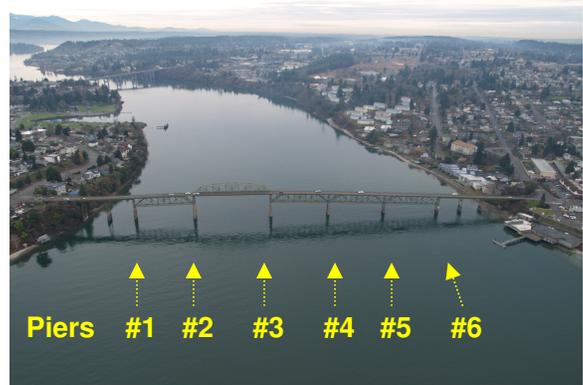
The primary areas of structural deficiencies are in the concrete piers and the structural steel trusses. Most of these elements were built in 1930.

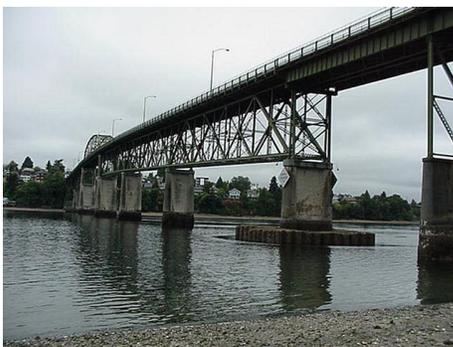
The concrete in the foundations is in varying states of deterioration. Testing and analysis of concrete taken from the main piers from 1976 thru 2003 determined that deterioration in the concrete has resulted from a process called Alkali Silica Reaction (ASR).

Alkali Silica Reaction (ASR) in concrete is a phenomenon that was first recognized in the U.S. around 1940 and has since been observed in many countries. ASR causes deterioration of mortars and concretes due to the swelling of gel formed by the reaction of alkali in cement-based materials with reactive silica in aggregates, in the presence of water. The swelling of the gel generates tensile stresses in the specimen resulting in expansion and cracks.

There is no known way to mitigate and fully address the ASR problem in the concrete foundations of the six piers supporting the steel truss spans.

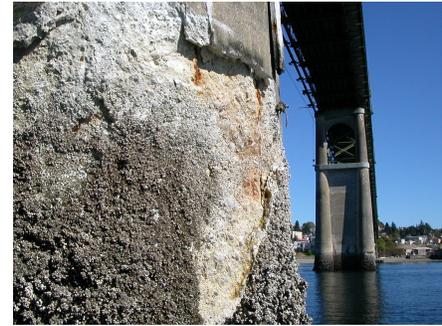
Overall, the substructure components are in poor condition at the main piers (built in 1930) and in satisfactory condition at the approach piers (built in 1949). Columns and pier walls at the main spans exhibit leaching cracks, rust stains, delaminations, soft concrete, and formwork holes. Exposed rebar is visible above and below the tidal zone, however mass marine growth prevents an exact detailing of this exposure.

The foundation is exposed at all piers in varying degrees. Main Piers 2 and 3 are in the worst condition with the original footing and seals now indeterminate from each other. At the corners, corroded remnants of rebar are visible where the footings have been rounded to an approximate 4 ft. radius. The pedestals at these piers are not distinguishable from the marine growth. Several cofferdams have been constructed around the different piers to shore up soft concrete. Some undermining is occurring at these piers due to local scour conditions.

Contract repairs to the main concrete piers were completed in 1949 (Piers 4 and 6) and 1991 (Pier 5) and 1996 (Piers 4 and 6). These repairs attempted to encase the deteriorating concrete in the concrete foundations but were not affective since the core concrete with ASR continues to deteriorate.
