Appendix I
MV Tillikum – Operational Details

To: Paul Brodeur, Director of Maintenance
From: Scott Calhoun, Staff Chief, MV Tillikum
Date: February 18, 2009
Subject: Biodiesel Final Report – MV Tillikum
Attachments: #1 – Biodiesel Timeline Chart
 #2 – Injector Problem Report

To: Paul Brodeur, Director of Maintenance
From: Scott L. Calhoun, SCE, MV Tillikum
Date: April 5, 2009
Subject: Condition Report, Fuel Oil Day Tank

From: Scott L. Calhoun, SCE, MV Tillikum
Date: April 5, 2009
Subject: Condition Report, Starboard Main Fuel Tank

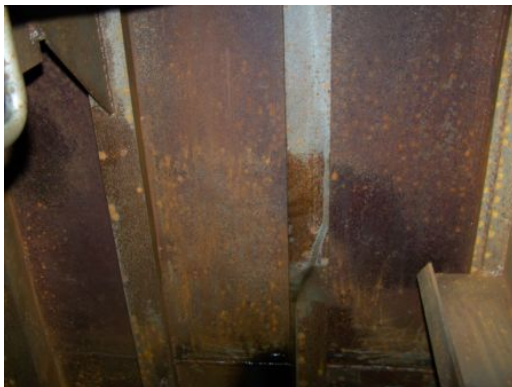
Day Tank Overhead (D001.jpg)

The Fuel Oil Day Tank was very clean. There is no real buildup on any surface in the tank. This is consistent with what we were seeing in operation while testing the B20 Canola product. With this product the purifier does the job of separating the solids from the fuel which keeps the Primary 2 Micron Racor Filters from plugging up.

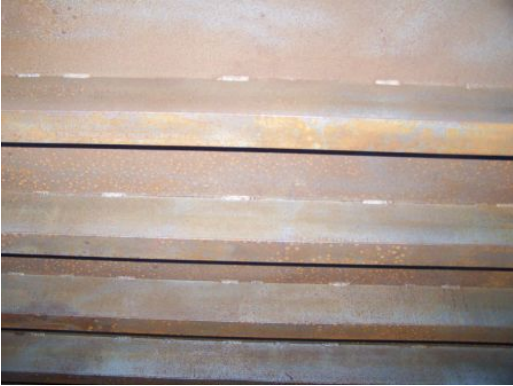
Storage Tank Overhead (S002.jpg)

Overall the tank internals are quite clean. There is no buildup on the top or sides of the tank. On the tank bottom there is a small amount of buildup (black in color) which is mostly in the bottom portion of the tank. Pictures S009.jpg, S012.jpg, and S013.jpg show black and brown colored streaking. The brown color is the skin of the tank and the black is the small amount of buildup. We did not go into the tank or get the remaining fuel out of the tank to expose the vee at the bottom.
