**Reach and Site Assessment for the SR 109/023
Moclips River Bridge, Moclips,
Grays Harbor County, Washington**

Work Order MS 5404
Ed Molash, Environmental Engineer
Jim Park, Senior Hydrologist
WSDOT Environmental Services
Watershed Management Program
Updated April, 2007

Washington State Department of Transportation
Environmental and Engineering Service Center
Environmental Services Office

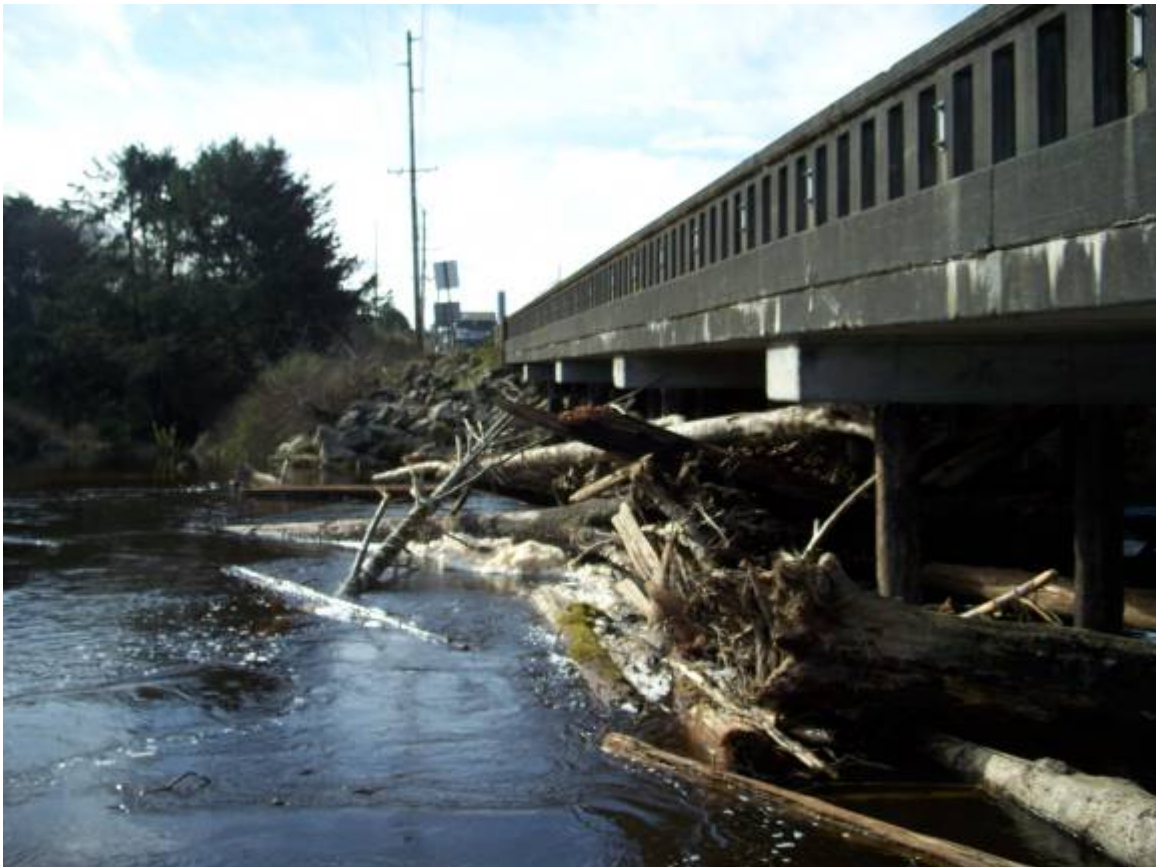
The SR 109/023 Moclips River bridge, built in 1955, is supported by five sets of piers with eight creosote wood piles supporting each of the piers. The large number of tightly-spaced piles routinely collects large woody drift and sediment from upstream sources, as shown in Figure 3.

Figure 3. Log jam accumulation on the underside of the Moclips River bridge structure (looking south, March 2007).

The primary cause for the repeated maintenance actions needed to remove drift from the bridge's understructure is the presence of 48 (5 piers with 8 piles each) in-water wood pile structures supporting the current bridge deck. These piles do not allow passage of much of the larger floating debris downstream of the bridge and accentuated the low velocity areas on the inside of the meander that promotes deposition of gravel and sediment deposition in a large river bar. The accumulated woody debris underneath the bridge also causes localized flow path alterations which also promotes left bank erosion beneath and downstream of the southern bridge abutment. A secondary, but still major, cause for the concurrent left bank/southern bridge buttress erosion and right bank aggradation directly downstream from the bridge/road location at the maximum curvature of a 180 degree, 175 foot radius meander.

1. Bridge replacement, preferably spanning the entire Moclips River channel. Removal of the 48 piers that support the existing bridge structure is critical to stopping the regular accumulations of drift beneath the structure and the associated downstream aggradation. It appears likely that due to federally-mandated free-board requirements at least one pier will be necessary to support the new structure. If so, bridge openings should be at least 80 feet and preferably 100 feet to allow passage of the large woody debris that routinely gets transported to the SR 109/023 bridge from the upstream floodplain.

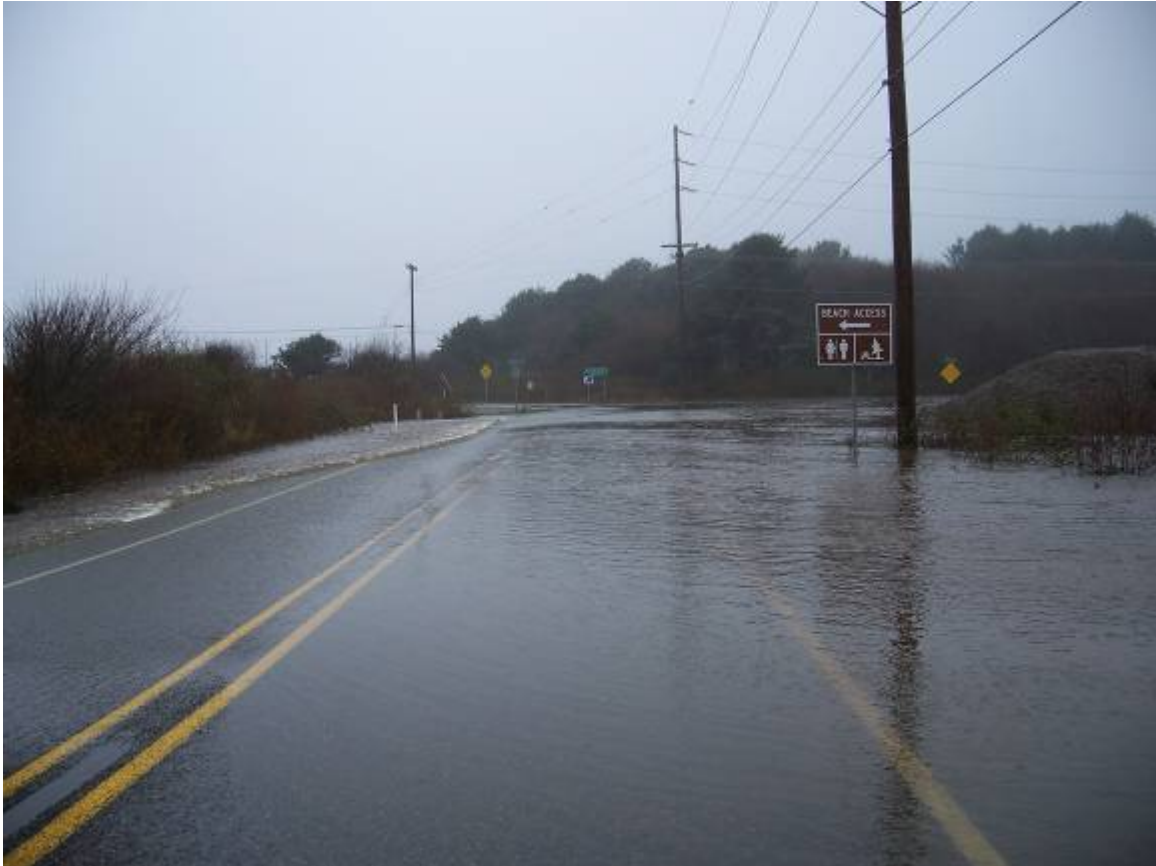
Figure 4. Flooding on SR 109 north of the Moclips River bridge in March 2007.

The current meander system and upstream bank revetment system acts to entrain the thalweg of the Moclips River to the left bank during low flows, increasing the erosion potential. At high flows and tides, the flow path and thalweg configurations change considerably. During elevated river stages, the pile of drift and debris that accumulated beneath the bridge during low flows causes the main flow path energy to split. One of the main flow paths remained entrained along the left bank while a new flow path paralleling the right (north) bank became established at high flows and tides (see Figure 4).

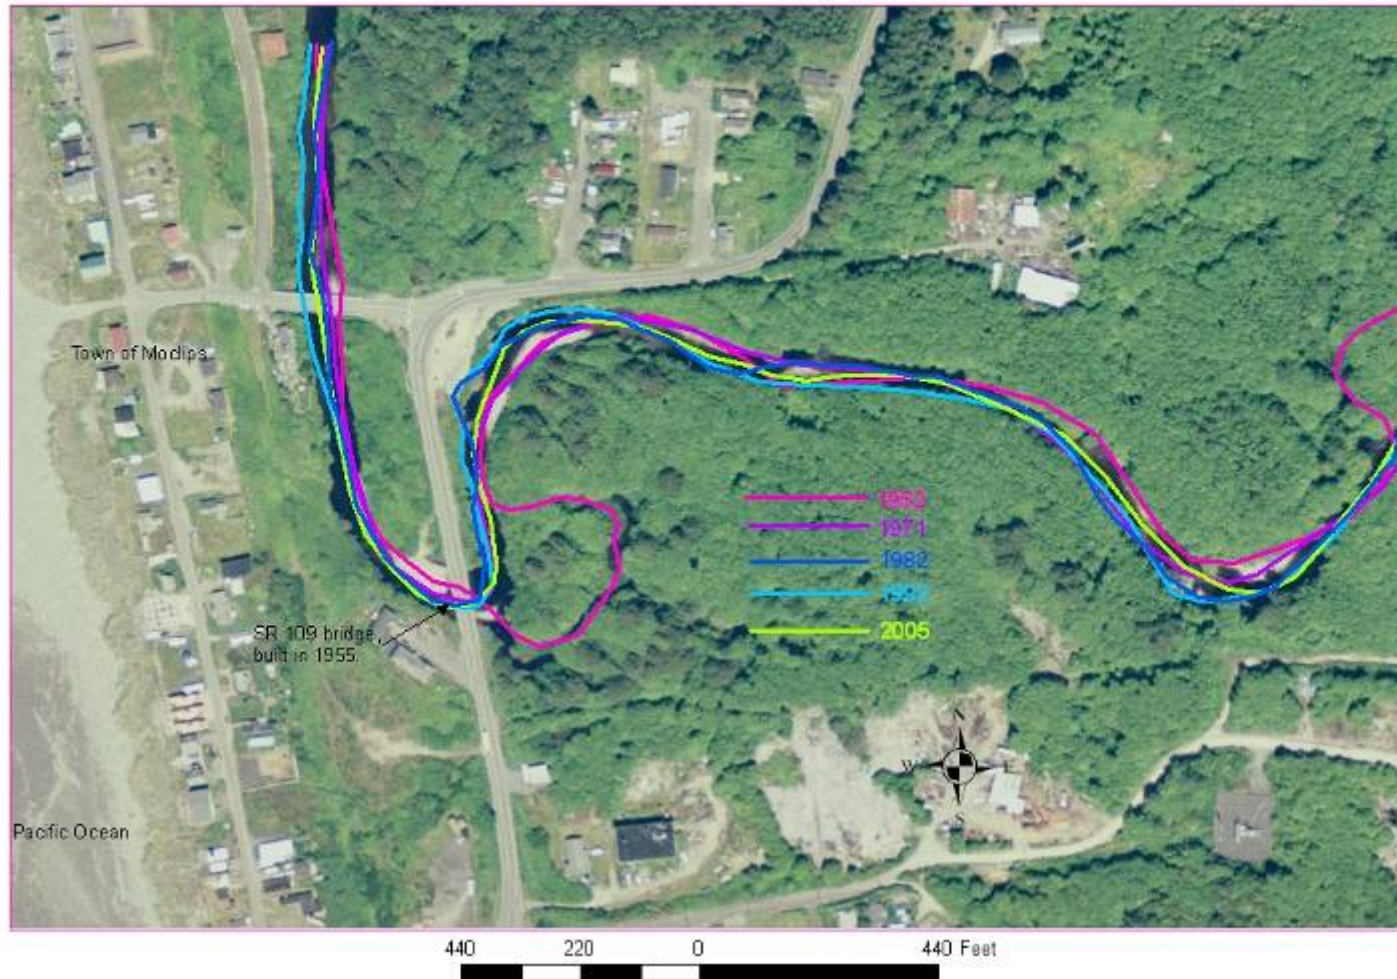
Mass wasting has not been observed in the Moclips basin due to the relatively mild valley slopes flanking the floodplain. An avulsion of the meander directly upstream of the SR 109/023 bridge occurred between 1955, the construction date, and 1971 (see Figure 8). The 1952 aerial photo (Figure 9) shows several significant features that accounts for the current bridge and river configurations. Directly upstream of the bridge there previously existed a tight left (clockwise) meander which resulted in the thalweg being positioned at an approximate 45 degree angle to the bridge opening.

The 1952 aerial also shows an in-stream mill pond next to a fairly large shake/lumber mill at RM 1.6, 1000 feet upstream of the SR 109/023 bridge structure. The pond was likely used to temporarily hold logs for milling. In the 1971 aerial photo (Figure 10) shows the avulsion of the nearest upstream left meander, changing the approach flow direction from 45 degrees to the bridge opening to nearly directly at the left bank and the southern bridge abutment. The 1971 aerial photo also illustrates the instream mill pond being seriously aggraded with sediment, indicating that a long-term cutoff of bedload to the downstream reach had occurred over time. The cutoff of bedload to the downstream reach likely created a “hungry water” scenario, where the entrapment of bedload and suspended sediment in the millpond increases the carrying capacity of flows moving downstream. The kinetic energy of the system below the pond is shifted such that the downstream flow velocities and shear stresses increased due to the lack of suspended sediment, and the lack of energy dissipation from bedload movement. This likely increased the erosion rate at the meander just upstream of the SR 109/023 bridge that eventually resulted in the avulsion and the dramatic shift of the river’s attack angle to the bridge structure. Figures 11 through 13 show the aerial photos of the site and reach for 1982, 1992 and 2005 respectively. Figure 8 shows each of the river’s alignments for the aerial photos described above.

Figure 8. Historic Alignments of the Moclips River near the SR 109/023 bridge, 1952 to 2005.

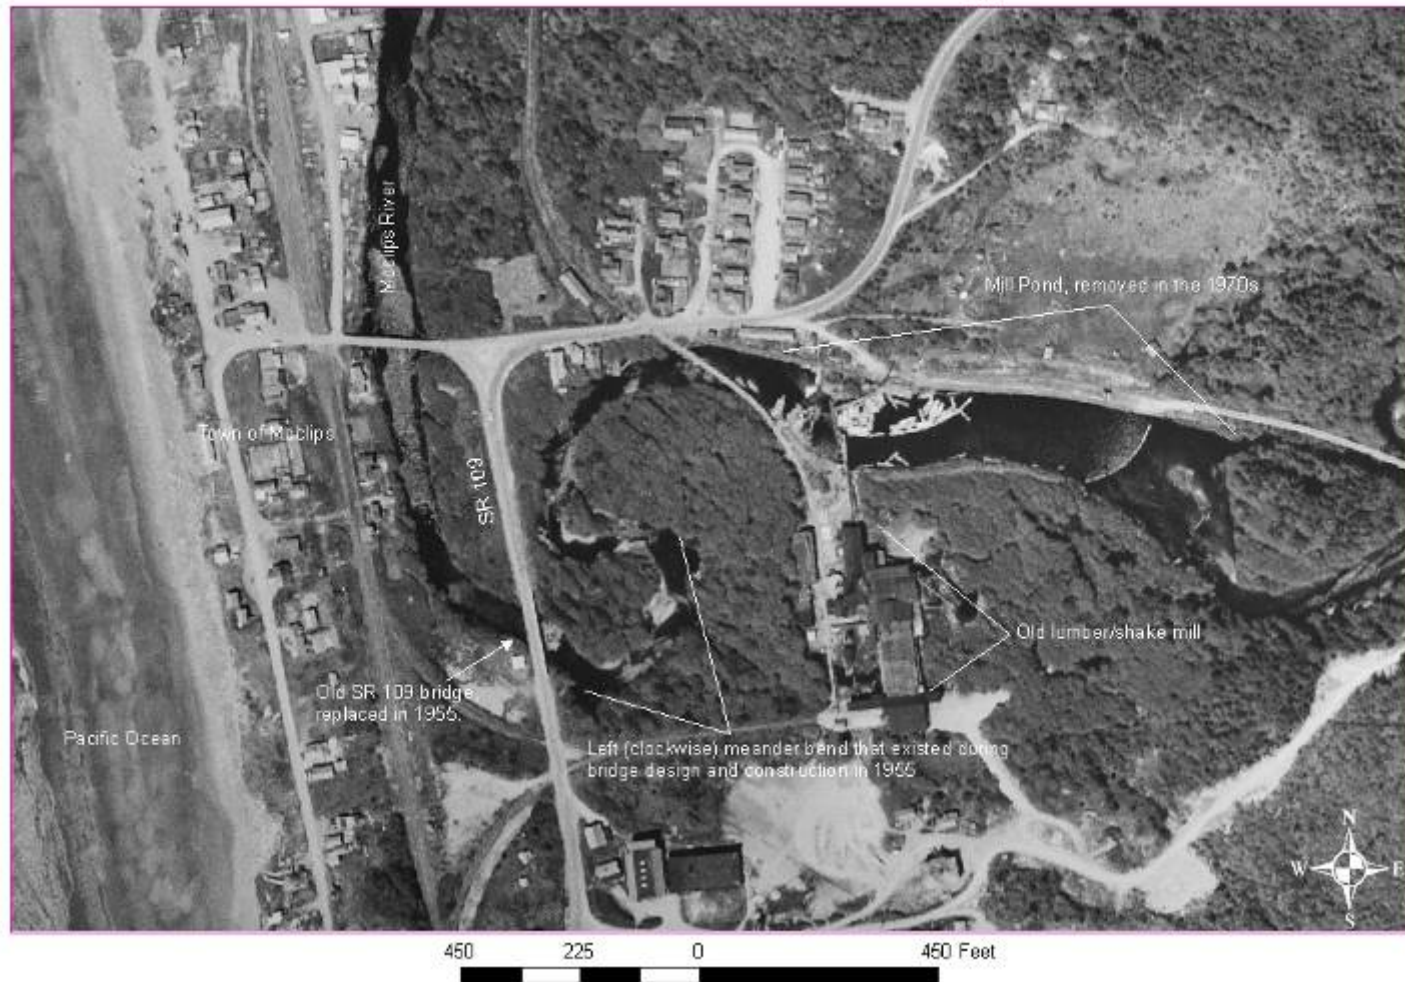
Figure 9. 1952 Aerial Photo in the Vicinity of the SR 109/023 bridge.

- Avoidance of the old mill site (located approximately 500 feet due east of the current 023 bridge; see Figure 9) is essential. As an older industrial site, the risk of finding hazardous materials or contaminated soils at the site would be significant and should be avoided at all costs. The old mill site is not listed as a MCTA, RCRA, or CERCLA site, but the mill was decommissioned long before these laws were enacted in the early 1970s.

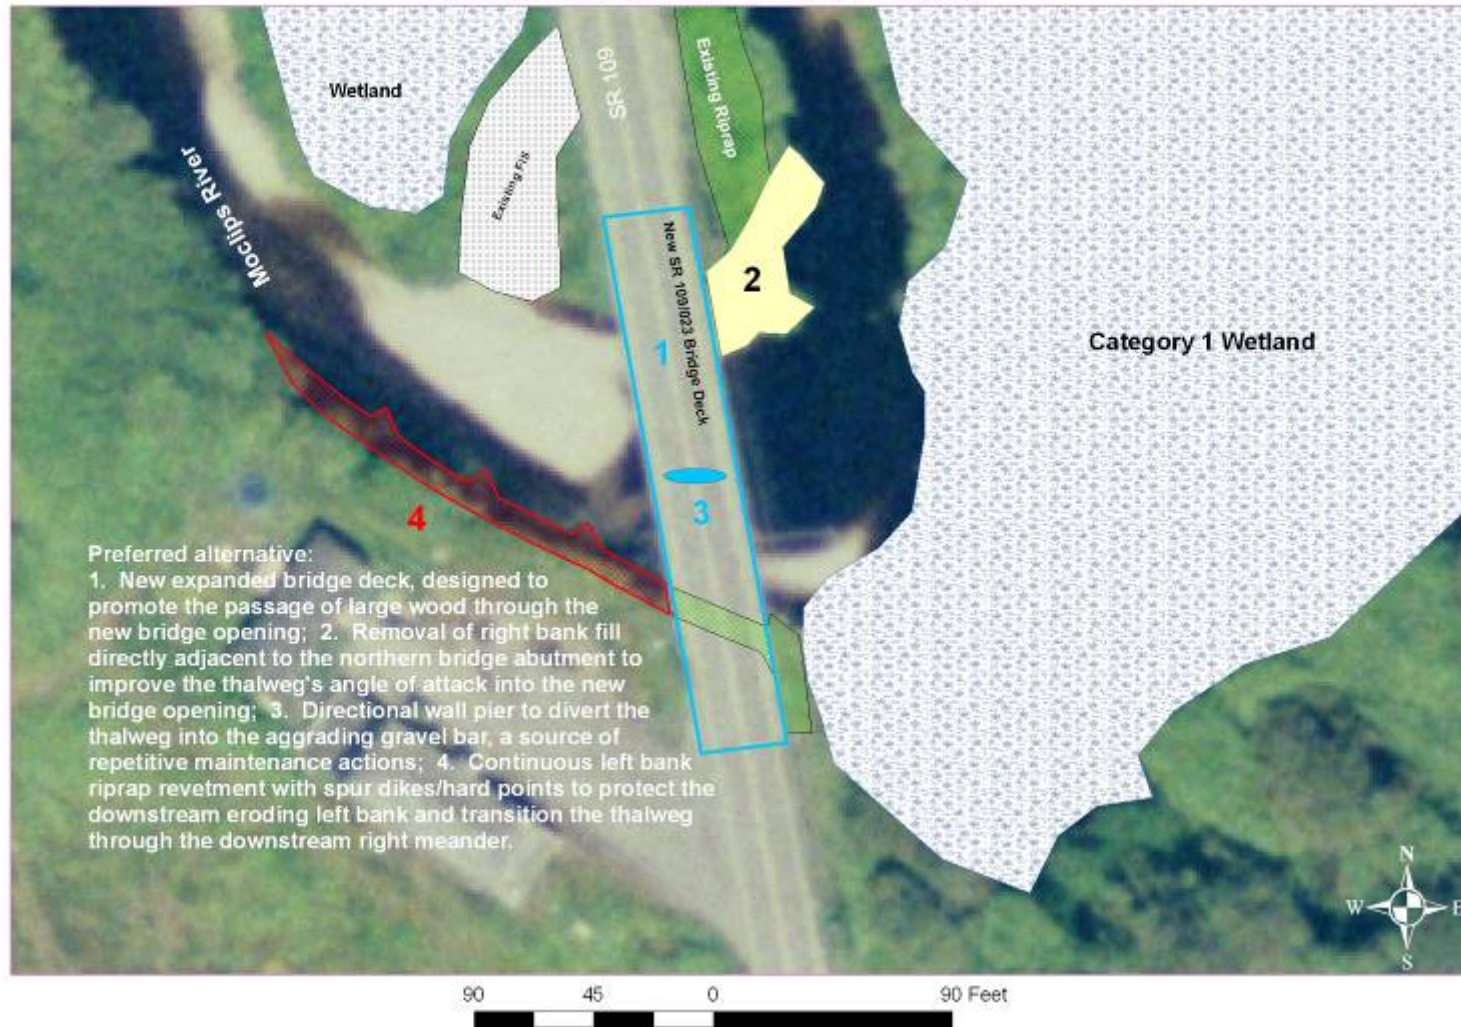
Figure 14. Preferred Alternative for the Moclips River SR 109/023 bridge.

Bridge replacement with directional wall pier(s), a left bank riprap revetment with spur dikes and a regraded right bank to reduce the angle of attack through the bridge opening: In this alternative, a bridge replacement would incorporate wall piers directed in an east-west orientation to help deflect the river's main flow energy through the center of the bridge opening, allow it to transition smoothly to the reach downstream of the bridge, and deliver flow towards the aggraded gravel bar that has been the cause of repeated maintenance actions. One significant factor is the daily stage variations on the Moclips that can regularly exceed 10 feet in a given day because of a combination of tidal fluctuations and storm flows.

Piers, if incorporated into the design, should preferentially be elliptical wall piers that have the ability to deflect part of the river flows perpendicular to the bridge opening, which would be in a east-west orientation. This feature would also help prevent aggradation at the downstream right bank that has been the cause of repeated maintenance actions in the recent past.

The SR 109/023 bridge replacement with directional wall pier(s), a left bank riprap re-
vetment with spur dikes and a regraded right bank to reduce the angle of attack through
the bridge opening appears to be the option with the highest net transportation and envi-
ronmental benefits and the lowest risk-to-cost option for this project. Mitigation should
not be necessary and costs other than for bridge construction should be minimal.

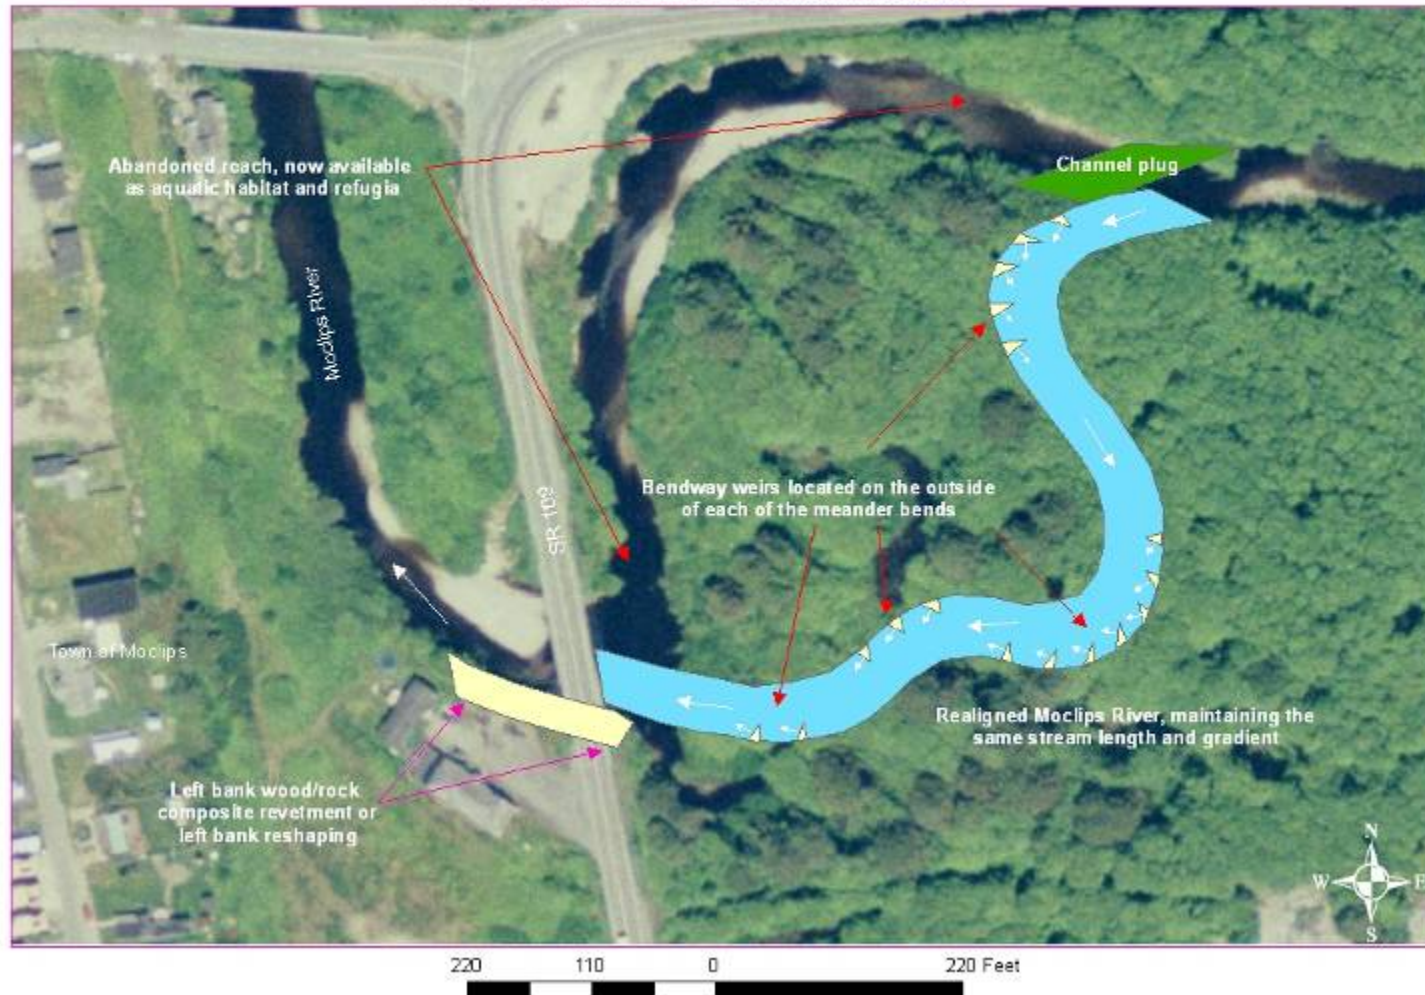
Figure 15. Alternative for the Moclips River SR 109/023 bridge.

Bridge replacement with Moclips River realignment and left bank reshaping: This alternative is probably the most comprehensive semi-permanent fix that could be realized for this project. It is also the most complex and probably the most expensive option due to the need for land acquisitions, extensive excavation, fill, and haul requirements. Environmental permitting and consultations with tribes and federal services would likely involve intensive and time-consuming negotiations. While realigning the channel would improve the angle-of attack over current conditions it would lengthen the channel in the upstream reach considerably, and would adversely affect what is currently excellent off channel habitat. Conversely, the river realignment option would have several benefits to SR 109, the SR 109/023 bridge, and aquatic habitat within the upstream reach. The realigned river would be placed far away from the SR 109 road prism until it approaches the new bridge at an angle that is close to perpendicular to the bridge structure and directing the river's thalweg through the center of the opening. The abandoned reach may then eventually evolve into a forested backwater wetland area that could provide substantial aquatic habitat and other wetland functions. However it would remain shorter than the re-aligned channel and thus always susceptible to re-occupation through river avulsion unless extensive measures were taken to thwart channel migration. With the river's angle of attack no longer directed at the left bank scarp, it could then be reshaped to assume a more natural angle of repose at a 3:1 slope and then revegetated with willows, cottonwoods, herbaceous shrubs, and other suitable riparian vegetation. Left bank re-
