**Site and Reach Assessment
South Fork Newaukum River
At SR 508, Milepost 5.75**

**Work Order MT0100
Chronic Environmental Deficiencies (CED) Program**

**Rob Schanz, Hydrologist
WSDOT Environmental Services
Hydrology Program**

July 2009

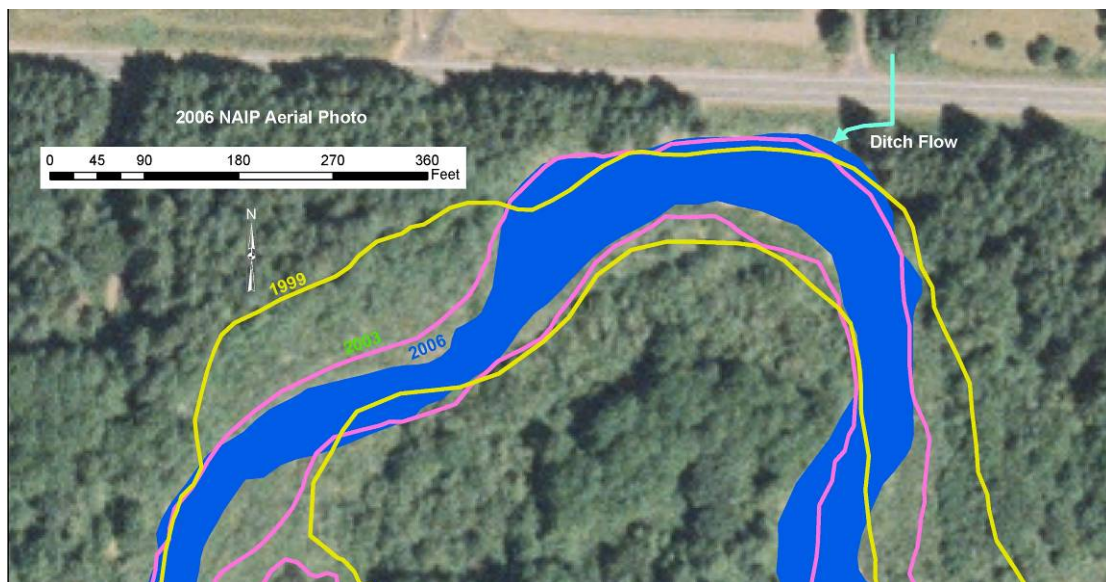
Figure 2. 2006 Aerial Photo with 1999 and 2003 Banklines at the Project Site.

Figure 2 shows an aerial photo of the river at the project site. The project site sits within a meander bend with a radius of curvature of about 185 feet. The stream approaches the bend in a relatively straight channel that takes an almost 90-degree turn before running parallel to SR 508. Bank erosion is concentrated against the outside of this bend, and has formed a deep scallop at the point where the river begins to turn against SR 508.

Road runoff and pasture drainage is currently being routed into a ditch that discharges into the elbow of the eroding bend. This saturates and weakens the bank structure at the point where erosive forces are highest.

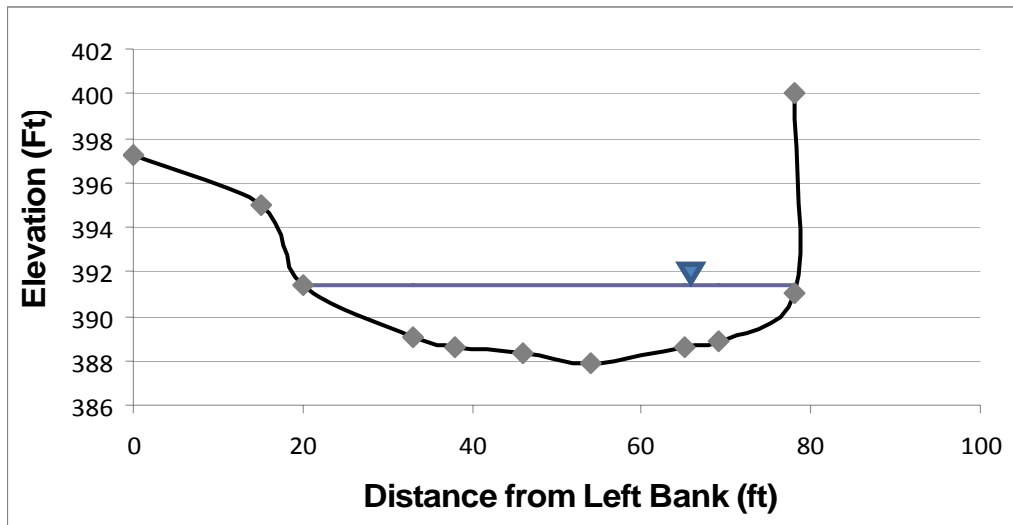
Figure 3. Channel Cross Section in the Pool at the Center of the Site.

Figures 3 and 4 show channel cross sections surveyed in September 2008. The eroded bank is nearly vertical, and drops into a scour hole that runs along the toe of the bank. The channel bed slopes upward from this hole to a gravel point bar on the inside of the meander bend. On the left bank this gravel point bar slopes steeply up to a low bench of canary grass and willows.

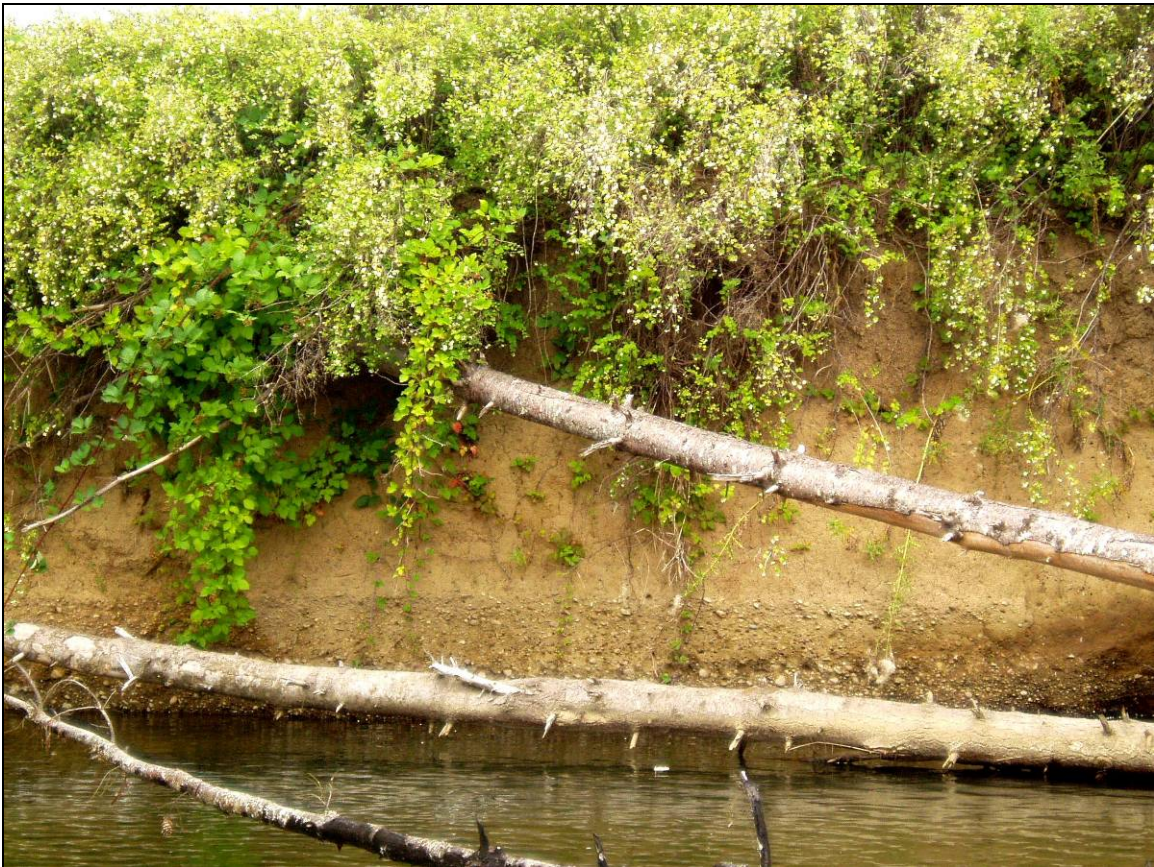
Figure 5. Photo of the Eroding Bank Soil Profile.

The eroding bank consists of a nine- to 11-foot vertical scarp of fine-grained alluvium (Figure 5). Driller's logs for nearby wells indicate this alluvium has some clay content, and is therefore sufficiently cohesive to maintain a vertical slope when eroded (Washington State Department of Ecology, 2008). Soils at the site are mapped by the USDA (1979) as Newberg fine sandy loam.

A layer of rounded gravel embedded in a matrix of fine sediment is periodically exposed along the base of the bank. This is probably a relic of historical river bed deposits that were buried as the river migrated across the valley floor. In some locations a layer of reddish sandy soil marks the transition between the overlying fine-grained alluvium and the buried gravel. No bedrock is exposed at the site, although boulders of marine siltstone transported from upstream are scattered along the toe of the eroded bank.

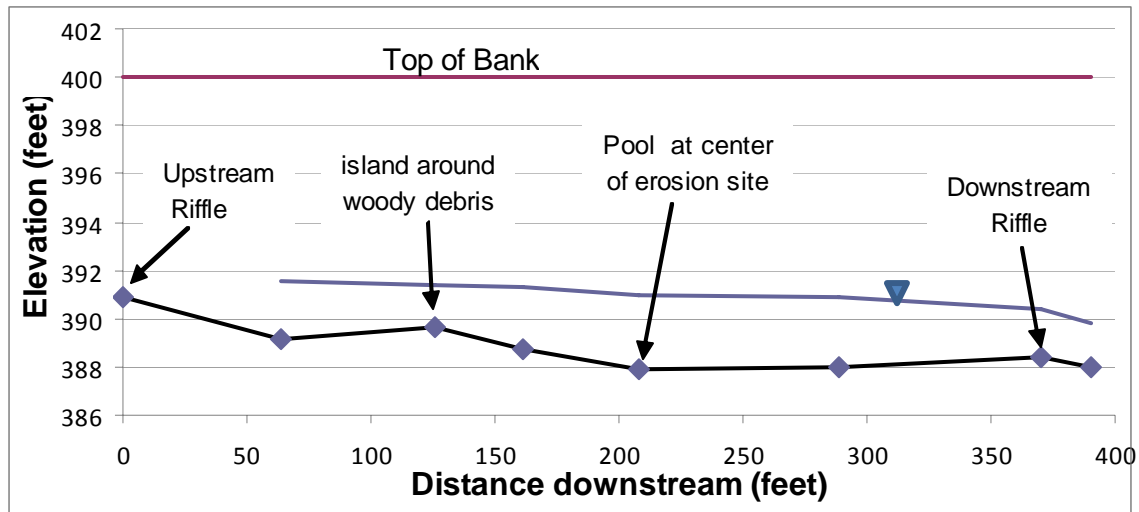
Figure 6. River Bed Profile at the Project Site.

Figure 6 shows the profile of the river bed thalweg as it passes the erosion site. The river approaches the erosion site through a series of riffles spaced 200 to 300 feet apart. The last of these riffles marks the upstream boundary of the eroded bank, and is made up of coarse gravels to large cobble. The bed slopes at about 0.69 percent between the riffles that bracket the erosion site.

As the river turns along the eroding bank it enters a long deep pool. The inlet of the pool contains coarse gravels and cobbles that are mixed with sand and occasionally buried in sandbars. In the center section of the pool streambed materials transition from one- to three-inch gravels on the point bar to fine silts and sands in scour holes. In the deepest part of the pool the sediment is mucky and covered with aquatic plants.

The pool tails out into a riffle with three-inch gravel mixed with six to 12-inch cobbles and few fines. More riffles continue downstream, interspersed with deep scour holes along eroded sections of the bank and around large woody debris.

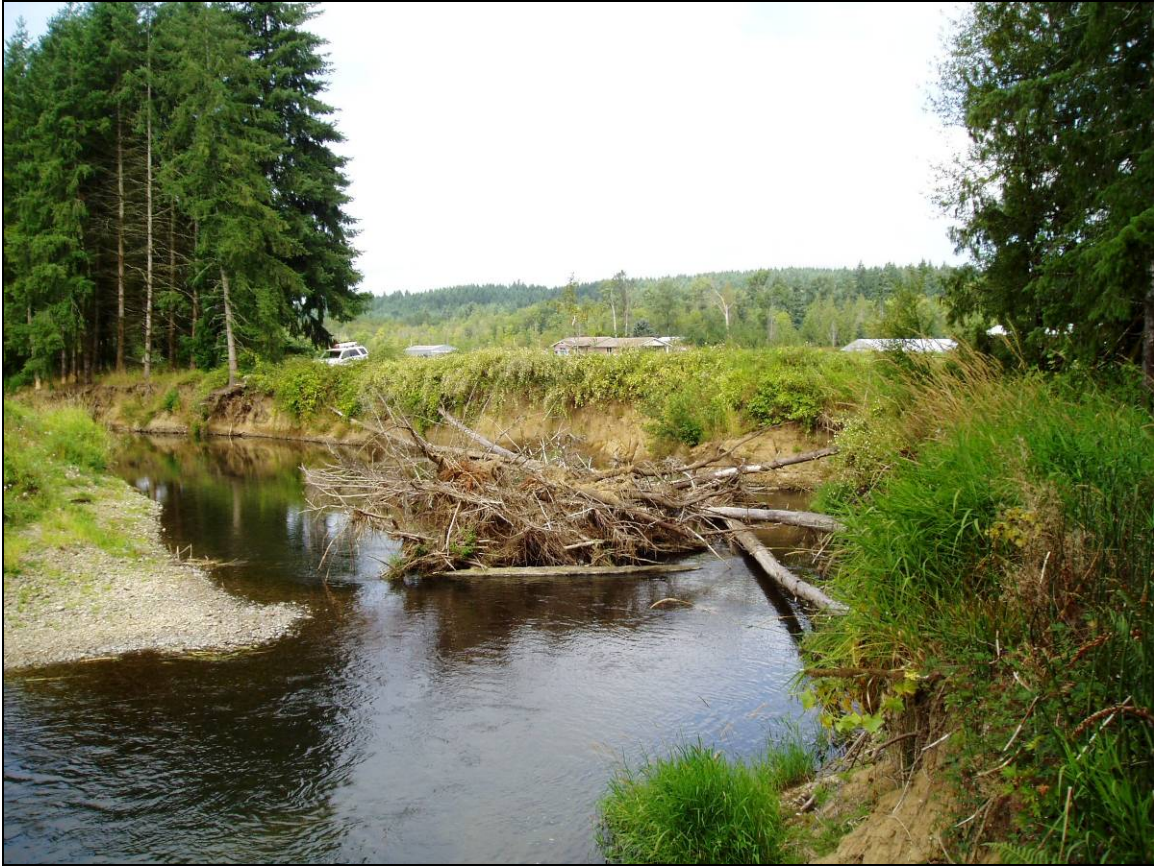
Figure 7. Large Woody Debris at the Project Site.

During our September 2008 site visit we observed a log cluster consisting of eight key pieces mixed with smaller debris in the sharp bend at the upstream end of the erosion site (Figure 7). Flow splits around this cluster, directing some of the river's energy against the bank. Key pieces were 18-24 inches in DBH, with rootwads intact. One was still cabled to a tree on the bank, and probably fell in after January 2006. A low island of mucky sediment has developed along the downstream face of this jam, where three key pieces intersect.

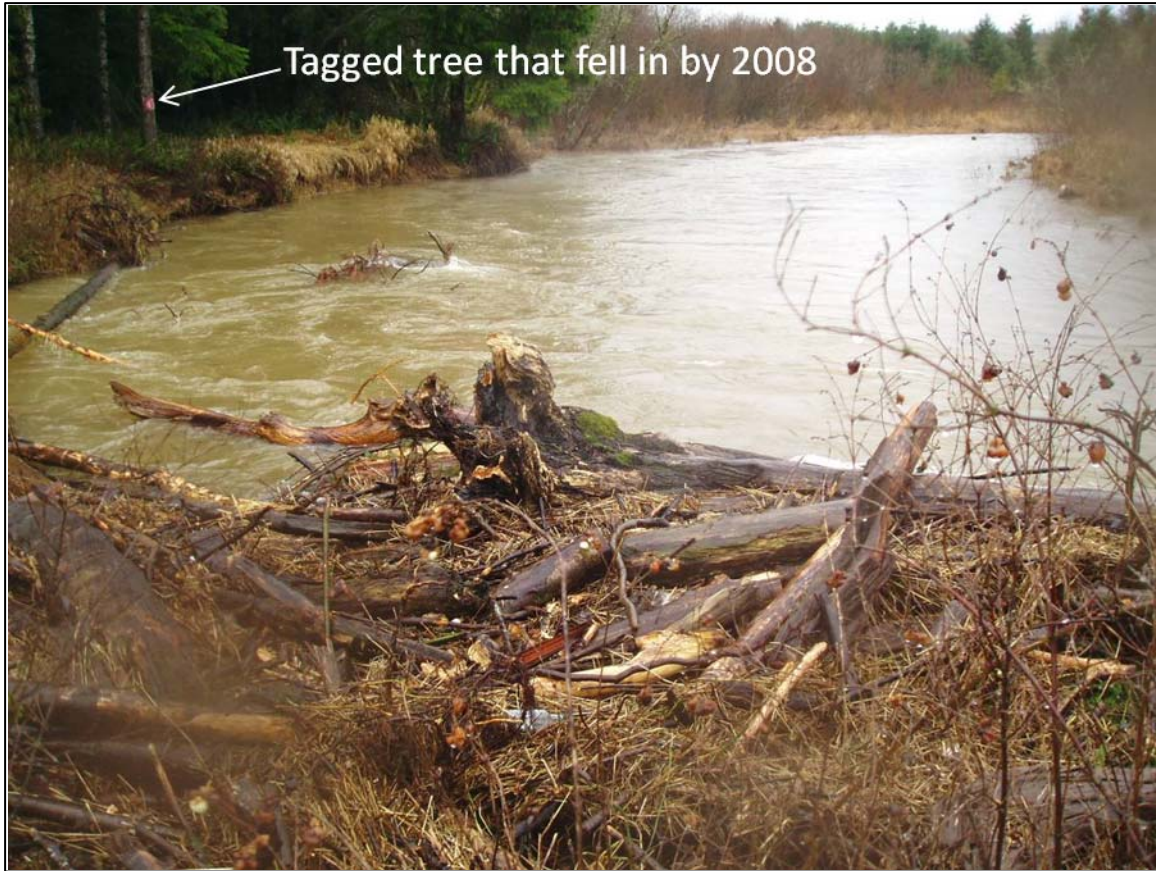
Figure 8. Raft of Woody Debris Protecting Bank, January 2006.

We briefly inspected the site during a January 2006 flood event. A log cabled by WSDOT to divert river energy away from the road had recruited a significant amount of woody debris that floated as a dense raft in the eddy at the upstream end of the eroded bank (Figure 8). The tagged tree on the photo is now one of the trees we observed in the September 2008 log cluster.

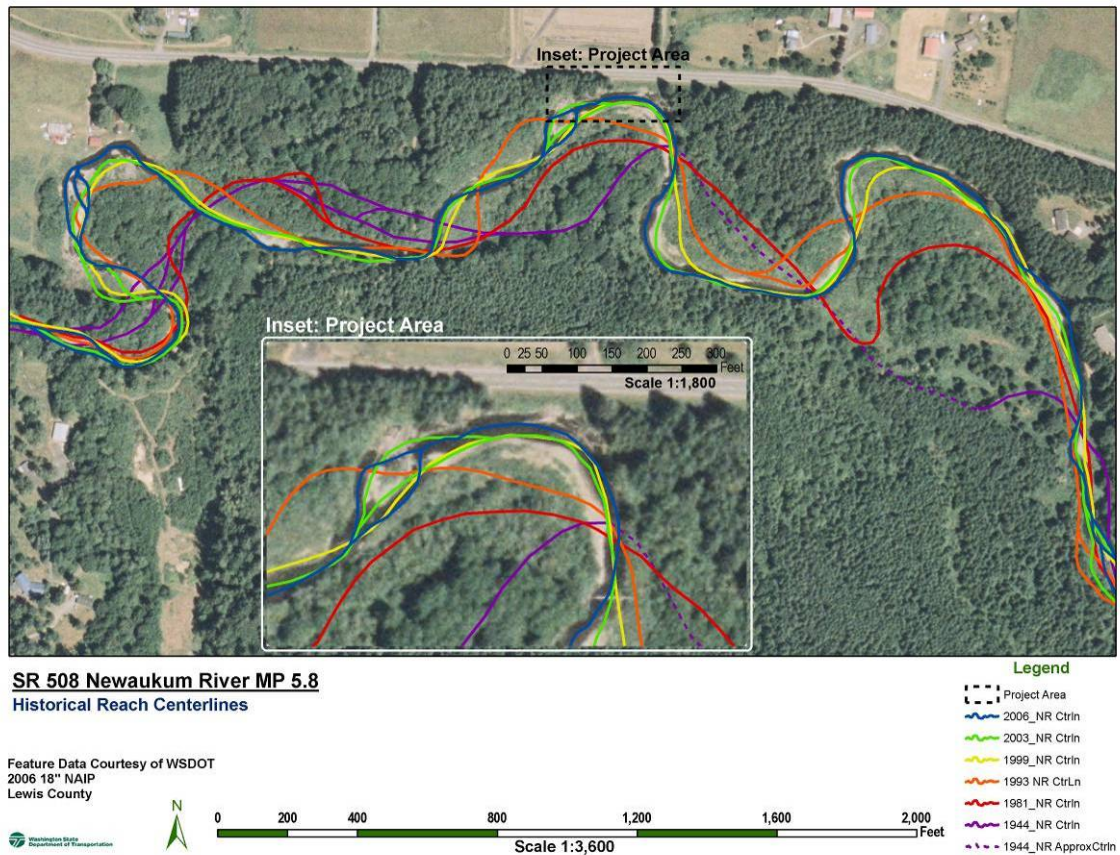
Figure 10. Channel Alignments shown in Historical Aerial Photos.

Figure 10 compares channel alignments shown in aerial photographs from 1944, 1981, 1993, 1999, 2003, and 2006. The 1944 photo shows a relatively straight channel that is distant from SR 508. By 1981 the river had developed meander bends that were extending northward towards SR 508, coming within 20 feet of the highway by 2003. Meander migration occurred primarily by north-south extension of bends, with little downstream translation.

In 2006 the river flowed through a well-developed series of meanders with an average belt width of about 514 feet. The channel top of bank width ranges greater than 100 feet in eroded bends, but averages about 85 feet in the reach. The ratio of the meander belt width to channel width is therefore about 6:1. Mature meander bends tend to have a belt width ratio near 6:1, so it is likely that the rate of meander extension will slow in the near future.
