TACOMA NARROWS AIRPORT 2005 PAVEMENT MANAGEMENT REPORT

February 2006

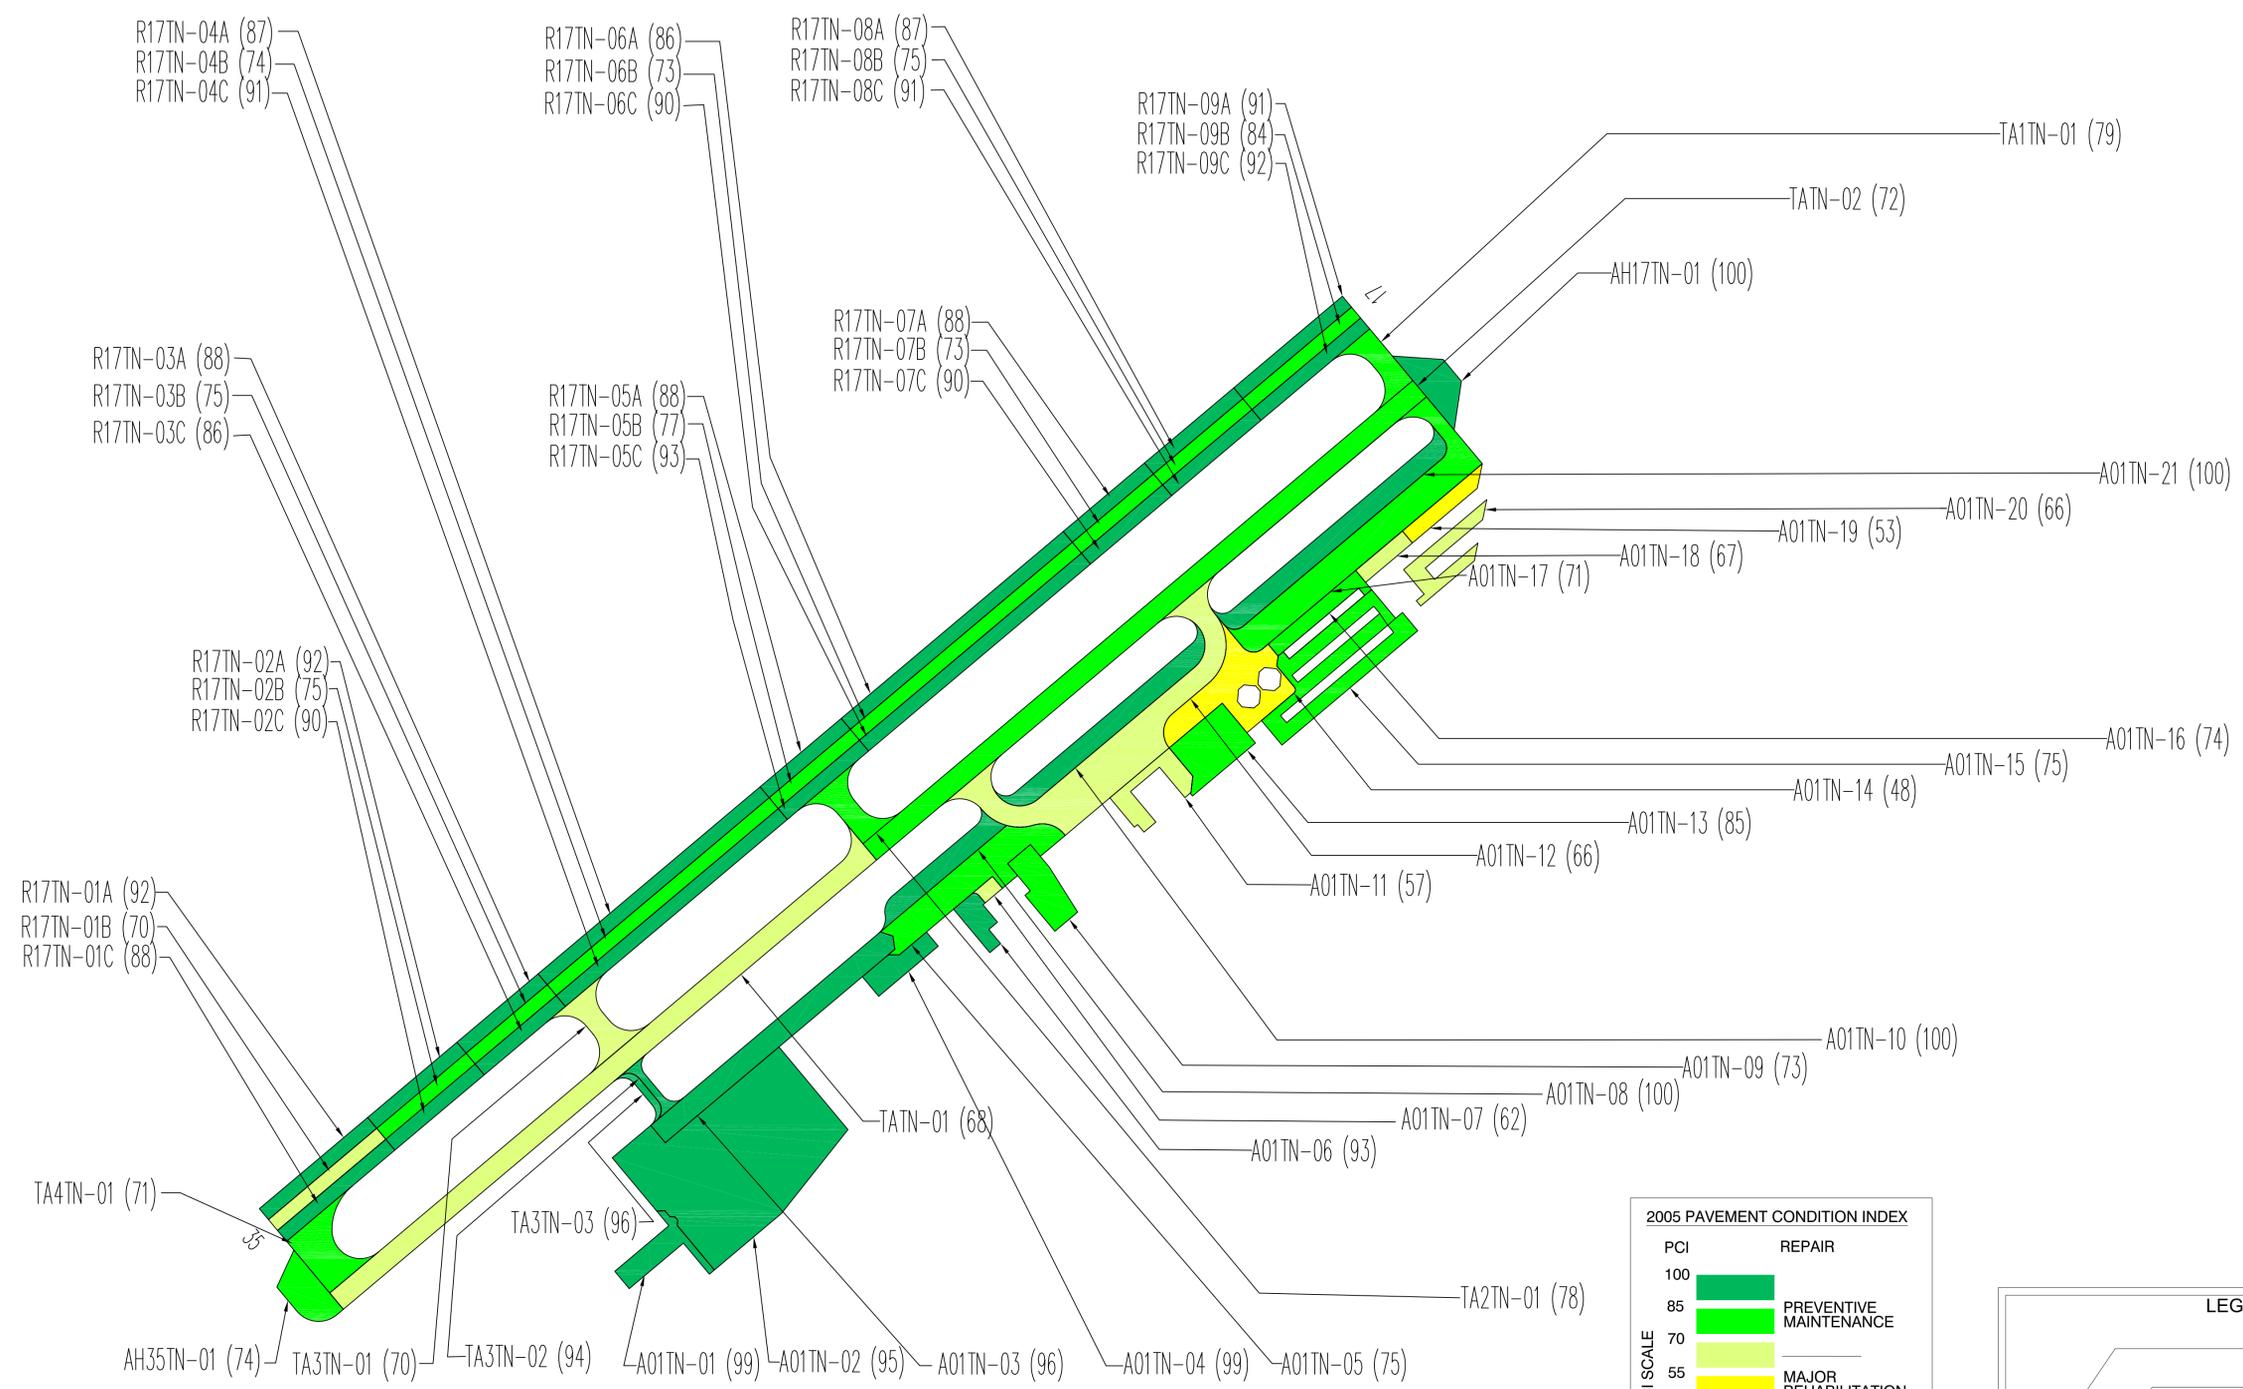
LOCATION: Tacoma Narrows Airport Tacoma, Washington			
PAGE TITLE: 2005 Pavement Condition Index Map			
DRAWING SCALE: 1" = 300'	DATE: February 2006	REVISED BY: TJS	DRAWN BY: MK
FILENAME: Yakima.dwg	AIRPORT ID: KTIW	LAYOUT NAME/NUMBER: Tacoma (PCI)	PAGE NUMBER: 9

The pavements at Tacoma Narrows Airport were inspected on June 4, 2005. The 2005 area-weighted condition of Tacoma Narrows Airport is 81, with conditions ranging from 48 to 100 (on a scale of 0 [failed] to 100 [excellent]). During the previous inspection in 1999, the area-weighted condition was 77.
