**Reach Assessment
Clay Creek at SR 410 MP 35.76**

**Rob Schanz, Hydrologist
Jim Park, Senior Hydrologist
WSDOT Environmental Services
Hydrology Program**

December 2009

Washington State Department of Transportation
Environmental and Engineering Service Center
Environmental Services Office

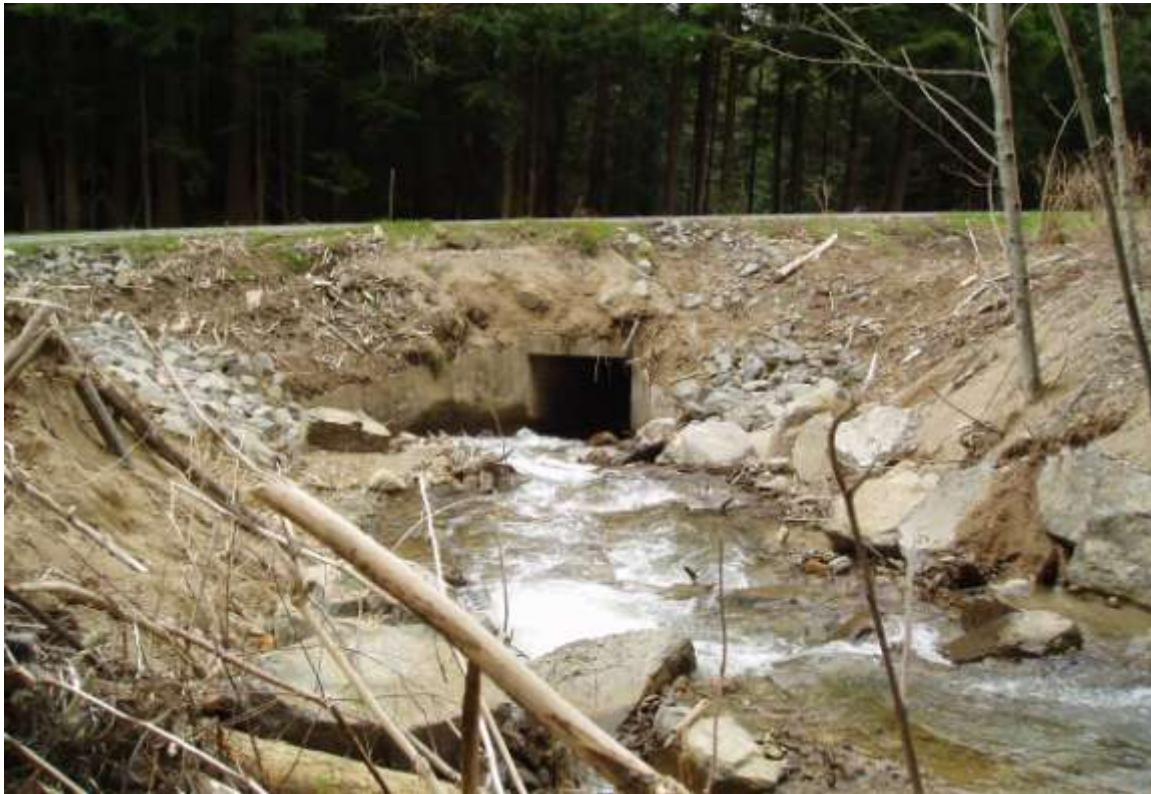
Figure 1. Photo of the Culvert Inlet after the 2009 Repair.

Clay Creek periodically delivers large pulses of sediment, rock, and woody debris that clog the culvert inlet. The creek then spills over SR 410 and splits into several incised gullies that lie east of the main channel. This covers the road with debris, and erodes the downstream road embankment at each gully. This occurred most recently during the January 2009 flood. Following this event WSDOT excavated debris from the channel bed to clear the culvert inlet, installed two boulder drop structures upstream of the inlet, and placed riprap on the banks adjacent to the upstream wingwalls (Figure 1). WSDOT also placed riprap at the heads of the east gullies to repair eroded sections of the downstream road embankment.

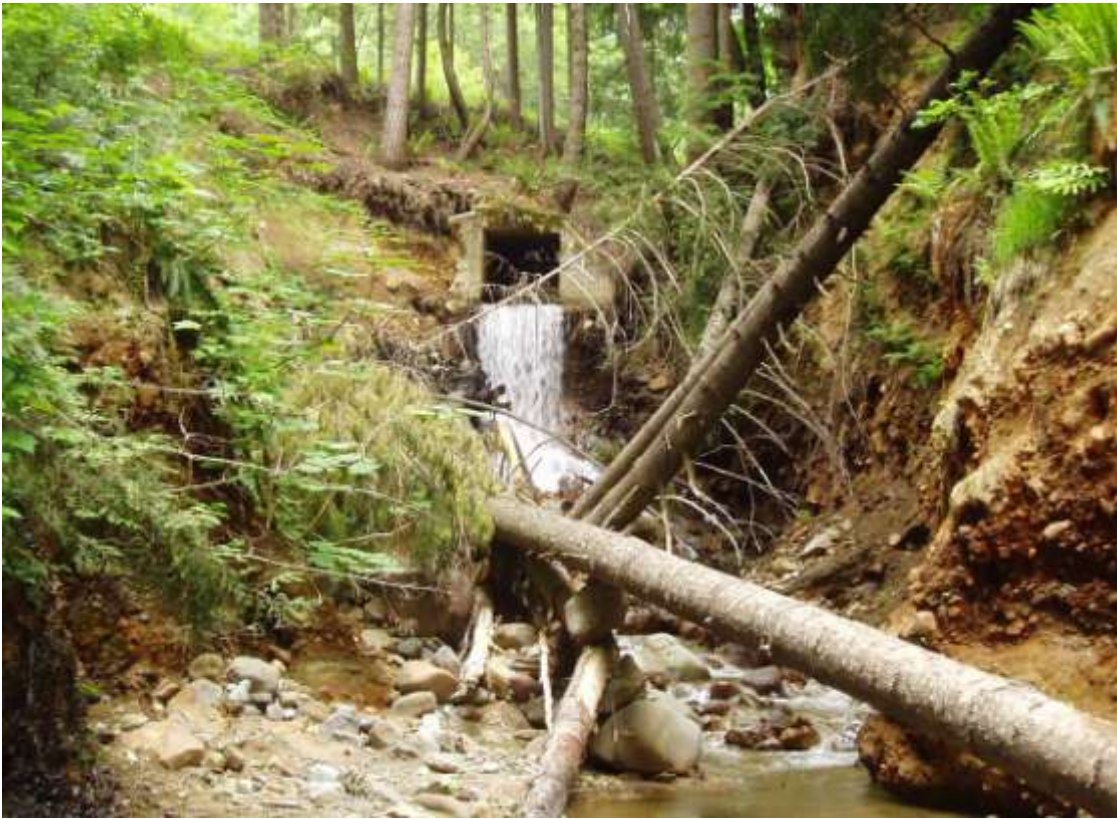
Figure 2. Channel Incision at the Culvert Outlet.

The steep and undersized culvert has also caused massive channel incision at the outlet (Figure 2). This incision has undermined the outlet apron and wingwalls, causing large sections to drop off into the channel bed. Water now spills 15 vertical feet off of the outlet apron onto a pile of rubble, riprap, and concrete debris. The flow drops another 12 vertical feet over this debris before meeting the scoured channel bed about 30 feet downstream. The culvert is a complete barrier to fish passage (WDFW and WSDOT, 2009).

The remaining sections of outlet apron and wingwalls are severely undermined, and continue to fail. This will eventually threaten the integrity of the road embankment.

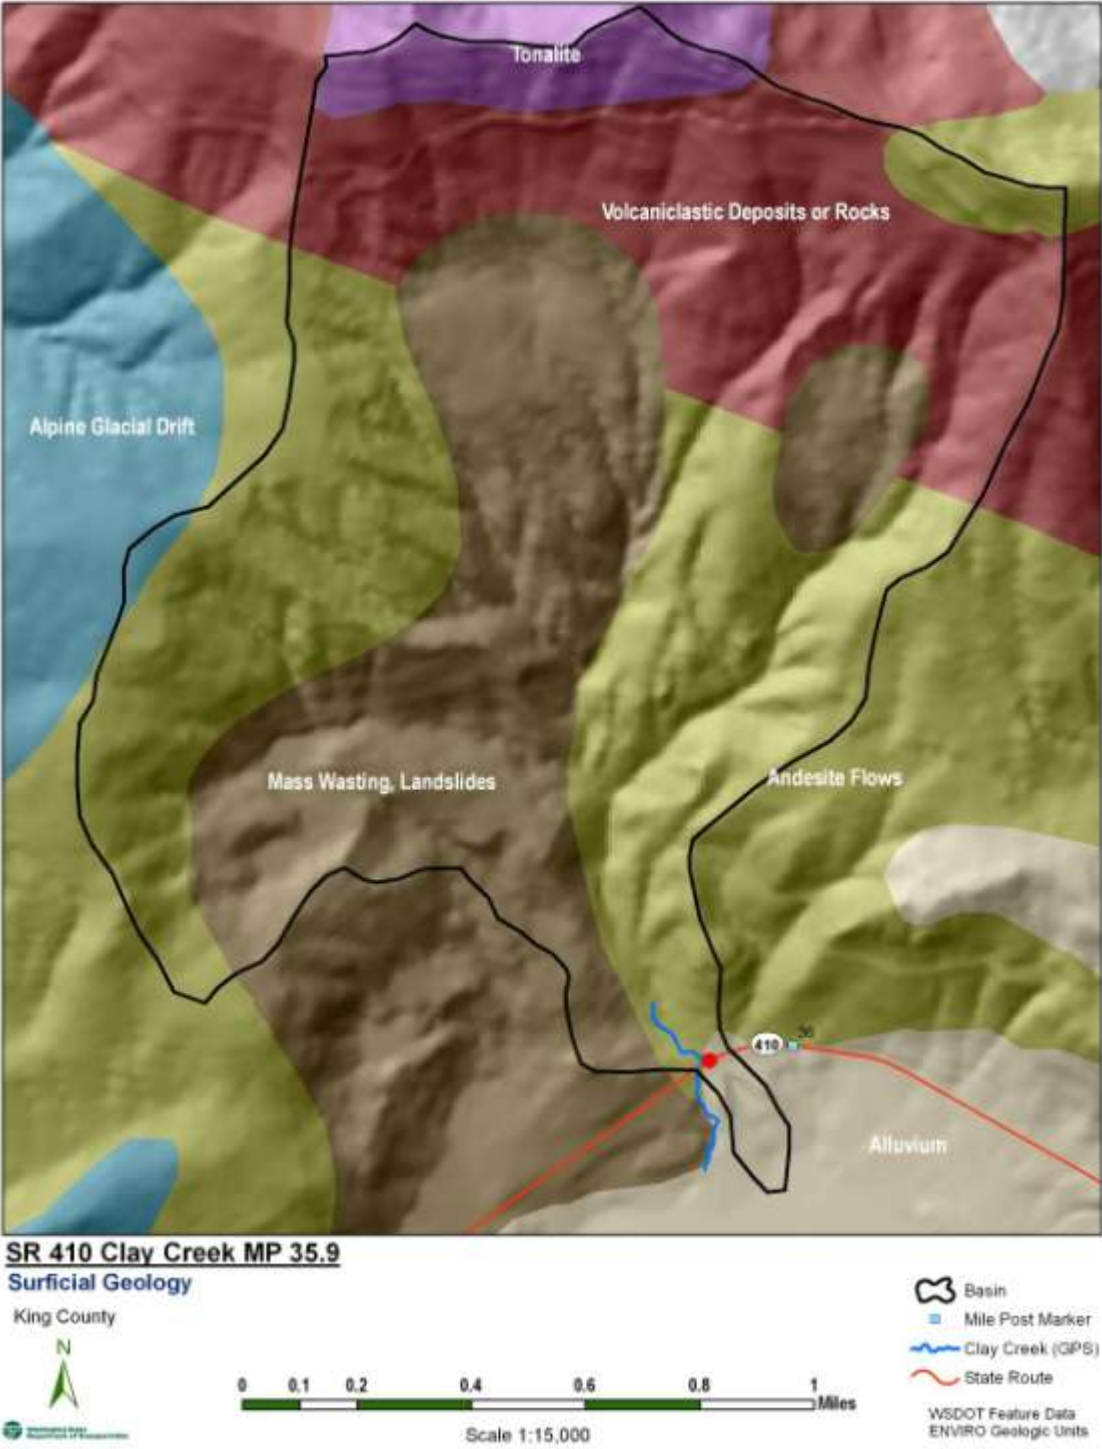
Figure 3. Watershed Boundaries and Surficial Geology.

Figure 3 shows the surficial geology of the Clay Creek watershed. The parent material in most of the watershed is volcanic rock, primarily andesite flows and volcanoclastic rocks. The steep valley walls are highly susceptible to mass wasting and landslides, and almost the entire western half of the watershed is covered by historical landslide deposits. These slide deposits continue across the SR 410 right of way and transition onto alluvial terraces and floodplains associated with the White River. The creek channel and east gullies on the downstream side of the road split around large hummocks that are likely derived from this slide material.

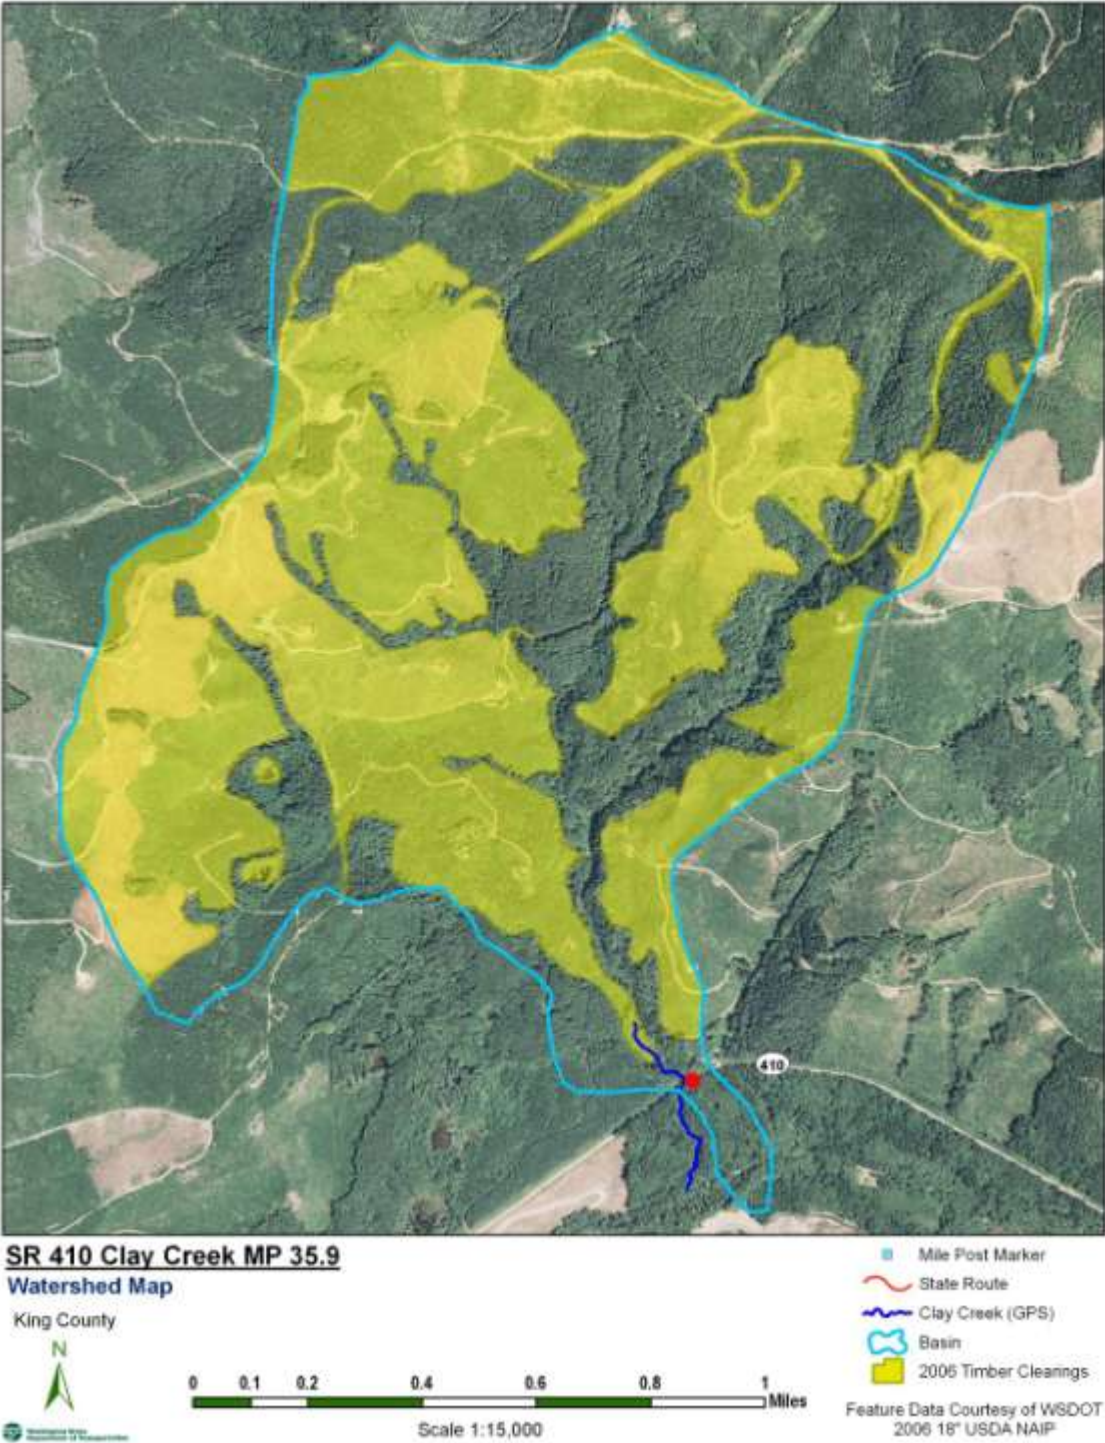
Figure 4. Recent Logging Activity in the Clay Creek Watershed.

Land use in the watershed is devoted primarily to timber harvest and forestry. Aerial photos from 1955, 2000, 2003, and 2006 were examined for major changes in the watershed, then contrasted with the 2006 full basin image. The 1955 photo shows only limited clear-cutting, but by 2006 recent clear-cuts covered about sixty percent of the watershed area. This high level of recent land disturbance increases the risk of landslides and debris flows to Clay Creek.

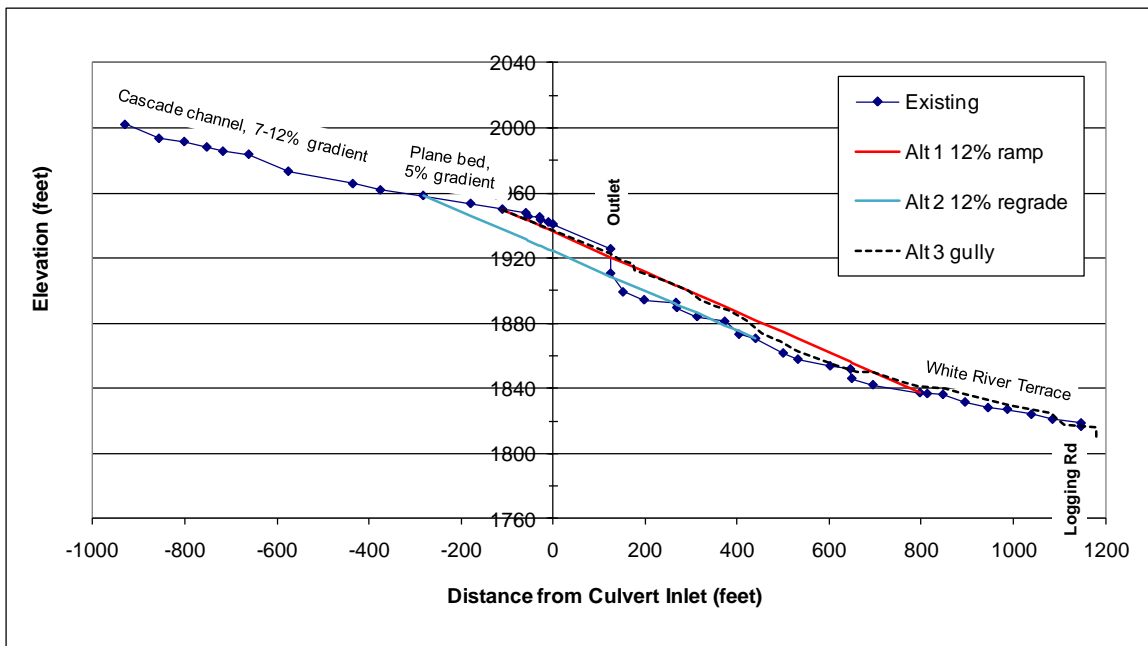
Figure 5. Profile of the Clay Creek Streambed.

Figure 5 shows the profile of the streambed upstream and downstream of SR 410, as surveyed by WSDOT in June 2009. The headwater channels begin as steep chutes (>20 percent gradient) scoured down to bedrock. The mainstem chute discharges onto boulder-covered falls about 2000 feet upstream of SR 410. These falls eventually transition into a cobble- and boulder-lined channel that slopes at between 7 and 12 percent. At these gradients the bed usually consists of a cascade channel with random pools spaced less than one channel width apart (Montgomery and Buffington, 1997). Large boulders and woody debris occasionally create short segments of step pool morphology (Figure 6).

Channel Gradient and Bedform: Each alternative re-grades the channel to eliminate the vertical drop below SR 410 and tie in at a linear gradient to stable channel segments upstream and downstream (Figure 5). Alternative 1 does this by filling downstream of SR 410 to raise the bed to meet the existing outlet elevation. The depth of fill would range from about 18 feet at the outlet to 4 feet near the end of the filled bed 700 feet downstream of SR 410.

Figure 5 compares the streambed profiles for each alternative. In all cases the terrain dictates a steep 12 to 14 percent channel with a coarse boulder and cobble bed to resist scour. This will create a cascade channel with chaotic flow through fields of randomly-strewn boulders, similar to natural segments upstream of SR 410. The channel would be constructed with a 20-foot bed width. Channel banks in excavated segments would slope at 2:1. Rootwads could be installed along the channel margins to provide roughness and habitat diversity. Engineered log or boulder sills would not be installed in the steep channel bed, since these would not be stable and would create drops that do not meet fish passage criteria. However, log sills and step pools may develop naturally over time as debris flows deliver large wood to the creek bed.

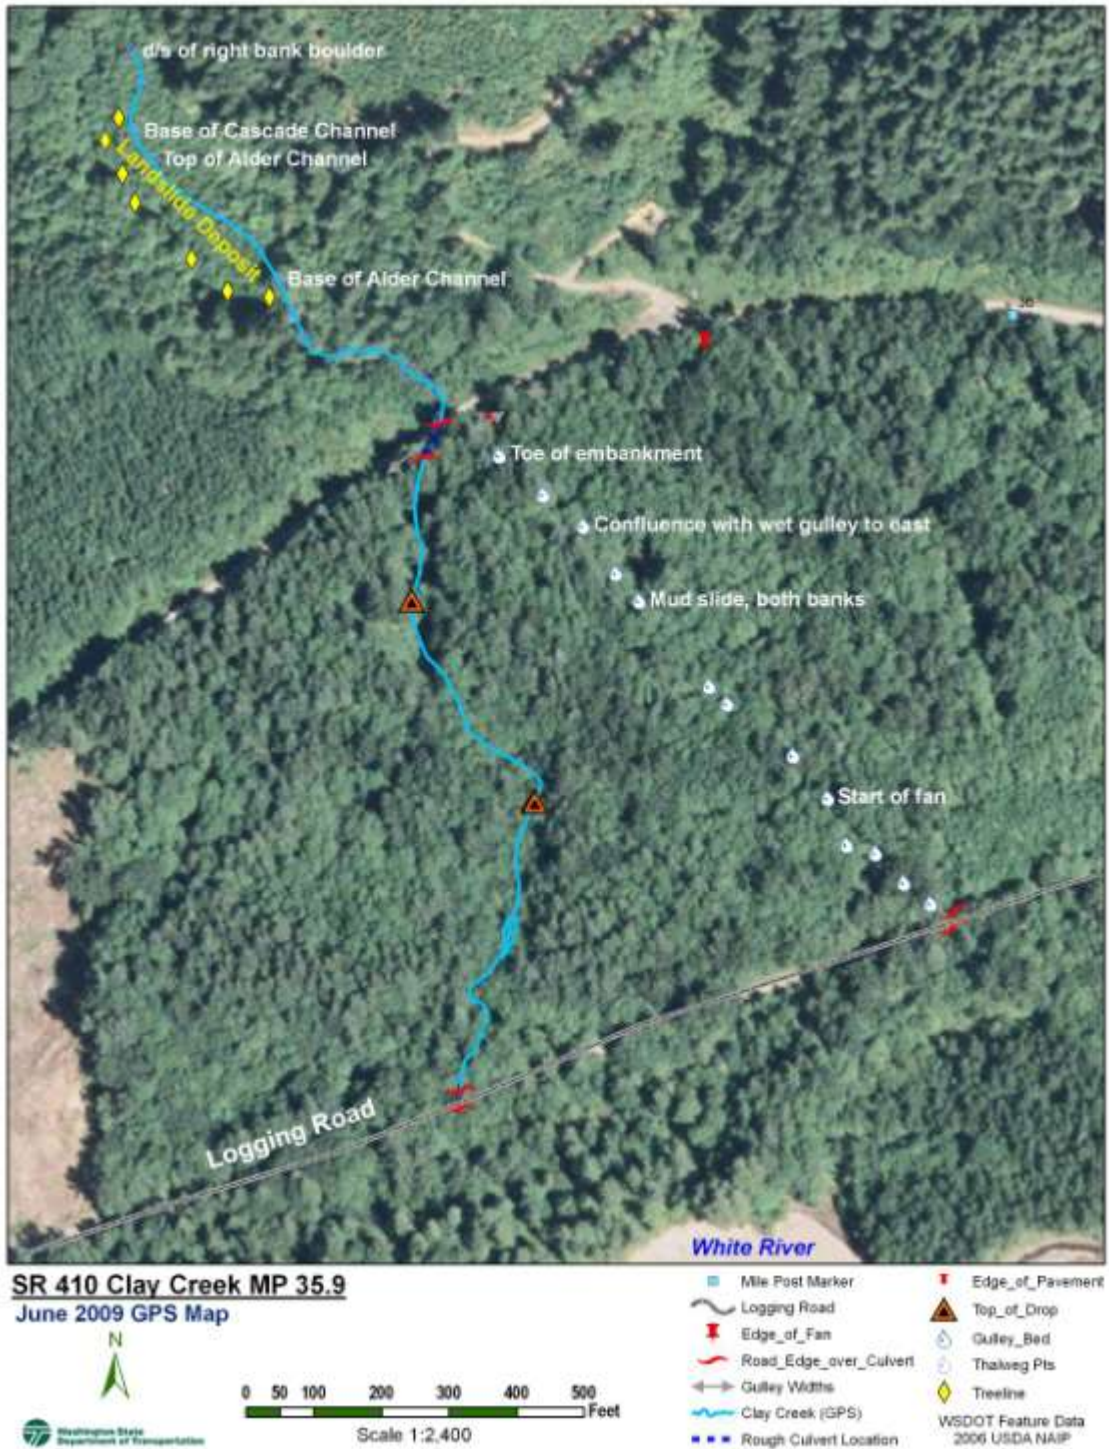
Figure 7. Channel Flow Paths Near SR 410

The existing outlet channel is heavily incised at the outlet, with numerous piles of woody debris and sediment from adjacent undercut banks. The bed slopes at about 10 percent before transitioning onto a White River floodplain terrace about 700 feet downstream of the culvert (Figure 7). Three major logjams create distinct steps in the profile with falls of three feet or more (Figure 8). As the creek transitions onto the terrace the gradient drops to about six percent. The channel on the terrace consists of a cobble-lined plane-bed that enters a 7-foot CMP logging road culvert 960 feet downstream of SR 410 (Figure 7). This culvert has a two-foot water surface drop at the outlet that is likely a fish passage barrier. The creek enters the White River about 350 feet downstream of the logging road.

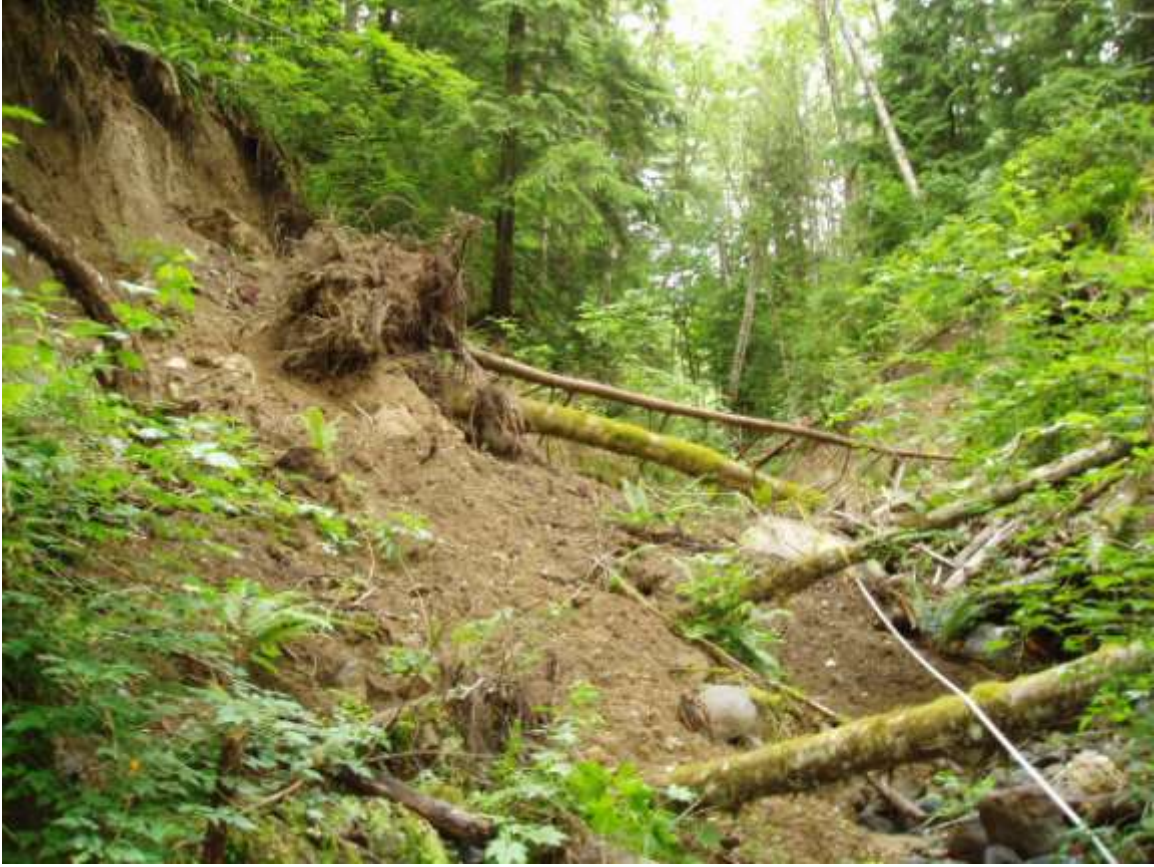
Figure 9. Failing Banks in the Gully Downstream of SR 410.

Gullies east of the existing channel periodically carry water and debris that spills over SR 410 when the culvert clogs. The first east gully has an alignment that provides a more direct crossing of the SR 410 right-of-way. This gully has a bed slope similar to what likely existed in the Clay Creek channel prior to incision, and is typically eight to 20 feet wide at the bottom. The bed consists of scattered boulders and cobbles embedded in volcanic silt and clay. The unvegetated banks frequently slump into the gully, and consist of angular cobbles embedded in sandy silt volcanic soil (Figure 9).
