Channel Migration Analysis Summary Report

A Component of the SR 530 Sauk River Corridor Analysis

Revised November 2009

Washington State Department of Transportation
Environmental and Engineering Service Center
Environmental Services Office

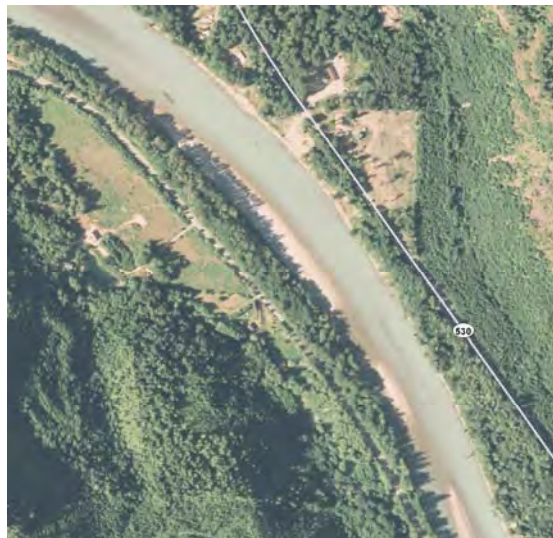
SR 530, MP 63.5

The US Forest Service identified two additional locations along SR 530 that, while located within areas that have the least migration in the historic record, may be vulnerable to future channel migration:

These sites may be appropriate for future monitoring. While WSDOT is not able to assess the sites because they are located on private property some distance from the highway, the agency will welcome information from property owners, USFS, or other interested stakeholders about changing conditions or other concerns.

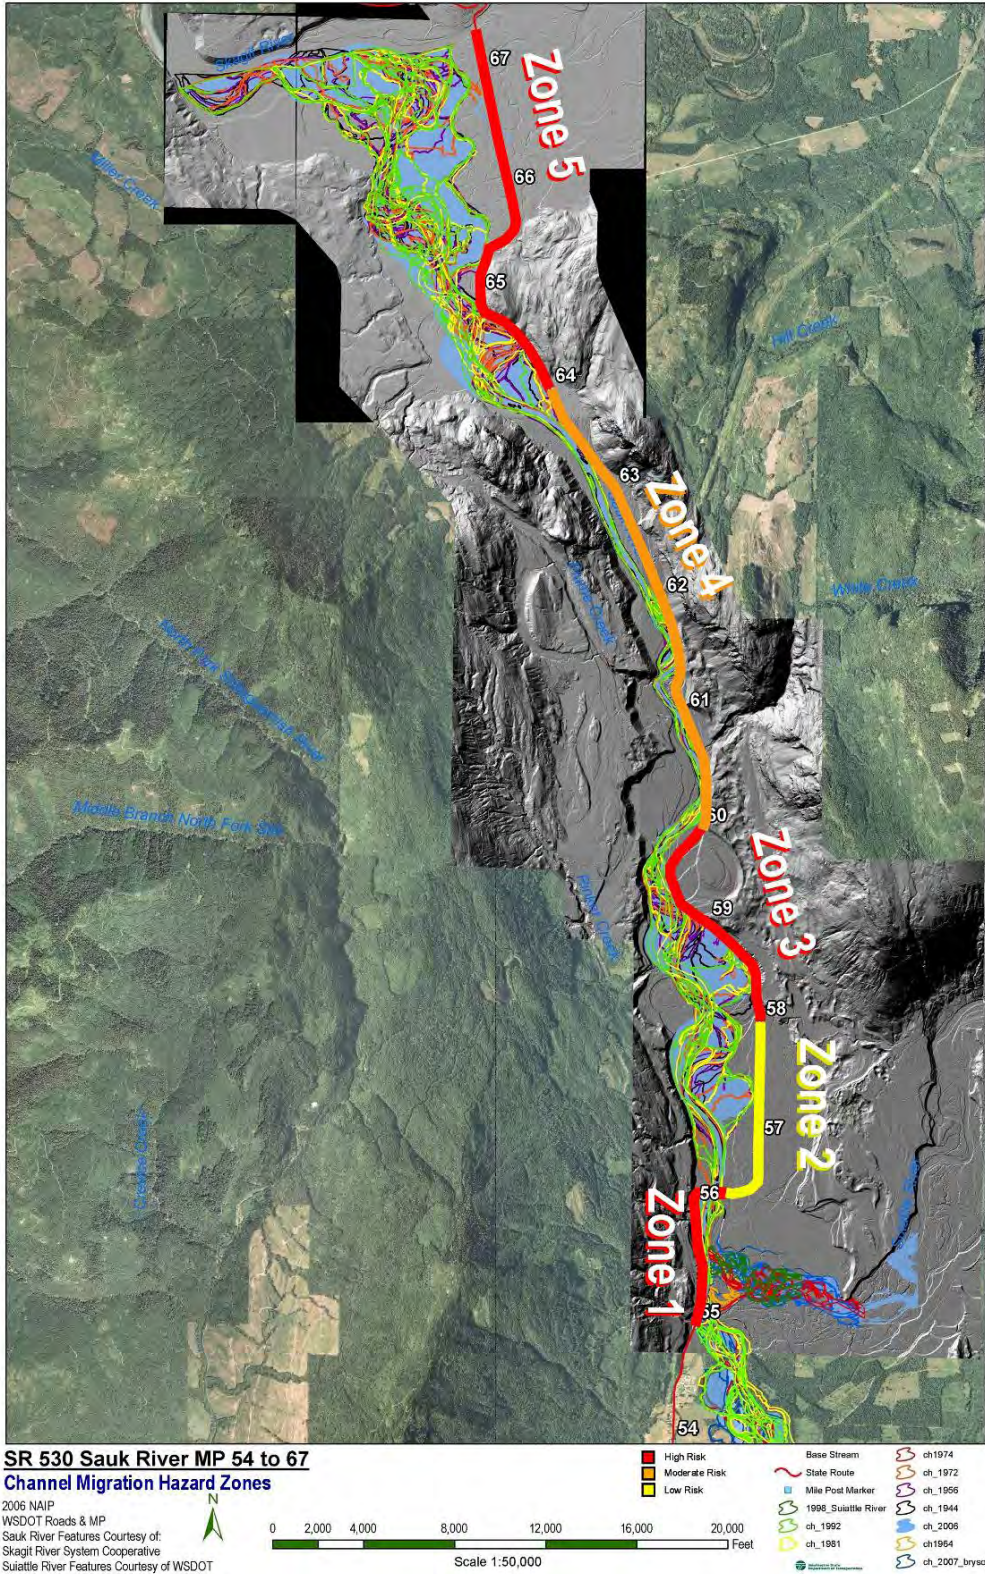
Figure 1. SR 530 hazard zones.

The SR 530 corridor along the Sauk River can be divided into five hazard zones, depending largely upon channel migration trends in the adjacent river reaches (See figures 1, 2 and 3).

- **Zone 1: Sauk Suiattle confluence (MP 55) to steel bridge (MP 56.22).** This is an area of high hazard. The highway is either within or at the edge of the channel migration zone. Channel migration in the adjacent reach is highly active and recent emergency bank stabilization projects have been undertaken.

- **Zone 2: Steel bridge SR 530/207 (MP 56.22) to MP 58.** This is an area of relatively low to moderate hazard. While channel migration is active the highway is relatively far from the river and lies outside of the jurisdictional floodplain. There is little to no maintenance history associated with channel migration or bank erosion in this area.

- **Zone 3: MP 58 to MP 60.** This area of high channel migration hazard is very active. Recent river avulsions have occurred. There are ongoing maintenance and erosion concerns in this area which have resulted in numerous emergency projects as well as a major project effort under the WSDOT Chronic Environmental Deficiencies (CED) program.

- **Zone 4: MP 60 to MP 64.** This is an area of moderate hazard. While the road runs relatively close to the river, channel migration in the adjacent reach has been very minor throughout the photographic record. While some bank stabilization activities have taken place here, most of these have not been recent. The channel is quite straight suggesting that this is a transport reach.

- **Zone 5: MP 64 to Skagit River (MP 67.34).** This is an area of relatively high channel migration hazard. The valley broadens to meet the floodplain of the Skagit River, and historic channel migration has been extensive. While this segment has not seen much in the way of recent maintenance needs, in the past the Sauk River has occupied side channels immediately adjacent to the road, requiring bank armor placements. While much of this highway segment is located well away from the river, the fact that it is in floodplain/CMZ that is shared by both the Sauk and Skagit rivers raises the objective hazard associated with channel migration. It is also important to note that even if portions of SR 530 are eventually relocated, it would still be necessary to cross the floodplain/CMZ to reach the Skagit River crossing regardless of the alignment chosen.

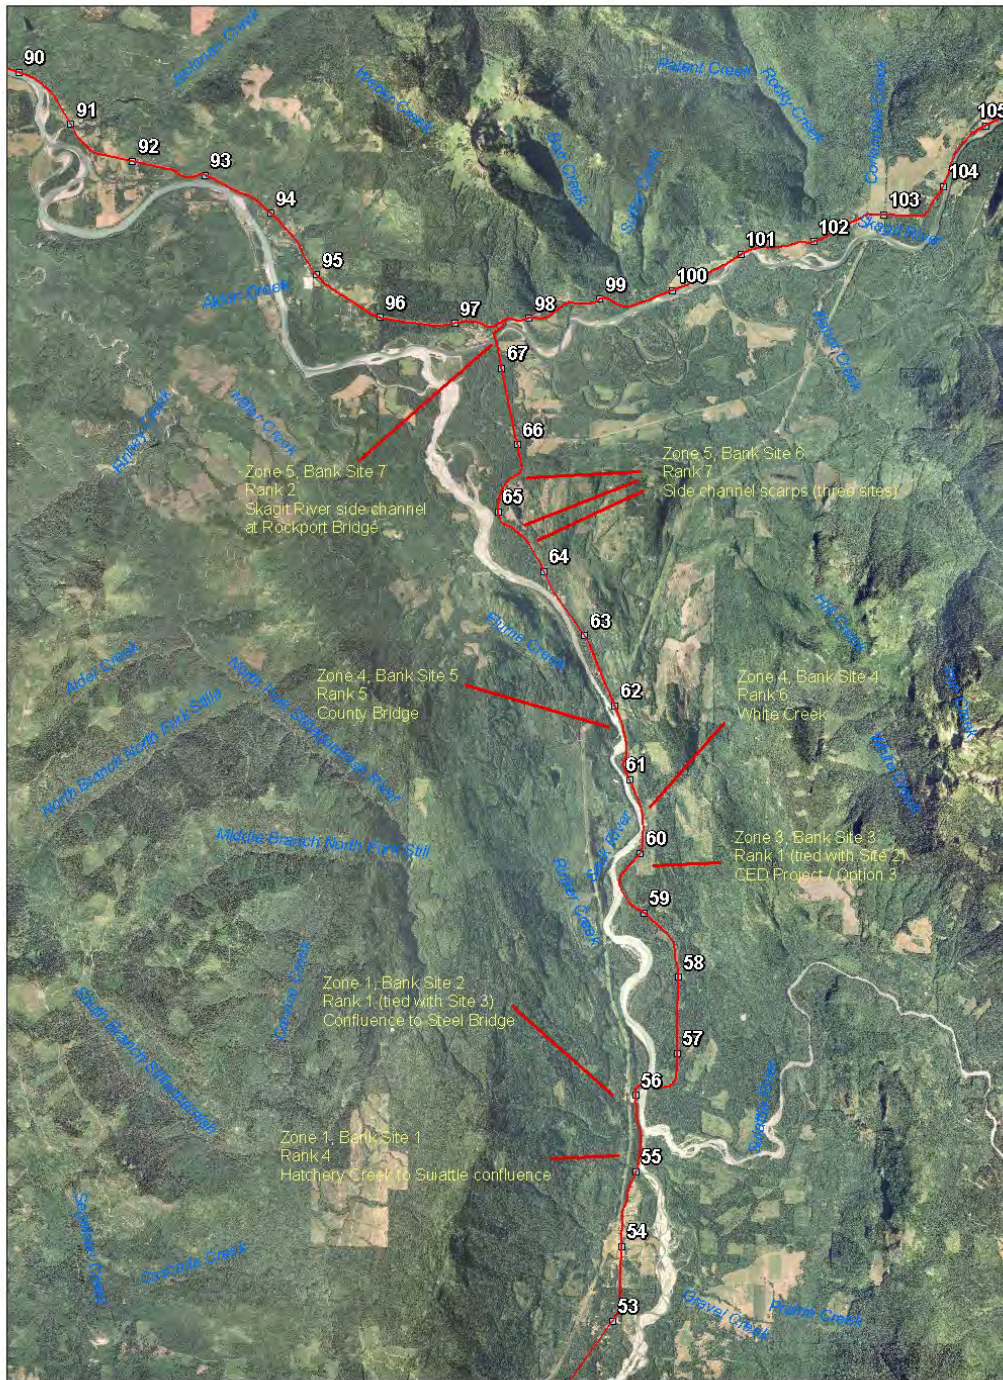
Figure 4. SR 530 Sauk River – Ranked bank stabilization sites.

WSDOT has identified six bank stabilization sites and one avulsion hazard site for prioritization in terms of the potential need for future bank stabilization activities. These are shown in Figure 4, and are described below and shown in Figure 4.

Zone 1, Bank Site 1: Rank 4. Hatchery Creek to Suiattle confluence (MP 55 to MP 55.5). Length is approximately 2,500 feet. Bank is 10-15 feet high and composed of older heavy loose riprap though some areas still have riparian vegetation. The riprap armor is compromised along several stretches of this scarp and will need eventual repair or replacement with an updated protective structure. Because this area is upstream of the confluence it is not as high of a risk area as the scarp extending downstream from the confluence, and it's thus ranked 4 on the list of existing and potential bank stabilization sites.

Zone 1, Bank Site 2: Rank 1 (tied with Site 3). Confluence to Steel Bridge (MP 55.5 to MP 56.2). Length is approximately 3,000 feet. This site is the location of an active adaptive management process stemming from HPA permit requirements for previous emergency bank stabilization projects. Augmentation or replacement of the bank stabilization emplacement here will be determined by the adaptive management process, as agreed to by WSDOT and WDFW. It is in an area of high migration and instability, largely due to sediment inputs from the Suiattle River. Because of this, the need for additional work at this site is highly likely. As such, it is an area of severe risk and is ranked number one on the list of bank stabilization sites. This ranking is provisional depending upon the outcome of feasibility studies examining realignment of the highway in this vicinity.

Zone 4, Bank Site 4: Rank 6. White Creek (MP 60.25 to MP 60.5). Length is approximately 1,200 feet. This site is in an area of reduced channel migration. It consists of a low angle (2:1) heavy riprap slope. This site is relatively stable and has not needed maintenance for erosion damage for well over ten years. This area is subjected to occasional

slides and rockfall, however, these threats come from the slope above rather than from the river. The thalweg approaches at a high angle of attack. However, the limited channel migration, low angle of the slope, and lack of recent maintenance activity puts the site in more of a low to moderate risk range. This site is ranked at number 6.

Zone 4, Bank Site 5: Rank 5. County Bridge (MP 61.4 to MP 61.7). Length is approximately 1,000 feet. Like Site 4, Site 5 is located in a reach that has seen little channel migration throughout the photographic record (which goes back to the 1940s). It is not very high (12 to 20 feet) and its angle of repose is within acceptable parameters for rock slopes (approximately 1.5:1). There has been no recent history of maintenance at the site and the armor is in good condition. This site is ranked at number 5.

Zone 5, Bank Site 6: Rank 7. Side channel scarps (MP 64.3, 64.6, and 65.3). Total length is approximately 800 feet. This “site” consists of three closely-spaced riprap slopes along tributaries and side channels to the Sauk River. The slopes are between 1.5:1 and 2:1 with a height ranging from 9 to 14 feet. While riprap repairs of the bank have occurred in the past, there has been no work at any of these scarps in over ten years. While channel migration is high in Zone 5, these locations do not appear to be under much mainstem influence at this time. The closest position of the mainstem in relation to the highway in this vicinity is at MP 65, where the mainstem is over 500 feet to the west. This site is ranked at number 7.

Zone 5, Bank Site 7: Rank 2. Skagit River side channel at Rockport Bridge (MP 67.2 to MP 67.34). Note: length not applicable to this site because it is not a bank stabilization site so much as it is a potential avulsion site. The Skagit River is threatening to avulse into a side channel on the right bank of the Skagit River. This side channel is bisected by the fill prism for SR 530 and its approach to the Rockport bridge. If this occurs, there is a high likelihood of catastrophic highway failure. A “Site and Reach Assessment” is planned for this location under the auspices of WSDOT’s CED program. Because of the high rate of channel migration in this area and the potential level of damage that an avulsion here could cause, this site is ranked at number 2.

These sites add up to a total estimate of 9900 LF of bank stabilization. If alternative 3 realignment is implemented this total drops to approximately 8500 although some minor banks stabilization may need to take place at the southern departure point for the realignment. With the possible exception of site 3, all of the bank stabilization sites appear to be conducive to the placement of log crib walls or crib benches. Because they have a comparatively smaller footprint and incorporate large volumes of large woody debris they have fewer impacts and convey superior environmental benefits than most other traditional types of bank stabilization design. The best option for site 3 is to relocate the highway segment that is against the mainstem, as has been proposed in the scope of the current CED project. While crib walls have been successfully built in the side channel portion of this site the remaining slope is much higher and steeper and poses much more significant challenges from the standpoints of constructability and slope stability. Specific design development for the bank stabilization sites should take place within the context of either updated or new Reach Assessments which lie beyond the scope of this report.

Site seven also needs a Reach Assessment to further clarify levels of risk and to develop design solutions that can be submitted for funding, however the fact that this is an avulsion site bisected by the roadway indicates that the solution will be much different than the other sites described here.

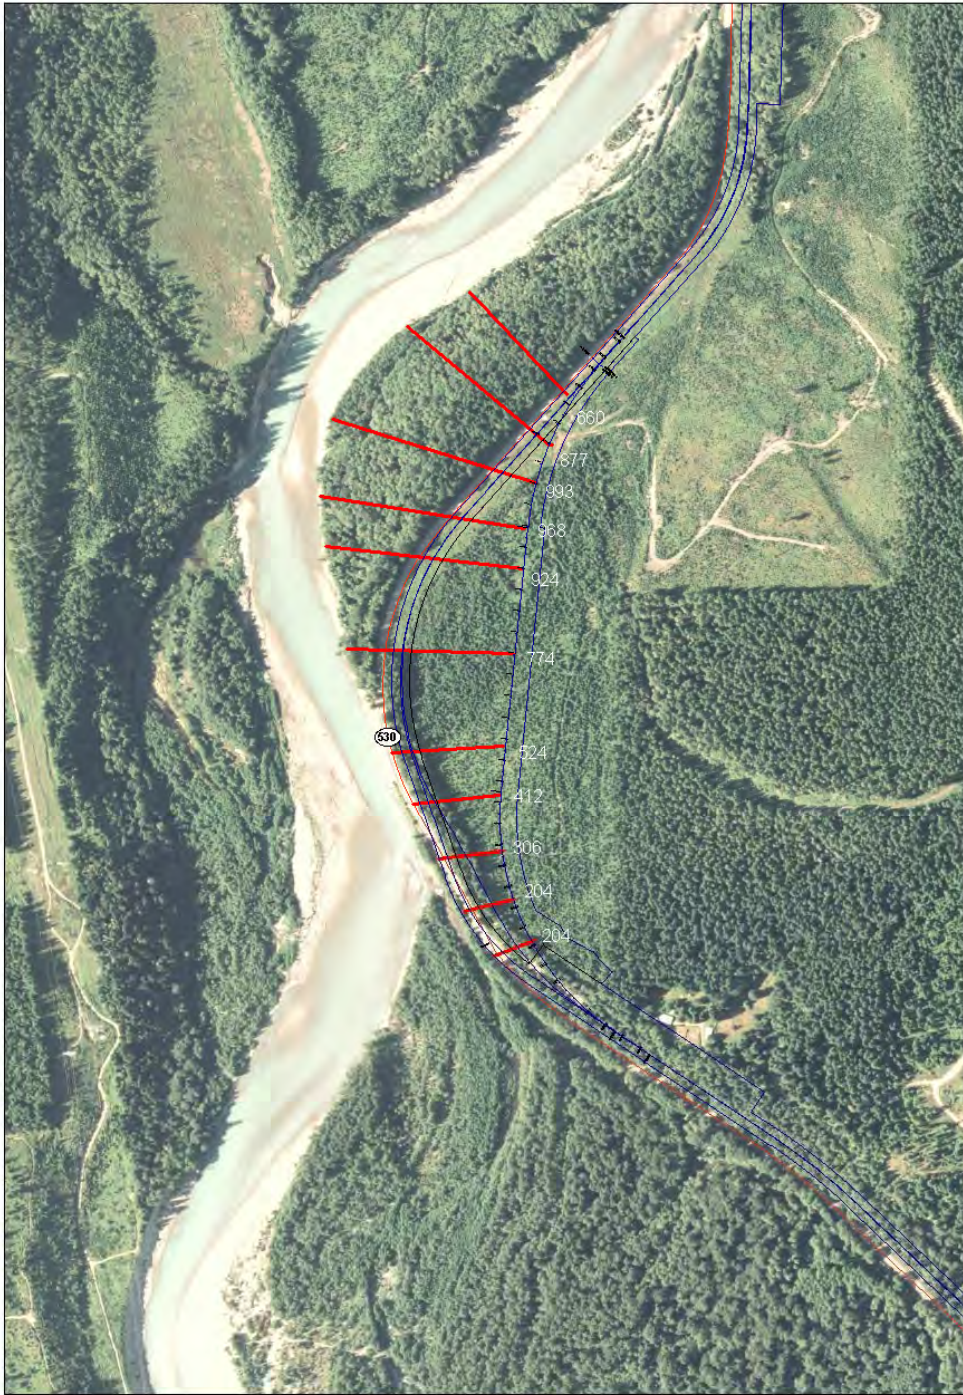
Figure 5. SR 530 Sauk River – Geotechnical setbacks for Site 3.

Zone 3, Bank Site 3: Rank 1 (tied with Site 2). CED Project / Option 3 (MP 59 to MP 60). Length is approximately 1,400 feet. This site is within the project area of an active CED project that is partially funded. It consists of a high, steep riprap slope ranging from 20 to 40 feet in height. It is steeper than the proper angle of repose (1.5:1) for riprap and is thus inherently vulnerable to failure. Several large emergency riprap repairs have been implemented at this site. The river strikes the toe of the slope at a high angle of attack. The gradient of the slope and the angle of attack by the river thalweg indicate that relocation of this highway segment away from the slope is the best option. However, WSDOT does not have full funding to complete this realignment. If the highway is not relocated in the immediate future, additional placement of riprap under emergency conditions will likely be necessary to protect the highway from failure. It is important to note that because of its height the log crib wall options that lend themselves well to the other existing and potential sites within the corridor may not be viable options at this site due to constructability and slope stability concerns. Because funding and consensus for proceeding with the realignment has not been secured this site is ranked at number 1, tying with site 2. This ranking is also provisional, as moving forward with the relocation would greatly reduce (if not eliminate) the need for further bank stabilization activities at this site. The realignment allows a geotechnical setback of at least 2:1 and as much as 4:1 through most of the proposed route (see Figure 5).
