December 6, 2006

SUBJECT: SR 101, C.S. 2301, Vicinity MP 338.2, DMC-101
Debris Flow Assessment and Geotechnical Recommendations

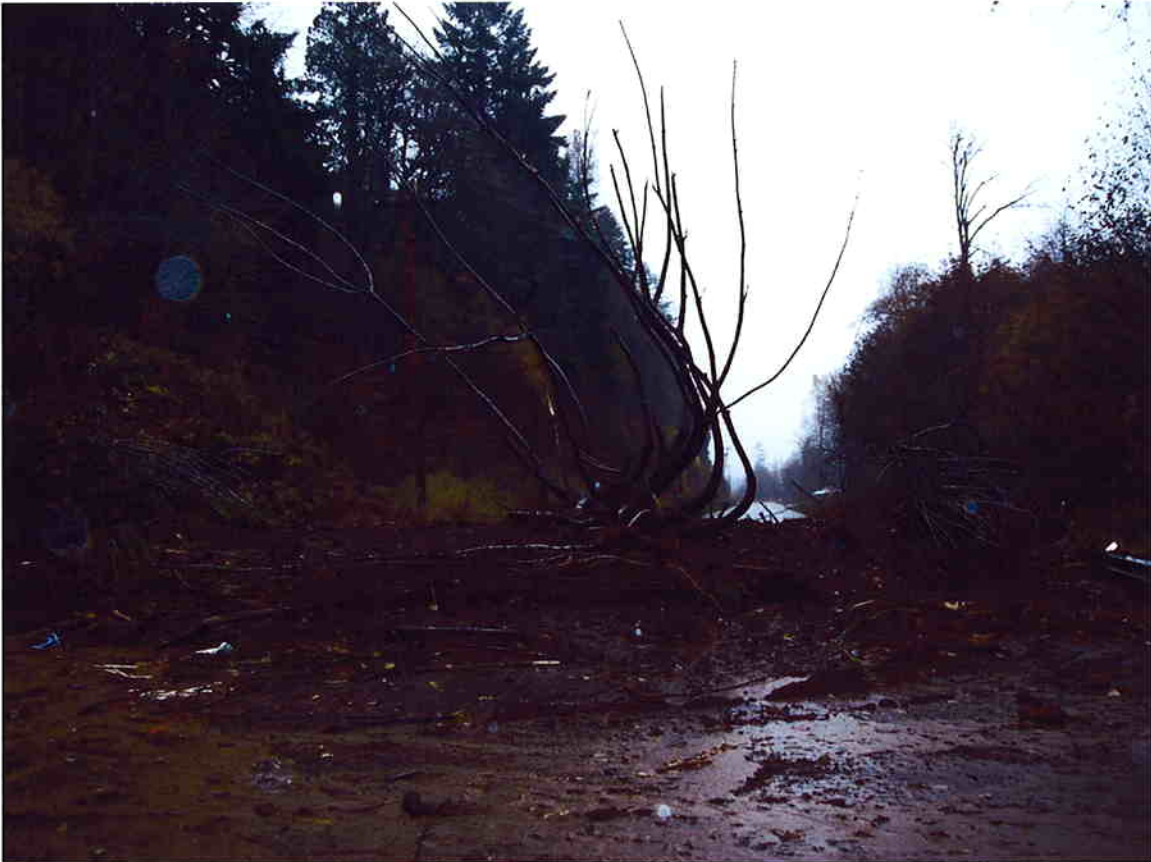
At your request, we have conducted a geotechnical assessment at the site of a debris flow that blocked both travel lanes in the vicinity of MP 338.2 on SR 101 (Figure 1). It is our understanding from Maintenance that a debris flow originating upslope of the highway deposited approximately 400 cubic yards of soil and woody debris on the highway on November 6, 2006 (Figure 2). Maintenance attempted to reopen the outer, northbound lane on this day, but another, smaller-volume debris flow initiated from the upslope area and covered the northbound lane of the highway again. Attempts to reopen the road were abandoned at this time and a request for a thorough geotechnical assessment was made by Olympic Region Maintenance.

Figure 2. A photo taken looking north on SR 101 on November 6, 2006. Approximately 400 cubic yards of material was deposited by a debris flow on SR 101, resulting in the closure of both lanes near Sunnyside Road.

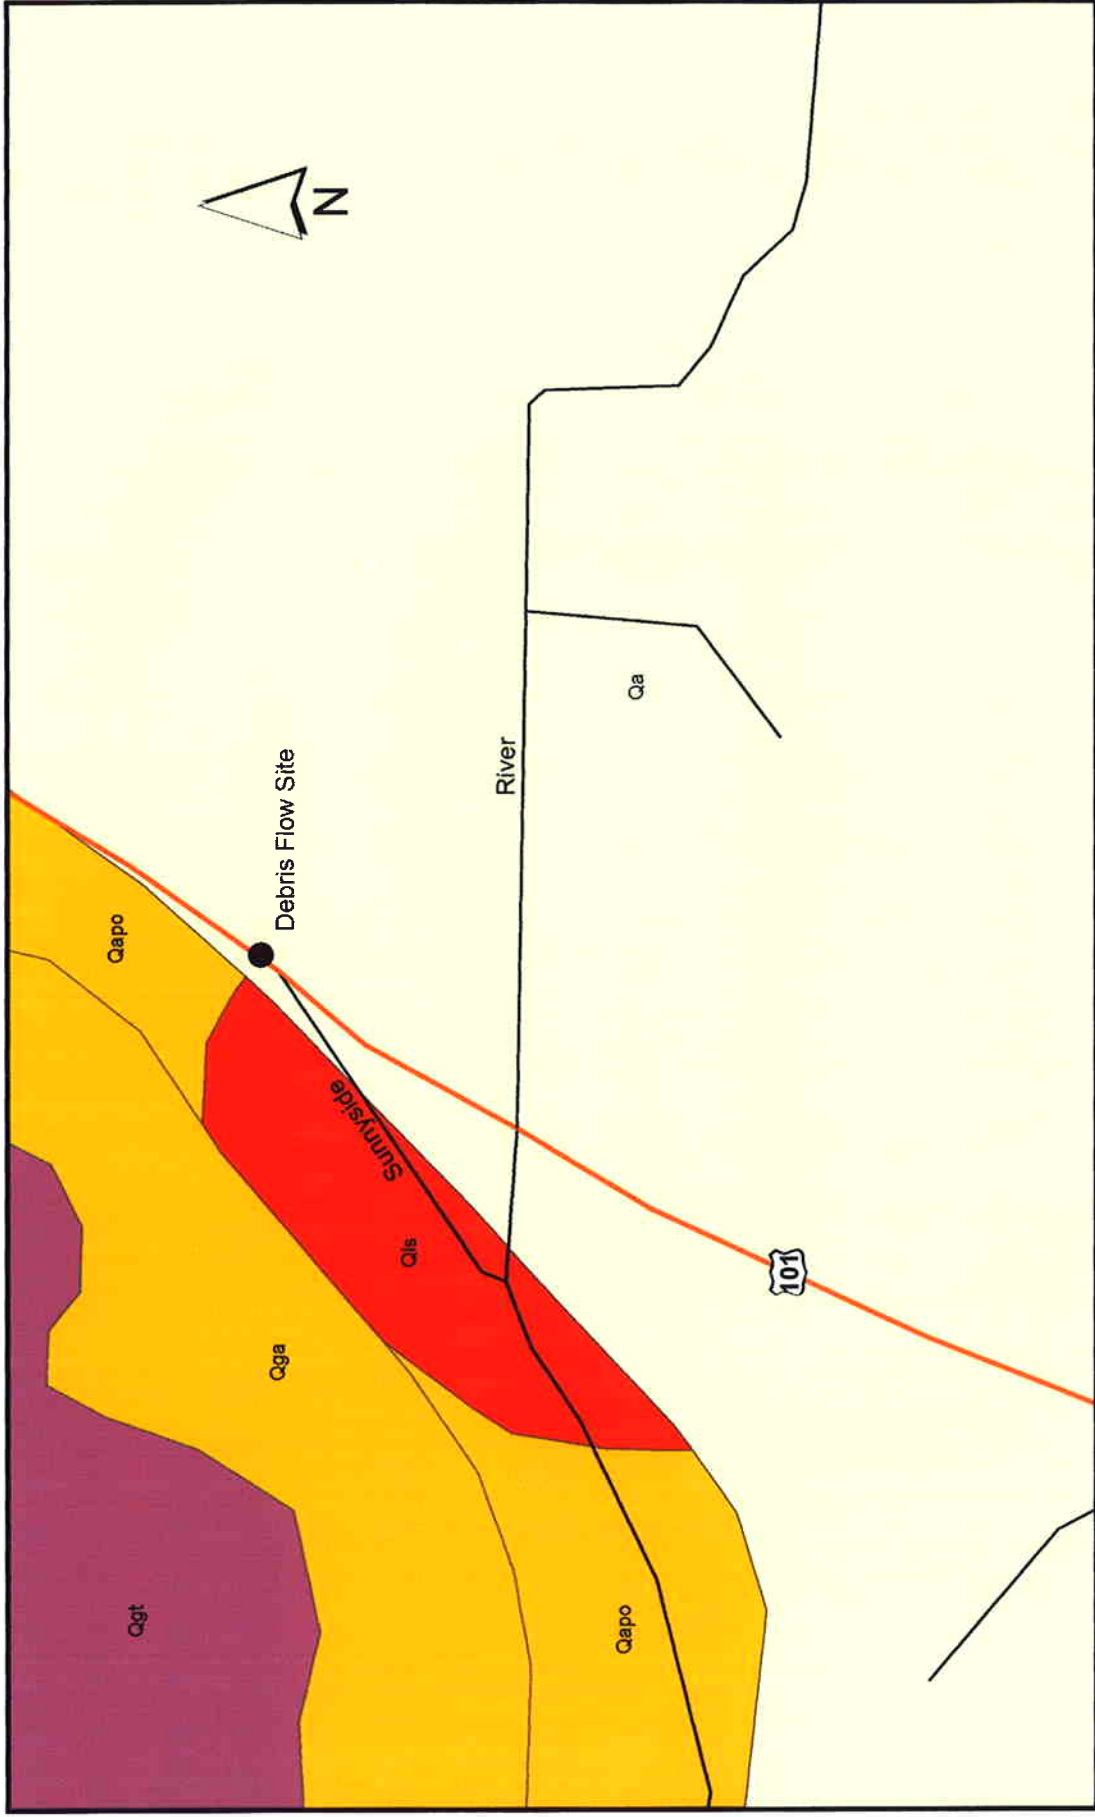
Figure 3

As illustrated in Figure 3, the debris flows initiated on the northern edge of an older landslide deposit, approximately 500 feet upslope of the highway in a confined channel with an average slope between 35 and 40 degrees. In Figure 4, springs can be seen emitting from the upper slope area on a silty clay layer in the slope. Upon closer examination, a number of springs were observed emitting from this geologic contact as it slightly dipped to the north.

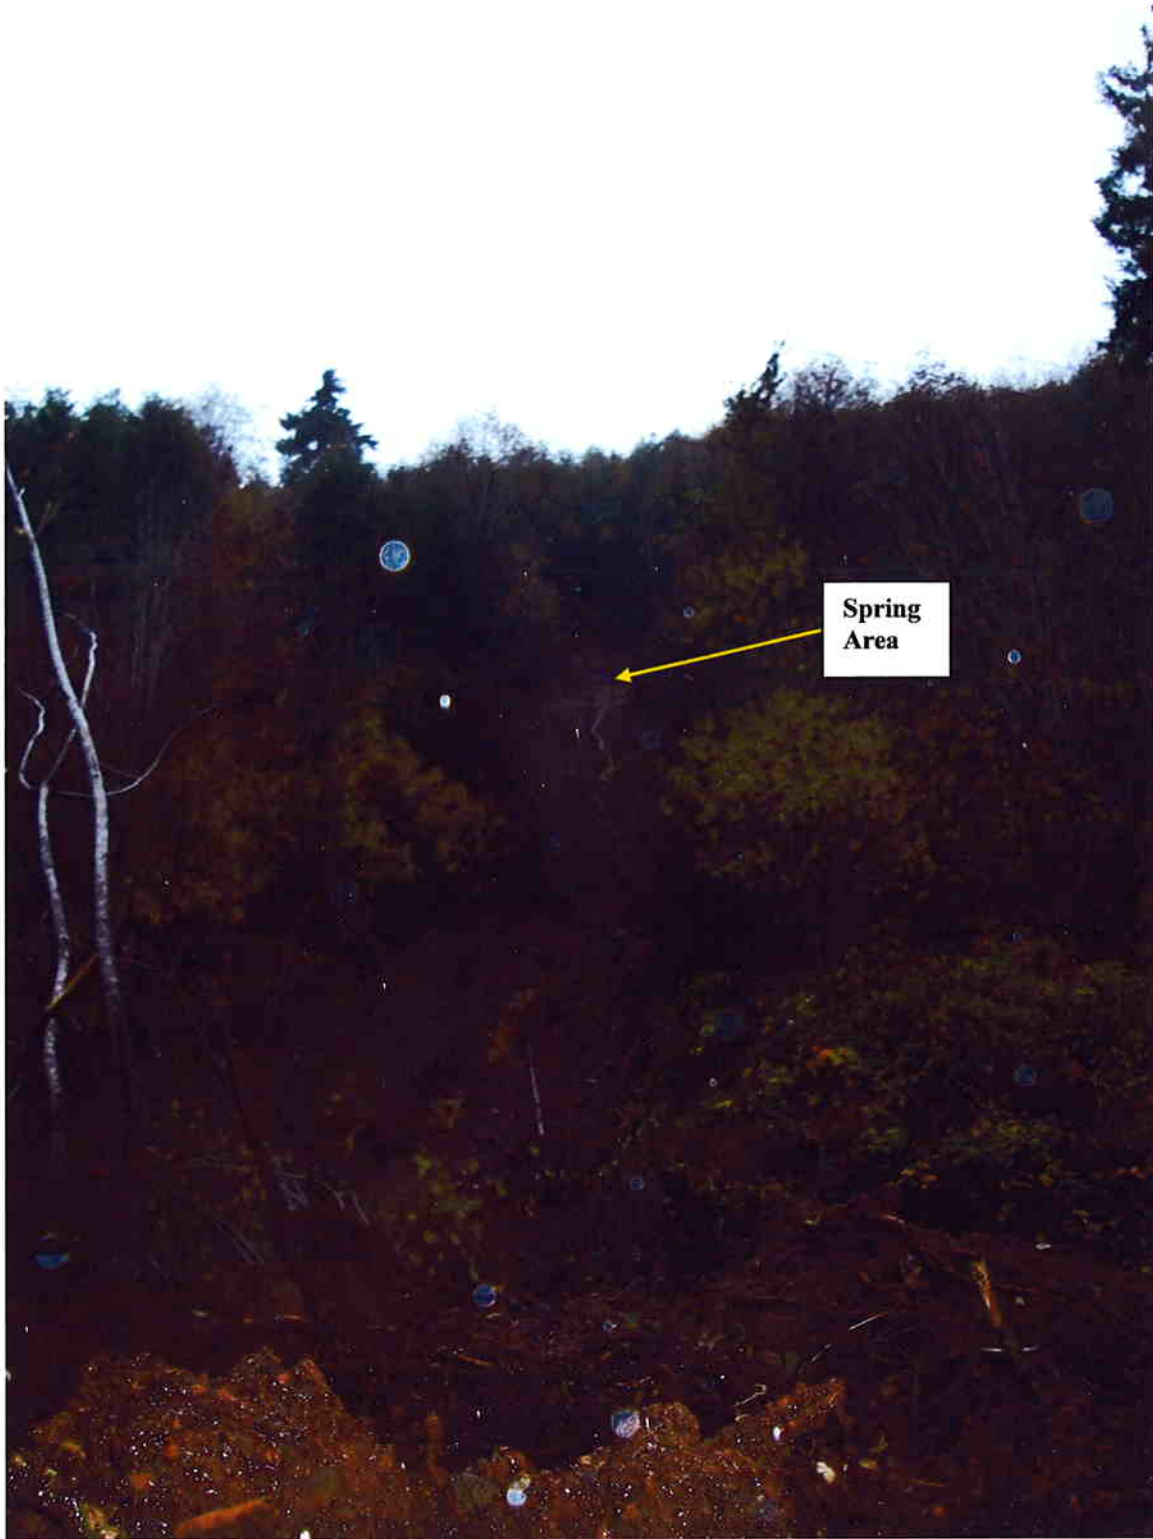
Figure 4. A photo taken from SR 101 looking at the initiation area and the path of the debris flow. Notice the springs emitting from the upper slope area.

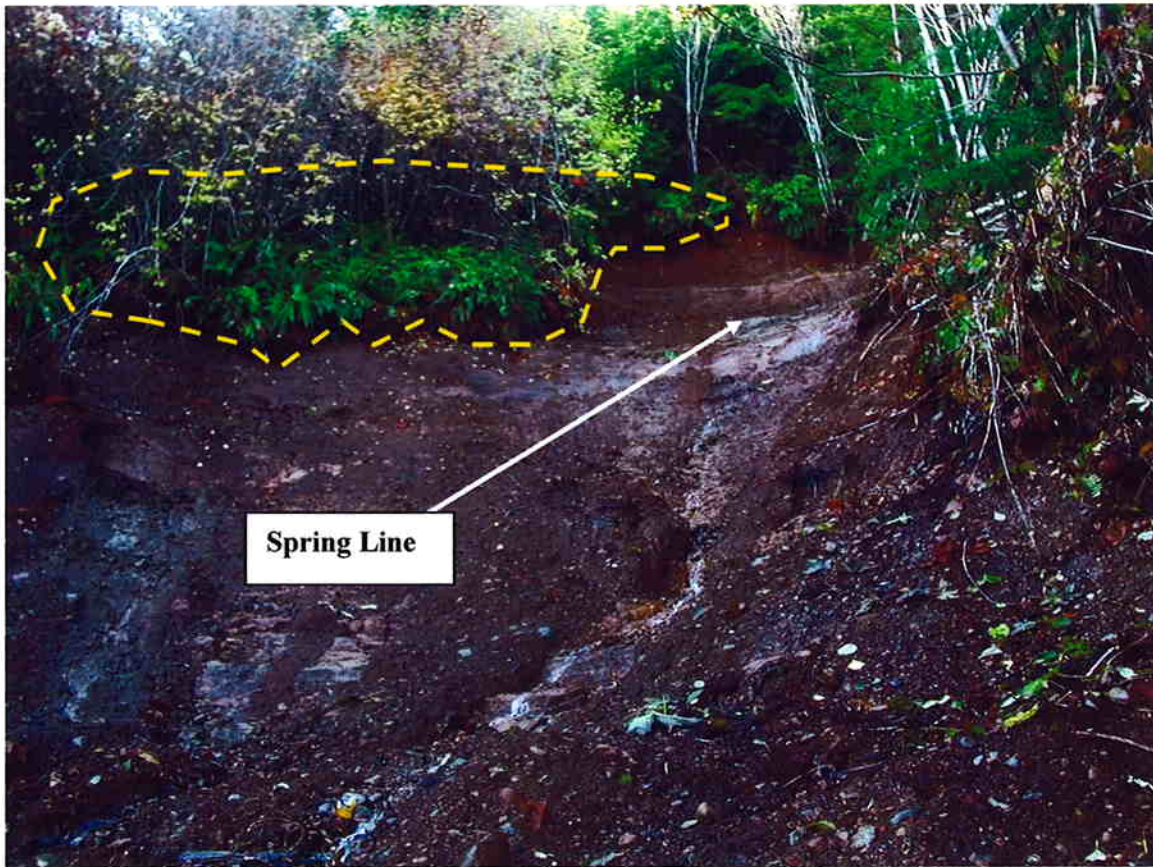
As we field reviewed the upslope areas surrounding the debris flow initiation zone, we found two areas where the slope partially failed. These detached masses had fresh, open tension cracks, the trees were leaning backwards (uphill), and the spring-line ran behind the detached blocks. The detached blocks are approximately identified in Figures 5 and 6. We estimate the volume of the detached masses to be on the order of approximately 500 cubic yards.

Figure 5. A photo of the detached mass to the left of the debris flow failure scar. The dashed, yellow polygon approximates the area of the southern detached mass.

We recommend that removal of the detached masses be accomplished from the side and above the debris flow source area. Pioneering and excavating immediately below the detached masses in Figures 5 and 6 should not be planned or undertaken. This mitigation option will require access agreements with adjacent property owners since we would be working outside of our right-of-way.

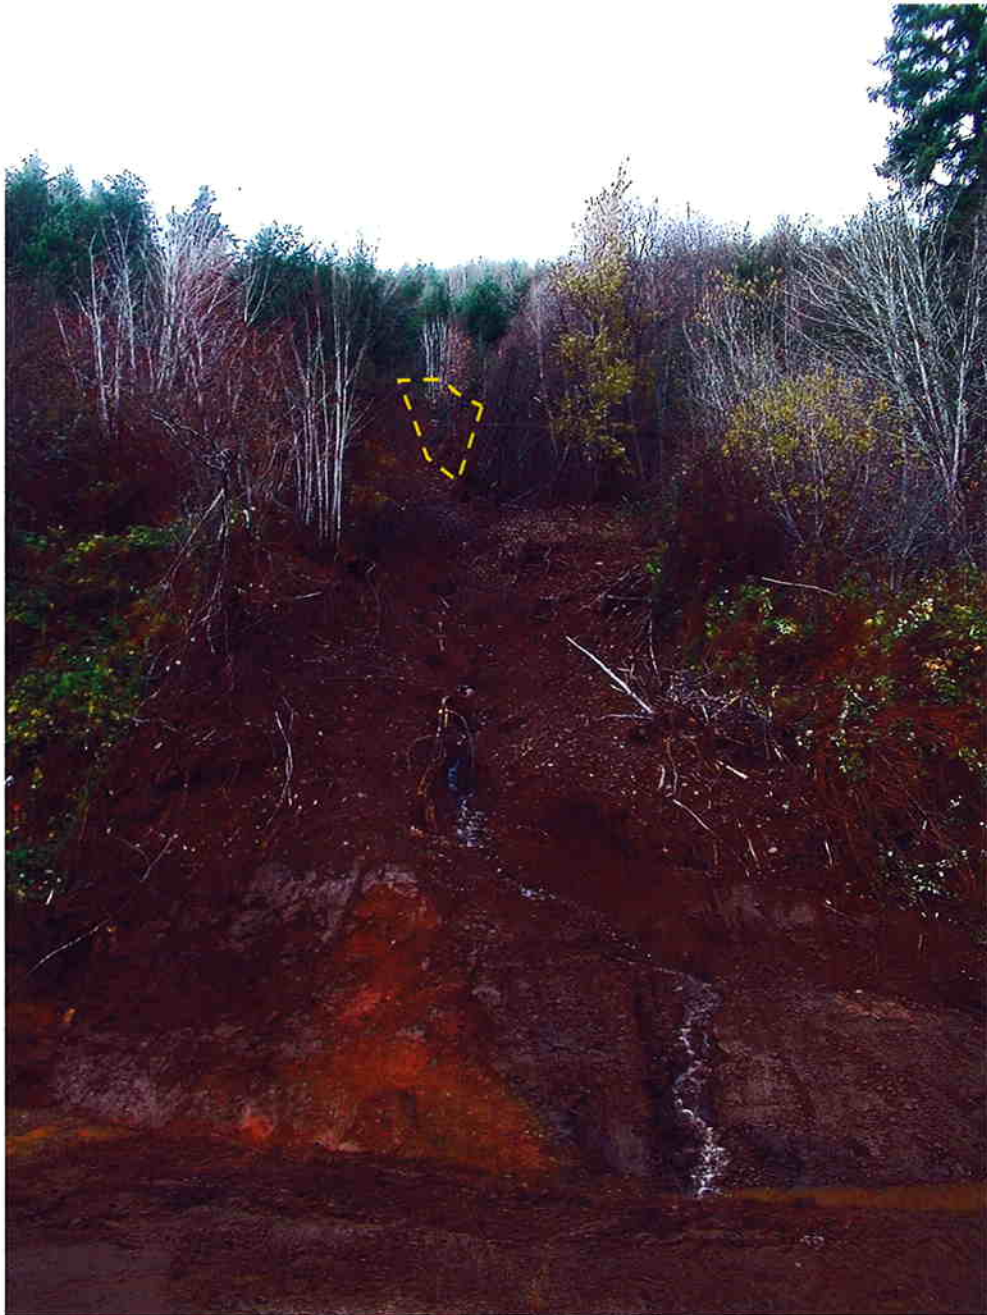
Figure 6. A photo taken from the highway looking up the debris flow chute on November 14, 2006 during road clean-up activities. We have approximated the area of the northern detached mass with a dashed, yellow polygon.

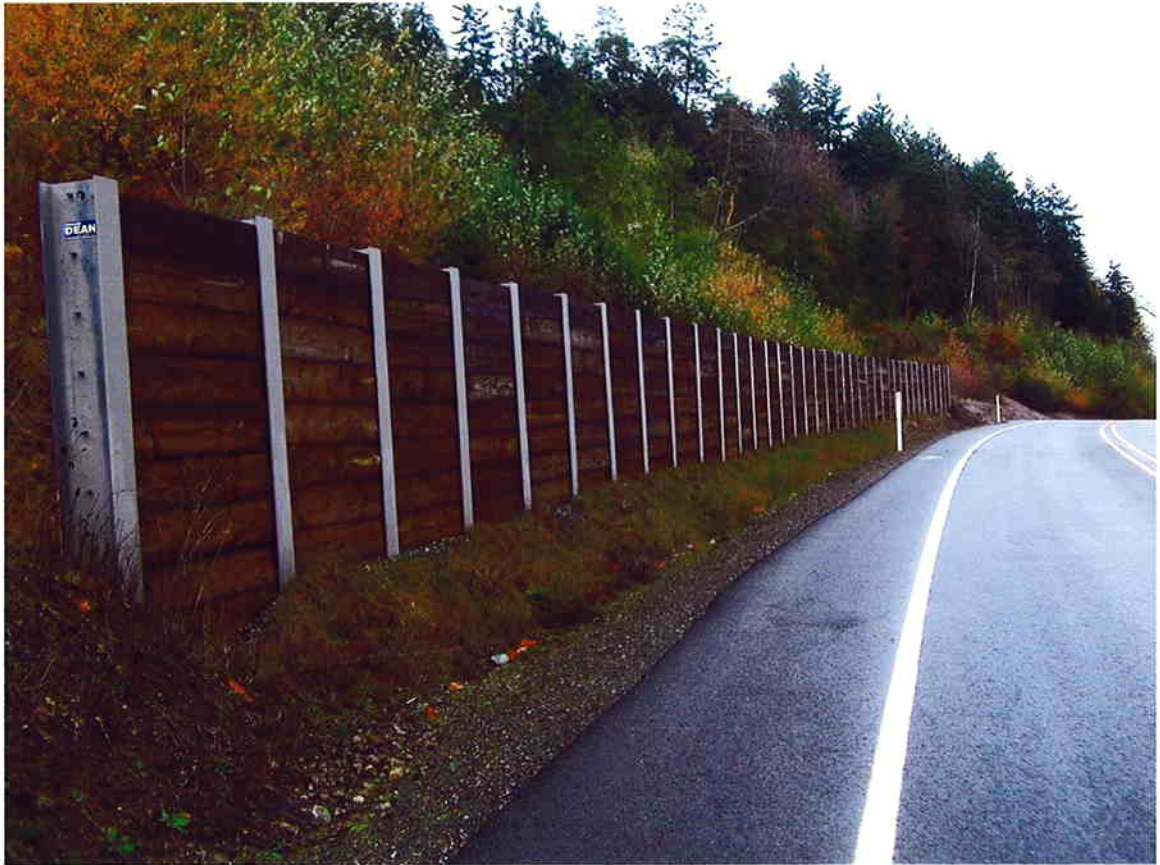
Figure 7. A photo of the soldier-pile wall option for containing debris flows.

The other alternative would be to construct a debris flow containment structure similar to those shown in Figures 7 and 8. It appears that a containment structure can be placed within our right-of-way across the debris flow chute. We estimate that the structure will need to be about 75 feet long to contain future debris flow events. The structure should be designed to contain a 500 cubic yard debris flow event.

Figure 7 shows a soldier-pile wall with wood-lagging that was constructed for the SR 101 MP 322.3 Vicinity Slide repair. Contract 5764 or Contract 5894 should be used to estimate the costs associated with this type of structure. The debris flow fence shown in Figure 8 was constructed for the SR 4 Germany Creek Rockfall and Debris Flow Mitigation project. Contract C6414 should be used to estimate the costs associated with this type of structure.

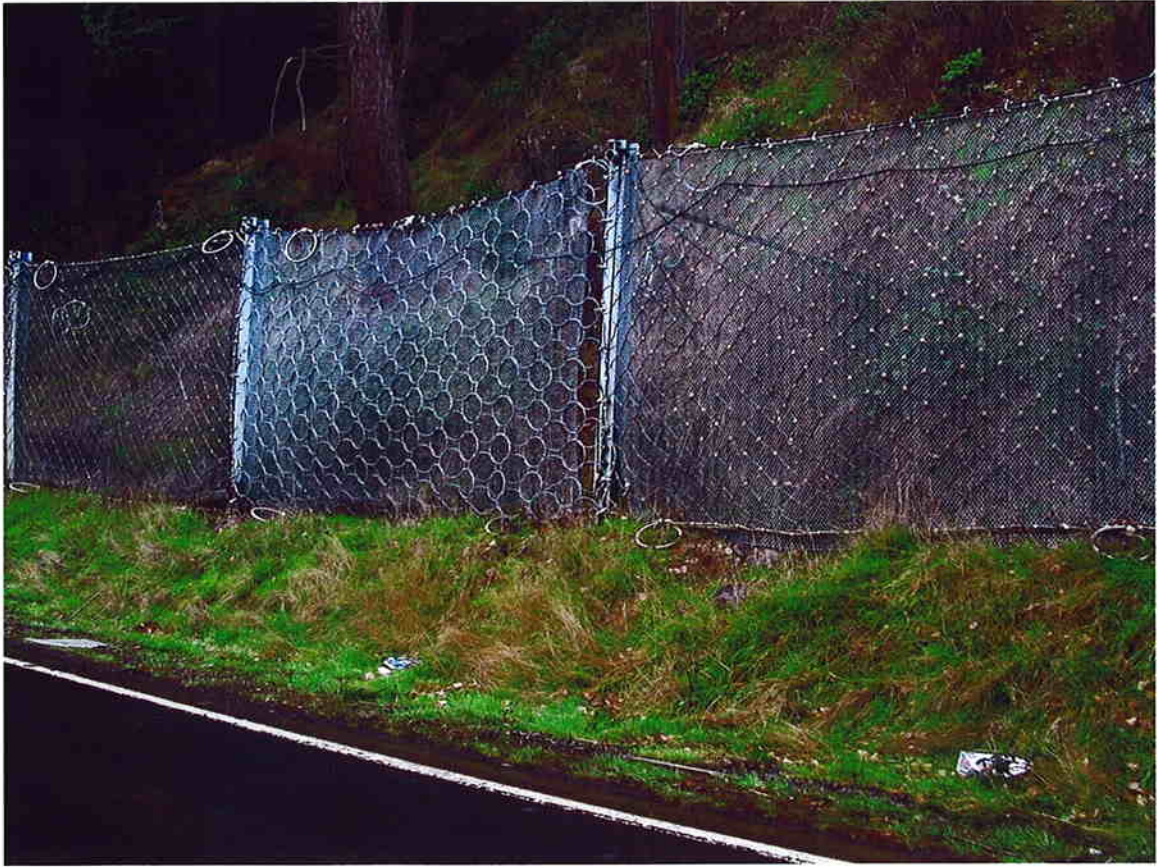
Figure 8. A photo of a typical debris flow fence constructed on SR 4.
