P2 Bridge Preservation - Steel Bridge Painting Projects

2009-11 Bien Priority Array

Steel Bridge Paint Form

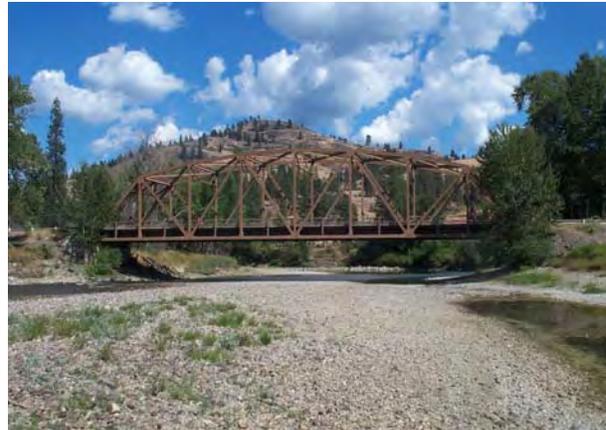
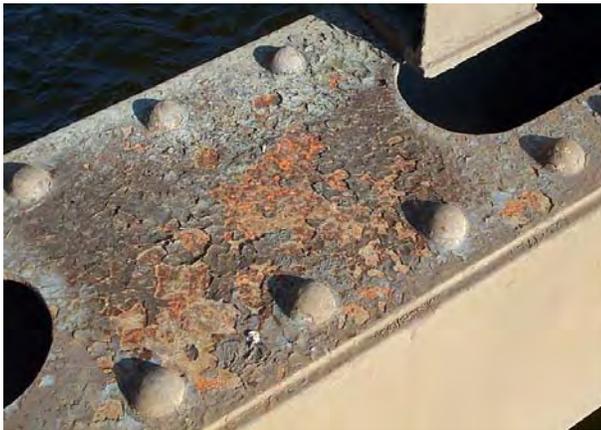
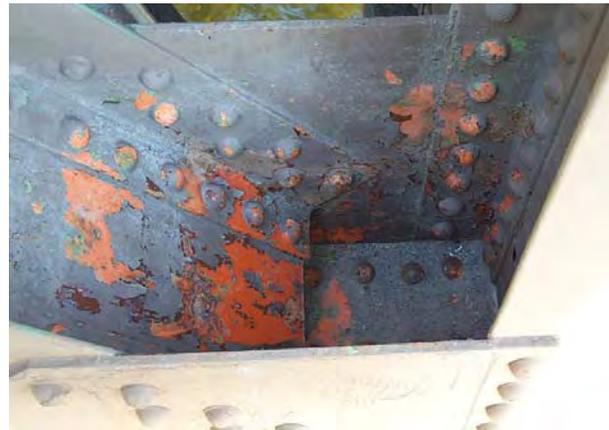
The top flange of the floor beams and stringers are embedded in concrete.

Paint is chalky and peeling, heavy in spots, on the diagonals and portals of the truss with rust blooms, approximately 15%. The paint on the stringers and floor beams is in good condition except for scattered rock chips from kids throwing rocks at swallow nests. The sand build up on the lower chord has been flushed, revealing the failed paint system.

Full removal of the paint is warranted on the top and bottom chords and the connection areas.

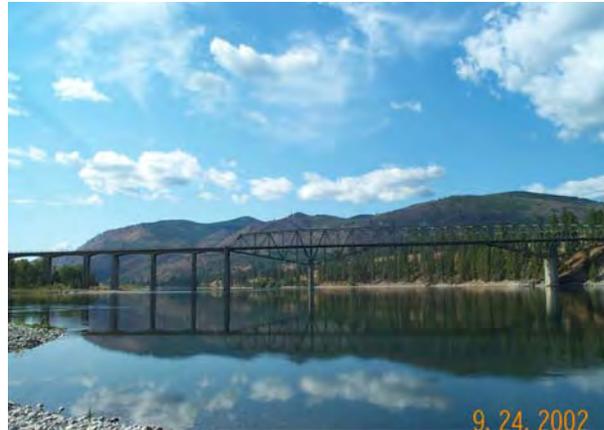
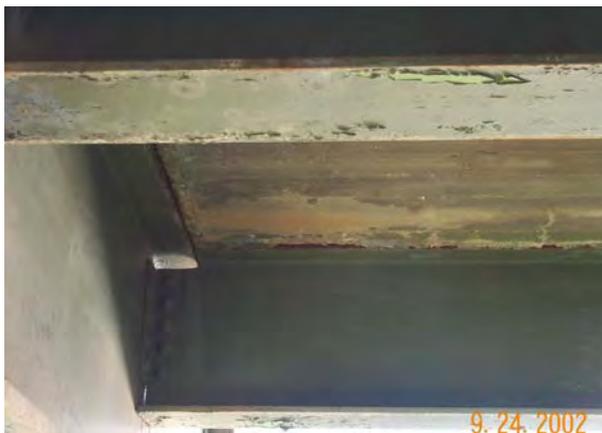
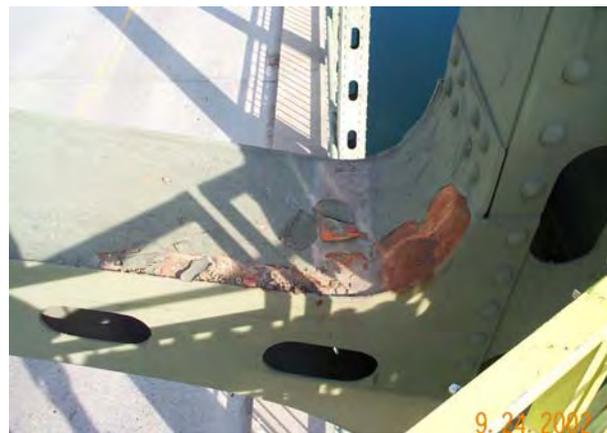
Paint is missing from most steel members due to the impact of snow removal with gravel. Steel Floorbeams; Peeling paint throughout webs. Steel Truss Members; The primer is exposed in places with some light rust where the paint has failed completely. The top paint coat is also peeling off in places with scattered rust blooms, particularly at top sways and laterals and inside top chords. Surface rust on the truss members at the deck level to about 6 ft. off of the deck. Paint is peeling inside most of the enclosed truss members. Metal Bridge Railing; All members are rusty with paint peeling or missing on 30% of the surface.

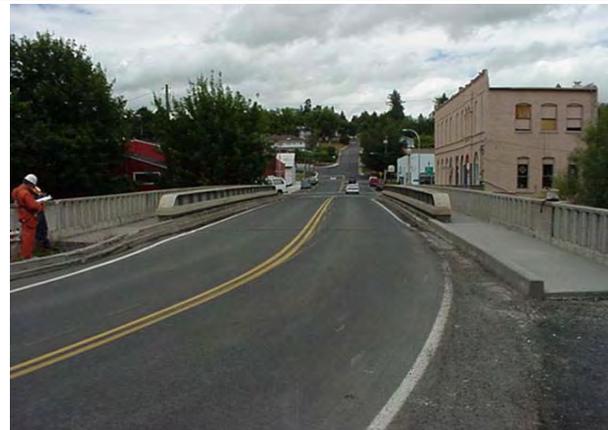
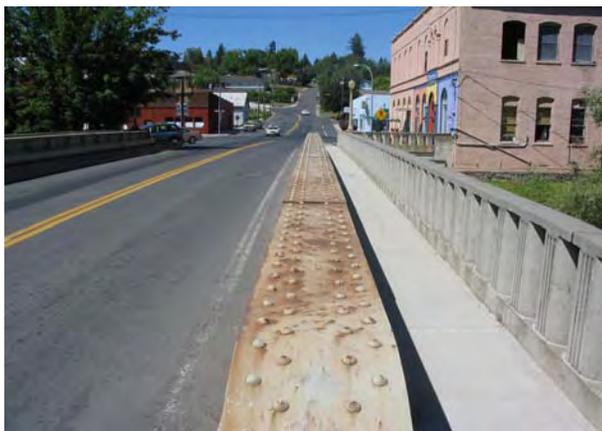
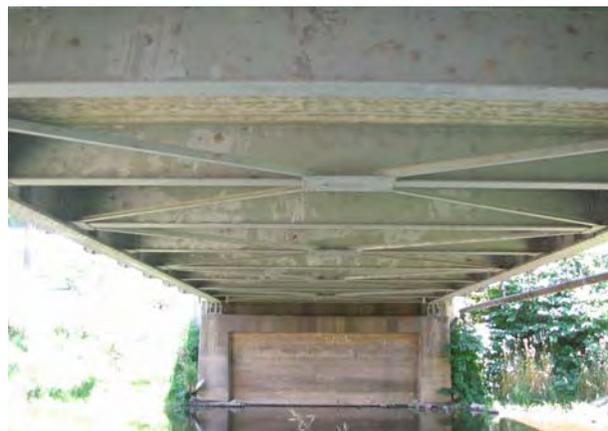
Thin and peeling paint with surface rust on most of the top flange of the girders (Photo 15). Paint is worn and peeling on lower portions of webs and bottom flanges of girders (approximately 20%). Rust blooms on lower webs and bottom flanges of girder (approximately 5%). Top coat of paint is peeling on floorbeams exposing primer (approximately 20% - Photo 22). A few areas of surface rust (less than 5%) on floorbeams.

All the paint on the top flange of the open girder should be removed to bare metal.
