## Misc Structures - North Central Region - 2009-11 Biennium

# Bridge Preservation Program (P2)

# Misc Structures Form

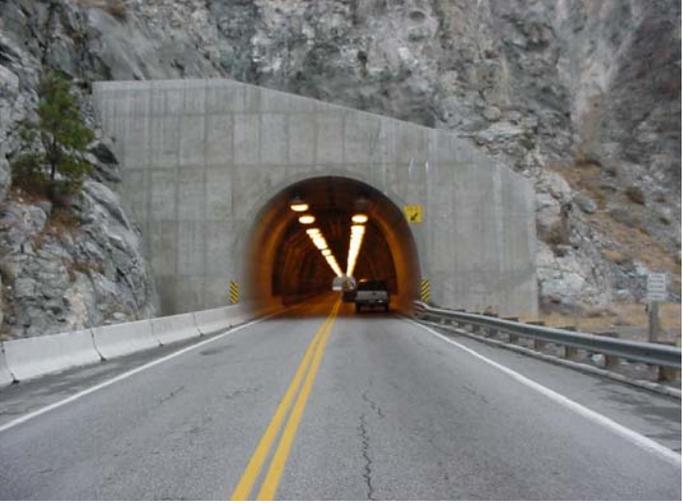
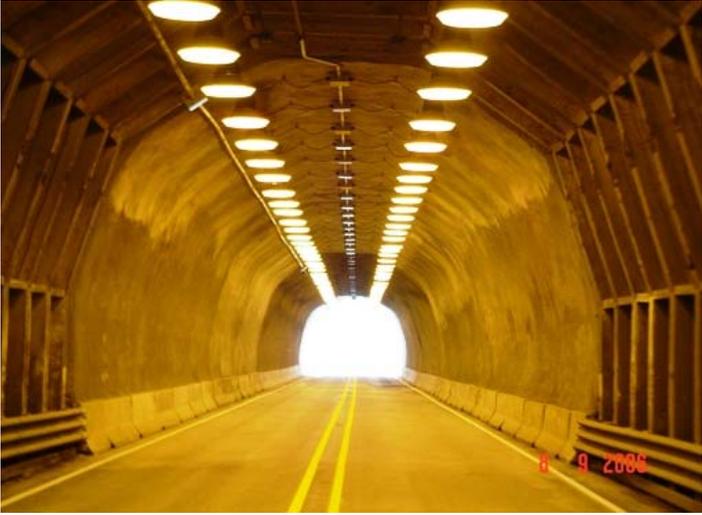
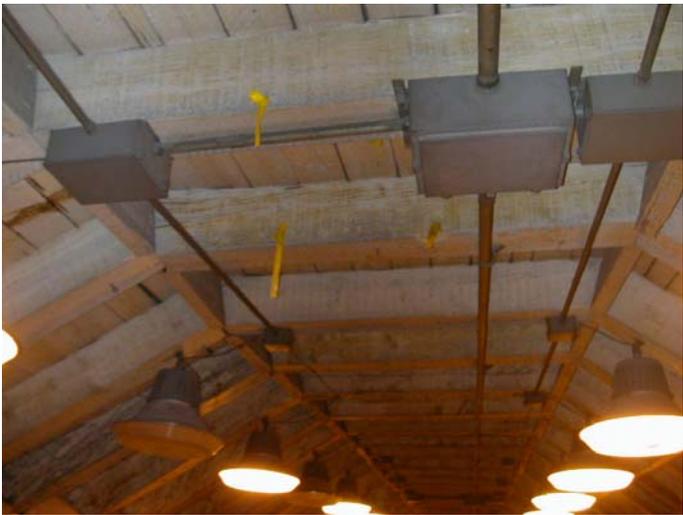
<p><b>Repair Description:</b> Rehabilitate the Tunnel Liner (stage 4)</p>				
<p><b>COMMENTS</b></p>				
<p>The south portal and a 150ft interior section was rehabilitated and lined with shotcrete in 2001 as part of contract 5986. The north portal and a 150ft interior section with timber elements was rehabilitated and lined with shotcrete in 2003 as part of contract 6492. A section of the tunnel was rehabilitated and lined in 2006 as part of contract 7049.</p> <p>The remaining timber section (about 170 feet) will be rehabilitated in a project scheduled to be funded in the 2011-13 biennium.</p>

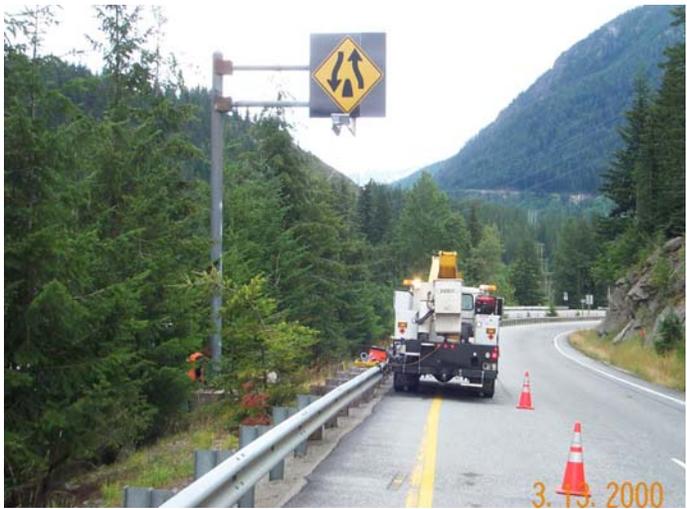
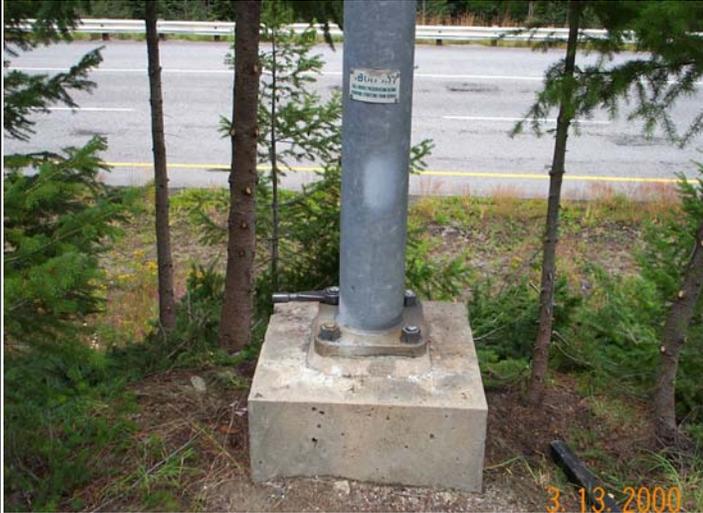
Repair Year:		2009-11 Priority#:	15			
CPMS Ad Date:		Bridge \$'s:	\$50,000			
		Repair Total\$'s:	\$200,000			
<h2>No Photo Available</h2>						
<b>Repair Description:</b> Replace Cantilever Sign Support						
<b>COMMENTS</b>						
A variety of indications were found among several anchor bolts in 2002. Location of indications changed after torquing. Program for replacement, and monitor indications. 6" diameter chords have surface cracks and rust in galvanizing. End chord connections have up to 1/16" gaps and surface rust throughout plates. End chord connection nuts not accessible thus tightness not verified. Four 1 3/4" x 66" anchor bolts. UT indication @ 12.75 (10% : 80% screen height) at the NW bolt and an indication @ 16.75 (10%) at the SE bolt. Location of indications changed after torquing. No hardened washers. Minimal nut engagement. Standoff is 1".
