P2 Bridge Preservation - Scour Repair

2009-11 Bien Priority Array

Bridge Foundation Scour Repair

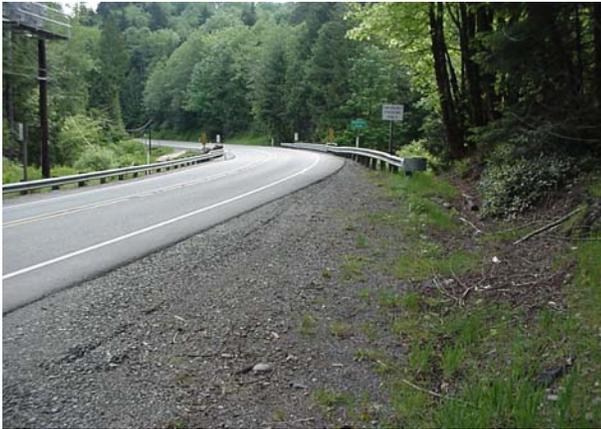
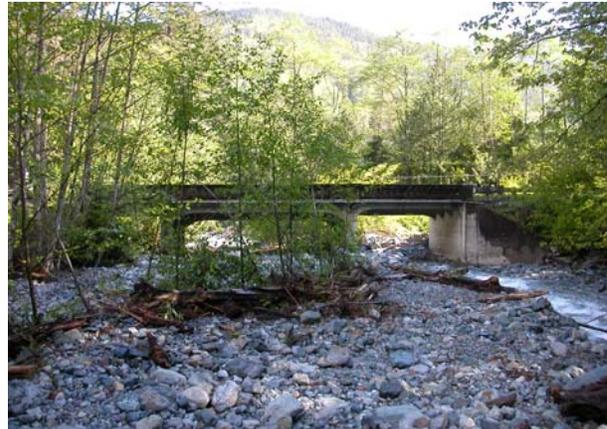
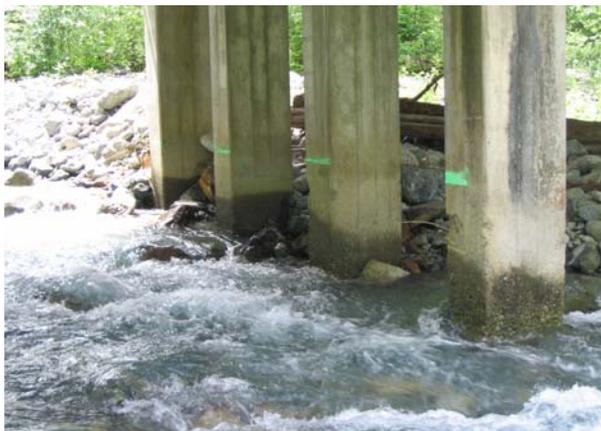
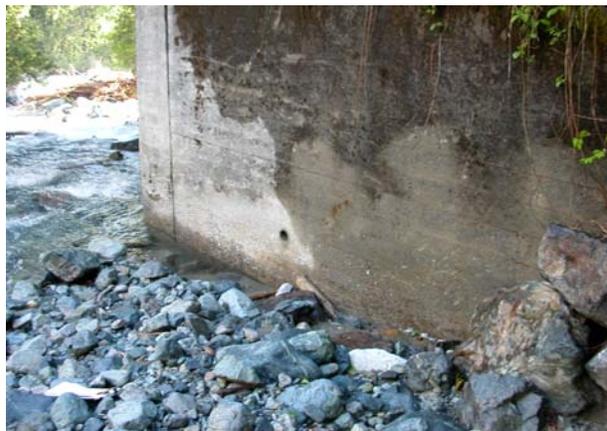
Photo 1 shows bridge scour, 6/2006. Photo 2 shows exposed footing at SE retaining wall, 4/2004. Piers 2 and 3 are scour critical. Rip rap must be maintained. Thalweg elevation is less than 5' above footing bottom elevation. Last repair by contract was in 1996.

BPO - Replace missing rip rap at SE retaining wall. Replace missing rip rap at the downstream side of P3. Bridge Management Unit - Program a P2 funded project, prioritize against other needs for 2009-11.

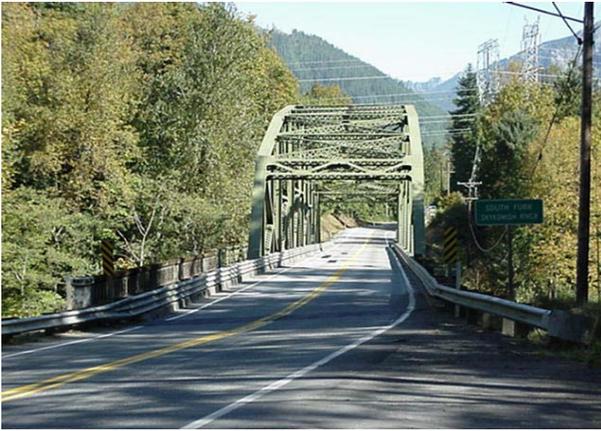
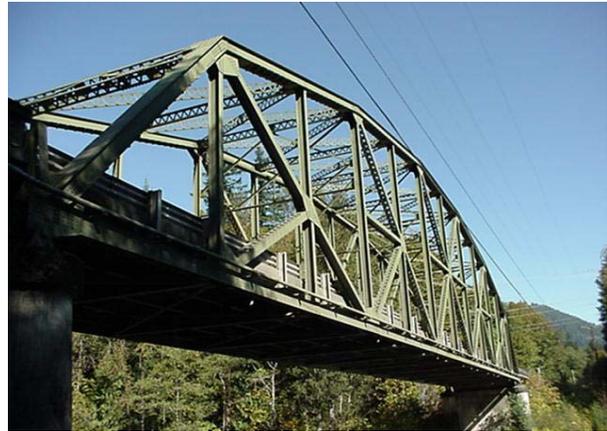
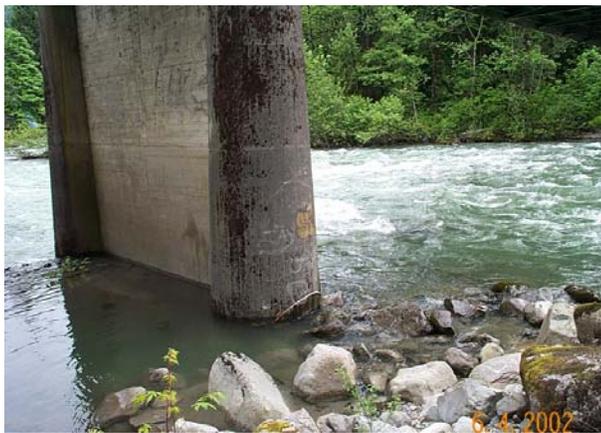
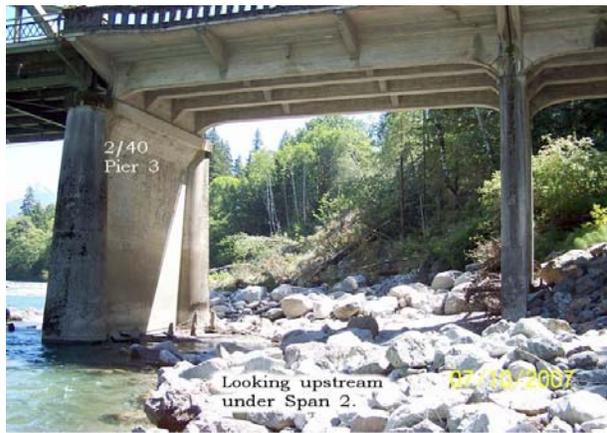
Approach CTB piers on spread footings. Main Truss piers on piles. There is riprap and river boulders at the east face and the nose of Pier 3. The tail and west side of Pier 3 has up to 3' of the side of the footing exposed (no undermining found). The upstream bank is eroding next to pier 2. The last contract repair was in 1996.

BPO - Repair the missing riprap at the downstream end of pier 3.
Bridge Management Unit - Program a P2 funded project, prioritize against other needs for 2009-11.

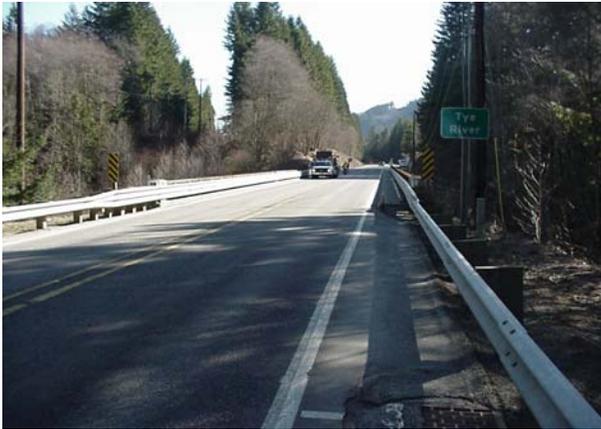
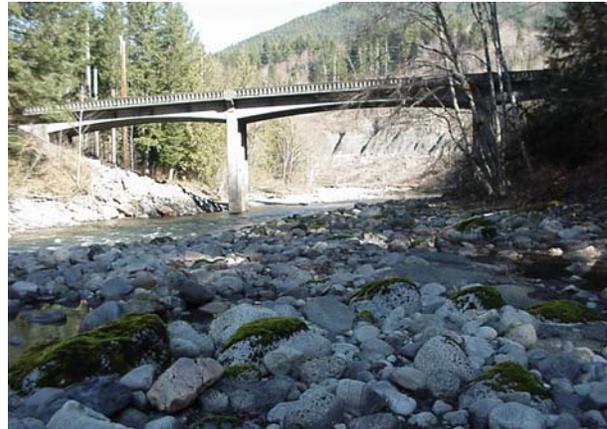
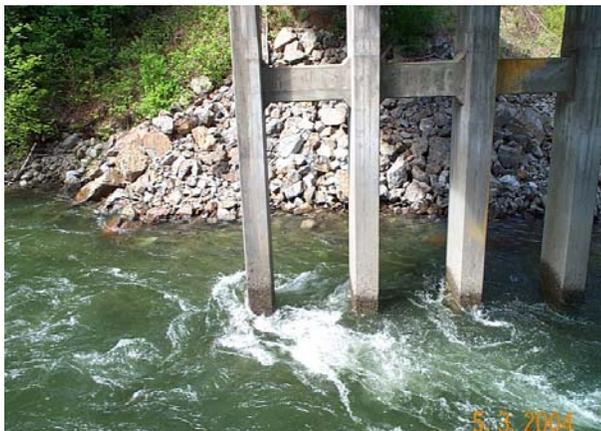
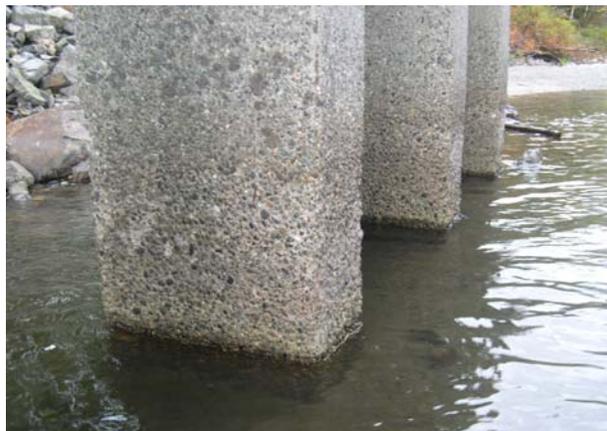
No rip rap along pier 3 columns. Up to 3 ft. exposed of face on Southeast corner. Top of pile cap is totally exposed. East face stream side footing is totally exposed. Sufficient pile length.

BPO - Rip rap along Pier 3 columns. Up to 3 ft. exposed of face on southeast corner. Top of pile cap is totally exposed. East face stream side footing is totally exposed.
Bridge Management Unit - Program a P2 funded project, prioritize against other needs for 2009-11.

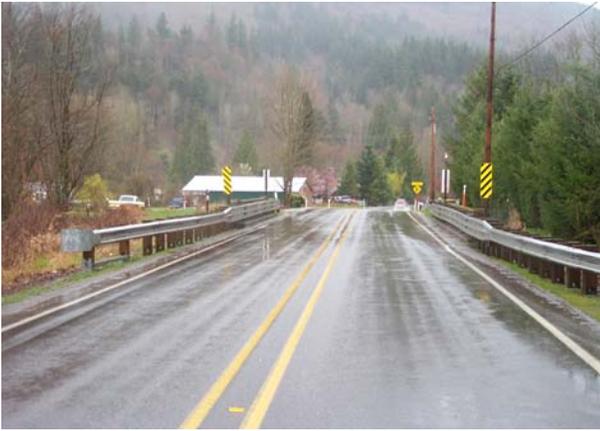
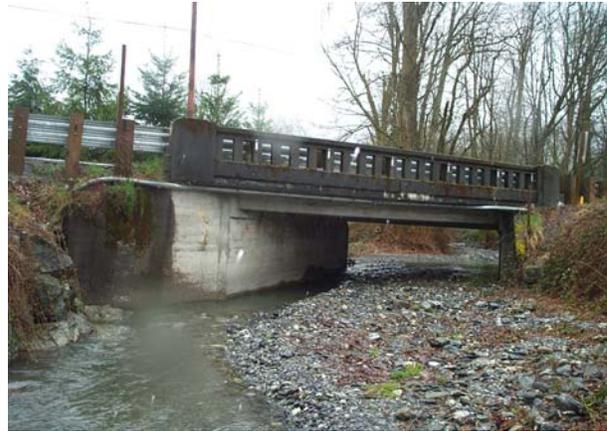
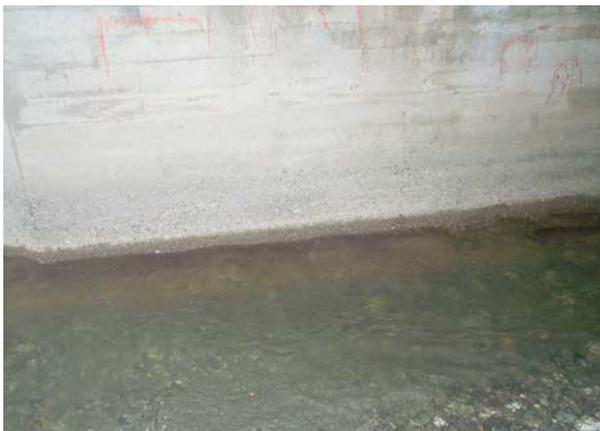
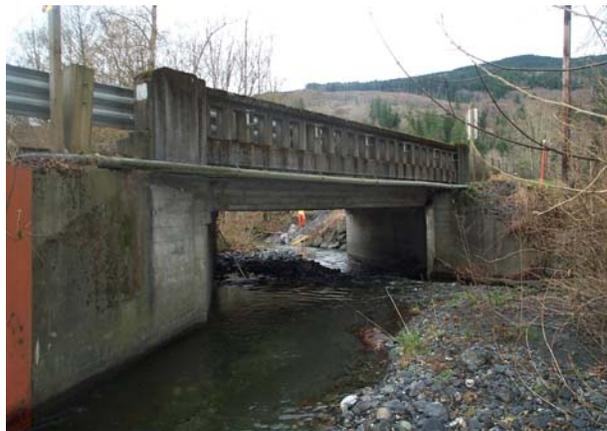
The footings are exposed. Stream bear against SE wingwall and corner of the bridge (Up to 3' deep scour hole) and shifts across to the East corner of the North abutment (15" deep scour hole). The N. abut. Footing is exposed up to 1' deep along 70% of its length. Bridge is not aligned with stream. Large trees on NE bank deflect the stream flow to SE wingwall.

BPO - Repair the Scour hole (up to 3 ft. deep) at SE corner of the bridge, 1 ft. deep Scour hole at NE corner and the scour hole along 70% of the North Abutment where top of footing is exposed, and up to 1 ft. of the footing side is exposed.
Bridge Management Unit - Scour Repair PS&E complete, Construction of scour repair planned for 2008.

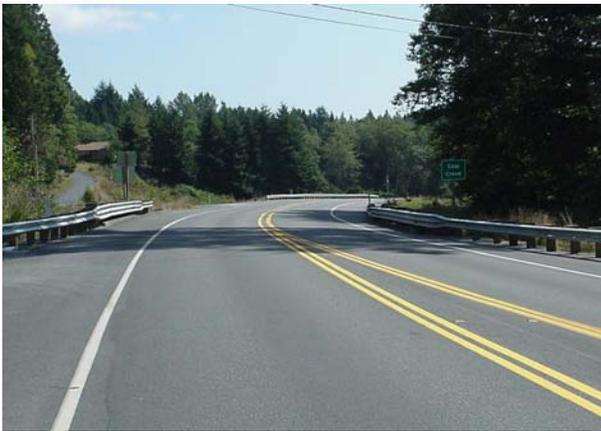
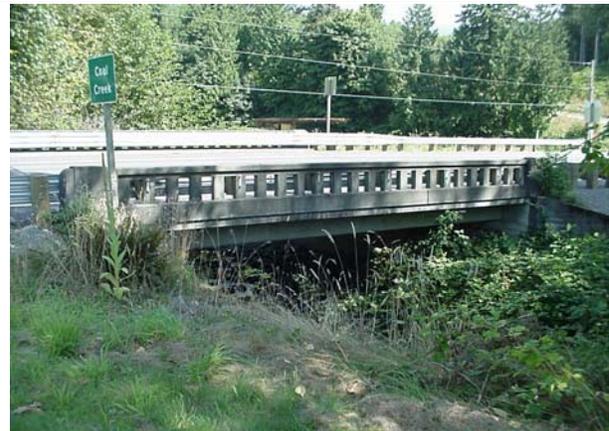
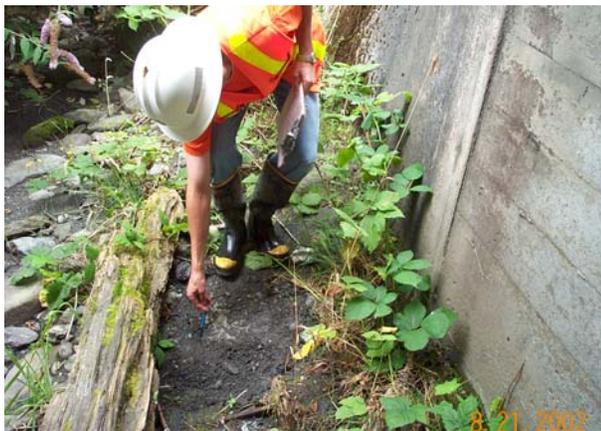
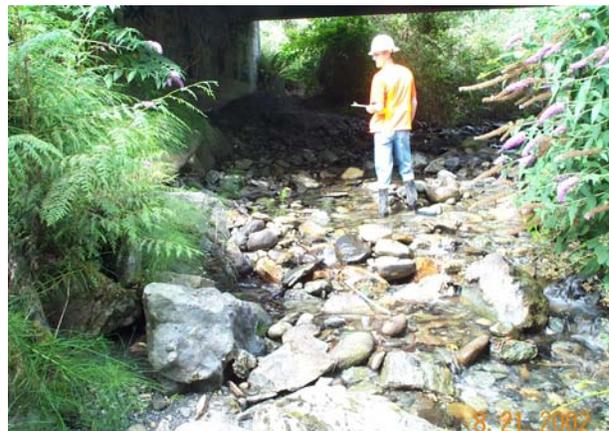
<p>Deficiencies:</p> <p>Exposed Footings. Top of northeast wing wall spread footing is exposed (photo 1). History of exposure of spread footings (1'-9" footing on 2'-6" seal). Riprap required. Photo 2 shows Downstream end of the bridge, showing degradation of creek bed.</p>	First Noted: 10/1/1996
	BPO Repair List Priority: 1
	Funding - P2 or M: P2
	07-09 Priority Rank: 1
	09-11 Priority Rank: 1
<p>Recommended Action:</p> <p>BPO - Cover the exposed footings with riprap. Build a rock drop structure (9"-1' drop) at the downstream end of the bridge. See USACOE plan sheets for details. Remove all cottonwood trees and debris north of bridge. Cottonwood trees have been cut and dropped into creek north of bridge. Bridge Management Unit - Scour Repair PS&E complete, Construction of scour repair planned for 2008.</p>	PIN:
	Bridge\$ Est:
	Total\$ Est: \$520,000

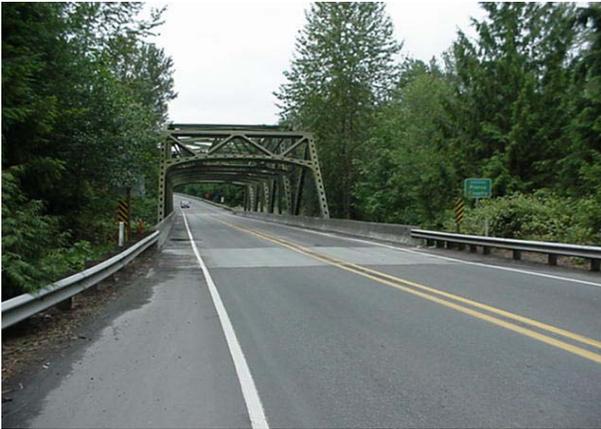
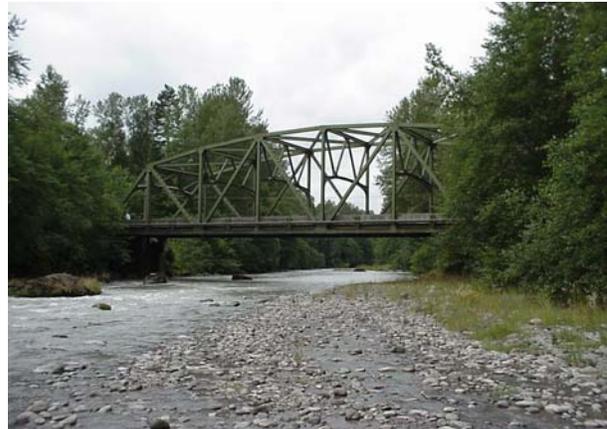
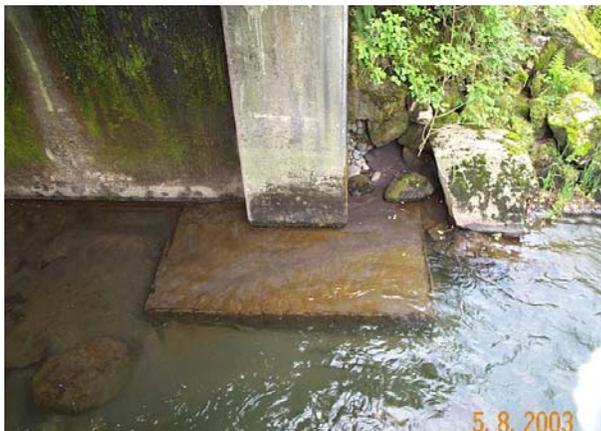
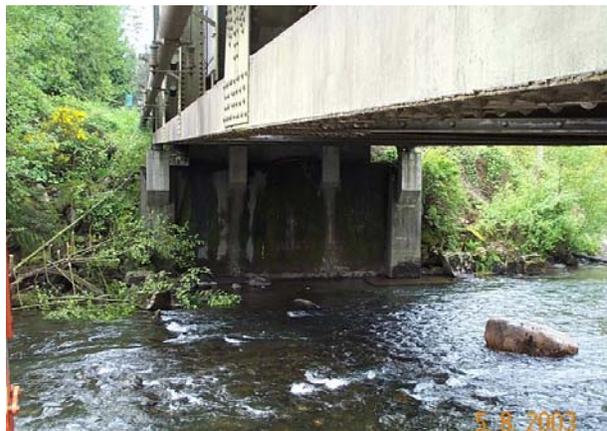
<p>Deficiencies:</p> <p>Pier 2 consists of spread footings 14' x 16' and 2.25' on 4' seals. The as-built plans say the foundation is on cemented sands. The footing at North end of Pier is exposed 1.3ft on the upstream side and 2.4ft on the down stram side. Hydraulics Office 5/28/96 - This bridge is scour critical if the thalweg migrates to Pier 2 or Pier 3. Riprap must be maintained at pier 2. Calc scour depth is 10ft below bottom of footings.</p>	First Noted: 7/18/2005
	BPO Repair List Priority: 1
	Funding - P2 or M: P2
	07-09 Priority Rank: 2
	09-11 Priority Rank: 3
<p>Recommended Action:</p> <p>BPO - Place heavy loose riprap, 2 layers thick over footing, at a minimum of 2:1 slope. Bridge Management Unit - The PE phase (\$80,000) for this P2 funded project is part of the 2007-09 bien.</p>	<p>PIN:</p> <p>Bridge\$ Est: \$141,000</p> <p>Total\$ Est: \$646,000</p>
