## P2 Bridge Preservation - Scour Repair

### 2009-11 Bien Priority Array

# Bridge Foundation Scour Repair

Olympic Region

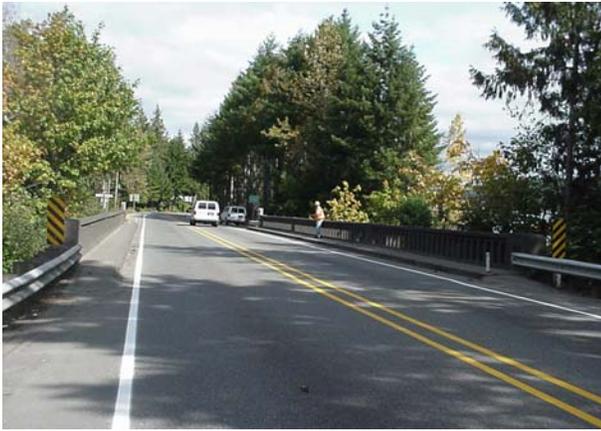
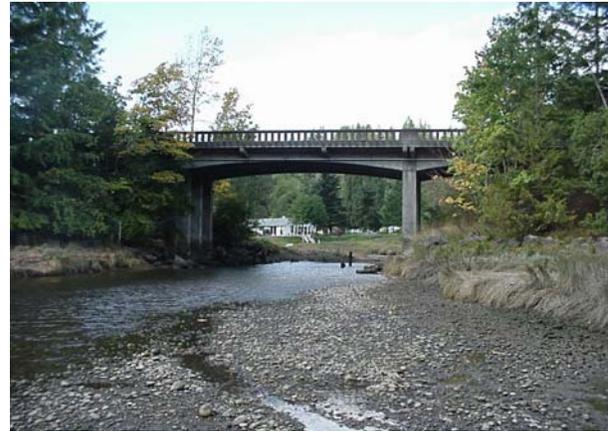
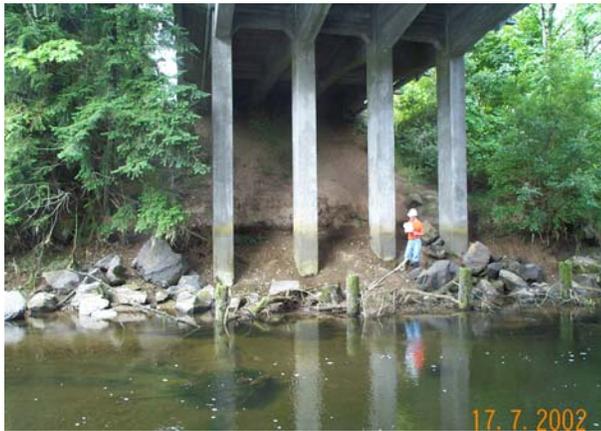
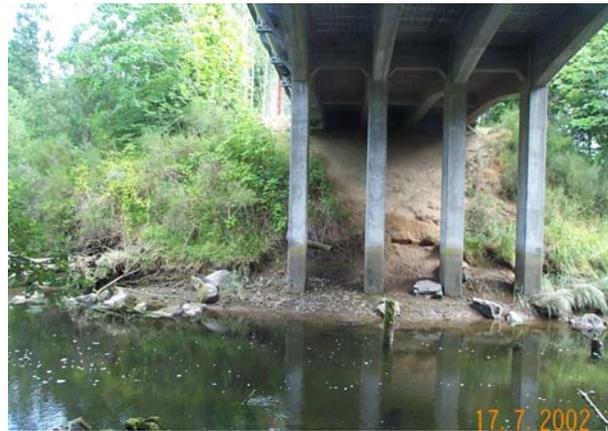
Bridge has spread footings. Riprap near piers 2 and 3 is no longer in place. Riprap placed just upstream that protect NW embankment is now in the middle of stream. The embankment is being undermined. P2 and P3 have 2ft footings on 6ft seals. P2 seal bottom is 12ft below channel, P3 is 8ft.

BPO - The rip rap has settled into the stream and the bank is beginning to erode. Place D50=1.2' riprap against the eroded upstream banks at both abutments.  
Bridge Management Unit - Prioritize with other statewide scour repair needs in the 2009-11 bien.

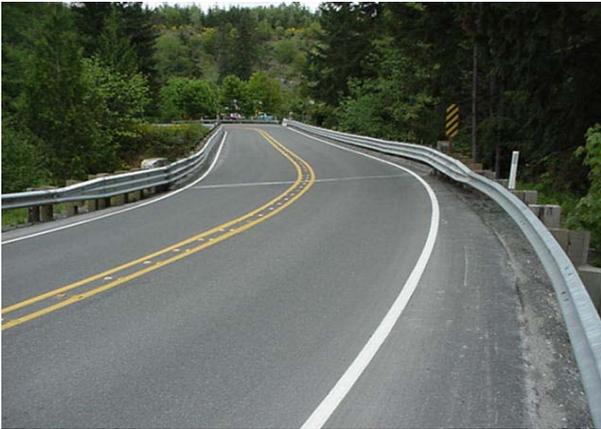
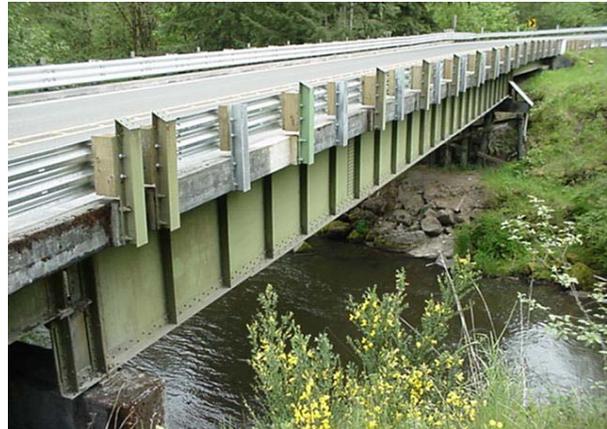
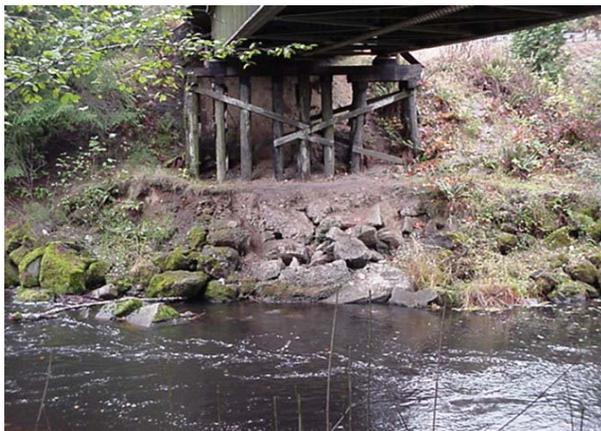
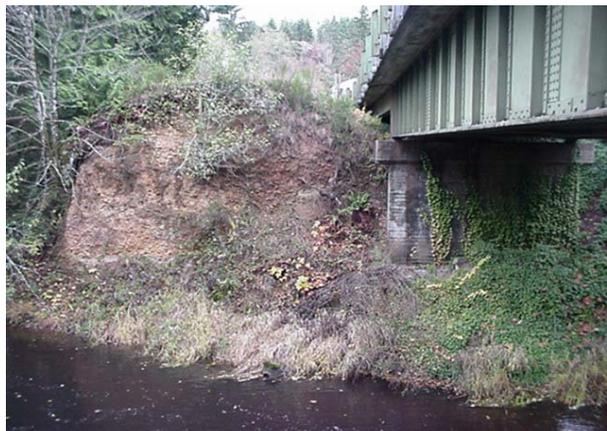
Damaged riprap at Pier 2. Pier 2 is pile foundation. Pier 2 is scour critical, with tips below calculated scour depth (see photo 1). Riprap must be maintained at both piers.

BPO - Place heavy loose riprap at Pier 2 to repair damaged protection.  
Bridge Management Unit - Prioritize with other statewide scour repair needs in the 2009-11 bien.

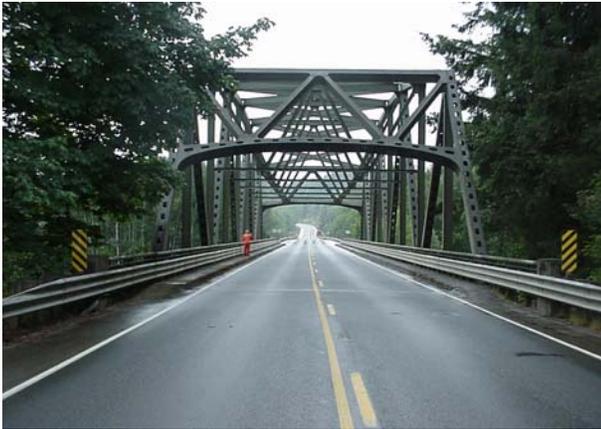
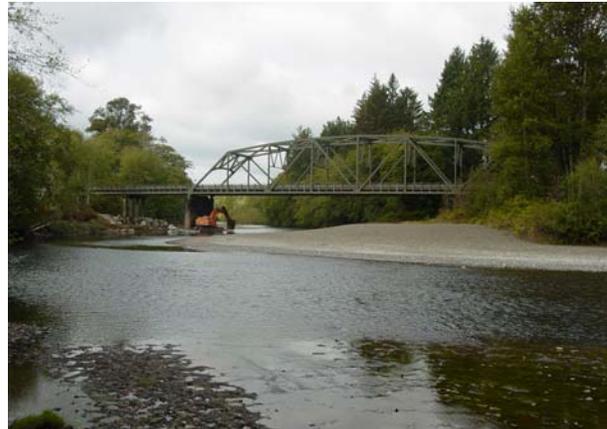
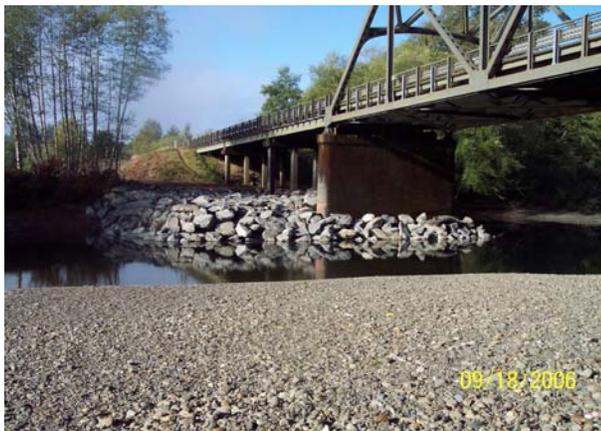
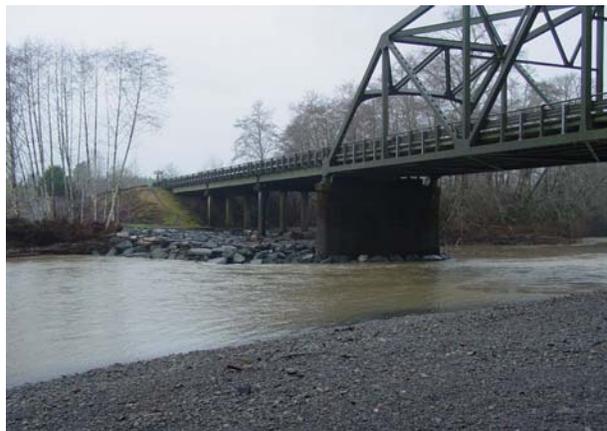
In 2006, the old riprap was removed and heavy riprap was placed all around Pier 4 and pier 3. There is a pool between piers 3 and 4 downstream of bridge River flow is eroding the south bank up and down stream. Pier 4 is scour critical.

BPO - Complete the scour repair.  
Bridge Management Unit - Next phase of repair will add more heavy riprap around pier 4 and install 5 barbs upstream from the bridge. Construction is planned for 2008.

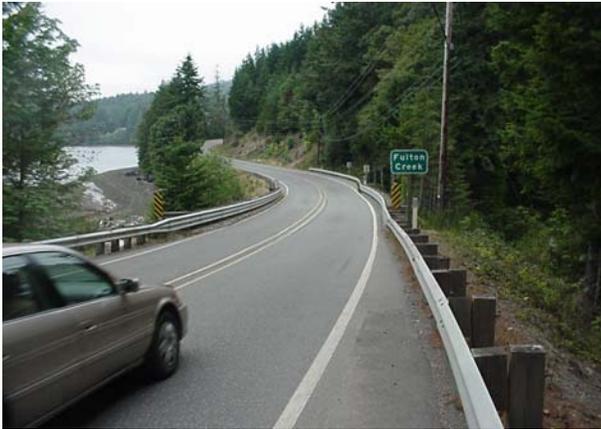
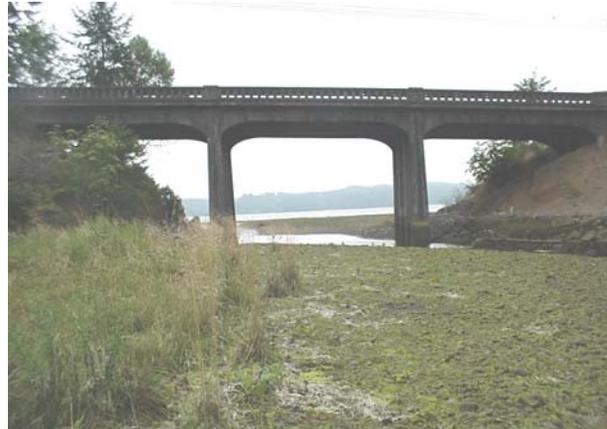
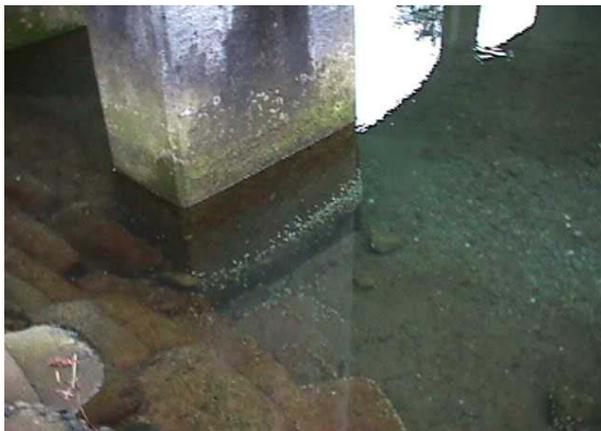
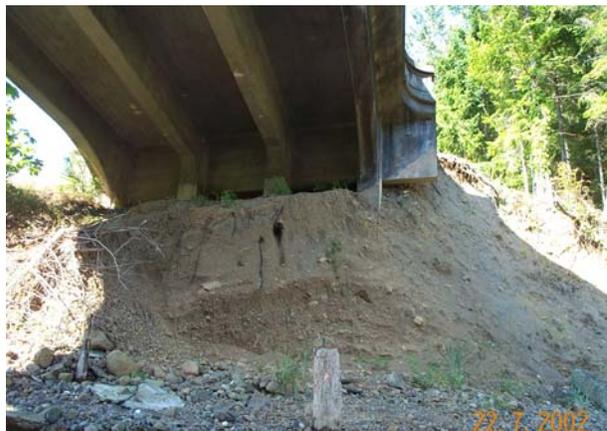
12/2000 Pier 2 embankment & Pier protection is undermined.  
7/2002 Embankment at SW corner of Pier 4 Abutment looking South.  
Bridge is on pile foundations.

BPO - Repair undermined embankment protection and pier protection at Piers 2 and 3. Concrete sack protection has sloughed away. Slope protection concrete bags at Pier 2 are undermined at the base between Columns 2A and 2C.  
Bridge Management Unit - Prioritize with other statewide scour repair needs in the 2009-11 bien.

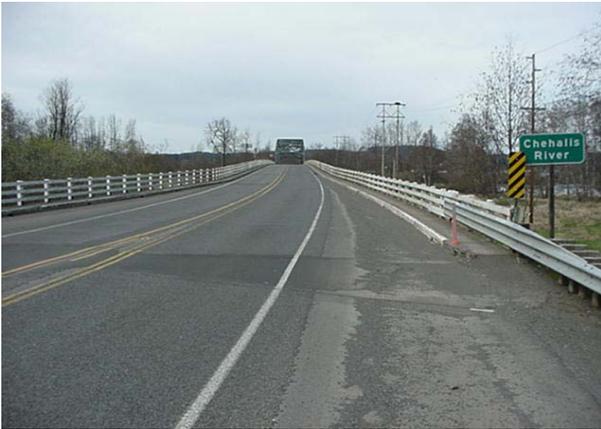
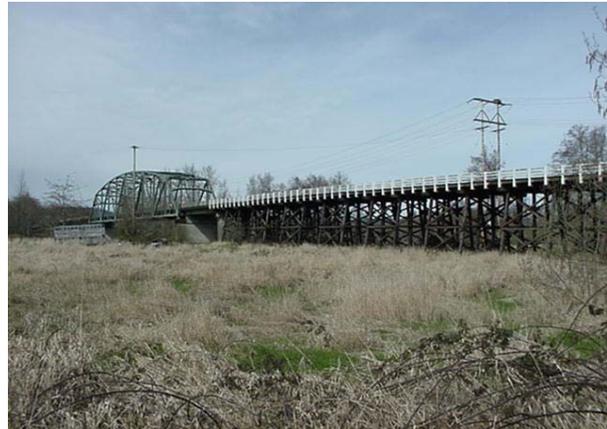
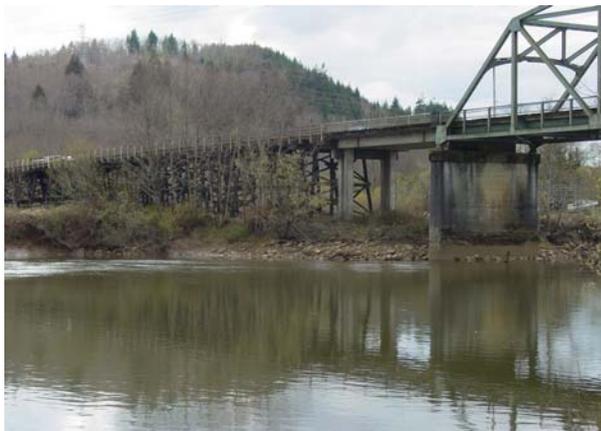
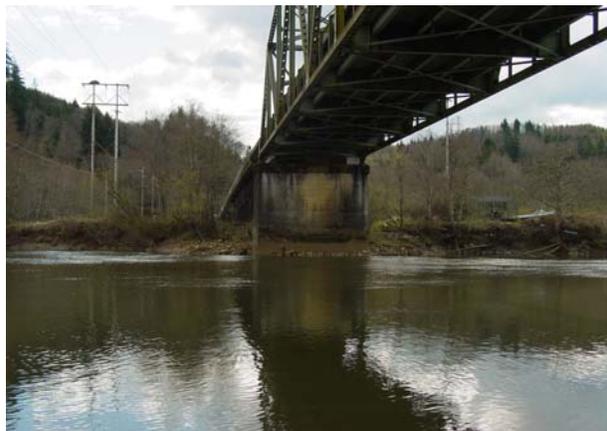
Riprap along bank by the south truss span is missing.

BPO - Add riprap to bank around south Truss pier.  
Bridge Management Unit - Olympic Region Maintenance is scheduled to perform the riprap work in 2007.

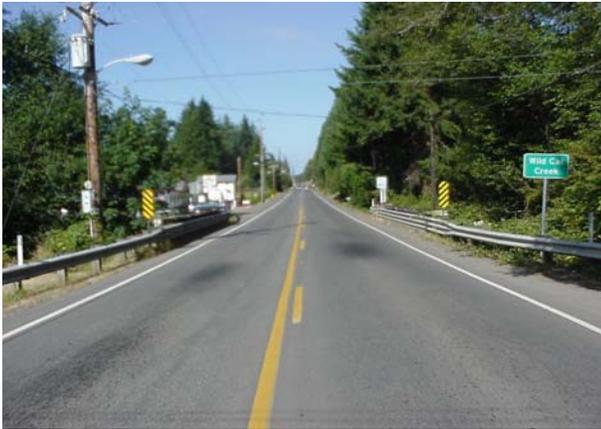
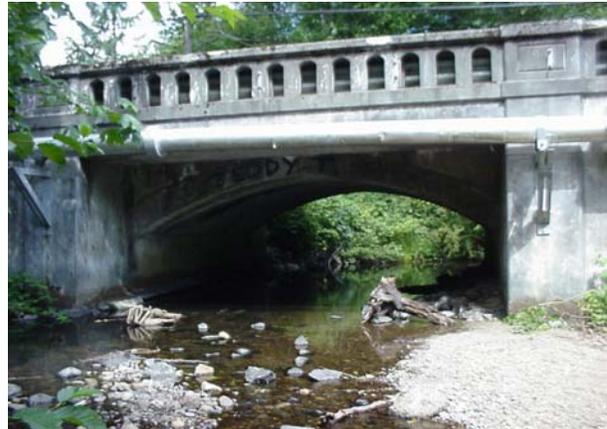
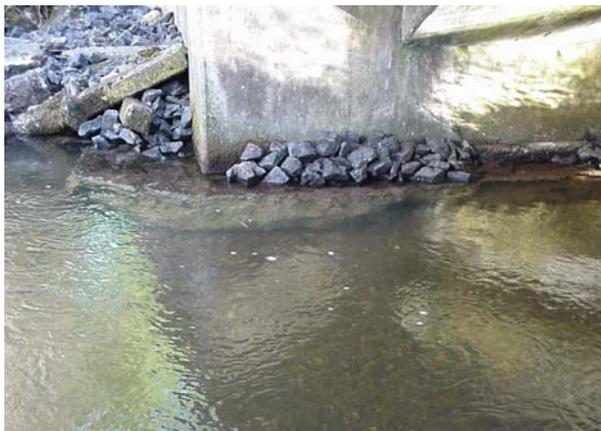
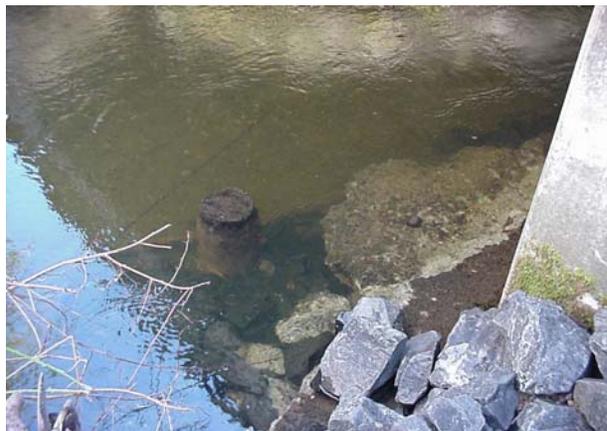
P1 apron is undermined approx. 2' at the NW corner. P2 is undermined up to 4' at the NE corner and it has many holes scattered throughout. The stream appears to have shifted to the East but bends back to the bridge opening. 10" dia. riprap scattered in waterway under and downstream of bridge.

BPO - Repair undermining of apron at NE corner of Pier 2 and all of Pier 1.  
Bridge Management Unit - Prioritize with other statewide scour repair needs in the 2009-11 bien.

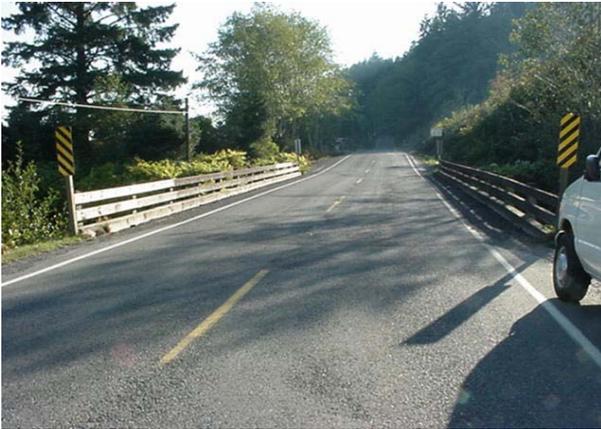
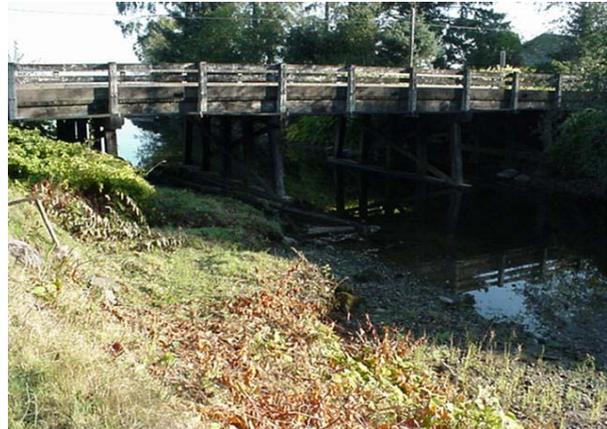
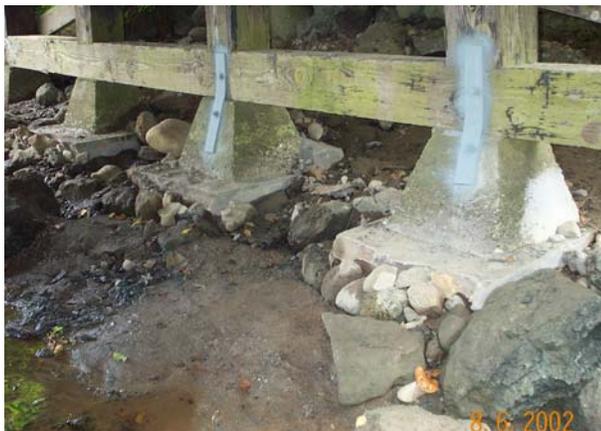
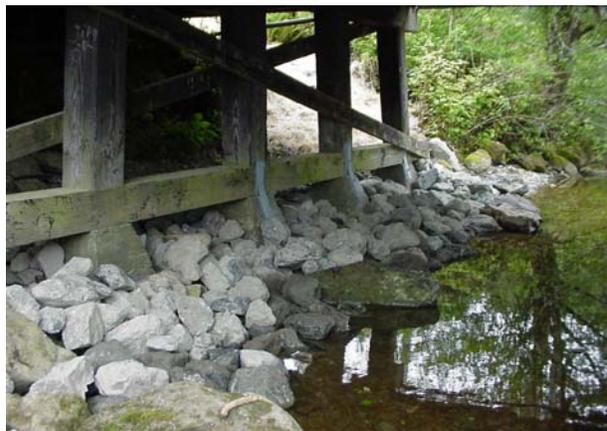
Undermining of footings corrected at pier 5 looking West in Aug 2002. Completed Repair of undermined footings looking East in 5/2003.

BPO - Place light-loose riprap around footing at Pier 5, see photo 8. Previous repair (#10000) of quarry spalls has washed away.  
Bridge Management Unit - Prioritize with other statewide scour repair needs in the 2009-11 bien.
