P2 Bridge Preservation - Scour Repair

2009-11 Bien Priority Array

Bridge Foundation Scour Repair

Bridge Preservation Program

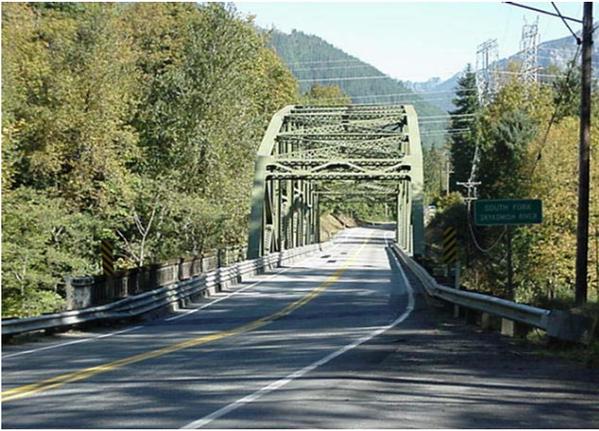
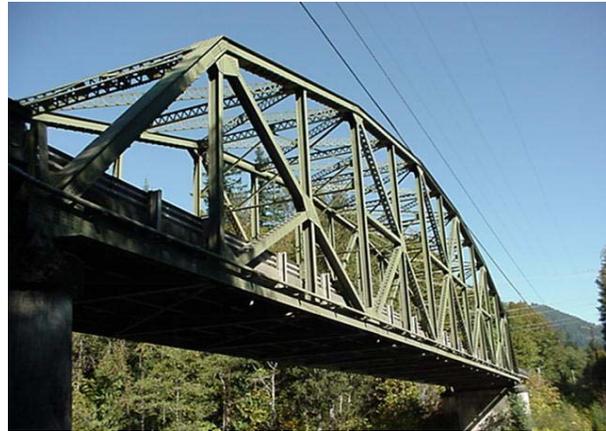
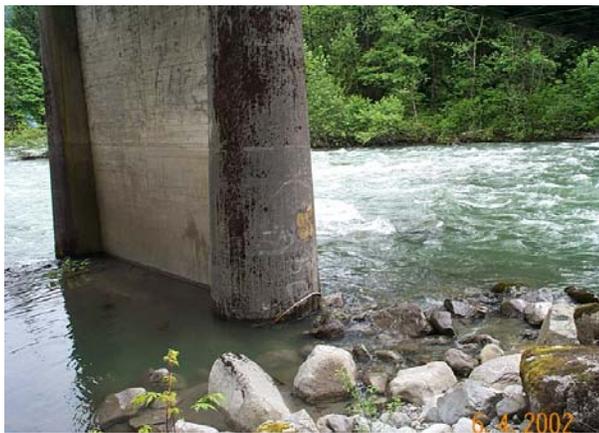
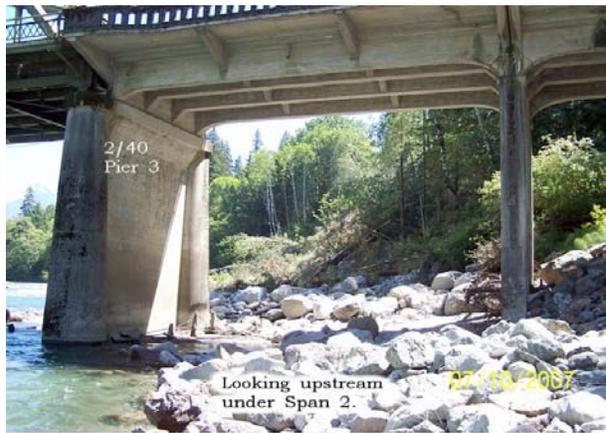
Approach CTB piers on spread footings. Main Truss piers on piles. There is riprap and river boulders at the east face and the nose of Pier 3. The tail and west side of Pier 3 has up to 3' of the side of the footing exposed (no undermining found). The upstream bank is eroding next to pier 2. The last contract repair was in 1996.

BPO - Repair the missing riprap at the downstream end of pier 3.
Bridge Management Unit - Program a P2 funded project, prioritize against other needs for 2009-11.

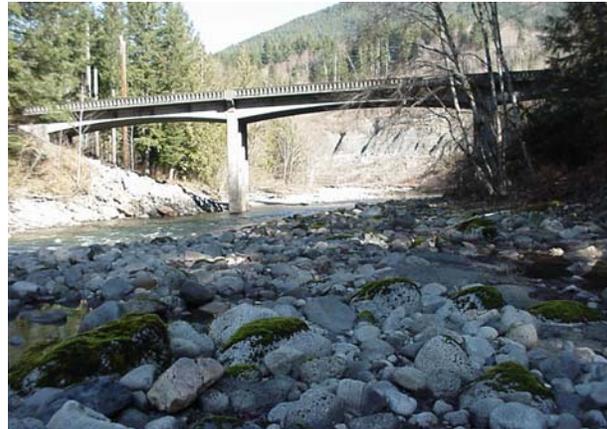
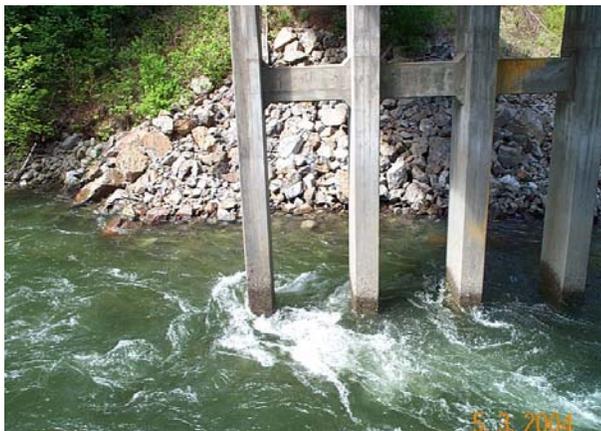
No rip rap along pier 3 columns. Up to 3 ft. exposed of face on Southeast corner. Top of pile cap is totally exposed. East face stream side footing is totally exposed. Sufficient pile length.

BPO - Rip rap along Pier 3 columns. Up to 3 ft. exposed of face on southeast corner. Top of pile cap is totally exposed. East face stream side footing is totally exposed.
Bridge Management Unit - Program a P2 funded project, prioritize against other needs for 2009-11.

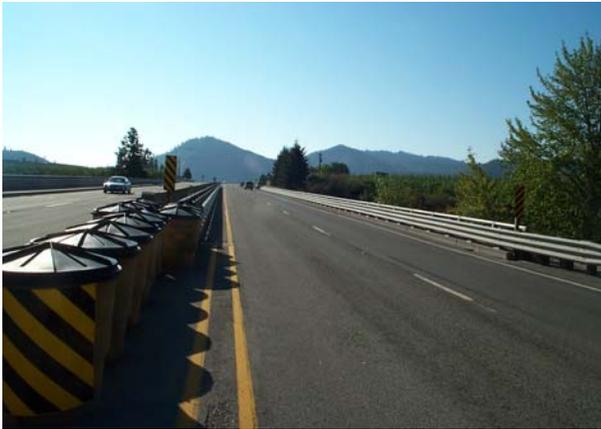
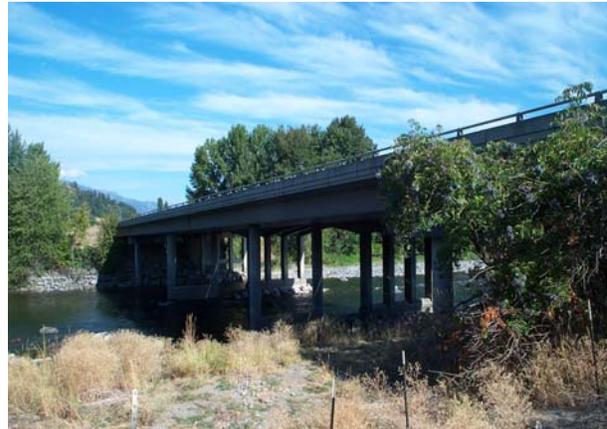
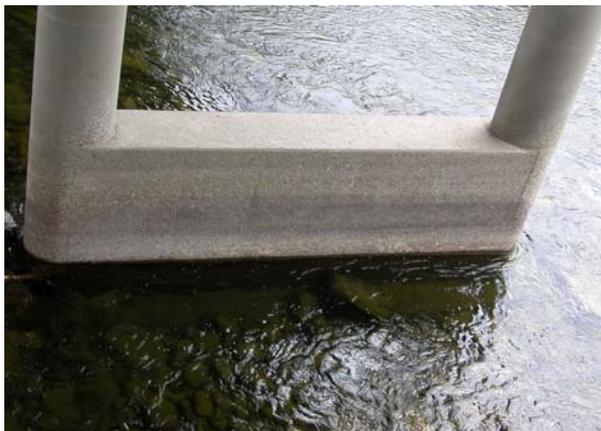
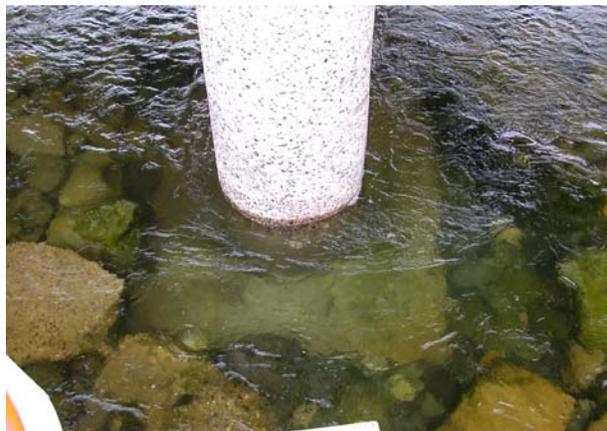
Pier 4 footing is exposed up to 4 feet deep, Pier 5 up to 6 feet. Piers 4 and 5 have 8 feet deep foundations.

A scour repair that added riprap around the foundations in the water was done in 1994 under contract 4474.

BPO - Install scour mitigation measures per direction of Bridge Preservation Scour Engineer to address exposed footings at Piers 4 and 5.

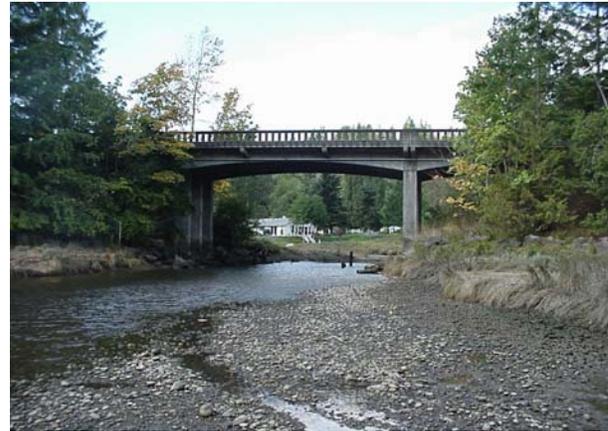
Bridge has spread footings. Riprap near piers 2 and 3 is no longer in place. Riprap placed just upstream that protect NW embankment is now in the middle of stream. The embankment is being undermined. P2 and P3 have 2ft footings on 6ft seals. P2 seal bottom is 12ft below channel, P3 is 8ft.

BPO - The rip rap has settled into the stream and the bank is beginning to erode. Place D50=1.2' riprap against the eroded upstream banks at both abutments.
Bridge Management Unit - Prioritize with other statewide scour repair needs in the 2009-11 bien.

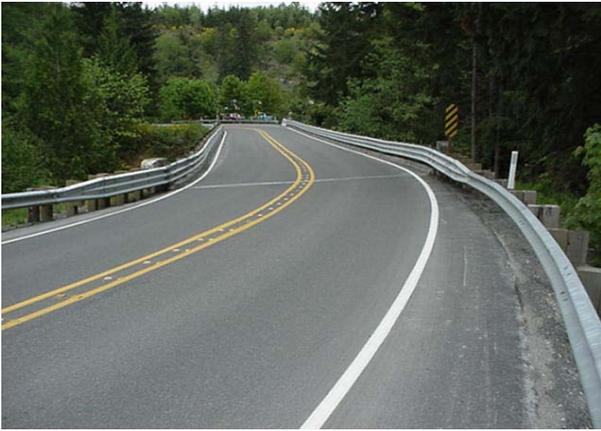
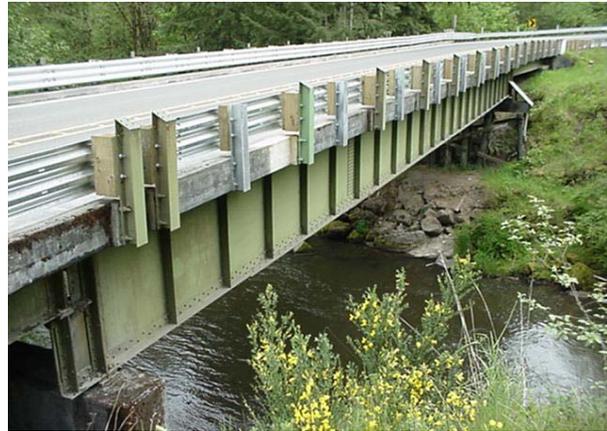
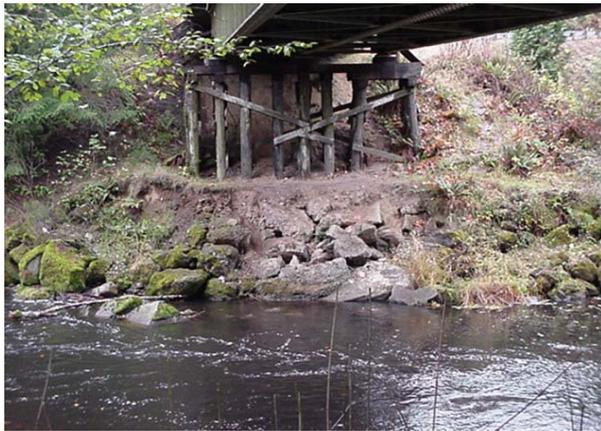
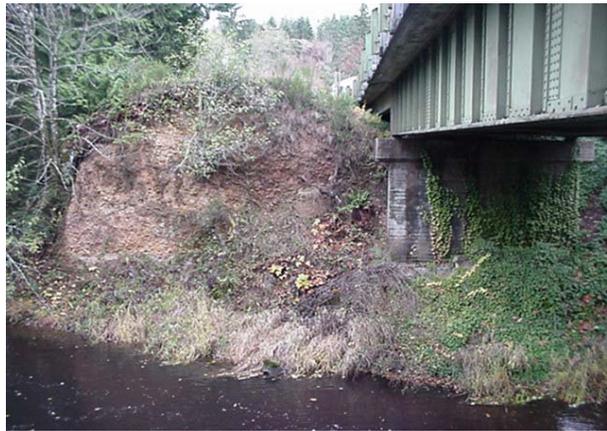
Damaged riprap at Pier 2. Pier 2 is pile foundation. Pier 2 is scour critical, with tips below calculated scour depth (see photo 1). Riprap must be maintained at both piers.

BPO - Place heavy loose riprap at Pier 2 to repair damaged protection.
Bridge Management Unit - Prioritize with other statewide scour repair needs in the 2009-11 bien.

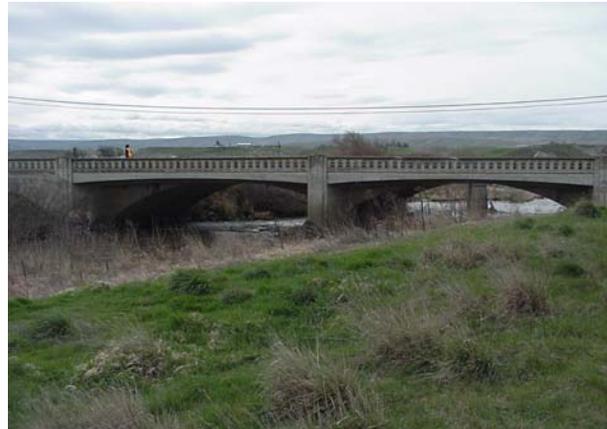
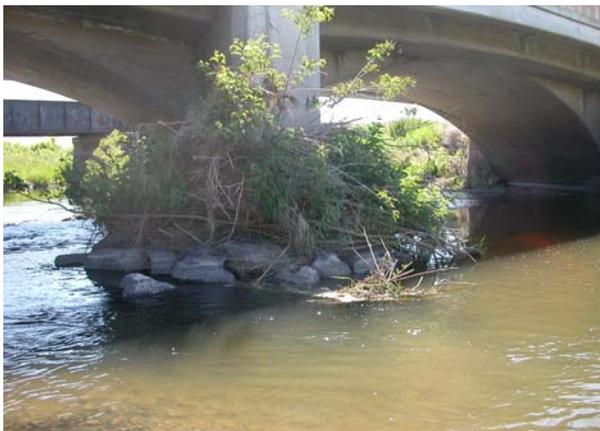
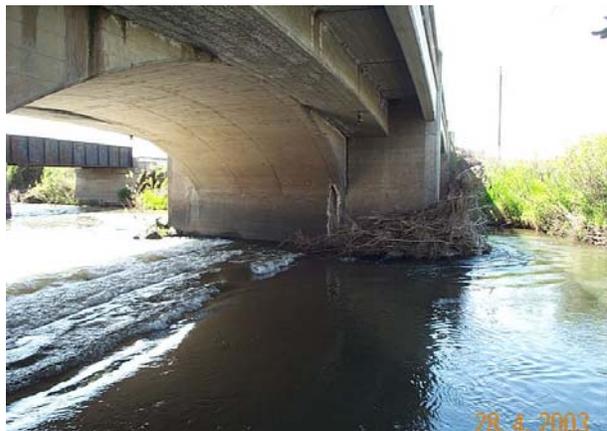
Deficiencies: Rip Rap and Debris at Upstream End of Pier 2, looking southwest. Rip Rap Installed at Downstream End of Span 1 Apron and upstream and downstream ends of Pier 2. Concrete apron has deteriorated.	First Noted: 12/20/2005
	BPO Repair List Priority: 1
	Funding - P2 or M: P2
	07-09 Priority Rank: 1
	09-11 Priority Rank: 1
Recommended Action: BPO - Repair deteriorated concrete apron. Add riprap downstream of bridge. Bridge Management Unit - Repair of Concrete Apron project is under design.	PIN:
	Bridge\$ Est:
	Total\$ Est: \$582,000

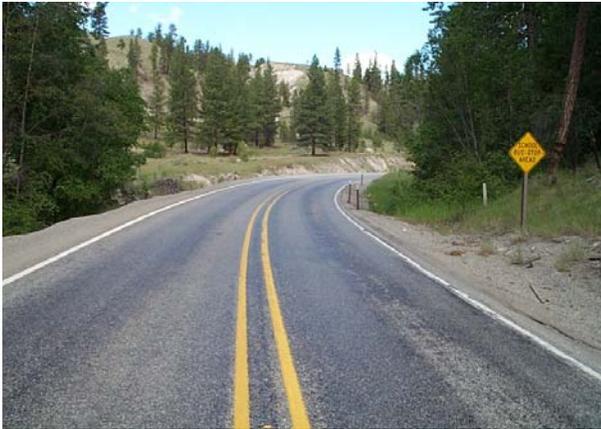
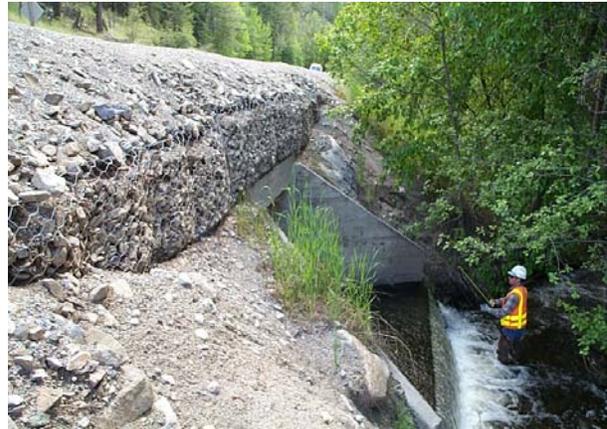
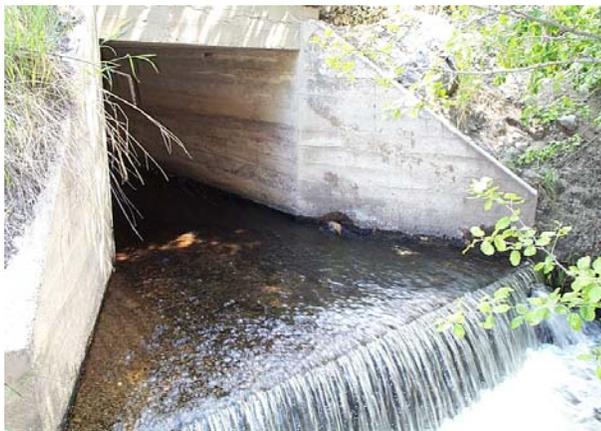
Culvert Outlet apron is undermined (North end). The undermining is up to 4ft deep and there is up to 3ft penetration on the west edge and 19 inches on the east edge on 7/26/2006.

BPO - Fill in undermining with quarry spalls and light loose riprap with consideration of fish passage.
Bridge Management Unit - Prioritize with other statewide scour needs in the 2009-11 biennium.

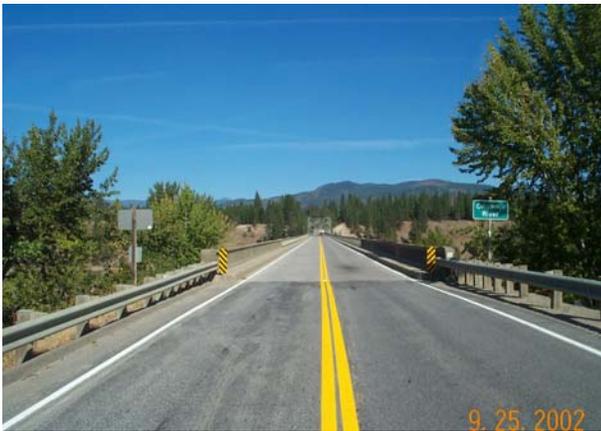
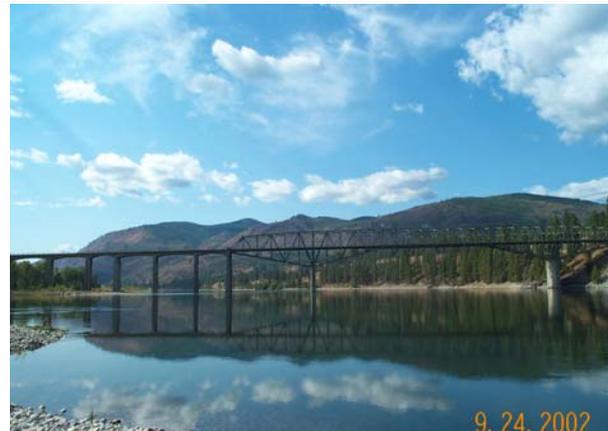
Pier 10 pedestals and the top surface of the footings are exposed. Small scour hole around column 11A. Pier 12 footing is exposed 2 ft vertically at NW corner per underwater inspection report of 10/21/2000. Exposed footing observed in 2006.

BPO - Place riprap at Piers 10, 11, and 12 and maintain riprap at Piers 9 and 13 in order to provide pier protection. Riprap should taper out 20 ft to 40 ft in the east-west directions.
Bridge Management Unit - Program a P2 funded project, prioritize against other needs for 2009-11.

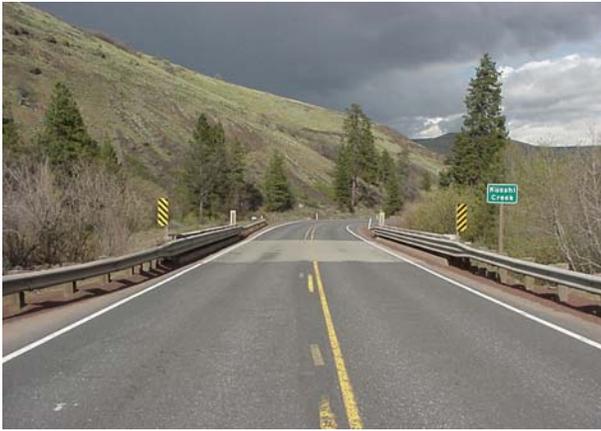
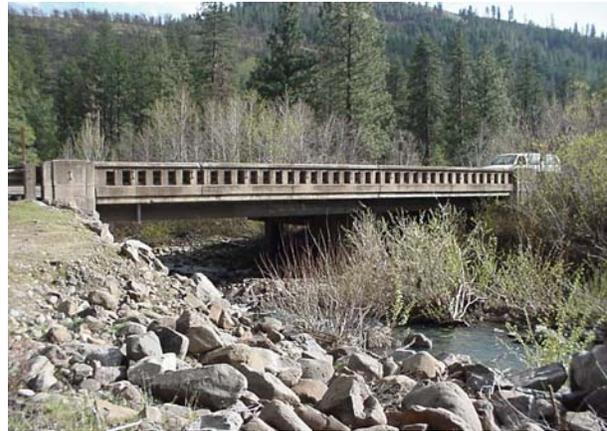
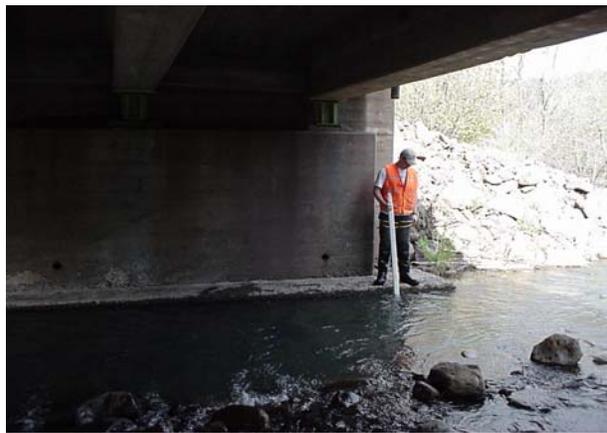
Pier 3 (North Abutment) has exposed footing for full length. Sill exposed up to 1.5' along East half of P3. Heavy riprap placed on the NW bank. Debris is building up on the abutment. Footings are 2 feet thick with no seals. Plans indicate footings may be on bedrock.

BPO - Repair riprap at Pier 3.
Bridge Management Unit - Prioritize against other statewide scour needs in the 2009-11 biennium.

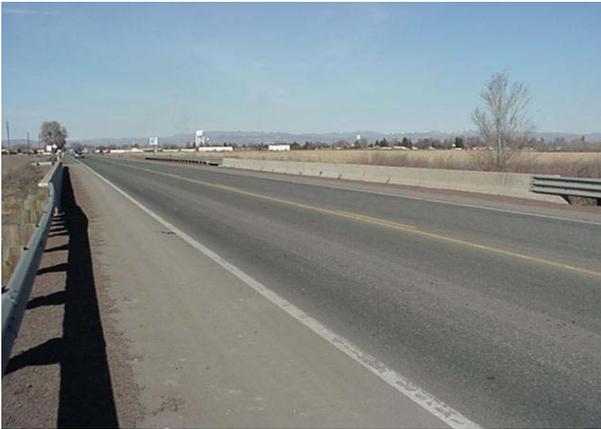
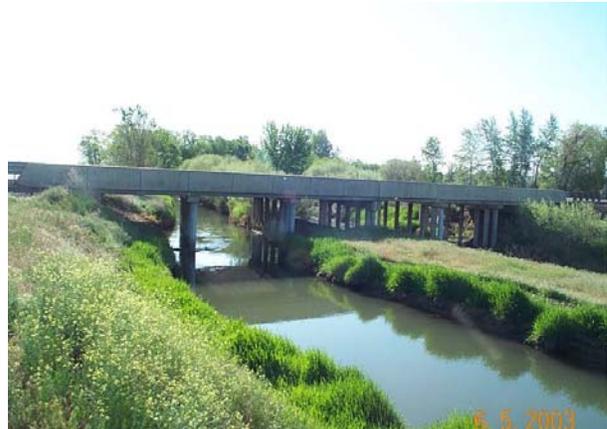
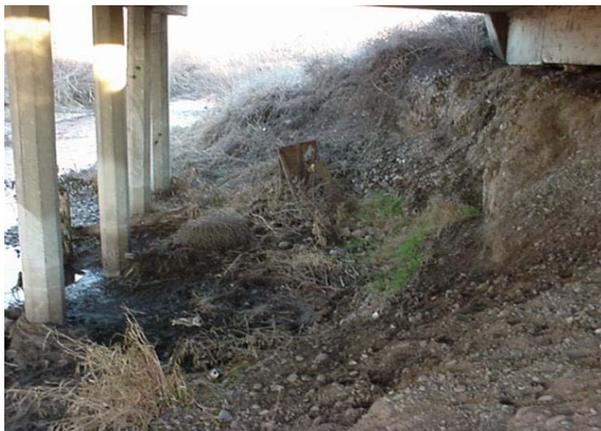
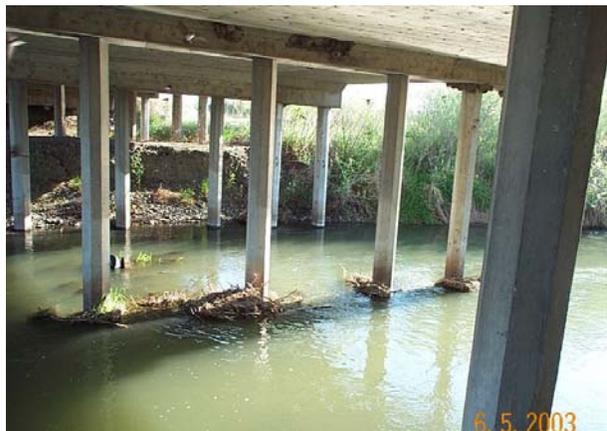
Scour hole behind Piles 2D, 2E, 2F in Pier 1 embankment. Debris hung up on Piles 3A, 3E and 3F. Calculated scour falls below pile tips at Pier 2. Monitor for channel migration. Current bottom of south channel is 4' above pile tips at Pier 2.

BPO - Fill scour area in Span 1 with quarry spalls back to original ground line.
Bridge Management Unit - Prioritize with other statewide scour needs in the 2009-11 biennium.

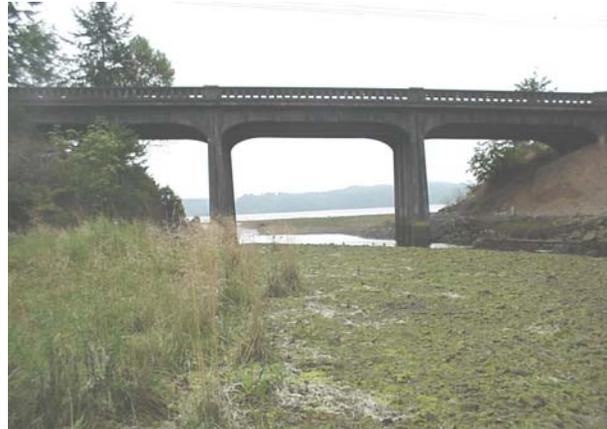
12/2000 Pier 2 embankment & Pier protection is undermined.
7/2002 Embankment at SW corner of Pier 4 Abutment looking South.
Bridge is on pile foundations.

BPO - Repair undermined embankment protection and pier protection at Piers 2 and 3. Concrete sack protection has sloughed away. Slope protection concrete bags at Pier 2 are undermined at the base between Columns 2A and 2C.
Bridge Management Unit - Prioritize with other statewide scour repair needs in the 2009-11 bien.

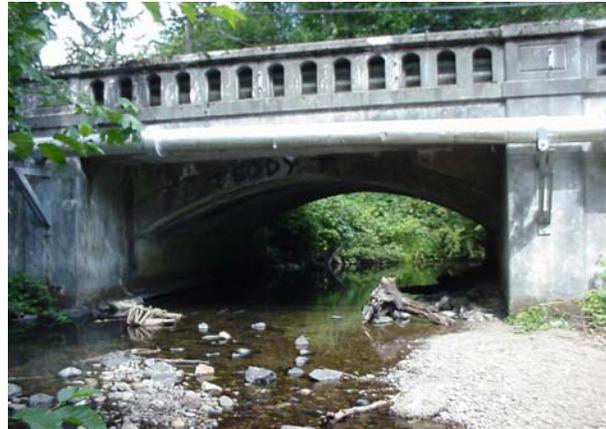
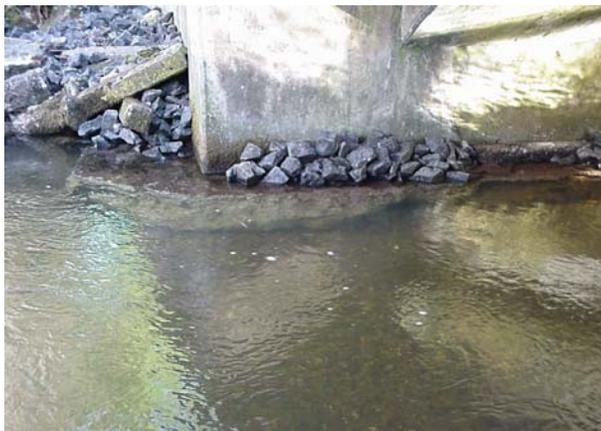
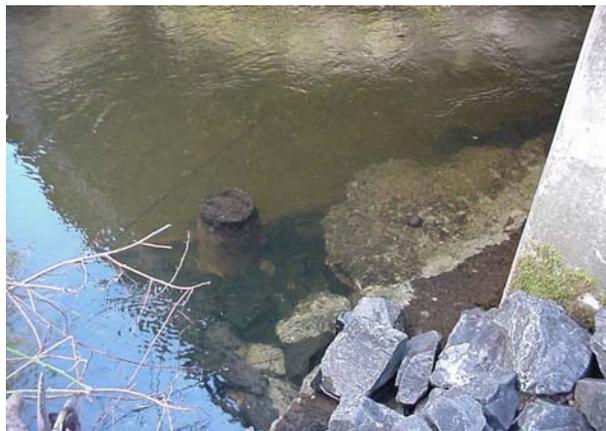
P1 apron is undermined approx. 2' at the NW corner. P2 is undermined up to 4' at the NE corner and it has many holes scattered throughout. The stream appears to have shifted to the East but bends back to the bridge opening. 10" dia. riprap scattered in waterway under and downstream of bridge.

BPO - Repair undermining of apron at NE corner of Pier 2 and all of Pier 1.
Bridge Management Unit - Prioritize with other statewide scour repair needs in the 2009-11 bien.

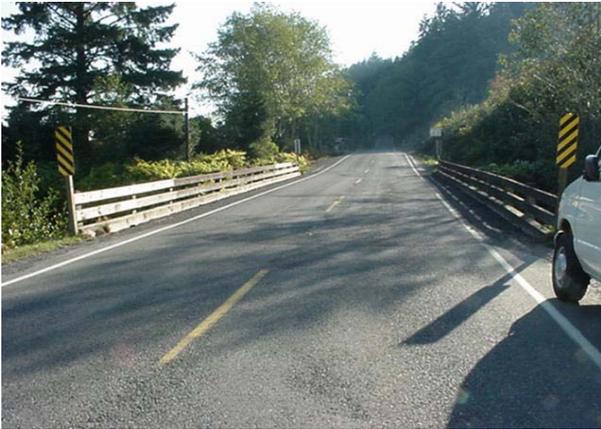
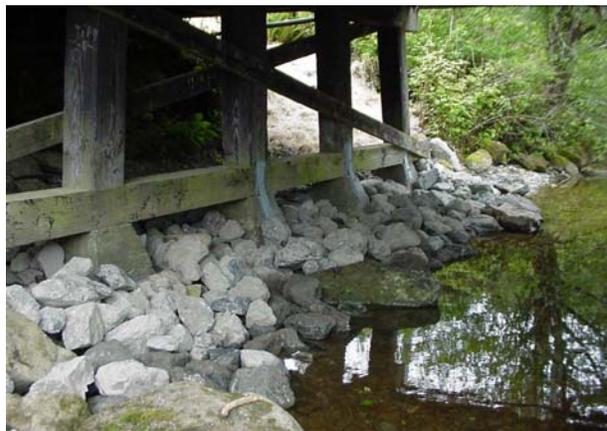
Undermining of footings corrected at pier 5 looking West in Aug 2002. Completed Repair of undermined footings looking East in 5/2003.

BPO - Place light-loose riprap around footing at Pier 5, see photo 8. Previous repair (#10000) of quarry spalls has washed away.
Bridge Management Unit - Prioritize with other statewide scour repair needs in the 2009-11 bien.

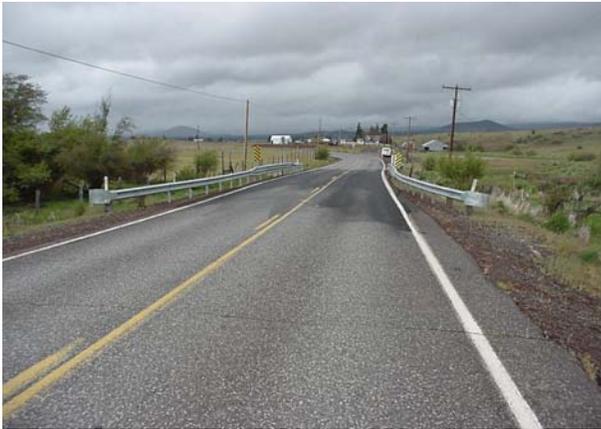
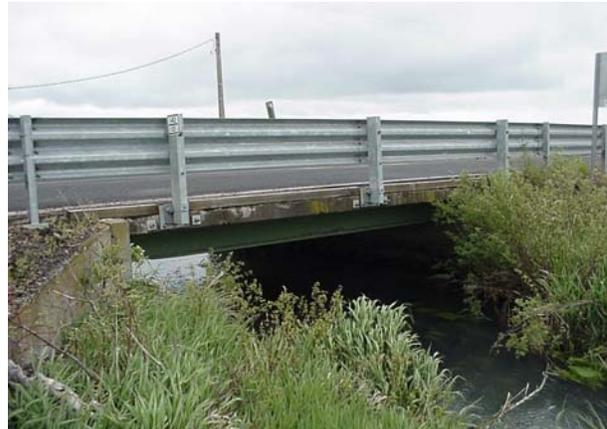
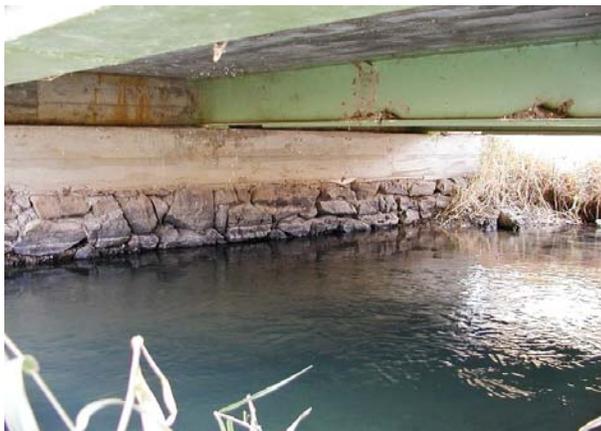
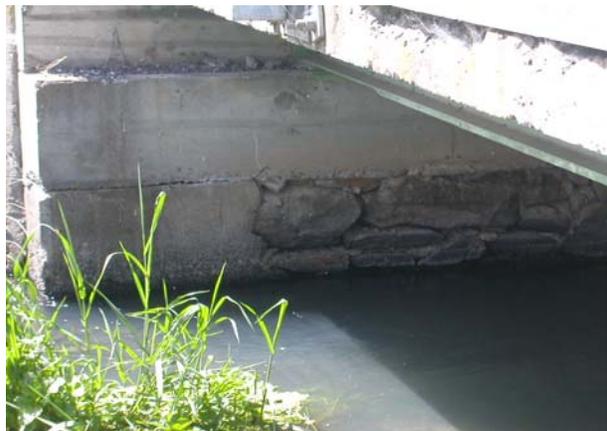
Stream flows against both abutments. Heavy silt deposition 2' thick at west abutment. Abutments are Stone & mortar wall. Unknown foundation depth. Mortar has been eroded by the stream action. Bridge has contraction scour problem and needs as much hydraulic opening as possible.

BPO - Place well graded light loose riprap, two to three layers deep (1' thick min.) along both stone & mortar abutment walls, tapering out at a 2:1 slope, blending into the existing groundline and banks. Repair modified 6/6/06 to priority 1 due to undermining of the east abutment per JHL/DCC.
Bridge Management Unit - Prioritize against other statewide scour needs in the 2009-11 biennium.

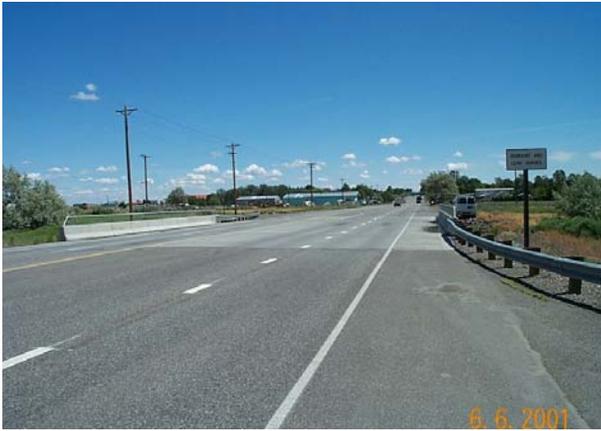
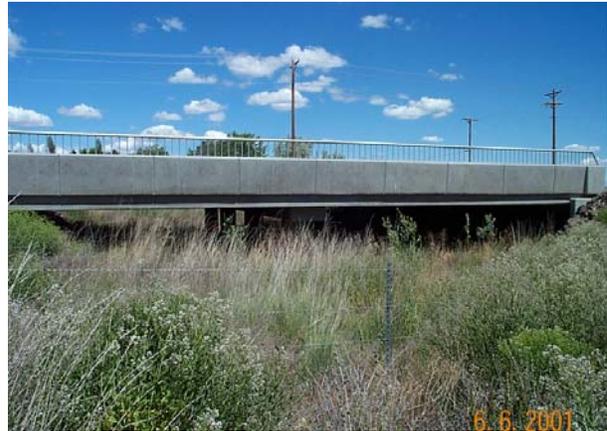
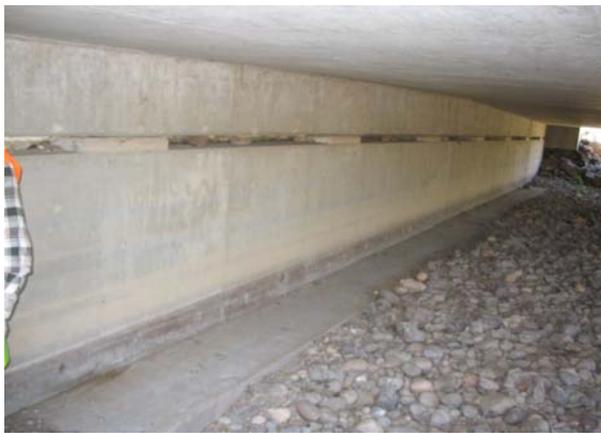
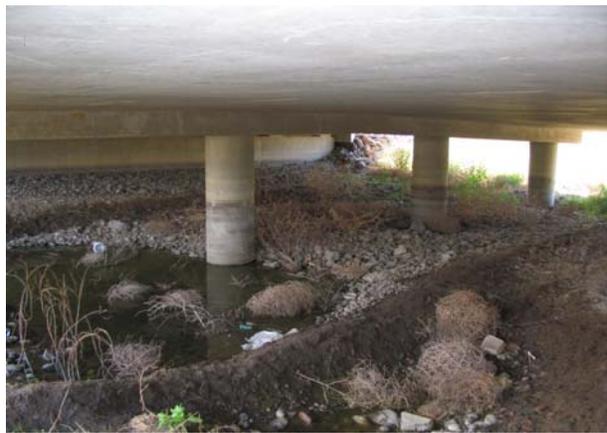
High water, high flow event has caused severe erosion. Abutments are exposed, see photos 3, 6, and 7. Scour hole around Column 3B. Riprap has been washed from Pier 3 abument at the north. Riprap in place at remaining corners of bridge.

BPO - Mitigate scour at abuments and Pier 2. Repair design in progress; construction not likely before 2009; review/update status each inspection; monitor until construction.
Bridge Management Unit - Prioritize with other statewide scour needs in the 2009-11 biennium.

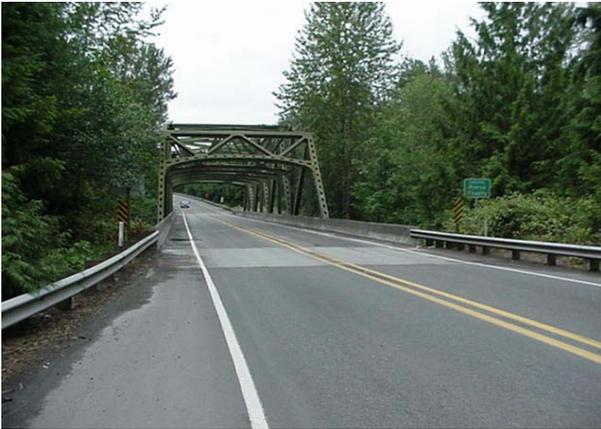
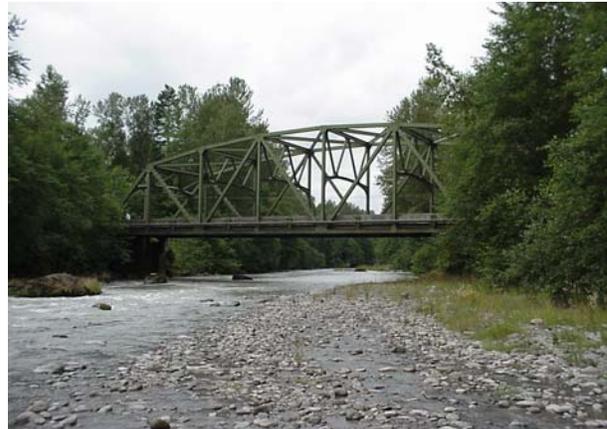
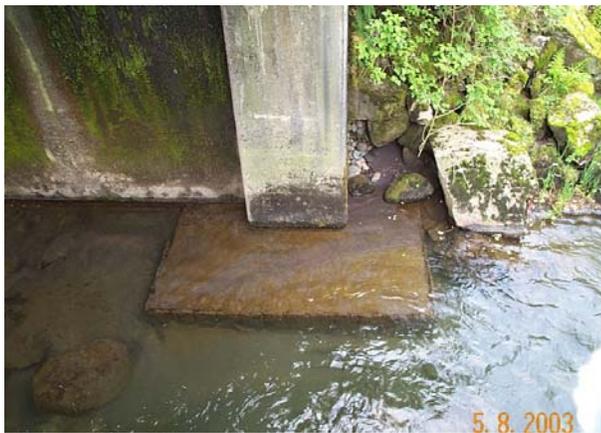
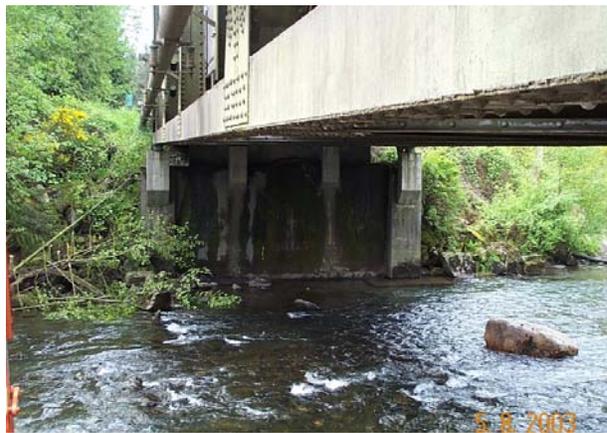
Pier 2 consists of spread footings 14' x 16' and 2.25' on 4' seals. The as-built plans say the foundation is on cemented sands. The footing at North end of Pier is exposed 1.3ft on the upstream side and 2.4ft on the down stram side. Hydraulics Office 5/28/96 - This bridge is scour critical if the thalweg migrates to Pier 2 or Pier 3. Riprap must be maintained at pier 2. Calc scour depth is 10ft below bottom of footings.

BPO - Place heavy loose riprap, 2 layers thick over footing, at a minimum of 2:1 slope.
Bridge Management Unit - The PE phase (\$80,000) for this P2 funded project is part of the 2007-09 bien.

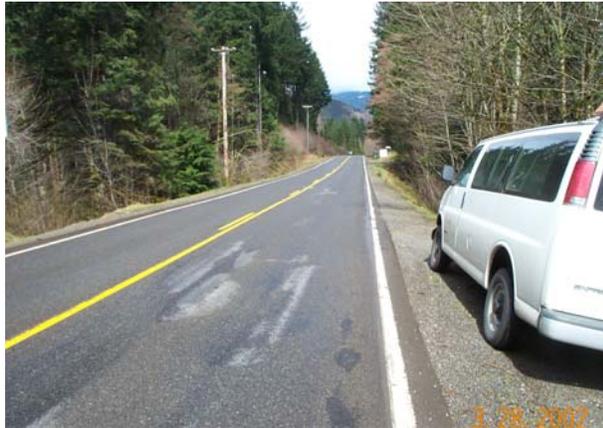
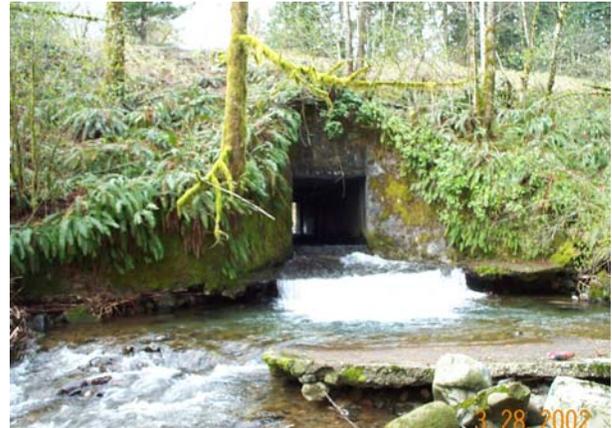
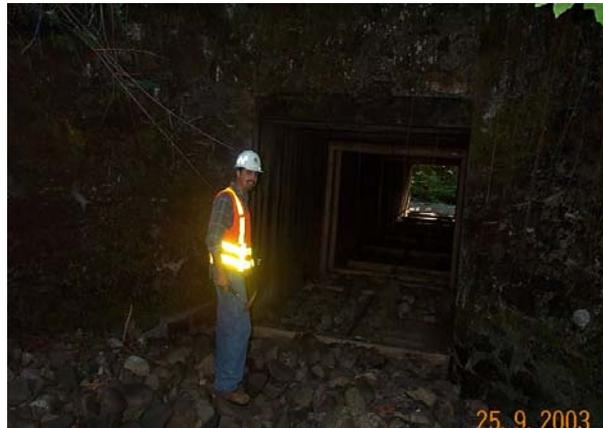
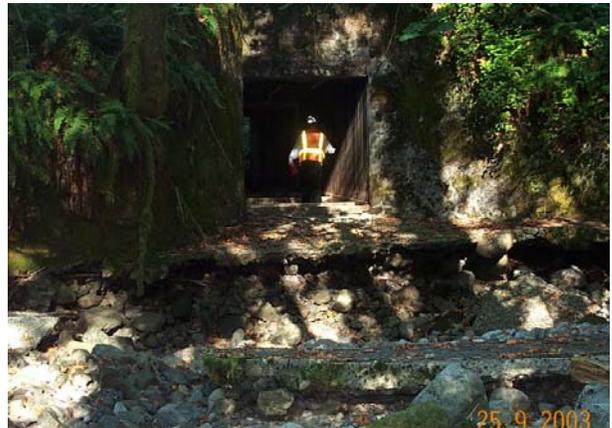
<p>Deficiencies:</p> <p>A large scour hole downstream of the structure. Half of the downstream concrete apron has broken off and is laying 20' downstream. The stream drops down 3' off the remaining apron which is undermined 4'. The upstream scour needs further mitigation.</p>	First Noted: 8/16/1999
	BPO Repair List Priority: 1
	Funding - P2 or M: P2
	07-09 Priority Rank: 43
	09-11 Priority Rank: 5
<p>Recommended Action:</p> <p>BPO - Correct for erosion and repair the concrete apron at the downstream end. Erosion has undermined the apron approx 4ft. and the NE masonry wingwall. Bridge Management Unit - Replacement of the culvert needs to be planned due to the estimated high cost of a scour repair.</p>	PIN: 450312B Bridge\$ Est: \$221,000 Total\$ Est: \$989,000

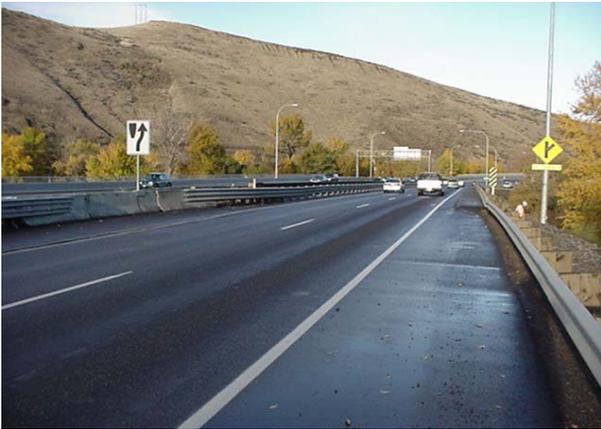
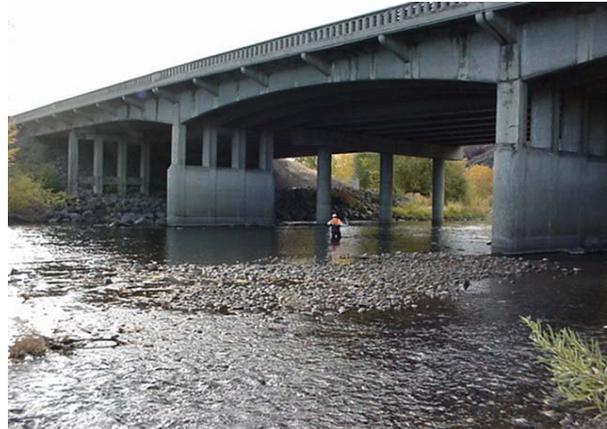
Previous inspections: Footing of P3 exposed up to 12" along the middle 12 feet of the so side. Rip-rap at nose and tail of Pier 3. The footing face of P4 exposed 5" along the north half, east end and exposed 2" along the south half, east end. The top of the east half of the Pier 4 footing is fully exposed. The top of the nw footing is exposed for 5 ft.

BPO - Replace missing riprap at piers 3 & 4.
Bridge Management Unit - Prioritize with other statewide scour needs in the 2009-11 biennium.
