Misc Structures - Southwest Region - 2009-11 Biennium

Bridge Preservation Program (P2)

Misc Structures Form

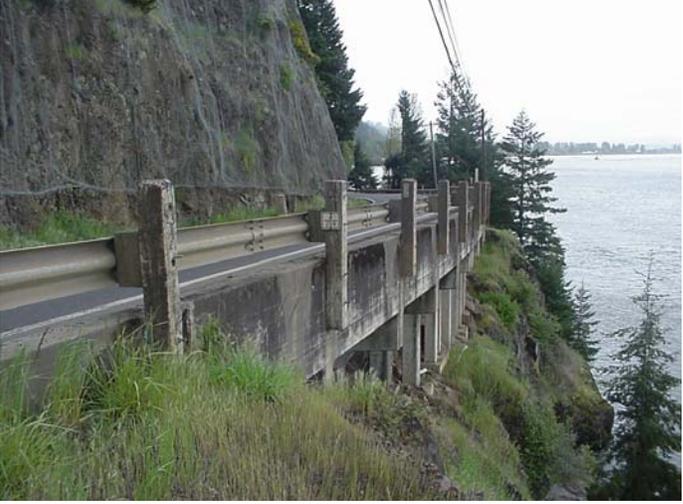
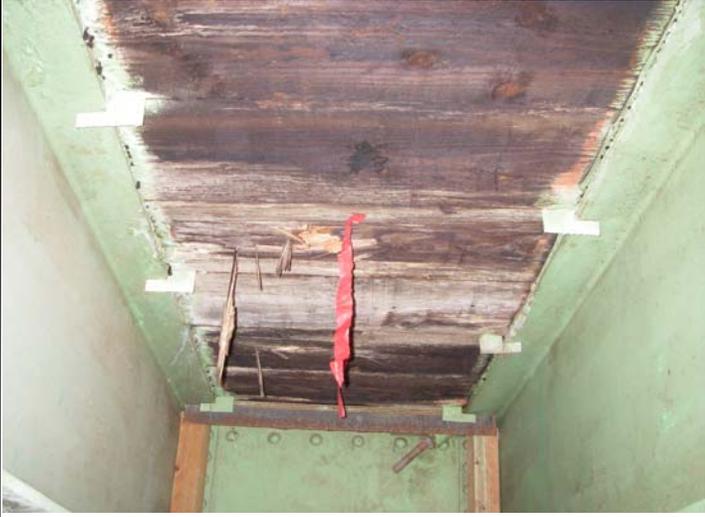
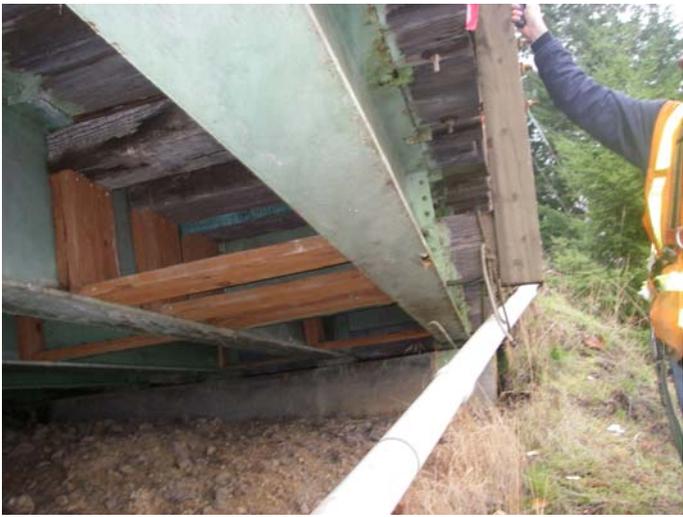
Repair Description:						
Replace Steel Span and upgrade bridge rail						
COMMENTS						
<p>This short steel span was added to this half bridge in 1950. The timber deck is deteriorating and needs to be replaced. Options will be explored, the assumption is a concrete slab will replace this steel span.</p> <p>Bridge Item Estimate: Repl Steel Span with concrete slab - $400 \times 33 \times 17 = \\$224,400$....say \$250,000. Upgrade bridge rail - $300 \times 290lf = \\$87,000$...say \$90,000. Bridge Item Total = \$340,000....use \$350,000 Project Total = Bridge Item x 2 = \$680,000....use \$700,000</p>

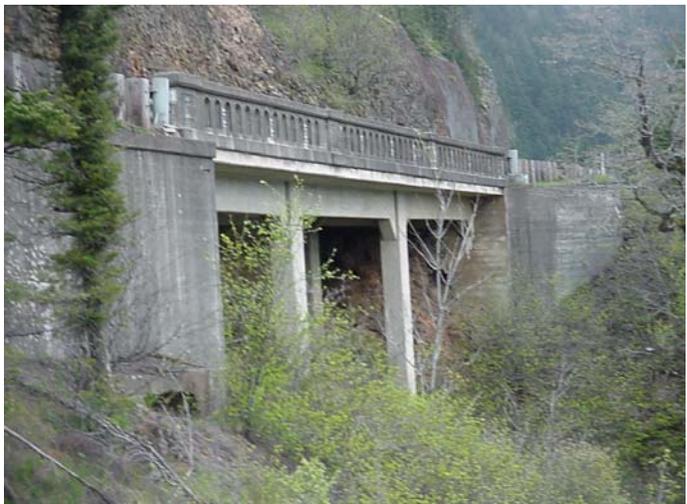
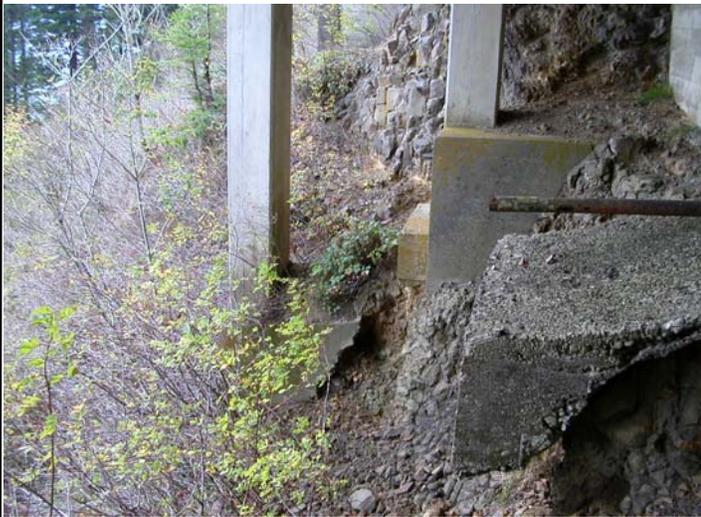
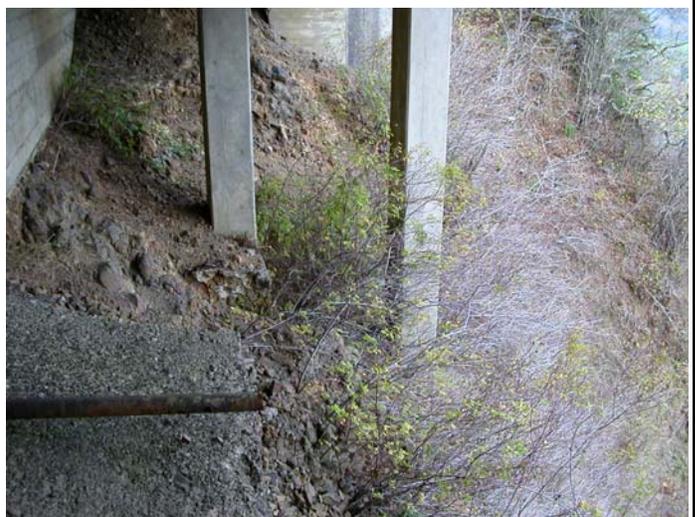
Condition coded to a "4" due to exposed footings at Piers 2 and 3. Footing are on a steep erodable slope. Columns 2A, 2B, 3A, and 3B are founded on erodible rock and have exposed footings. Column 3A has 4" of exposed rebar due to lack of cover at the top of the north face. Spread footings at Columns 2A, 2B, 3A and 3B are sitting on highly weathered basalt (Photos #3-6) and are exposed. The supporting rock at the Pier 2 footings are eroded to a vertical face parallel to the footing face. An 18" concrete culvert dumps water on a concrete pad in the vicinity of the footings.

Shotcrete rock slope around foundations under half bridge

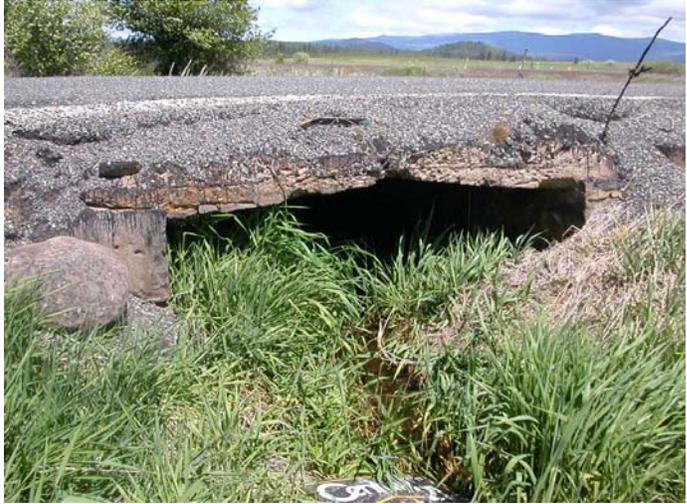
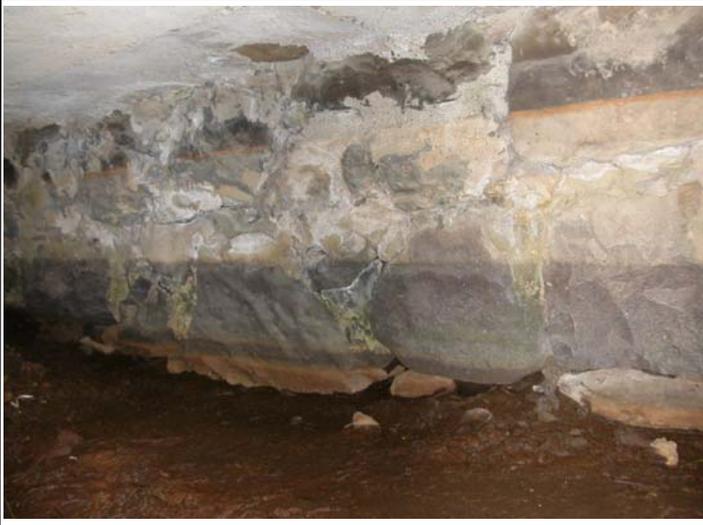
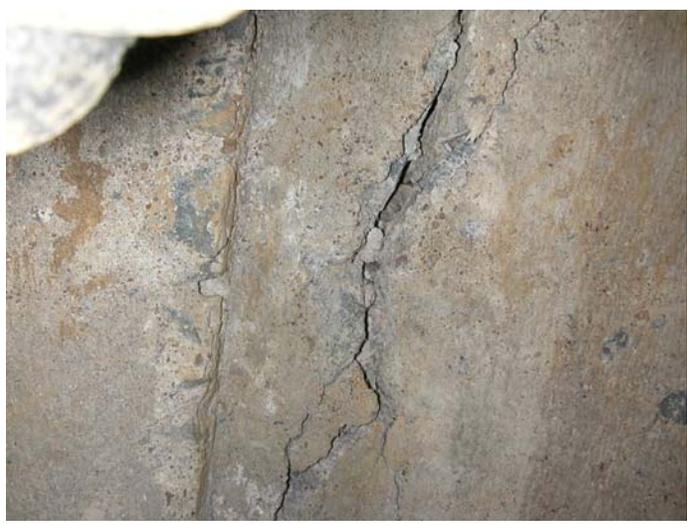
Repair Description:						
Replace Culvert						
COMMENTS						
<p>Masonry Culvert is oriented south to north. SR 142 is oriented west to east. Culvert is located within the "Y" at SR 142 and Glenwood Road. Crack up to 1" wide and minimum 2" deep in ceiling along the centerline of the structure (transverse to direction of traffic). The only reinforcement appears to be two layers of welded wire fabric. Culvert is deteriorated with spalls, delams and rock pockets in ceiling. Walls are stone and mortar with leaching, missing mortar, and areas of patches. Unknown foundations.</p>

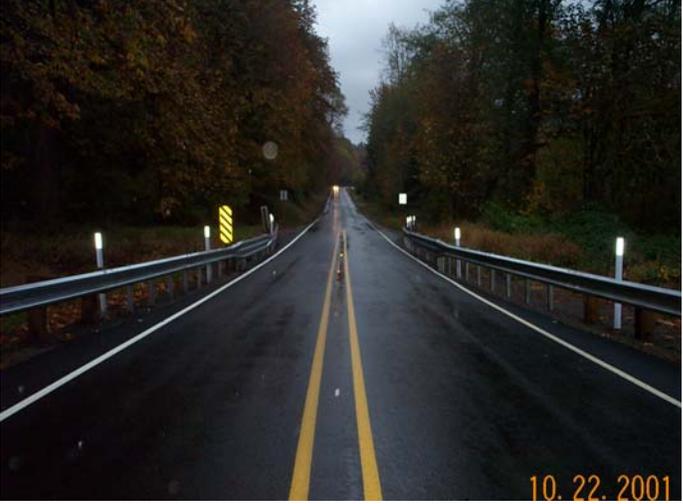
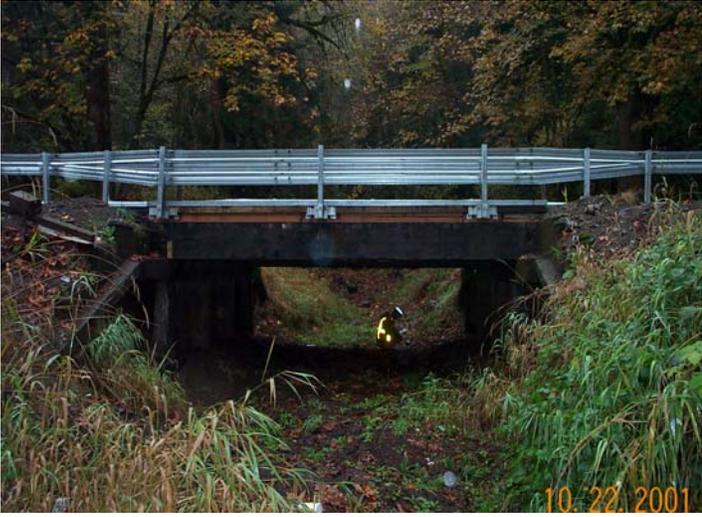
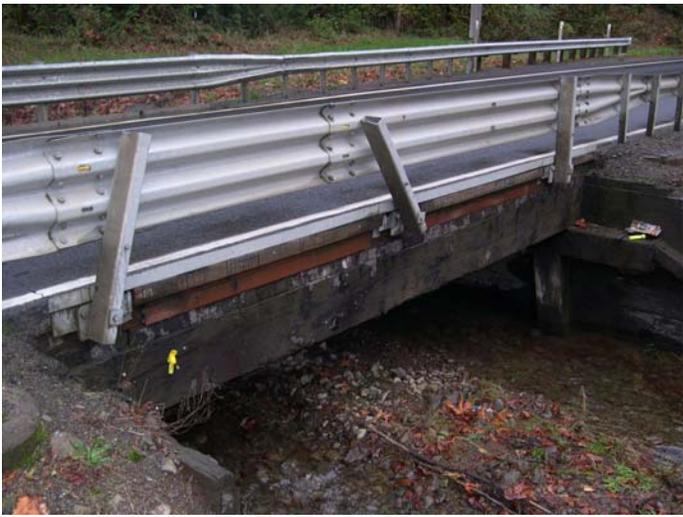
Repair Description: Replace Timber Bridge							
COMMENTS							
The replacement of this structure should be done with bridges 508/23 and 508/25. The bridge has a history of stream aggradation. Plans of the bridge are unavailable. Superstructure coded as a "4" due to the RT Girder, Girder 1A.
