P2 Bridge Preservation - Scour Repair

2009-11 Bien Priority Array

Bridge Foundation Scour Repair

Southwest Region

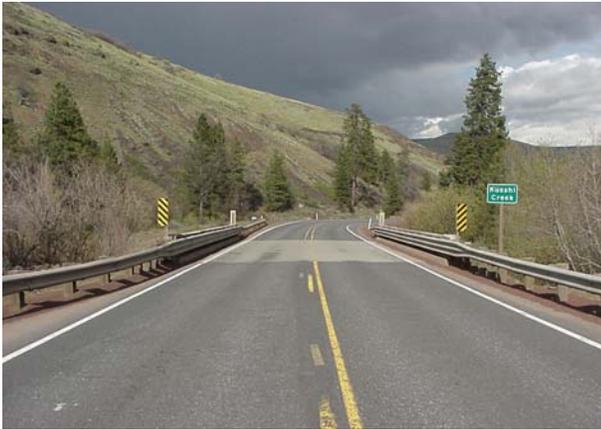
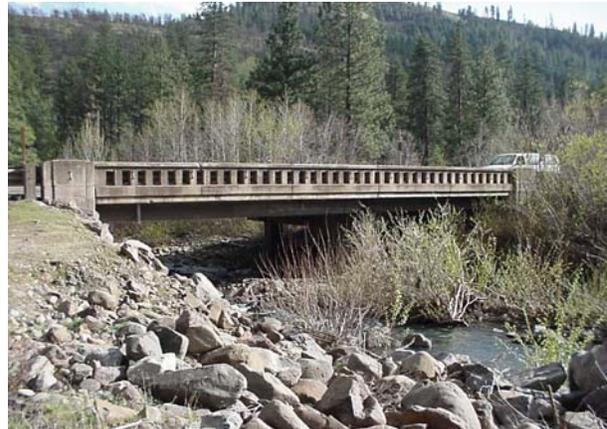
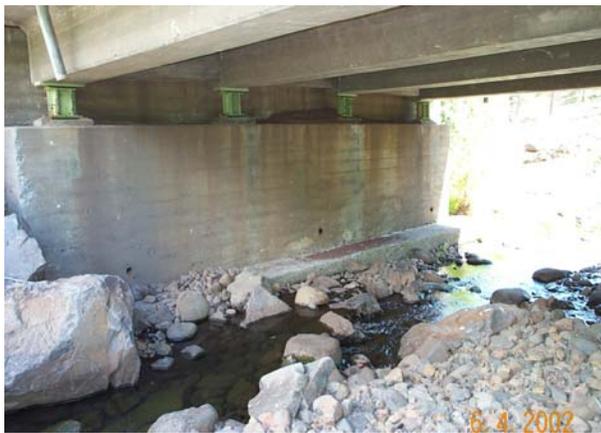
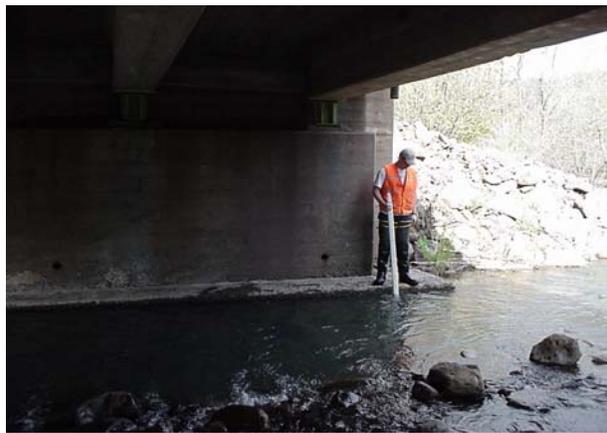
Pier 3 (North Abutment) has exposed footing for full length. Sill exposed up to 1.5' along East half of P3. Heavy riprap placed on the NW bank. Debris is building up on the abutment. Footings are 2 feet thick with no seals. Plans indicate footings may be on bedrock.

BPO - Repair riprap at Pier 3.
Bridge Management Unit - Prioritize against other statewide scour needs in the 2009-11 biennium.

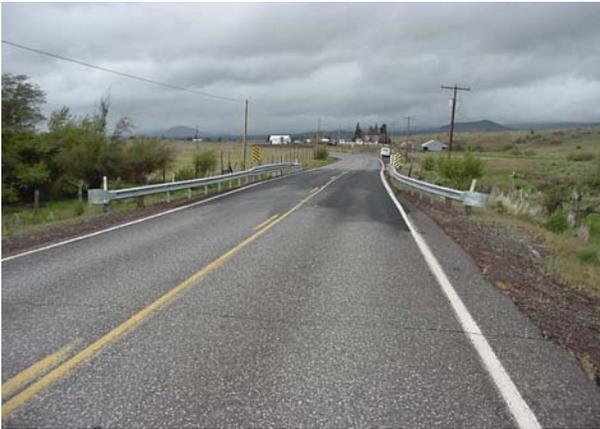
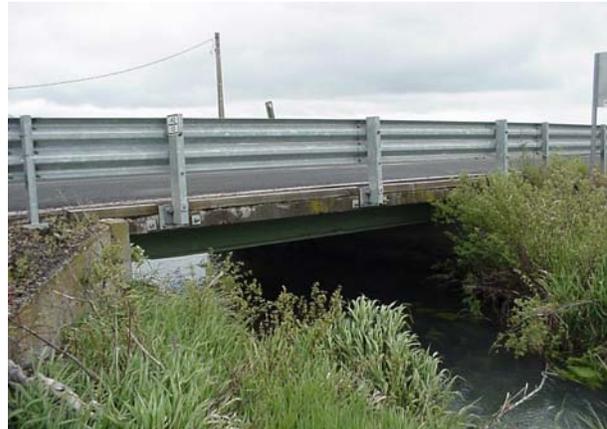
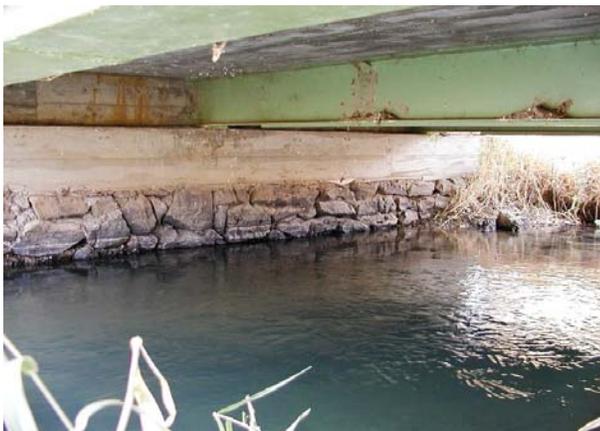
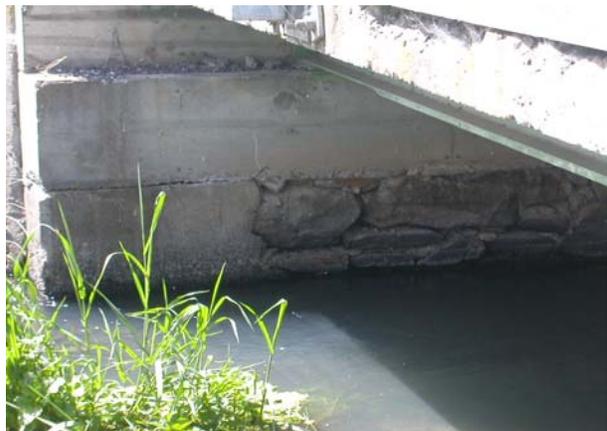
Stream flows against both abutments. Heavy silt deposition 2' thick at west abutment. Abutments are Stone & mortar wall. Unknown foundation depth. Mortar has been eroded by the stream action. Bridge has contraction scour problem and needs as much hydraulic opening as possible.

BPO - Place well graded light loose riprap, two to three layers deep (1' thick min.) along both stone & mortar abutment walls, tapering out at a 2:1 slope, blending into the existing groundline and banks. Repair modified 6/6/06 to priority 1 due to undermining of the east abutment per JHL/DCC.
Bridge Management Unit - Prioritize against other statewide scour needs in the 2009-11 biennium.

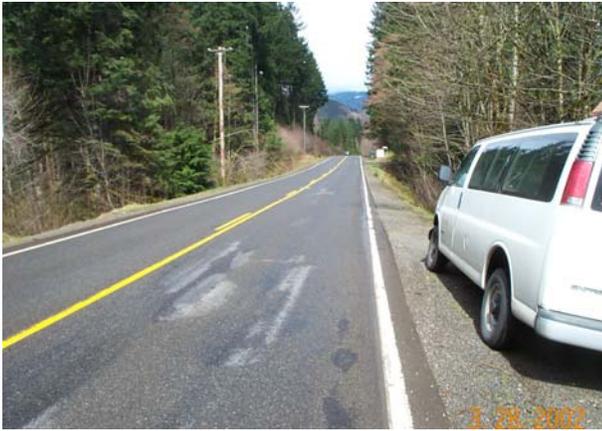
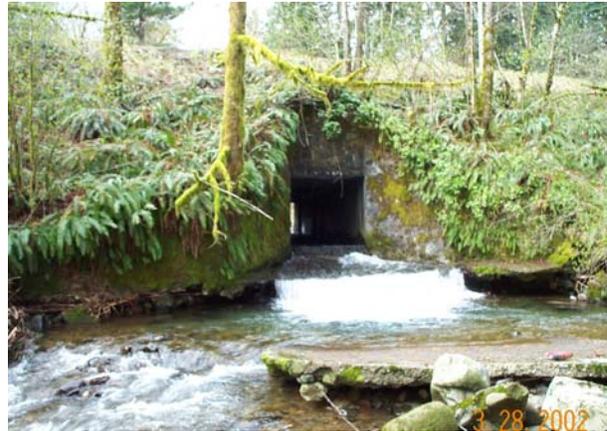
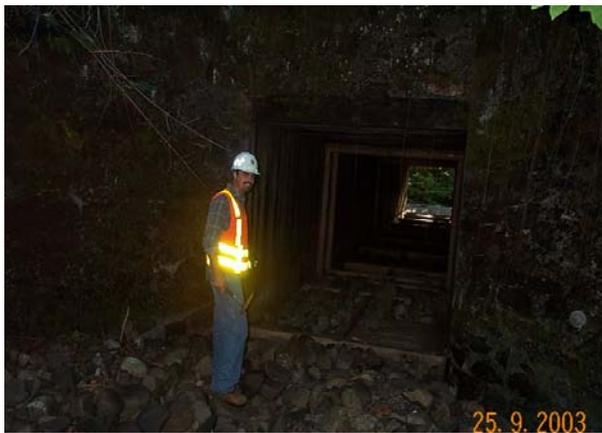
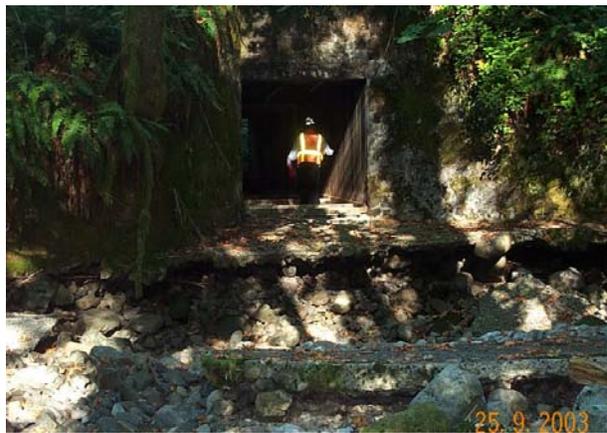
A large scour hole downstream of the structure. Half of the downstream concrete apron has broken off and is laying 20' downstream. The stream drops down 3' off the remaining apron which is undermined 4'. The upstream scour needs further mitigation.

BPO - Correct for erosion and repair the concrete apron at the downstream end. Erosion has undermined the apron approx 4ft. and the NE masonry wingwall.
Bridge Management Unit - Prioritize against other statewide scour needs in the 2009-11 bien.
