# **Asphalt-Rubber Binder Stress Absorbing Membrane Interlayer**

Final Report  
WA-RD 128.1

Wheeler I/C to Adams Co. Line, I-90

Final Report  
EXPERIMENTAL PROJECT WA 77-02  
FHWA Contract DOT-FH-15-248

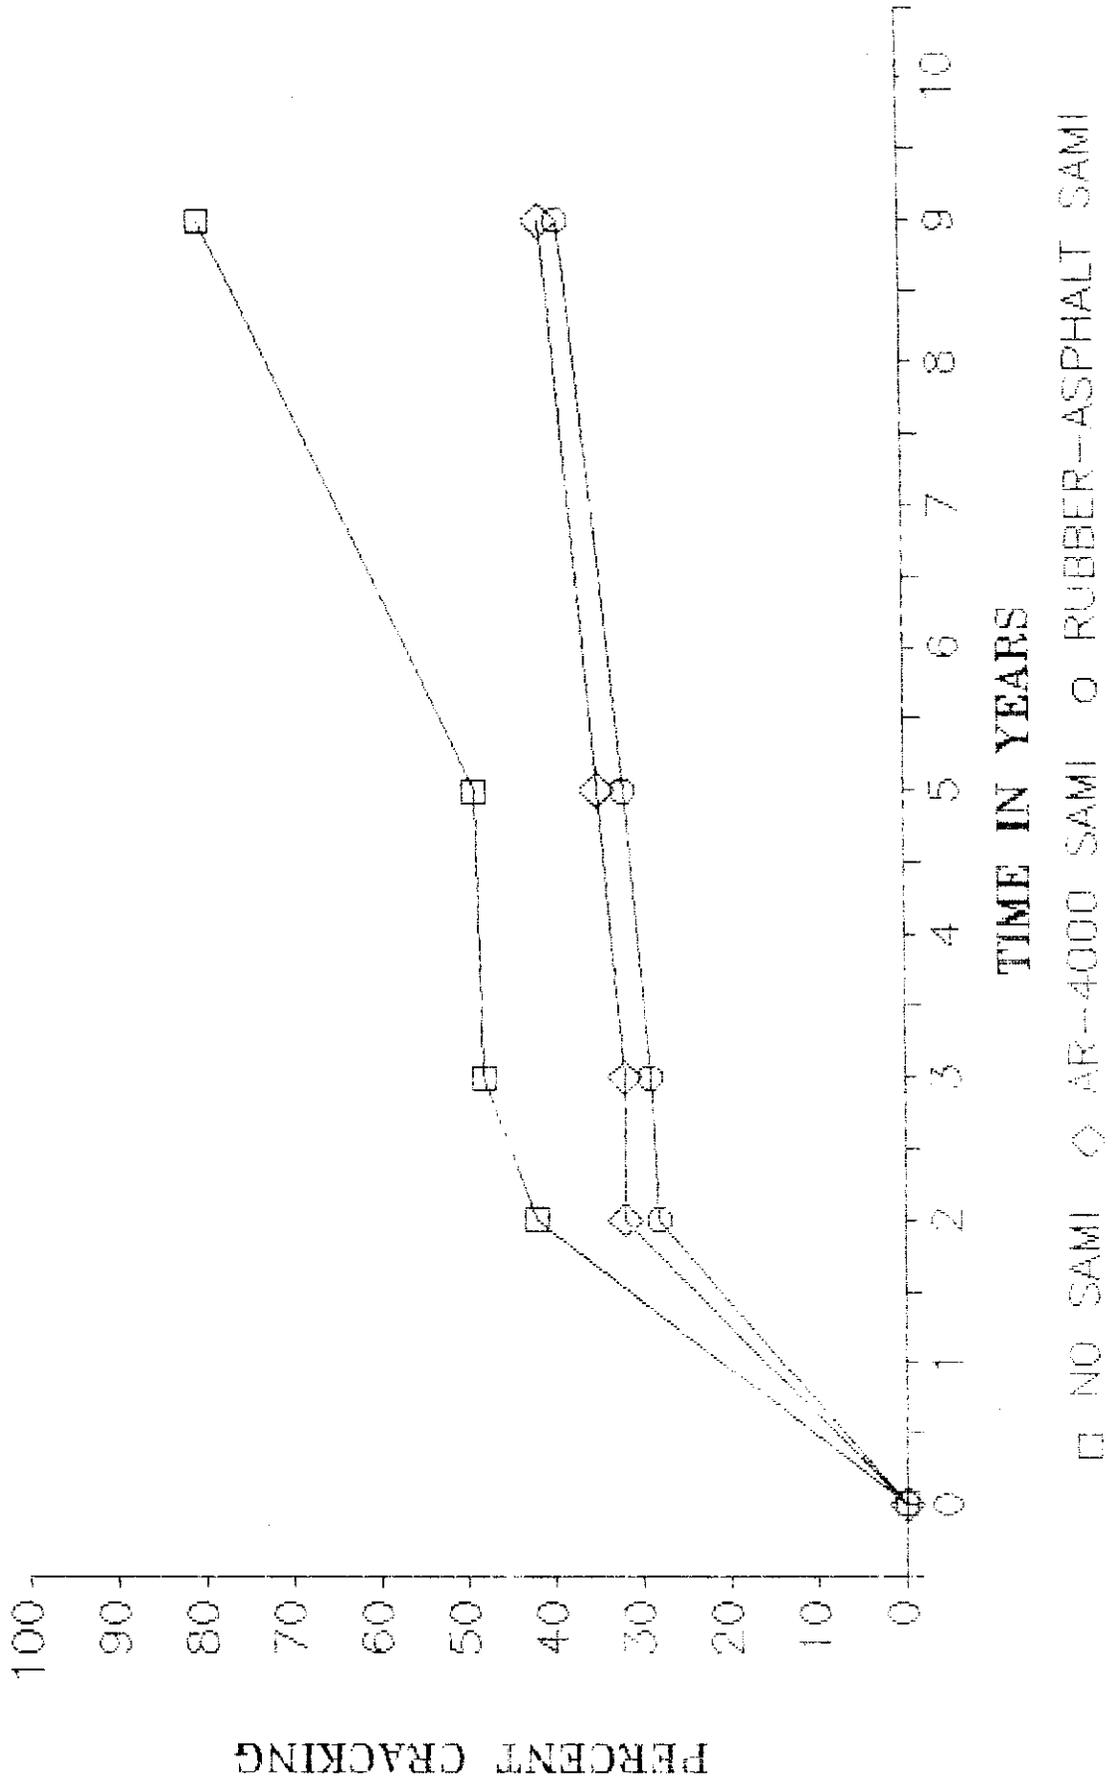
Figure 1

A comparison of the transverse cracking from the infrared photographs with the transverse cracking now present indicates that most of the major transverse cracks have reflected through the overlay. The asphalt-rubber SAMI study sites are now showing 39 percent of the original cracking which compares with 41 percent for the paving grade asphalt SAMI and 80 percent for the control section without either type of SAMI. The comparison can be seen in Figure 1. The asphalt-rubber SAMI, which costs twice as much as the paving grade asphalt SAMI, is functioning only slightly better than the paving grade asphalt SAMI in preventing or reducing transverse reflection cracking. Both SAMI's are performing much better than the section with just CSS-1 tack coat and overlay, however this might be due totally or in part to the additional overlay thickness imparted by the SAMI's.

PERCENTAGE OF CRACK REFLECTION  
VERSUS TIME
