Evaluation of Tieback Performance

WA-RD 269.1

Final Technical Report
January 1993

Final Technical Report
Research Project GC 8719, Task 19
Tieback Performance

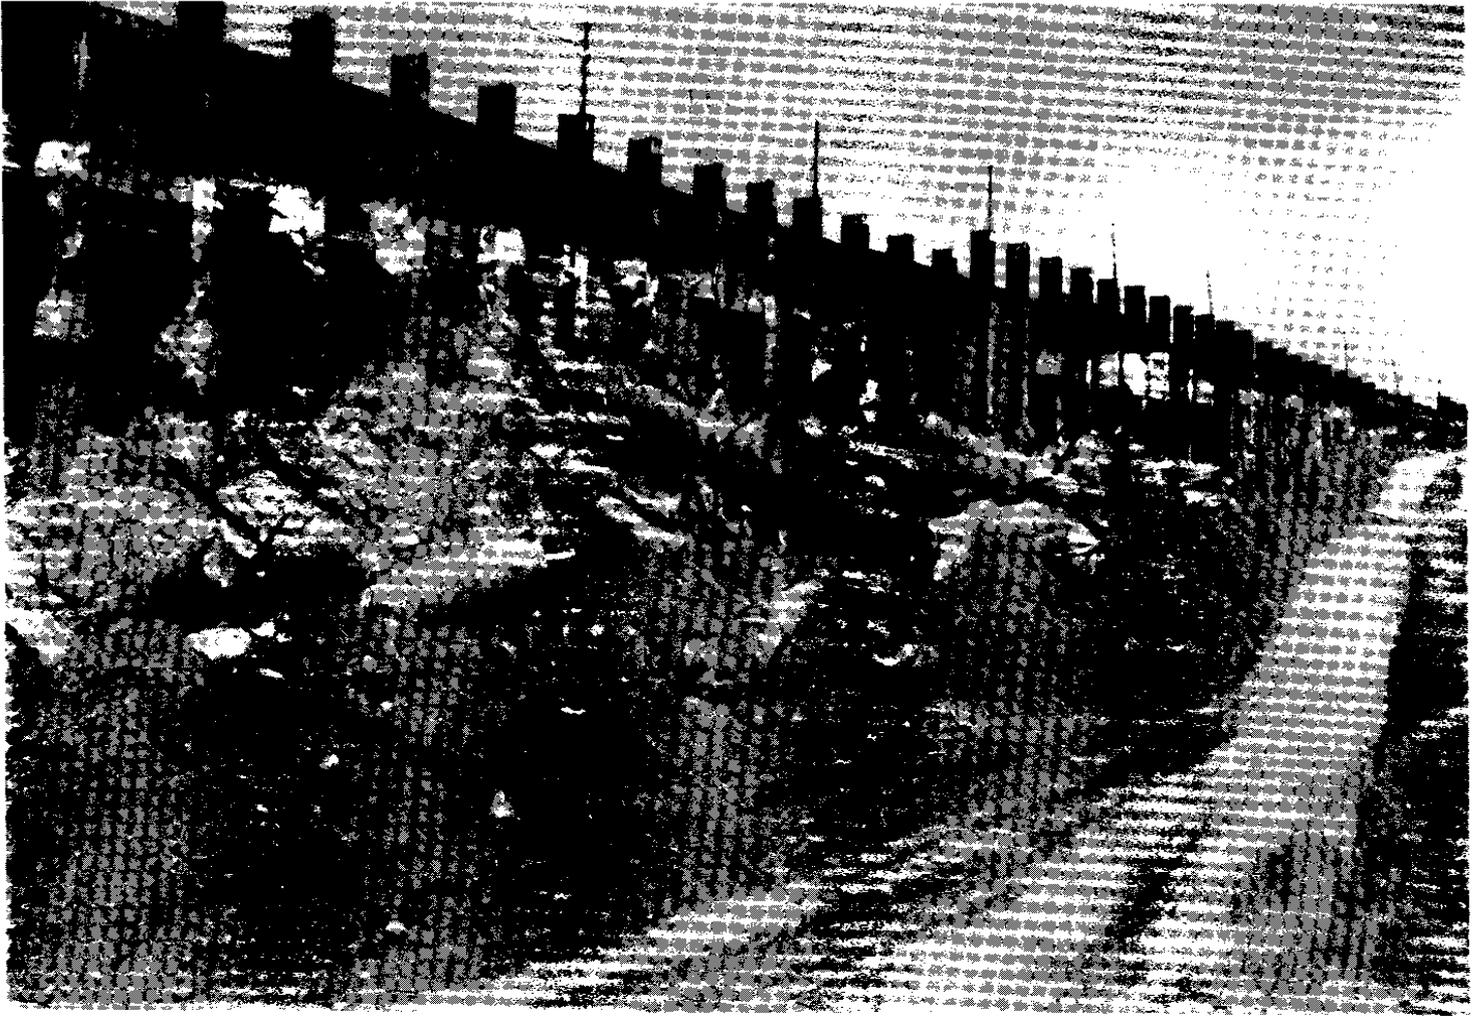
Figure 8. Typical Disturbance Caused by Mass Excavation with Bulldozers and Backhoes

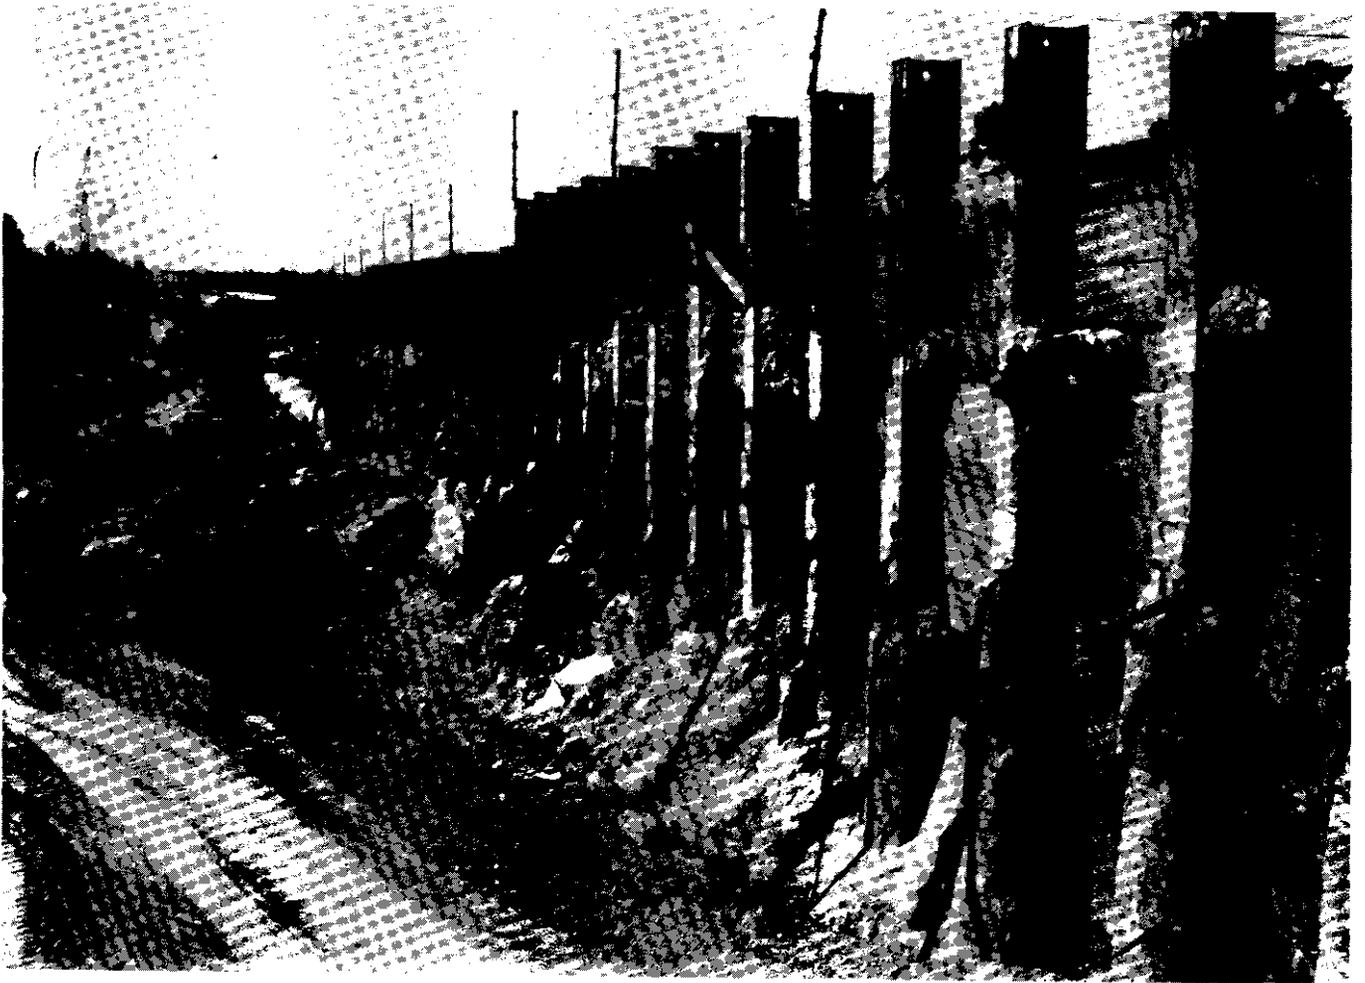
Figure 15. Highly Disturbed Anchor Tendons in No-Load Zone

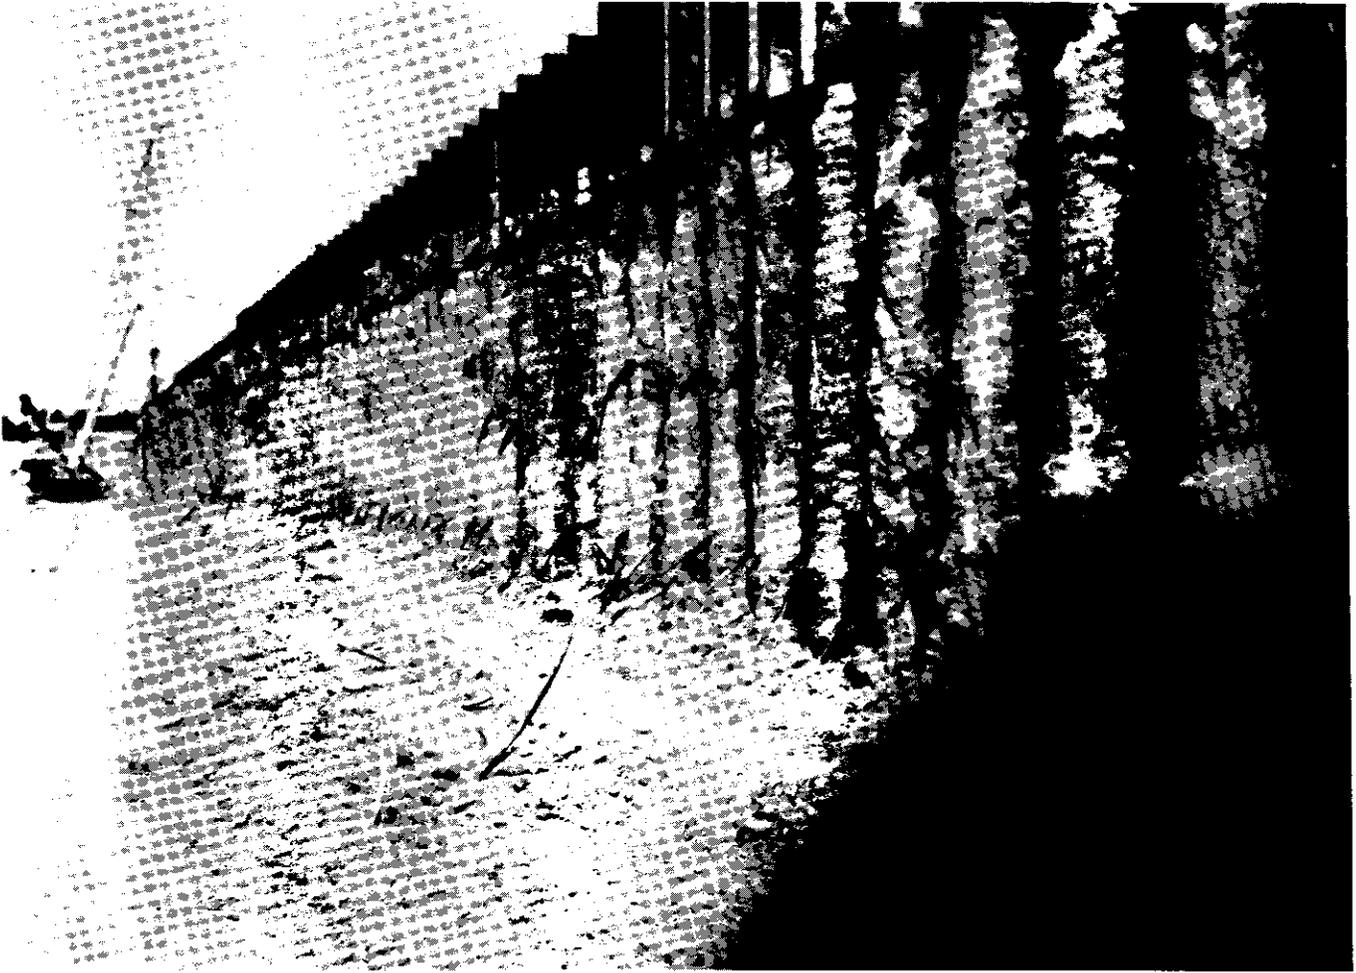
Figure 16. Anchor Tendons Cut Such That Characteristics in No-Load Zone Could Not Be Observed

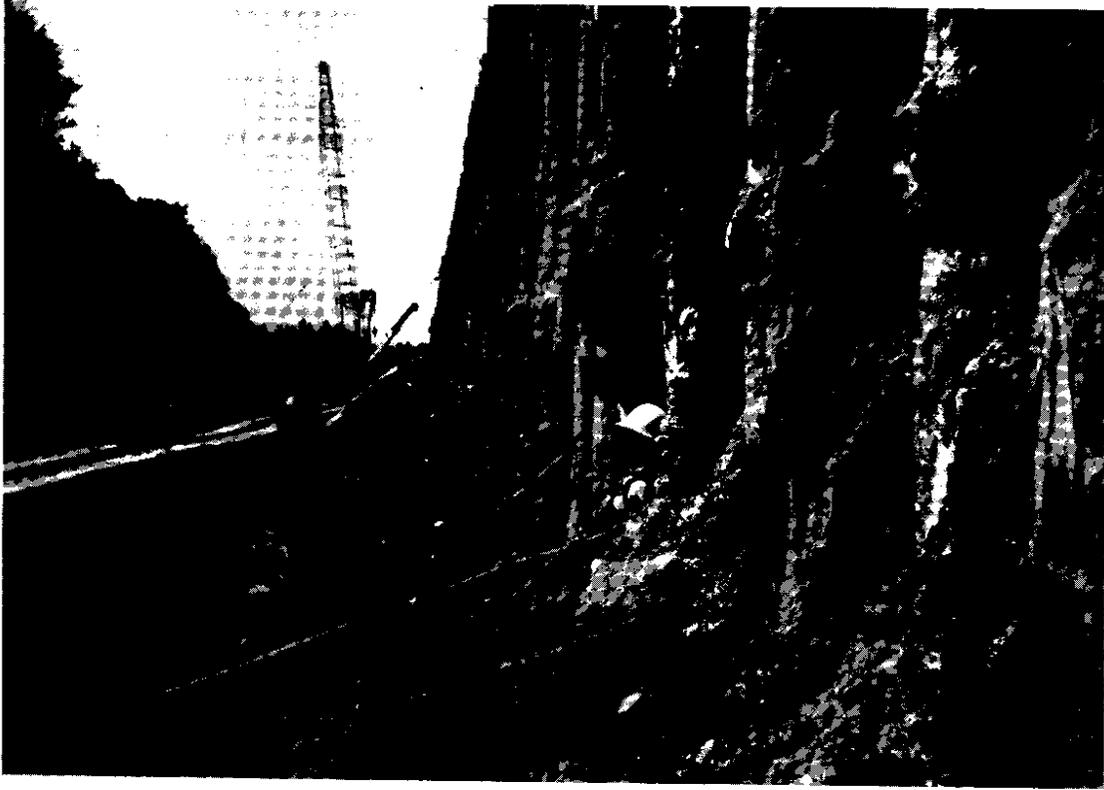
As a result, the general state of disturbance of each tieback was also noted to identify any correlation between disturbance and other characteristics. As illustrated in Figure 17, disturbance of the tiebacks ranged from negligible to severe.

Figure 17. Variable Tieback Disturbance in Anchor Head/Trumpet Zone

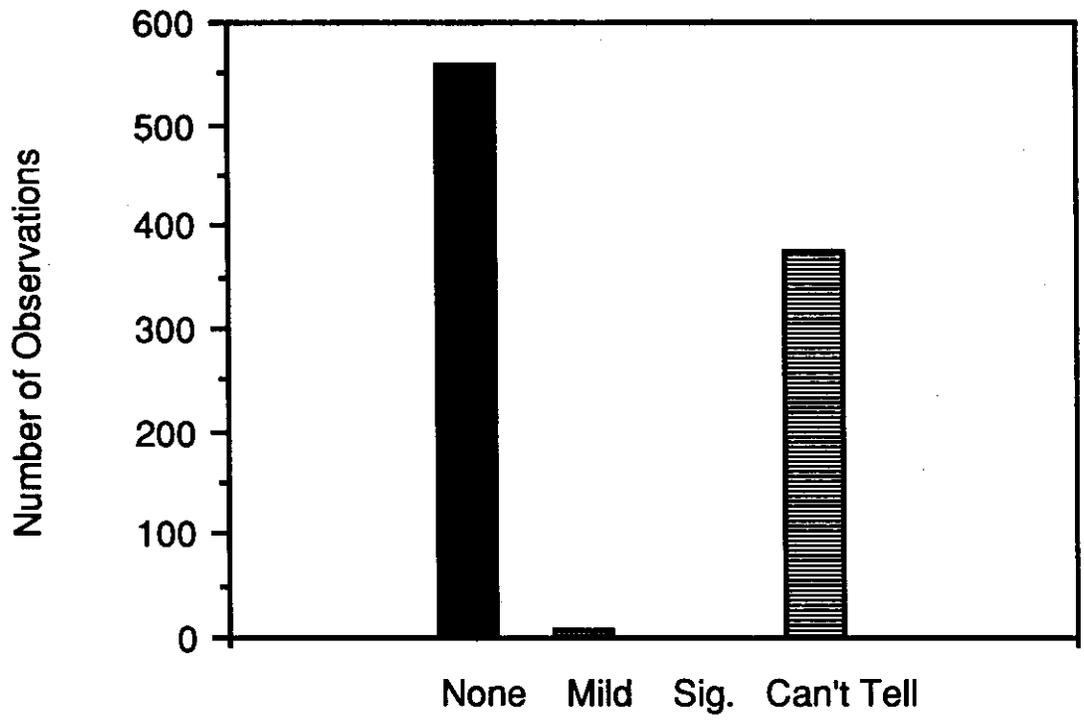
The observations of anchor tendon corrosion were notable for the lack of significant corrosion. In 375 of the 944 tiebacks that the researchers attempted to observe, it was impossible to determine whether corrosion had occurred. Of the remaining 569 anchor tendons, however, no corrosion was observed in 560 (98.4 percent). Evidence of mild corrosion was observed on only 9 (1.6 percent) anchor tendons, and *significant corrosion was not observed on any anchor tendon*. The distribution of observed tieback corrosion is shown graphically in Figure 19.

Figure 19. Observations of Anchor Tendon Corrosion

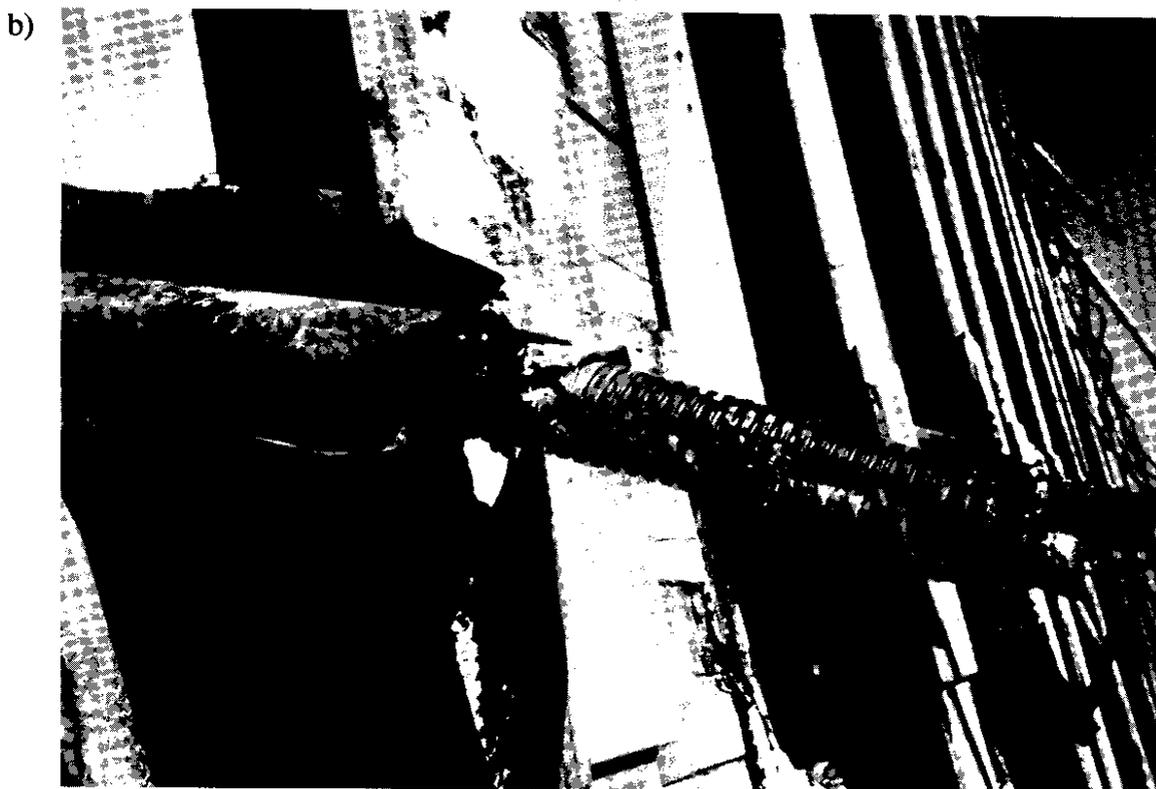
Observations of grease leakage from the trumpet, which would indicate increased potential for corrosion in the anchor head zone, were complicated by physical disturbance of the anchor tendon and trumpet during excavation. Figure 20 shows examples where mild grease leakage was observed with little and moderate tieback disturbance. At some locations, it appeared obvious that the observed grease leakage was exacerbated, if not wholly caused, by anchor tendon disturbance. As a result, the grease leakage observations must be interpreted in conjunction with observations of the level of anchor tendon disturbance.

Figure 20. Observations of Mild Grease Leakage with (a) Little Anchor Tendon Disturbance, and (b) Moderate Anchor Tendon Disturbance

Specification of a positively sealed trumpet should be considered for all permanent tieback installations. The trumpets observed in this investigation overlapped the outer layer of anchor tendon corrosion protection, but did not use a positive seal. Though the rate of observed leakage was quite small, and though occurrence of grease leakage does not directly lead to the occurrence of corrosion, the potentially dire consequences of corrosion in the anchor head/trumpet area requires that such a specification be considered. As an alternative, grout sealing should also be considered.

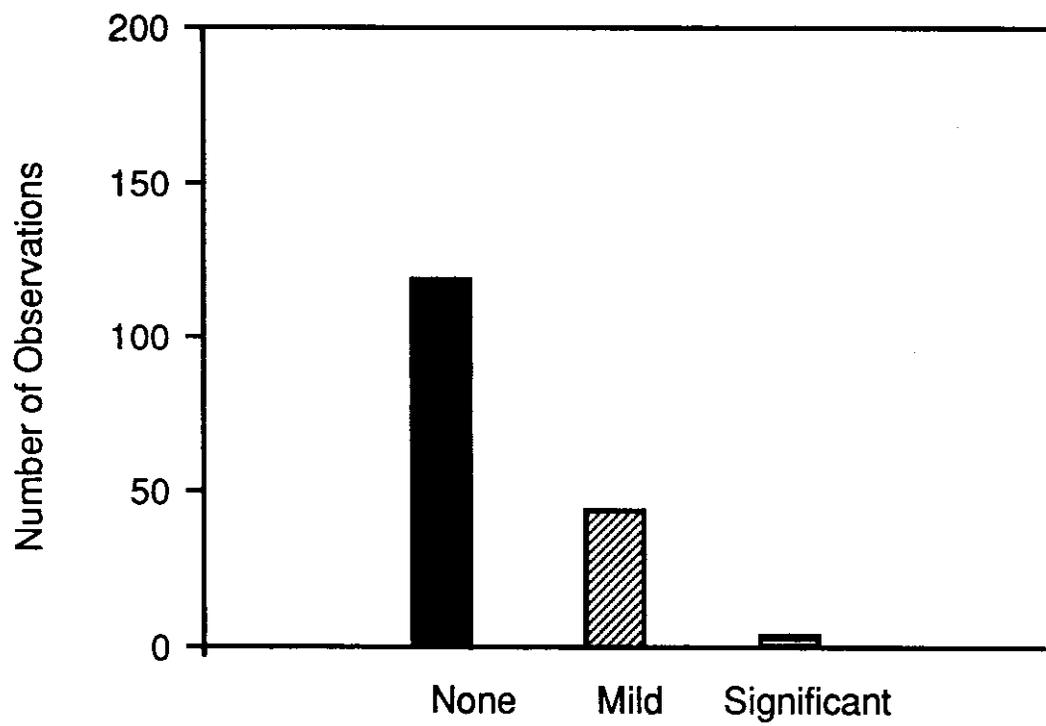
The most useful of these observations were those for which no evidence of anchor tendon disturbance was visible. As illustrated in Figure 21, over 71 percent of the undisturbed trumpets exhibited no noticeable leakage, and only 2.4 percent exhibited significant leakage. Even for those in which significant leakage did occur, evidence of significant corrosion of the anchor tendon was not apparent.

Figure 21. Distribution of Grease Leakage Observations among Trumpets for Which No Disturbance Was Observed

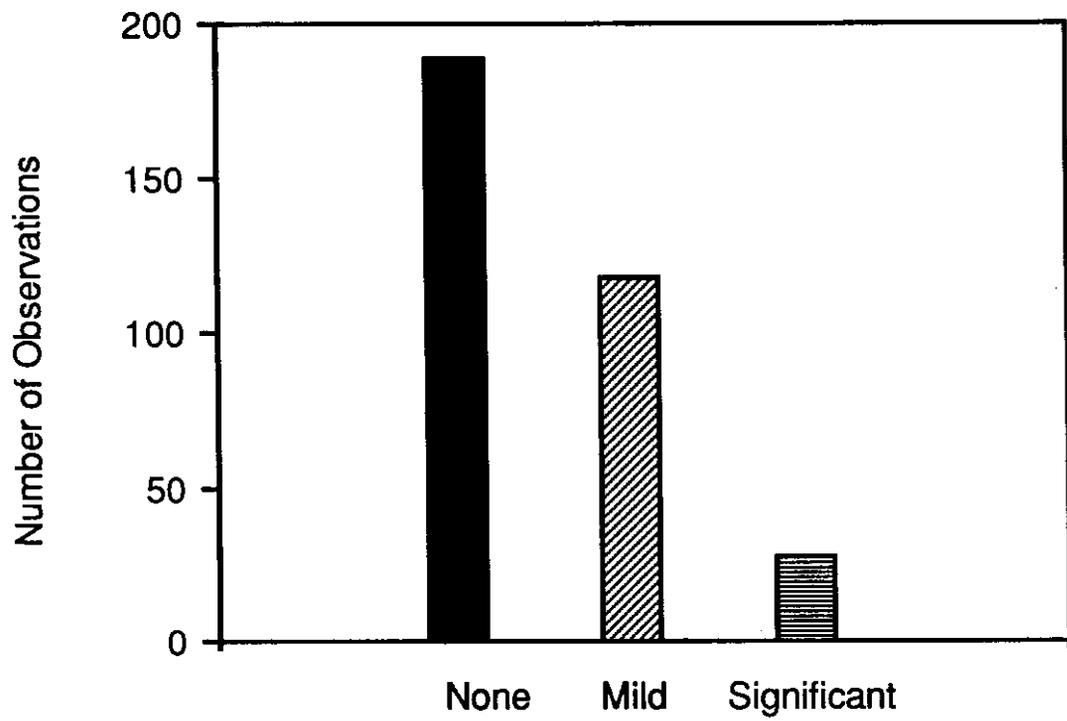
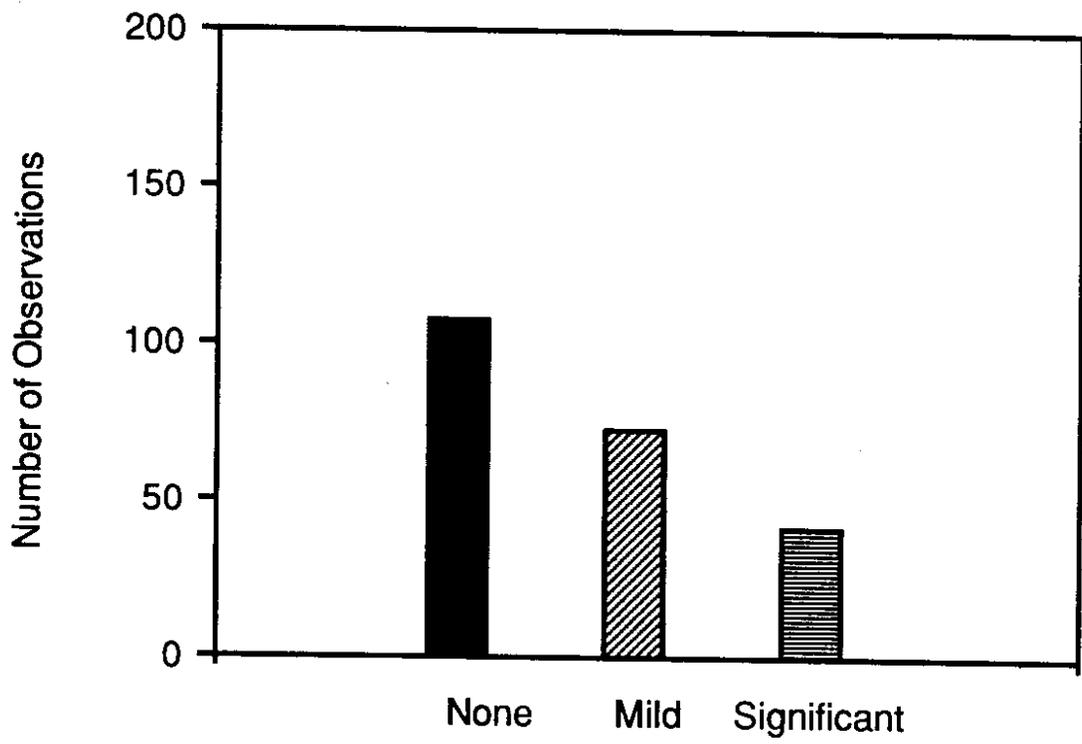
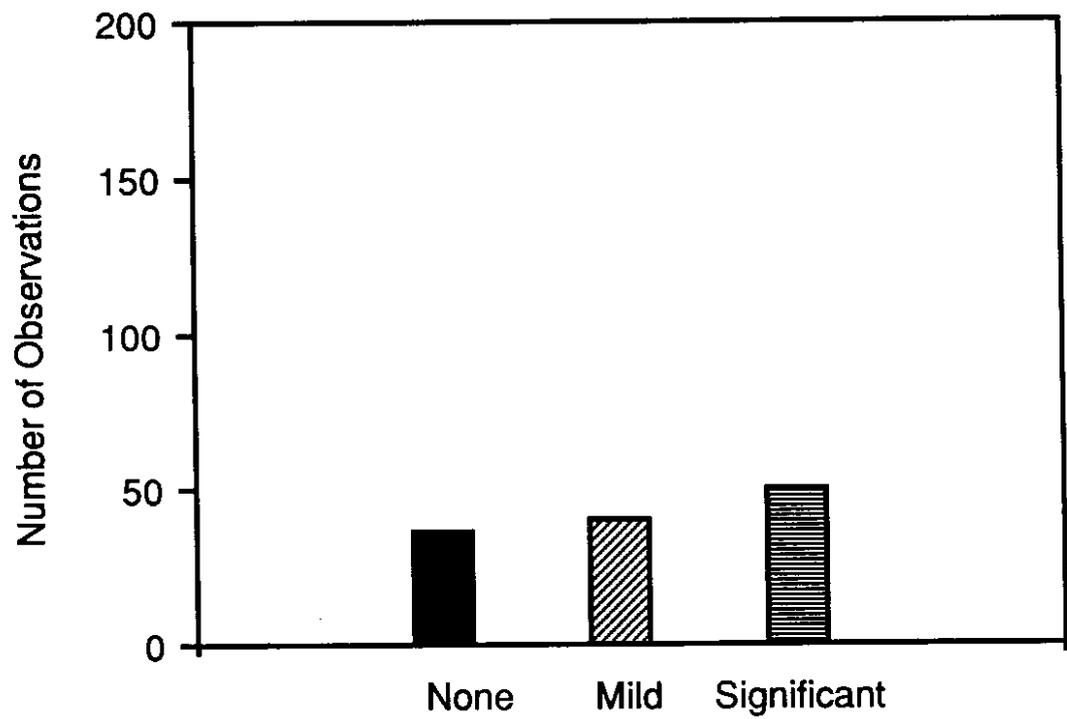
Correlation between the amount of grease leakage and the amount of anchor tendon disturbance was significant, as indicated in Table 2 and in Figures 22, 23, and 24, which show respective grease leakage observations for little, moderate, and severe disturbance. Figure 25 illustrates the distribution of anchor tendon disturbance associated with observations of significant grease leakage. Even for those in which significant leakage did occur, evidence of significant corrosion of the anchor tendon was not apparent.
