PERFORMANCE OF GEOTEXTILE SEPARATORS

WA-RD 321.2

Final Report
January 1996

Final Summary Report
Research Project T9233, Task 13
Geotextile Separators II

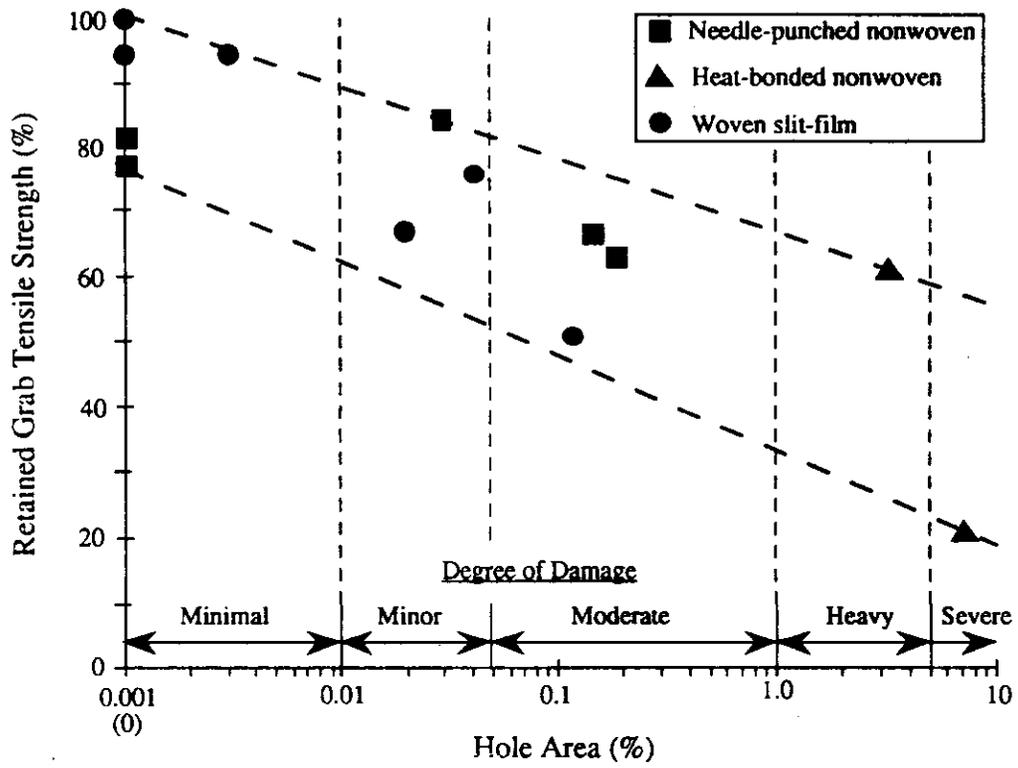
Figure 5. Percent Retained Strength vs. Percent Hole Area

The results in Figure 5 are similar to those of Koerner and Koerner (6, 7), although they plotted their results as a function of the number of holes greater than 6 mm, rather than as the percentage of hole area. Thus, a hole 30 mm in diameter would have the same credit as a hole 6 mm in diameter. It is more meaningful to plot the percentage of retained strength as a function of the percentage of hole area of each geotextile.

It is interesting to note that, of the four geotextiles that did not sustain any damage, the two woven geotextiles had higher percentages of retained strengths than the two needle-punched nonwoven geotextiles. Although the heat-bonded nonwovens had the highest percentage of hole areas, the geotextile from the Coal Creek Road site had a reasonable retained strength. This finding could be due in part to the fact that most of the

holes in the geotextile were quite large, and tensile test specimens were not taken in those areas. The geotextile from the Carroll Road site had numerous, very uniform holes, and its retained strength values are quite indicative of its present condition.

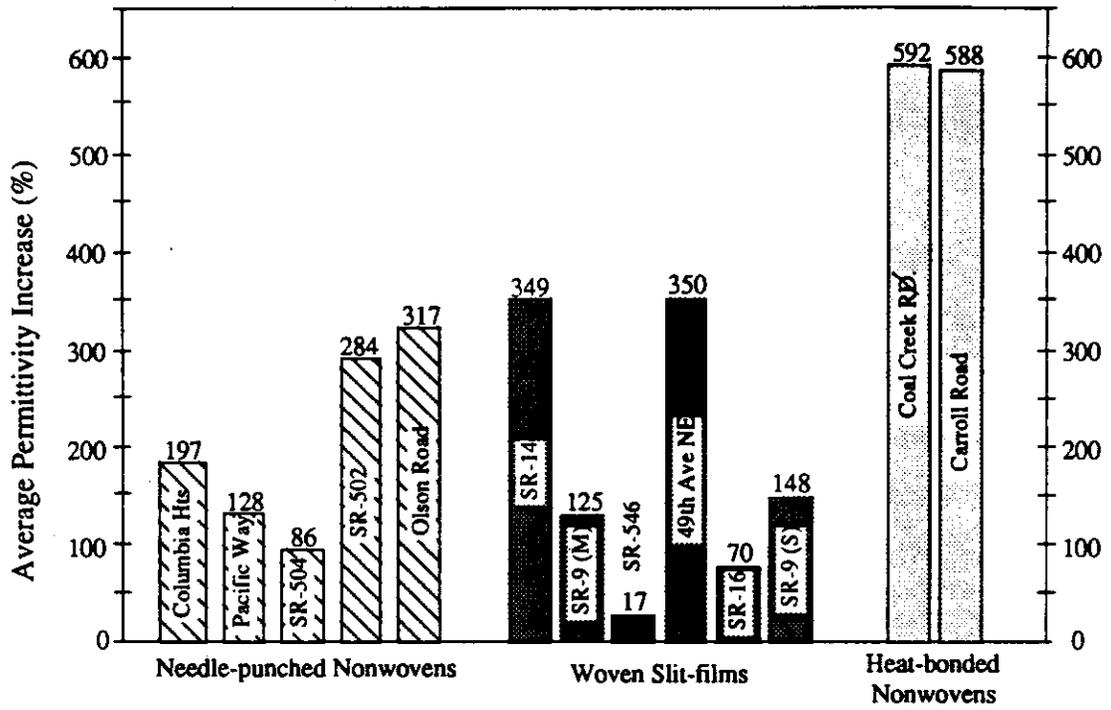
Figure 7. Average Percentage Permittivity Increase (after washing) vs. Geotextile Type

Laboratory permittivity tests were conducted to assess the general blinding/clogging characteristics of the recovered geotextiles. Figure 7 shows the results of the permittivity tests as a percentage of permittivity increase after washing according to geotextile type. The needle-punched nonwovens and the woven slit-films performed similarly. The two needle-punched nonwovens with the greatest increases in washed permittivity were from the SR 502 and Olson Road sites. The SR 502 geotextile was

installed over a lean clay subgrade. The geotextile at the Olson Road site was installed over a silty sand subgrade. The woven geotextiles with the greatest washed permittivity increases experienced significant caking. Both of the heat-bonded nonwovens showed the highest increases in washed permittivity. Even the heat-bonded geotextiles overlying the organic debris at Coal Creek Road had a high increase in washed permittivity. This indicates that the heat-bonded nonwovens are more susceptible to clogging than are other geotextiles.
