Post Construction Report
In-House Experimental Feature

EVALUATION OF TRINIDAD LAKE ASPHALT OVERLAY PERFORMANCE

Contract 6441
SR-16
Tacoma Narrows Bridge – Eastbound
MP 7.28 to 8.41

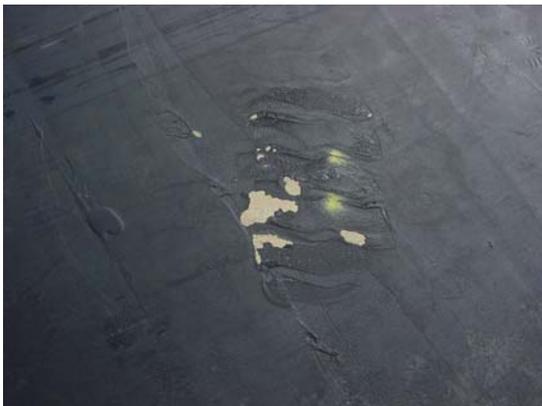
In many places the polymer modified bituminous hot melt adhesive had been damaged by equipment. Repair of these areas consisted of applying additional polymer modified bituminous hot melt adhesive the morning of the paving. Before paving, the area to be paved was cleaned of debris by hand broom.

Figure 7. Damage to adhesive layer.

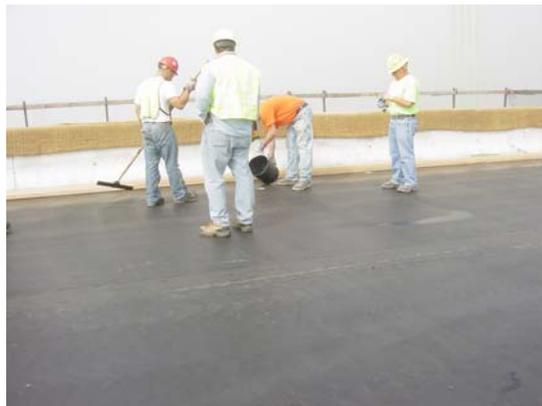
Figure 8. Repairing adhesive layer.

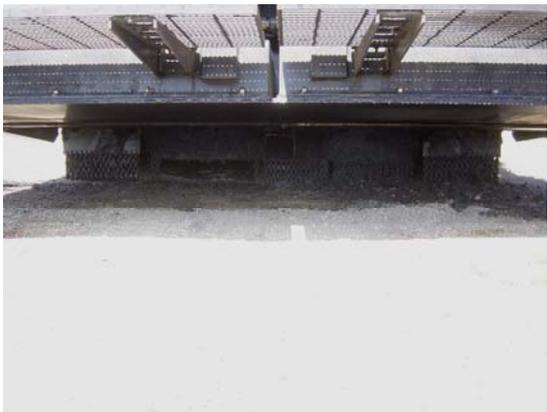
Paving was accomplished using an Ingersoll-Rand/Blaw-Knox PF-4410 paver (Woodworth equipment number 703) and a Terex/Cedarapids CR 662RM Road Mix transfer vehicle. Inspection of the paver revealed that it was missing a section of the mix management kit (MMK). The MMK is a retrofit which consists of a series of chains that help to contain the mix in front of the screed in order to prevent segregation. Without the MMK retrofit, less mix is distributed to the area in front of the gear box which can leave a segregated streak in the center of the mat. It is not clear if the missing section contributed to the streaks in the mat (See Streaks in Pavement). From June 21 onward, the paver was replaced by another Blaw-Knox PF-4410 paver (Woodworth equipment number 710) which had an intact retrofit kit.

Figure 11. Missing chains on MMK retrofit on Ingersoll-Rand Blaw-Knox PF-4410 paver.

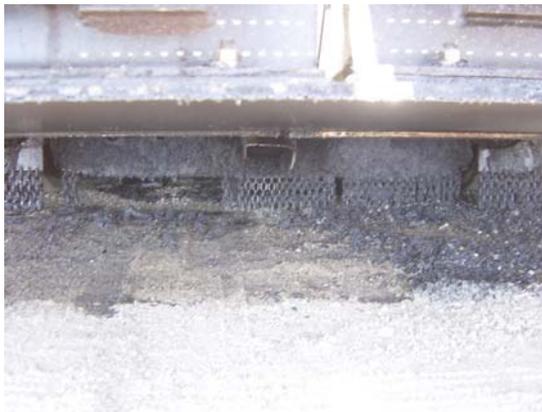
Figure 12. Missing chains on MMK retrofit.

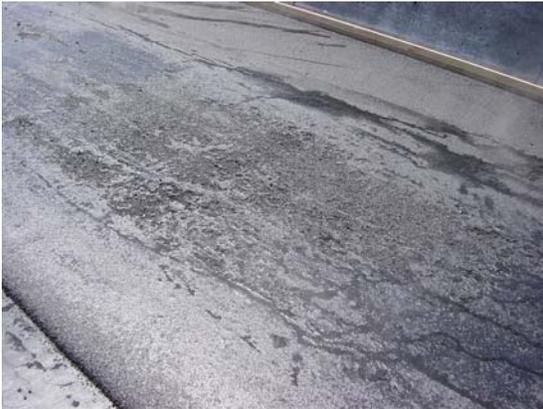
During placement of the job control strip for the base course the large rollers began picking up mix from the newly laid mat. Pickup occurred between 300 and 700 feet from the west end of the bridge. The mix had to be removed from the roller drums before the roller could continue, delaying the compaction operation. Voids left in the mat were repaired by carrying mix back to the damaged area in shovels and a wheelbarrow. Despite the repair efforts voids and open areas remained in the mat. The voids were more or less centered about 6.5 feet from the

Figure 16. Mix pickup area immediately after rolling.

face of the barrier. The problem ceased when the large rollers were removed from the paving operation and replaced by smaller rollers.

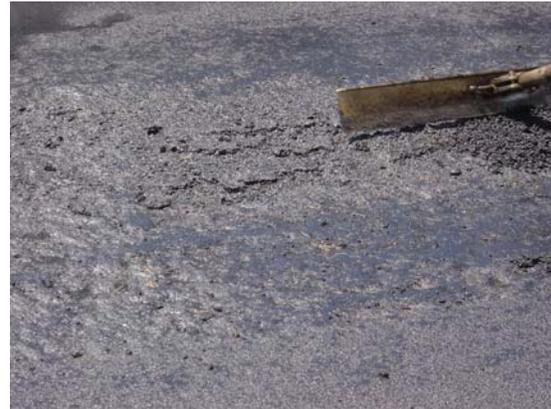
Figure 17. Raking in mix to repair pickup area.

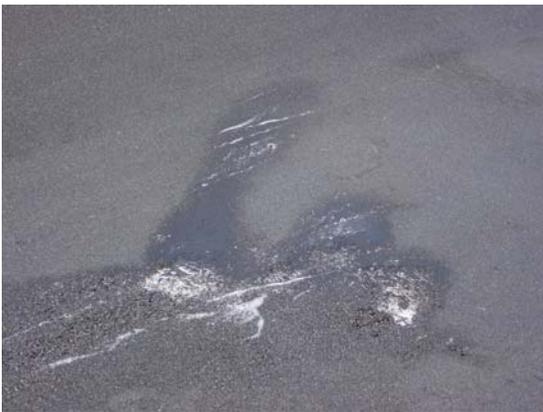
Figure 18. Area of mix pickup after completion of rolling.

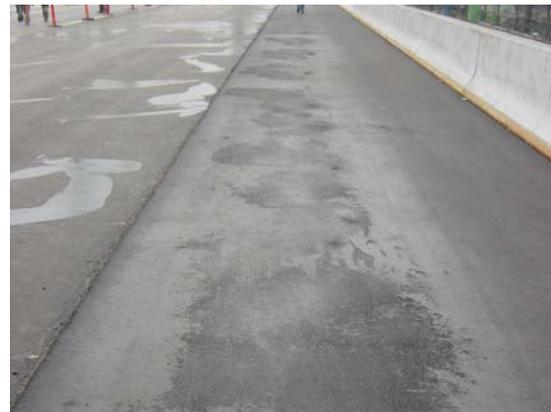
Figure 19. Area of mix pickup prior to the next days paving.

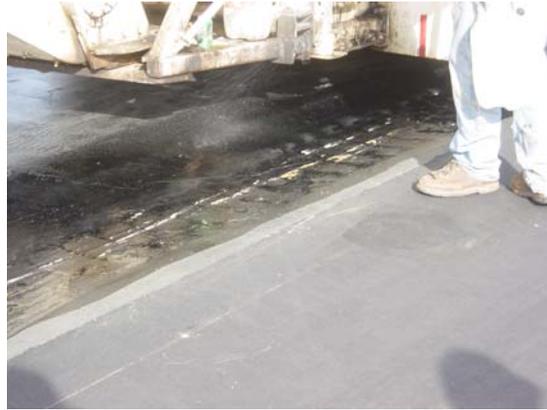
During placement of the base course the Contractor applied water using hand held sprayers ahead of truck tires and vehicle tracks in order to prevent damage to the polymer modified bituminous hot melt adhesive. One area of tack coat incurred damaged by the track on the Terex transfer vehicle. The area may have been more susceptible to damage since it had

Figure 21. Adhesion layer damaged by track.

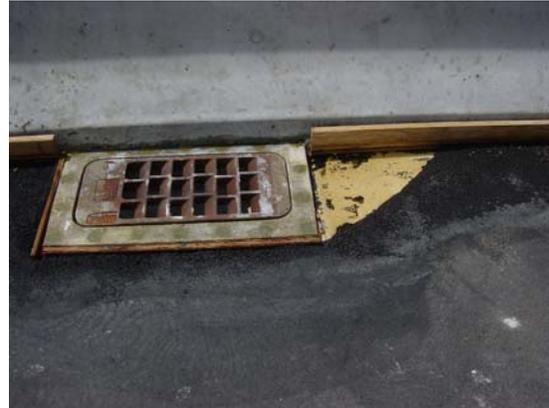
After completing paving the base course in Lane 2 at the west end of the bridge the Contractor turned the paving train around and began paving eastbound in Lane 3. A water truck sprayed water on Lane 2 to cool it enough to allow trucks which were delivering mix to pave Lane 3 to drive on Lane 2. At this time Lane 1 had only been paved to within about 250 feet of the east end of the bridge which left the bridge drains two inches higher than the current grade. The water flowed to the east end of the bridge and accumulated adjacent to the barrier in Lane 1 since it could not get into the bridge drains. After completion of paving Lane 3 the contractor proceeded to pave the remaining base course in the east end of Lane 1. The contractor attempted to remove the excess water that had accumulated in Lane 1 using leaf blowers prior to paving, but water was still present near the curb and over parts of the lane during paving.

Figure 23. Area removed near scupper due to water damage.

Portions of the base course and tack layer were affected by the water and had to be removed around the bridge scuppers. The repair consisted of reapplying the bonding layer and replacing the base course material at the end of the next days paving.

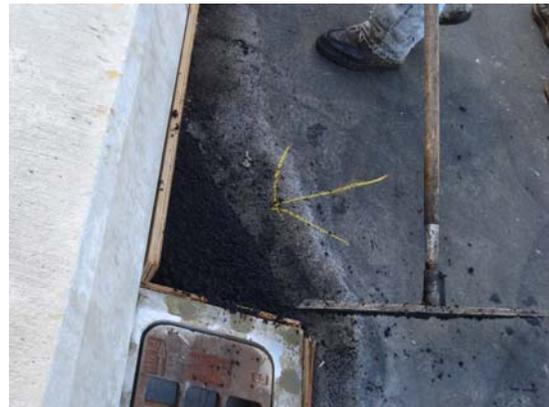
Figure 25. Repaired pavement.

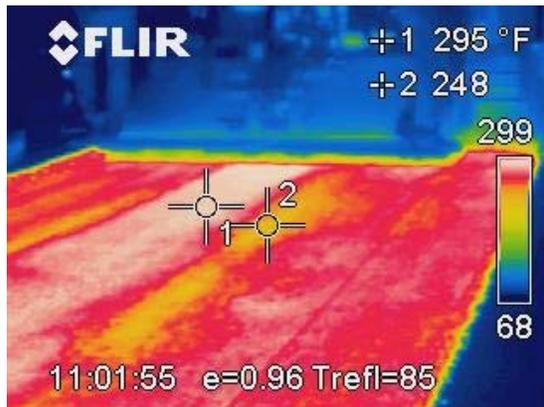
Infrared imaging was used during HMA placement to check for differences in temperature that could lead to potential density differentials. The imaging revealed temperature differentials ranging from 10°F to more than 40°F. Temperature differentials can lead to areas of inadequate compaction in the mat. They are usually caused by mix inside the haul vehicle cooling on the outside of the load faster than in the center. If the mix is not remixed before it passes through the paver, areas of cooler mix will be present in the mat. Temperature differentials on the TNB appeared as longitudinal streaks as opposed to periodic cooler patches which are usually associated with end dumping directly into the paver.

Figure 27. Temperature differential of 47°F in top course.

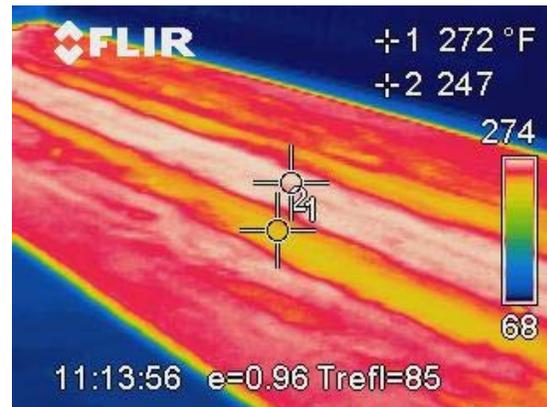
Figure 28. Warmer center in base course.

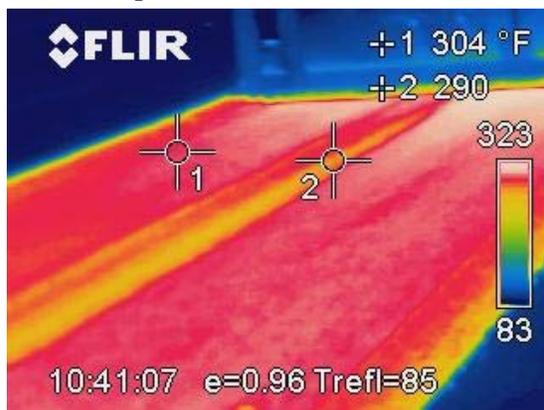
Figure 29. Mat with cooler center recorded on June 20.

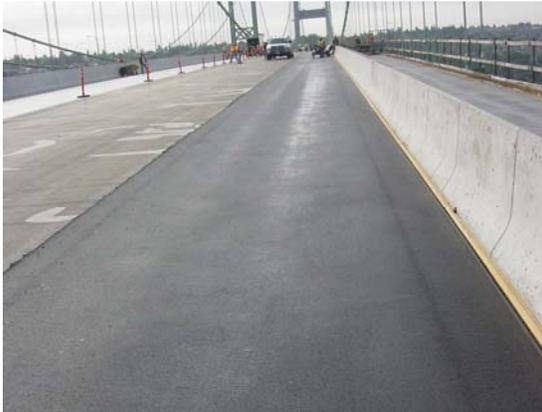
Both lifts in all lanes displayed some level of visible streaking after paving. Some of the streaks appear to be located at the screed extensions while others seem to be associated with cool streaks in the mat visible on the infrared photographs. It was not clear if the streaks are superficial or represent defects in the mat.

Figure 31. Steaks in base course on lane one.

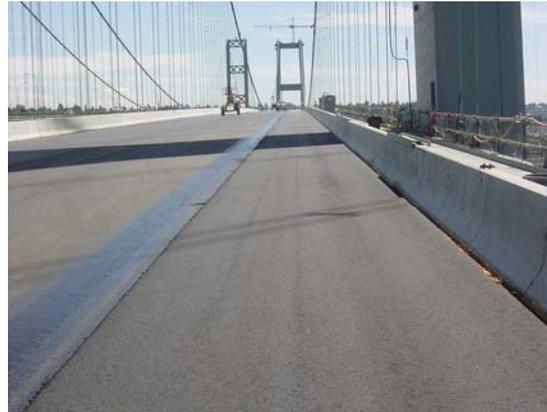
Figure 32. Steaks in top course on lane one.

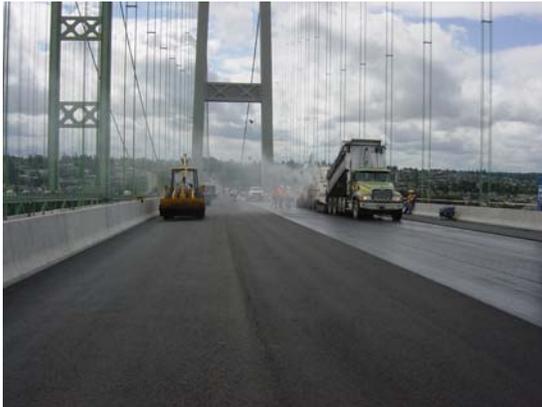
Figure 33. Steaks in top course on lanes four and five.

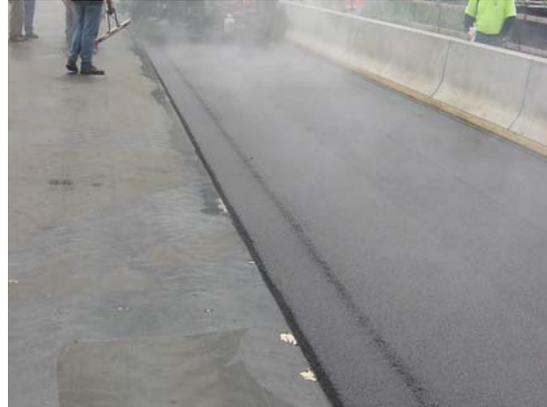
Figure 34. Streak left by screed extension.

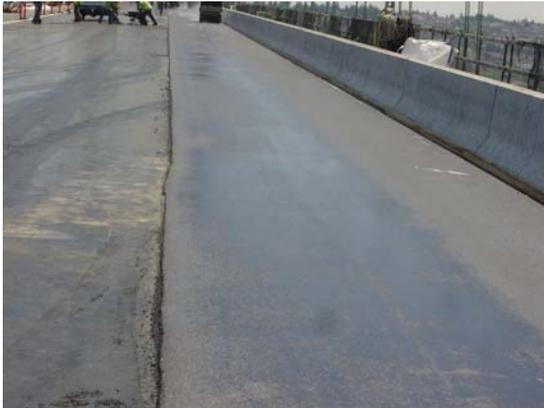
Slight flushing occurred after placement of the job control strip. Flushing appeared to be isolated to the section between 3.5 feet from the face of barrier to the edge of the paved lane at 10.5 feet. The flushing seems to correspond to high asphalt content test results on Lane 1.

Figure 35. Flushing in lane one immediately after paving.

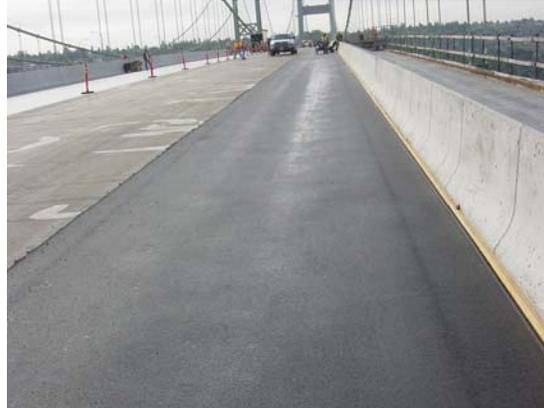
Figure 36. Flushing in lane one several days after paving.

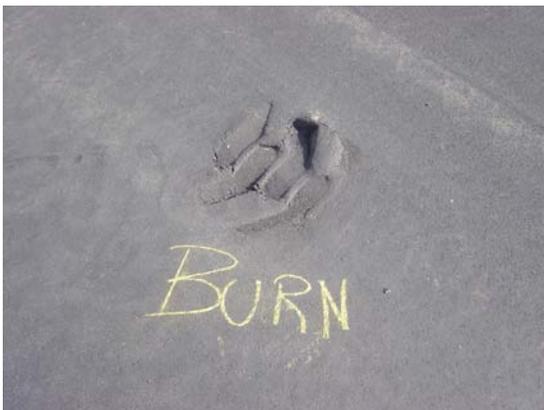
Figure 37. Indentation in base course left by equipment tire.

There were many areas where tires from equipment sitting on the bridge left indentations in the base course. These areas were repaired by heating with a weed burner and reshaping before placing the next lift.

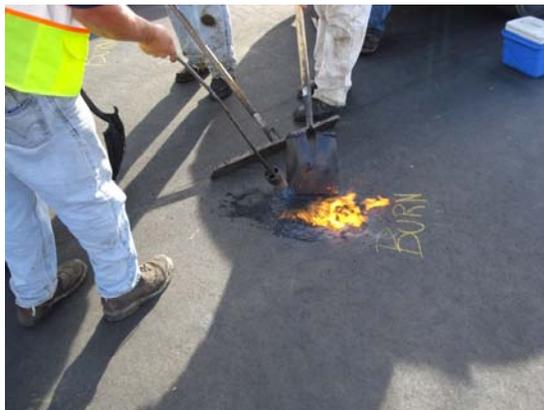
Figure 38. Repairing indentation.

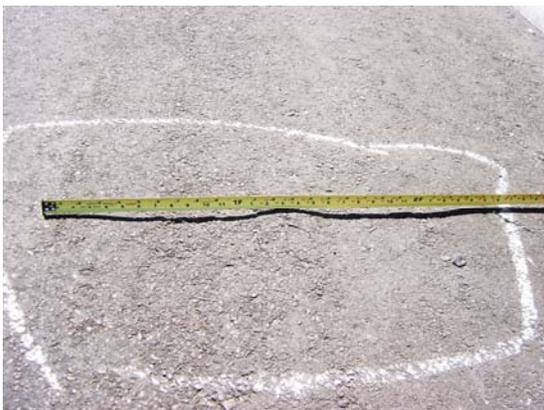
An inspection on July 9th revealed that there were many indentations in the top course caused by construction activities. Some of the indentations were clearly due to equipment tires or the outrigger supports for a 300 ton Demag crane while the cause of others could not be identified. Cracks were associated with some of the indentations where the mix appeared to have been sheared by the object causing the indentation.

Figure 39. Tire indentation near west end.

Numerous indentations, cracks and spills were present on the mat after it was complete. Most if not all of these can be attributed to the construction activities occurring on the bridge after placement of the overlay. Some of the damaged areas were superficial but many required repair by methods which likely will affect the performance of the pavement. In order to avoid this type of damage in the future, paving should not begin until work on or above the bridge deck is complete.

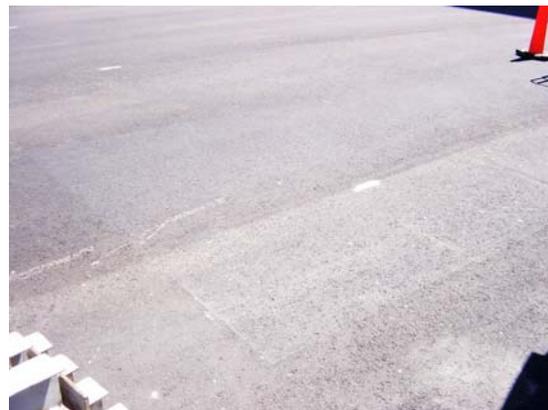
Figure 40. Indentation left by Demag crane pad.

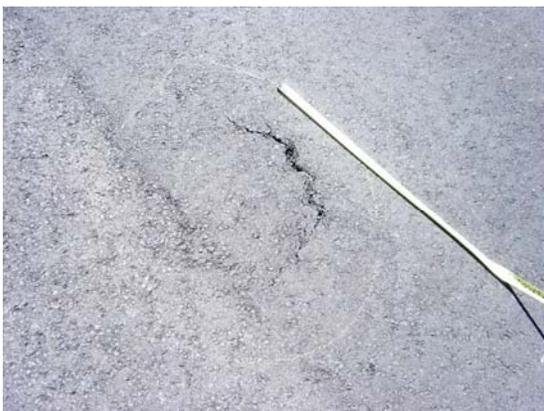
Figure 41. Indentation with crack near midspan.

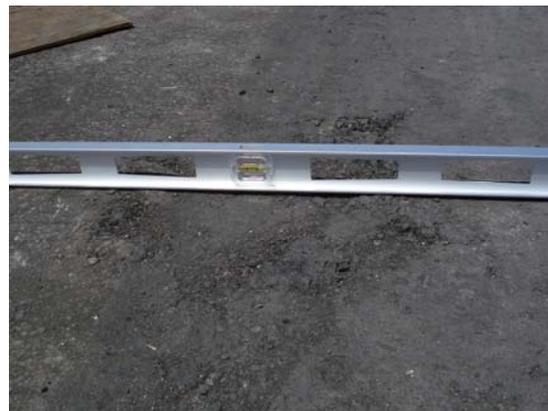
Figure 42. Possible repaired area.

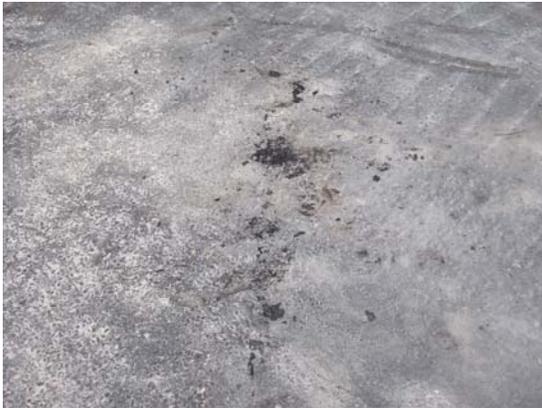
Solvent spilled from the west tower onto the completed overlay in Lanes 2 and 3 which required the pavement to be removed and replaced. Repair included rotomilling the damaged pavement, repairing the three layer membrane system and repaving with conventional asphalt.

Figure 43. Solvent spill.

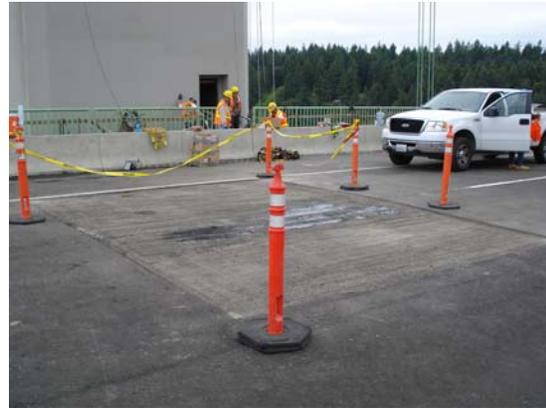
Figure 44. Damaged pavement removed from lane 2 and 3.

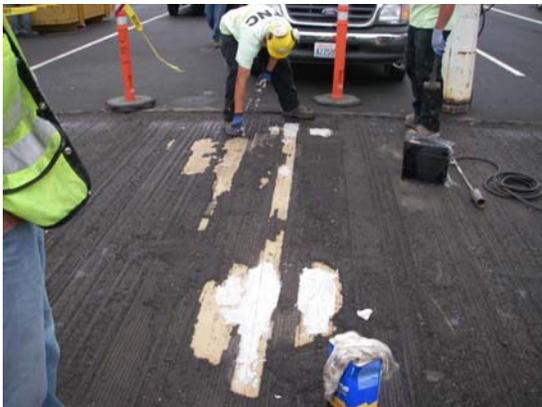
Figure 45. Repairing isolation layer.

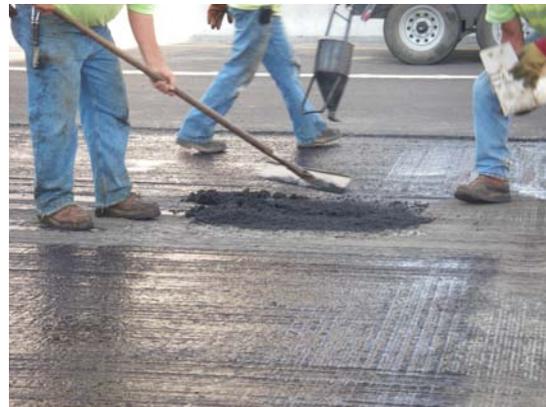
Figure 46. Repairing base course.

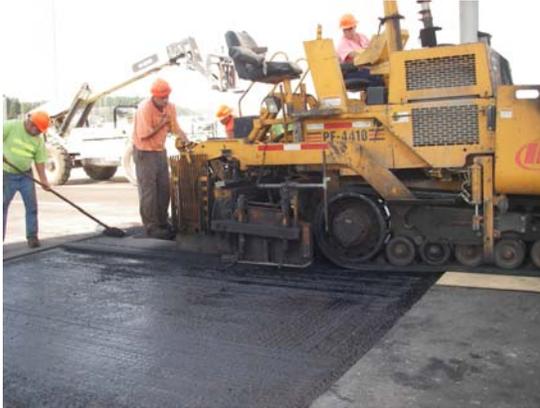
Figure 47. Replacing top course.

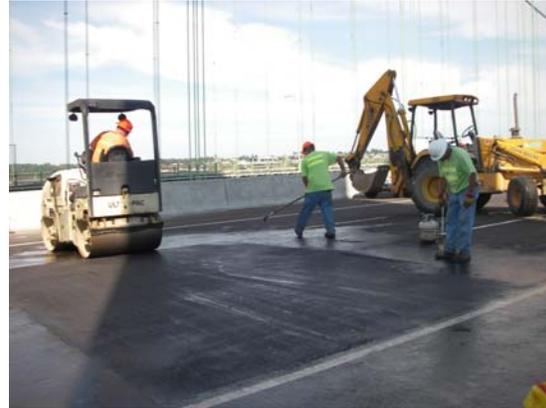
Figure 48. Finished patch.
