Trinidad Lake Asphalt Overlay Performance Final Report

WA-RD 710.2

TRINIDAD LAKE ASPHALT OVERLAY PERFORMANCE FINAL REPORT

Contract 6441
SR-16
Tacoma Narrows Bridge – Eastbound
MP 7.28 to 8.41

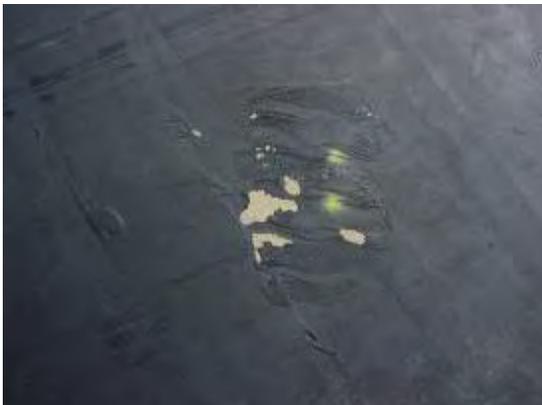
Figure 9. Damage to adhesion layer.

applying additional adhesive and the entire deck surface was cleaned with hand brooms to prevent further damage from equipment.

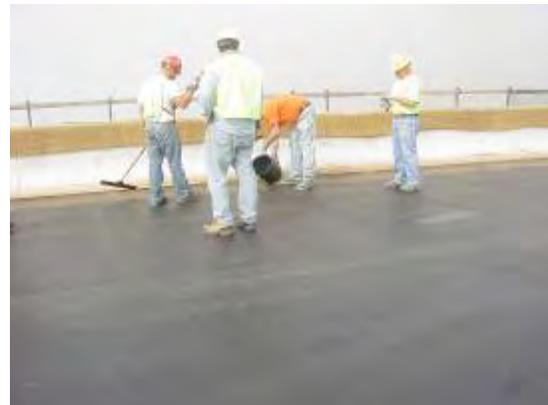
Figure 10. Repairing adhesion layer.

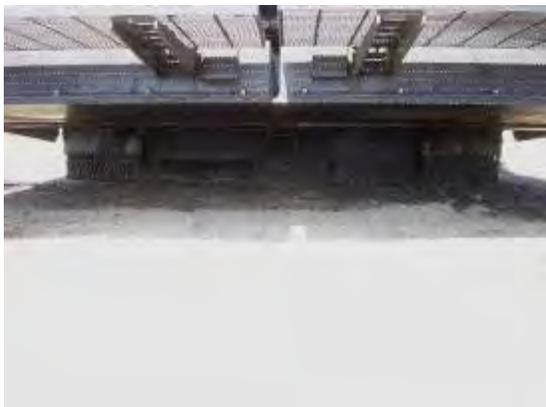
Figure 13. Missing chains on MMK retrofit on I-R/Blaw-Knox PF-4410 paver.

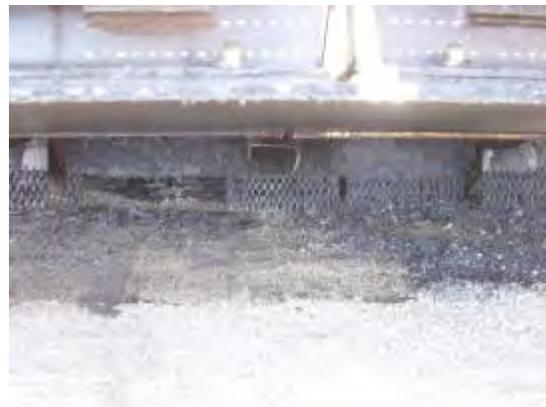
Figure 14. Missing chains on MMK retrofit.

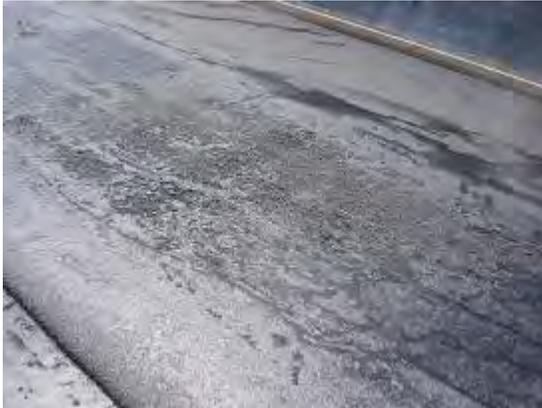
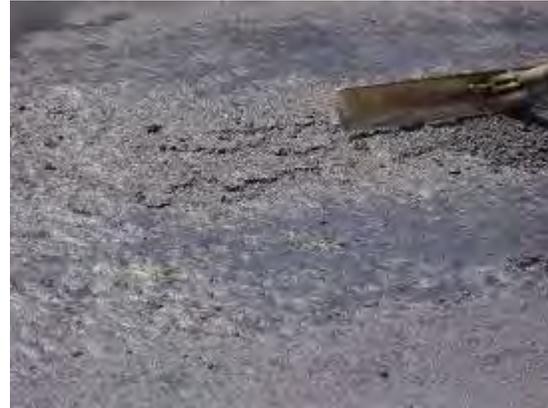
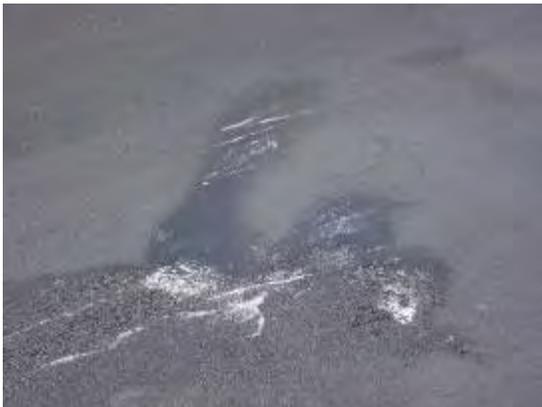
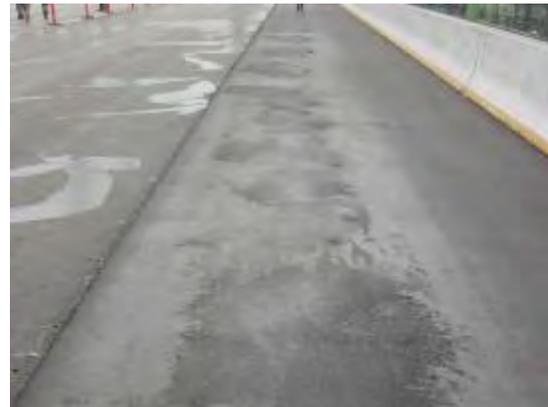
During placement of the job control strip for the base course the large rollers began picking up mix from the newly laid mat. Pickup occurred between 300 and 700 feet from the west end of the bridge. The mix had to be removed from the roller drums before the roller could continue, delaying the compaction operation. Voids left in the mat were repaired by carrying mix back to the damaged area in shovels and a wheelbarrow. Despite the repair efforts voids and open areas remained in the mat. The voids were more or less centered about 6.5 feet from the face of the barrier. The problem ceased when the large rollers were removed from the paving operation and replaced by smaller rollers.

Figure 16. Mix pickup area immediately after rolling.

Figure 17. Raking in mix to repair pickup area.

Figure 18. Area of mix pickup after completion of rolling.

Figure 19. Area of mix pickup prior to the next day's paving.

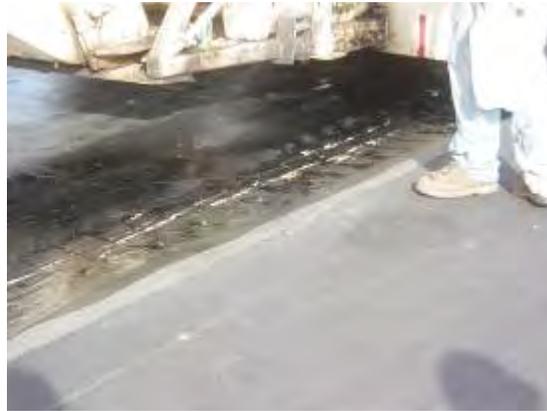
During placement of the base course the Contractor applied water using hand held sprayers ahead of truck tires and vehicle tracks in order to prevent damage to the polymer modified bituminous hot melt adhesive. One area of tack coat incurred damaged by the track on the Terex transfer vehicle. The area may have been more susceptible to damage since the adhesion layer had been repaired earlier in the day. Otherwise this method appeared successful in preventing damage.

Figure 21. Adhesion layer damaged by track.

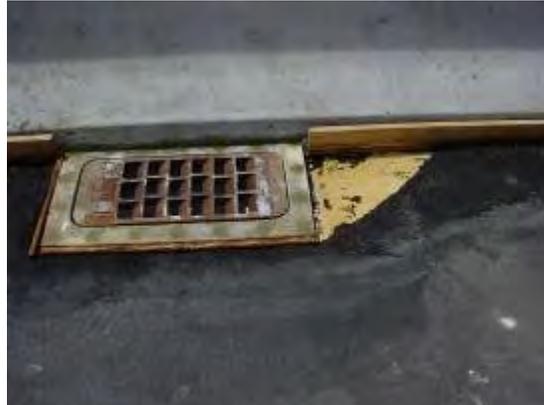
After completing paving the base course in Lane 2 at the west end of the bridge the Contractor turned the paving train around and began paving eastbound in Lane 3. A water truck sprayed water on Lane 2 to cool it enough to allow trucks which were delivering mix to pave Lane 3 to drive on Lane 2. At this time Lane 1 had only been paved to within about 250 feet of the east end of the bridge which left the bridge drains two inches higher than the current grade. The water flowed to the east end of the bridge and accumulated adjacent to the barrier in Lane 1 since it could not get into the bridge drains. After completion of paving Lane 3 the contractor proceeded to pave the remaining base course in the east end of Lane 1. The contractor attempted to remove the excess water that had accumulated in Lane 1 using leaf blowers prior to paving, but water was still present near the curb and over parts of the lane during paving.

Figure 23. Triangle of adhesion layer removed near scupper due to water damage.

Portions of the base course and tack layer were affected by the water and had to be removed around the bridge scuppers. The repair consisted of reapplying the adhesion layer and replacing the base course material at the end of the next day's paving.

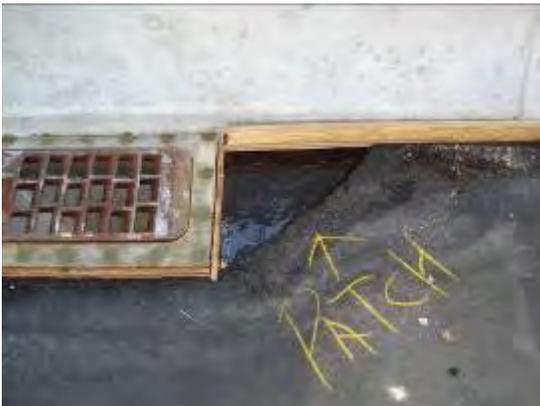
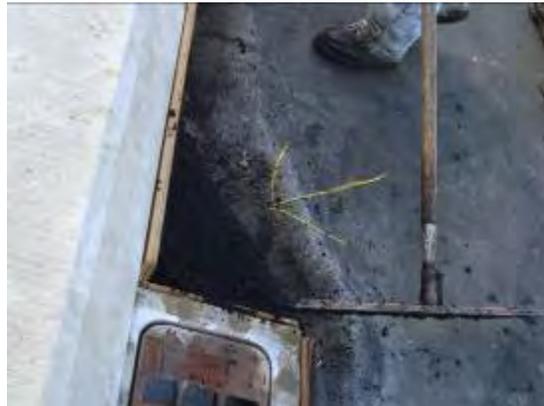
Figure 24. Adhesion layer repaired.

Figure 25. Repaired adhesion layer.

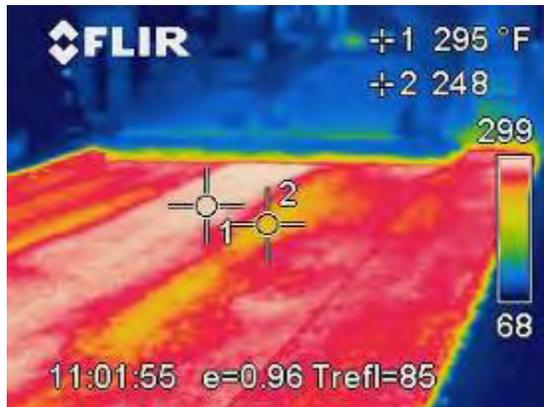
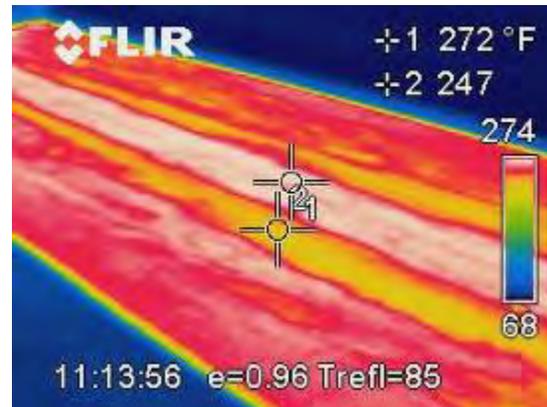
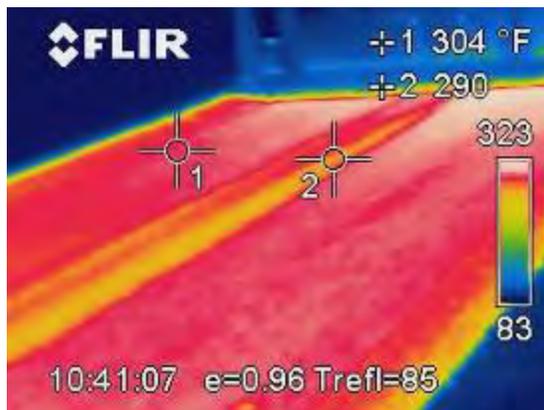
Infrared imaging was used during HMA placement to check for differences in temperature that could lead to potential density differentials. The imaging revealed temperature differentials ranging from 10°F to more than 40°F. Temperature differentials can lead to areas of inadequate compaction in the mat. They are usually caused by mix inside the haul vehicle cooling on the outside of the load faster than in the center. If the mix is not remixed before it passes through the paver, areas of cooler mix will be present in the mat. Temperature differentials on the TNB appeared as longitudinal streaks as opposed to periodic cooler patches which are usually associated with end dumping directly into the paver.

Thermal imaging revealed three identifiable patterns of temperature differentials across the pavement surface during top course paving. The most common pattern is a warmer streak down the center of the mat flanked by cooler streaks on each side. Temperature differentials were greatest with this pattern, some being over 40°F. A second pattern with the cooler streak in the center is also apparent on some of the images. Most of the temperature differentials were within about 15°F in this pattern. Uniform temperature was seen across the mat on a few occasions.

Figure 27. Temperature differential of 47°F in top course.

Figure 28. Warmer center in base course.

Figure 29. Mat with cooler center recorded on June 20.

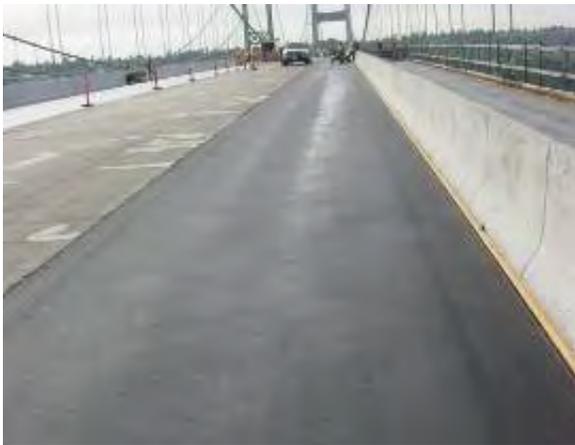
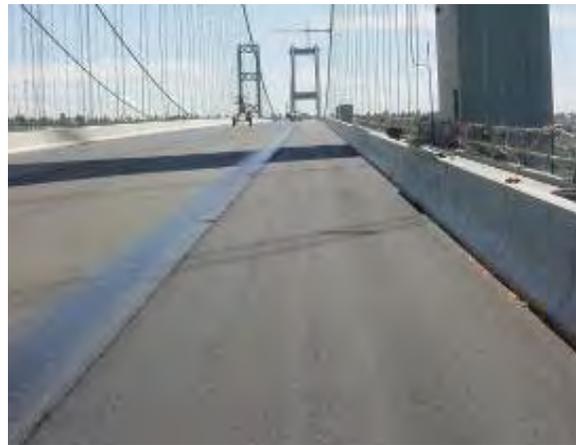
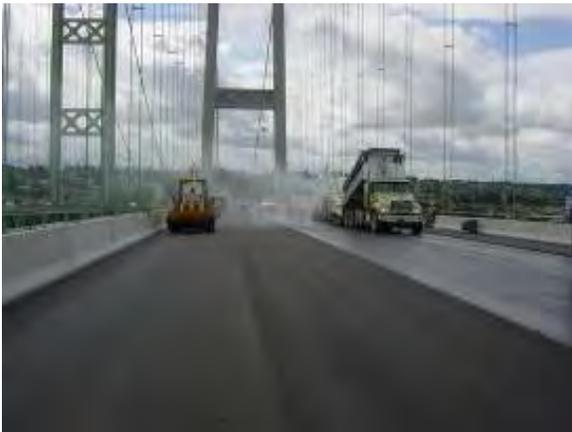
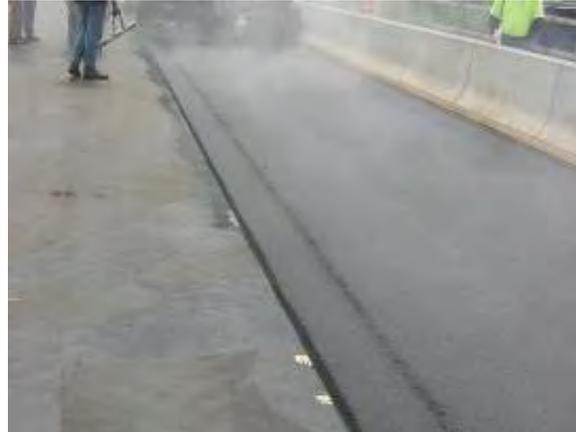
Both lifts in all lanes displayed some level of visible streaking after paving. Some of the streaks appear to be located at the screed extensions while others seem to be associated with cool streaks in the mat visible on the infrared photographs. It was not clear if the streaks are superficial or represent defects in the mat.

Figure 31. Streaks in base course on Lane 1.

Figure 32. Streaks in top course on Lane 1.

Figure 33. Streaks in top course on Lanes 4 and 5.

Figure 34. Streak left by screed extension.

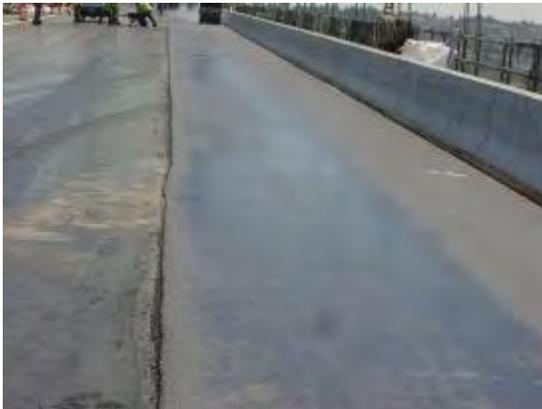
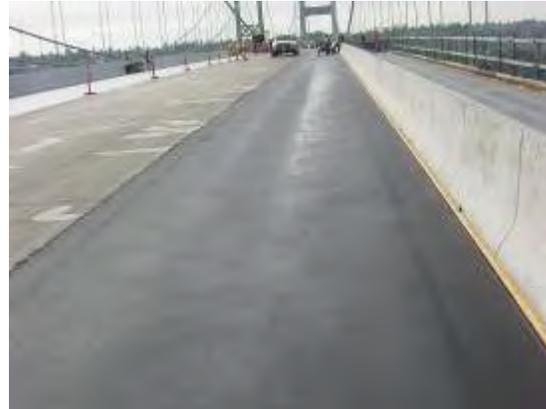
Slight flushing occurred after placement of the job control strip. Flushing appeared to be isolated to the section between 3.5 feet from the face of barrier to the edge of the paved lane at 10.5 feet. The flushing seems to correspond to high asphalt content test results on Lane 1.

Figure 35. Flushing in Lane 1 immediately after paving.

Figure 36. Flushing in Lane 1 several days after paving.

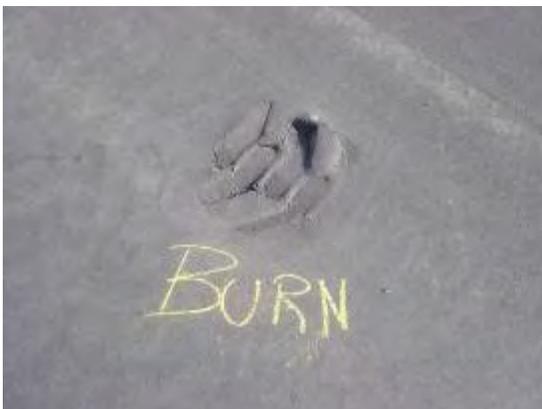
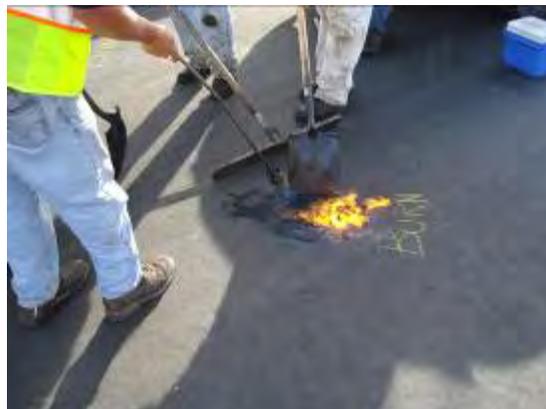
Figure 37. Indentation in base course left by equipment tire.

Figure 38. Repairing indentation.

There were many areas where tires from equipment sitting on the bridge left indentations in the base course. These areas were repaired by heating with a weed burner and reshaping before placing the next lift.

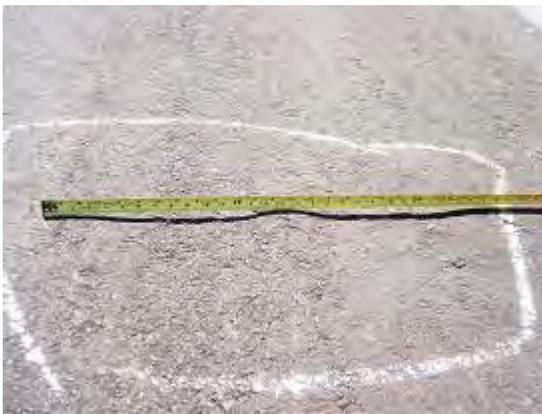
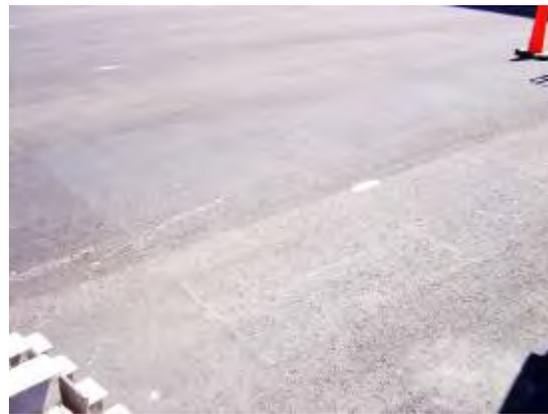
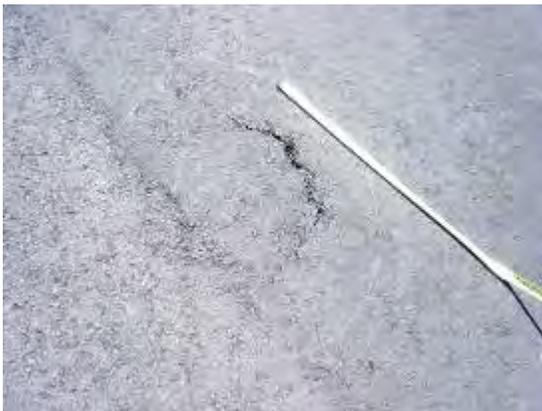
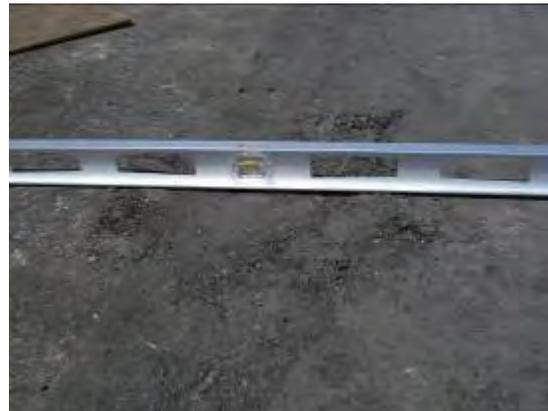
An inspection on July 9th revealed that there were many indentations in the top course caused by construction activities. Some of the indentations were clearly due to equipment tires or the outrigger supports for a 300 ton Demag crane while the cause of others could not be identified. Cracks were associated with some of the indentations where the mix appeared to have been sheared by the object causing the indentation.

Figure 39. Tire indentation near west end.

Figure 40. Indentation left by Demag crane pad.

Figure 41. Indentation with crack near midspan.

Figure 42. Possible repaired area.

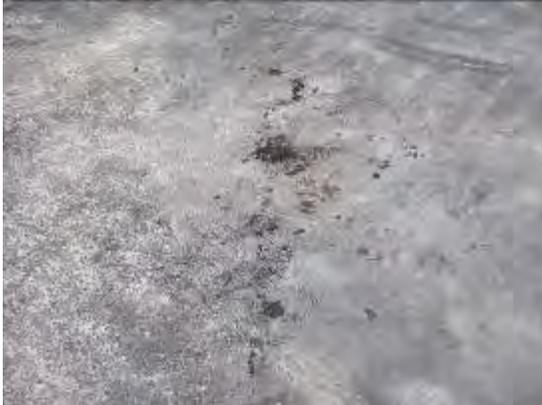
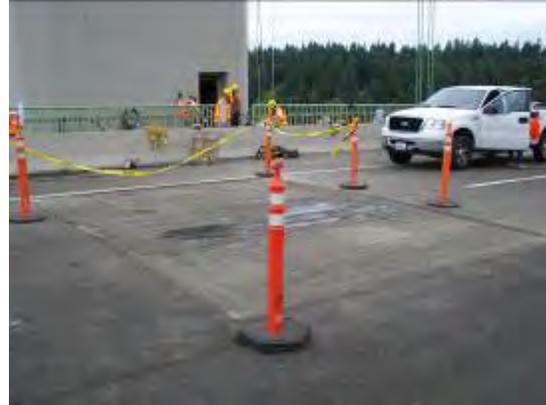
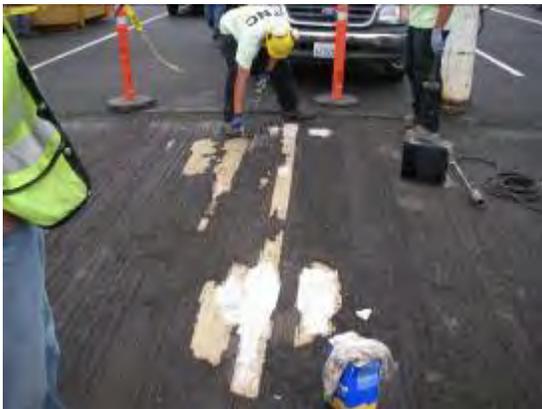
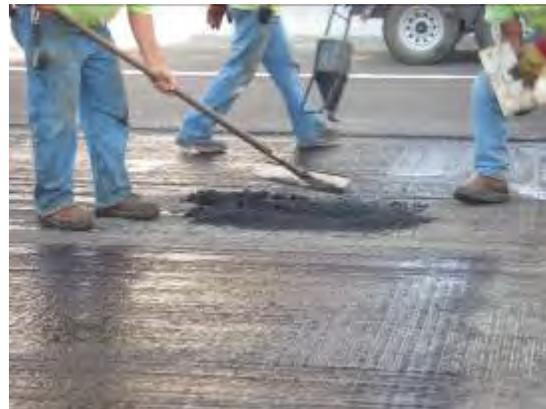
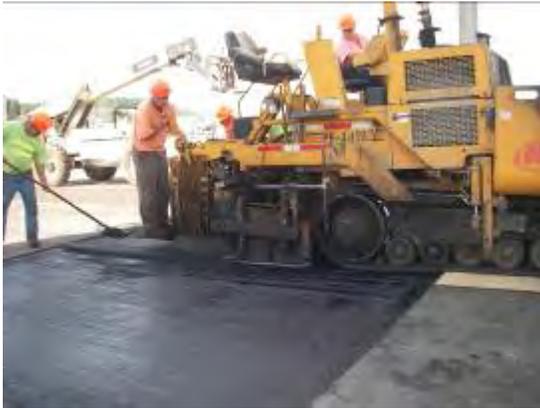
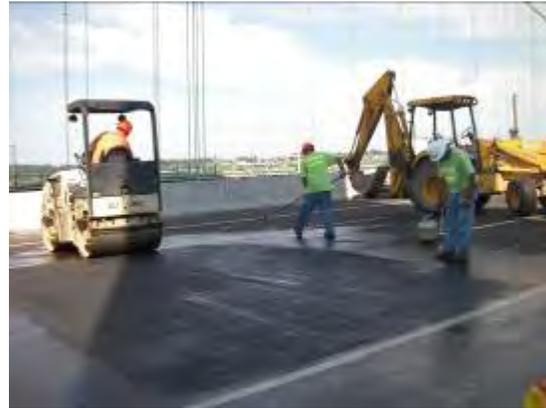
Figure 43. Solvent spill.

Figure 44. Damaged pavement removed from Lane 2 and 3.

Solvent spilled from the west tower onto the completed overlay in Lanes 2 and 3 which required the pavement to be removed and replaced. Repair included rotomilling the damaged pavement, repairing the three layer membrane system and repaving with conventional HMA.

Figure 45. Repairing isolation layer.

Figure 46. Repairing base course with conventional HMA.

Figure 47. Replacing top course with conventional HMA.

Figure 48. Finished conventional HMA patch.

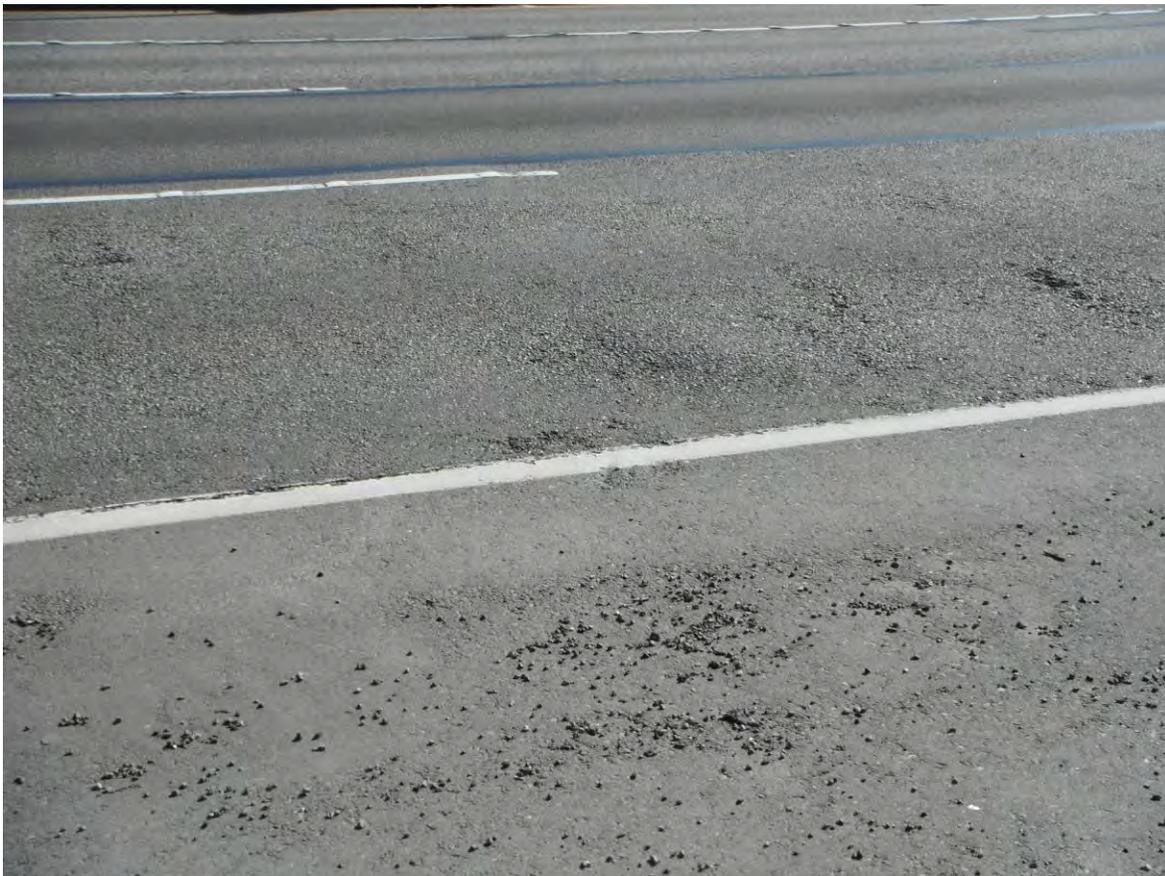
A visual survey was conducted on May 1, 2014 to document the condition of the wearing course at the end of 82 months (2 months shy of seven years). The most noticeable feature of the wearing course was raveling in the wheel paths on all of the lanes and patching in Lanes 2 and 3. The raveling was consistent in the wheel paths of all lanes with linear areas where the aggregates were missing giving the impression of it being a longitudinal crack. Lane 2 of the three general purpose lanes contained a multitude of patches in the wheel paths indicating that the raveling was greatest in this lane. Photos of the pavement on May 1, 2014 are included in Figures 53 to 62.

Figure 53. Severe raveling in the wheel paths of Lane 1 and patch in Lane 2. Note accumulation of gravel on the shoulder. (Photo from 5/1/2014)

The visual survey revealed the damage done to the wearing course over the seven years since it was constructed. All lanes are exhibiting areas of severe raveling which are characterized by linear areas of missing aggregate that resemble a longitudinal crack. Lanes two and three have experienced the greatest degree of damage as witnessed by the large number of patches in those lanes. Figures 61 and 62 showed above, a conventional HMA patch that was placed to repair an area of the original TLA mix that was damaged by a solvent spill. It appears that the raveling on the patched area is less than the surrounding TLA mix pavement.

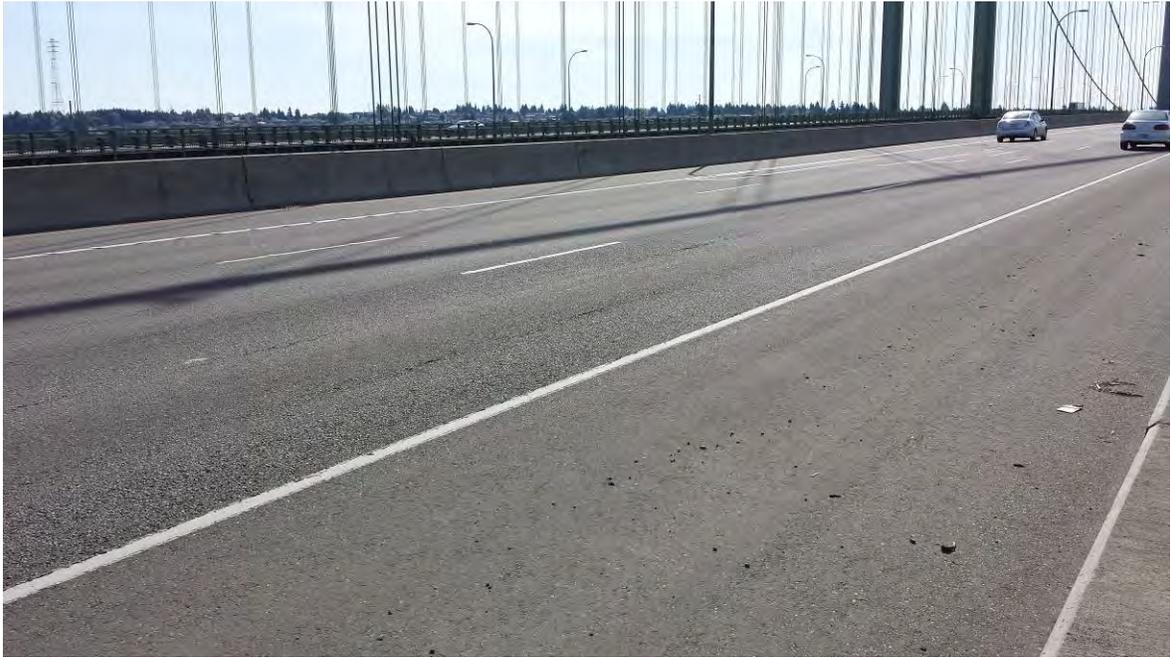
Figure 54. Severe raveling in the wheel paths of Lane 1. Note linear nature of the raveling in left wheel path of Lane 1. (Photo from 5/1/2014)

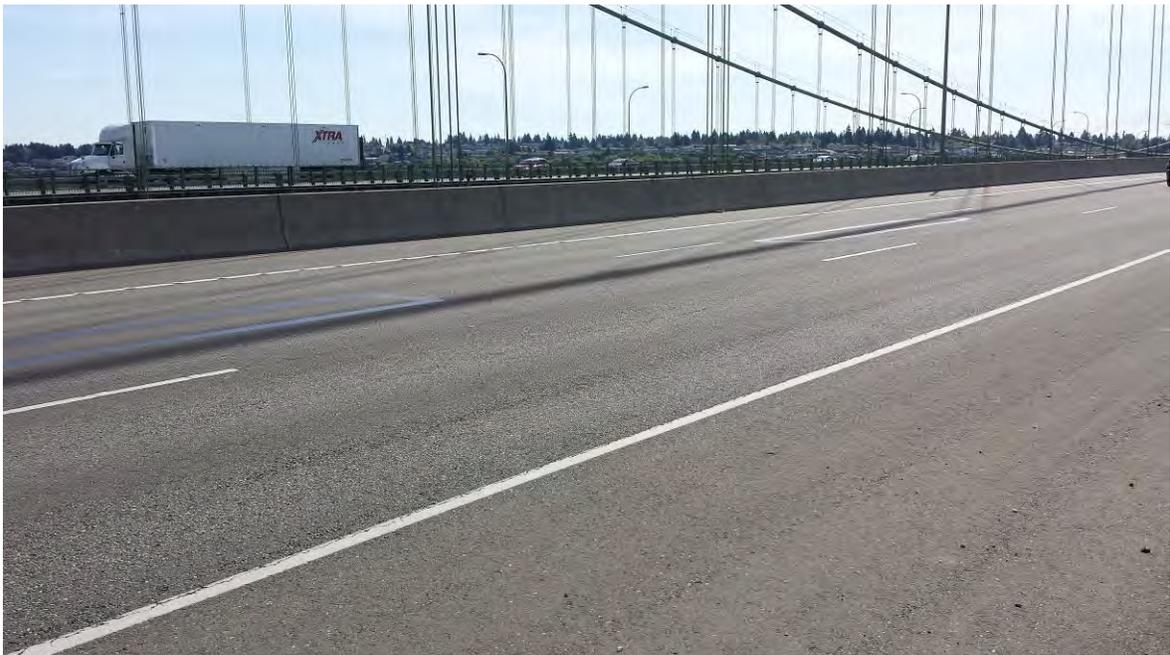
Figure 55. Severe raveling in Lane 1, patch in Lane 2. (Photo from 5/1/2014)

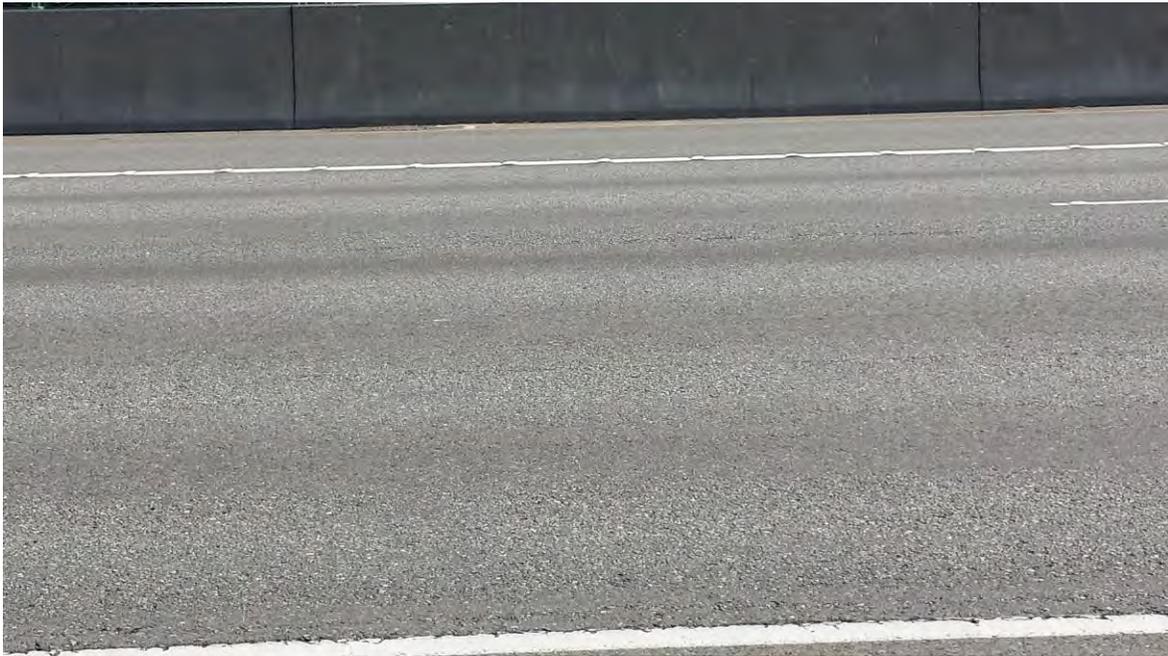
Figure 56. Moderate raveling in all lanes. (Photo from 5/1/2014)

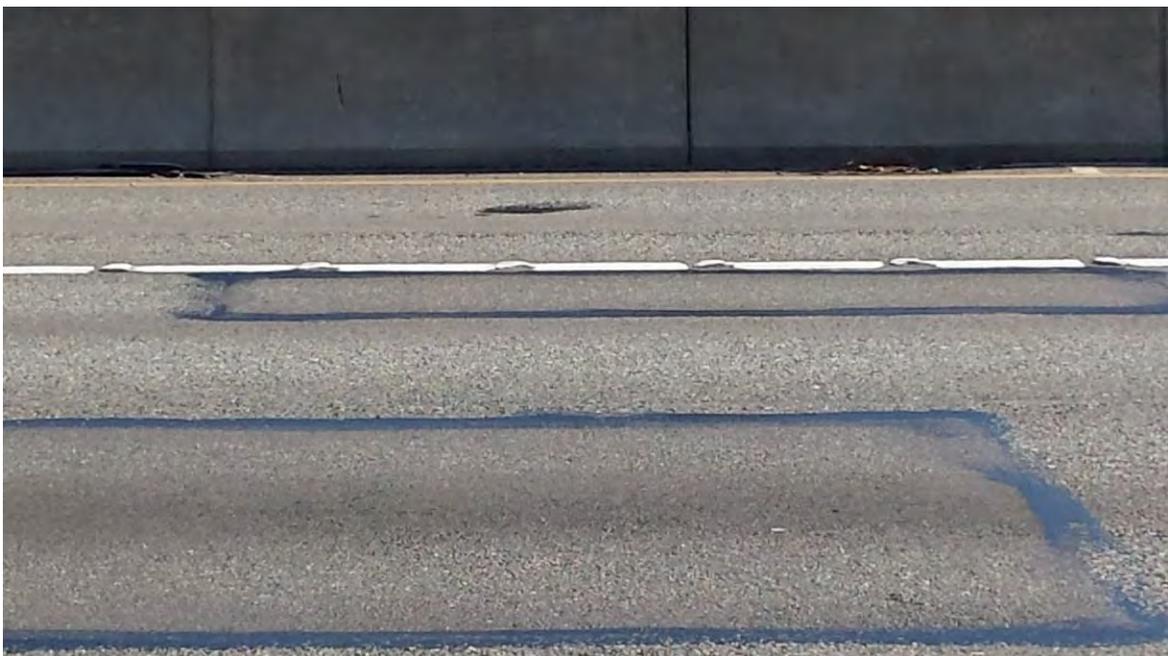
Figure 57. Patches in Lane 3, pothole and raveling in HOV Lane. (Photos from 5/1/14)

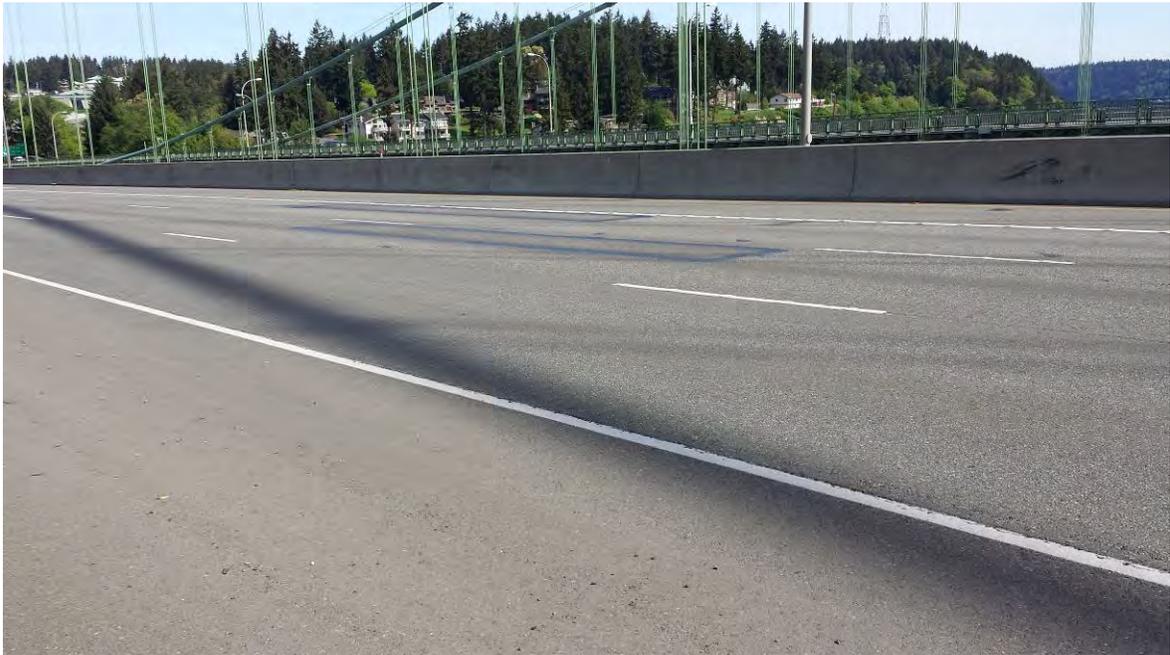
Figure 58. Patches in Lanes 2 and 3. (Photos from 5/1/14)

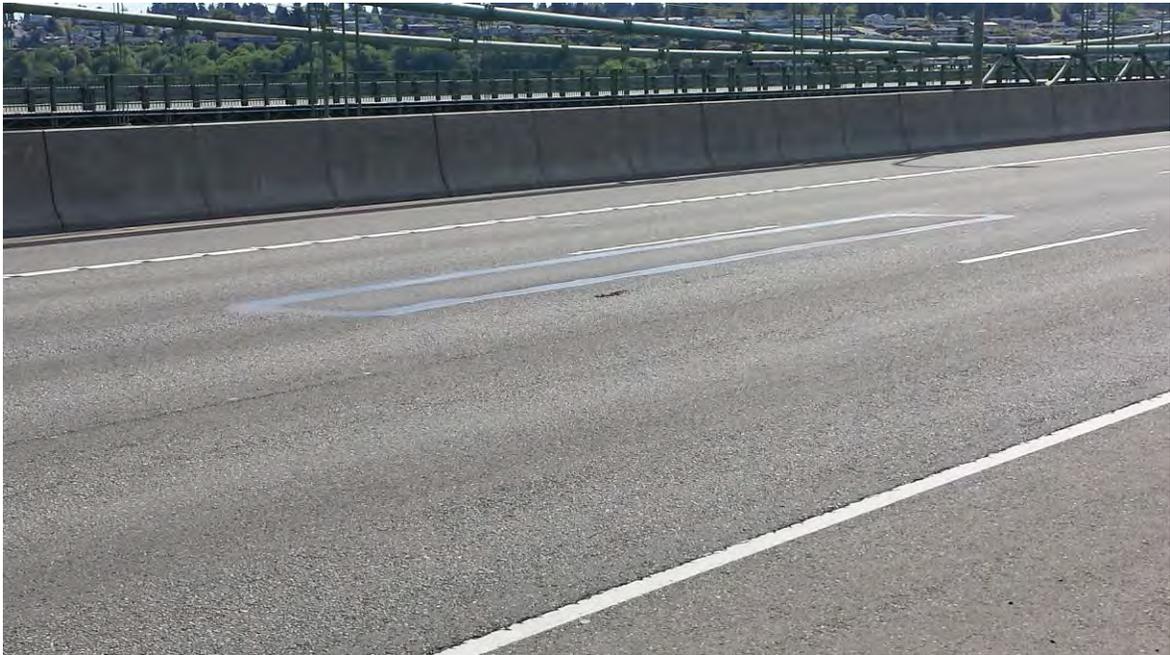
Figure 59. Patch and severe raveling in Lane 2. (Photos from 5/1/14)

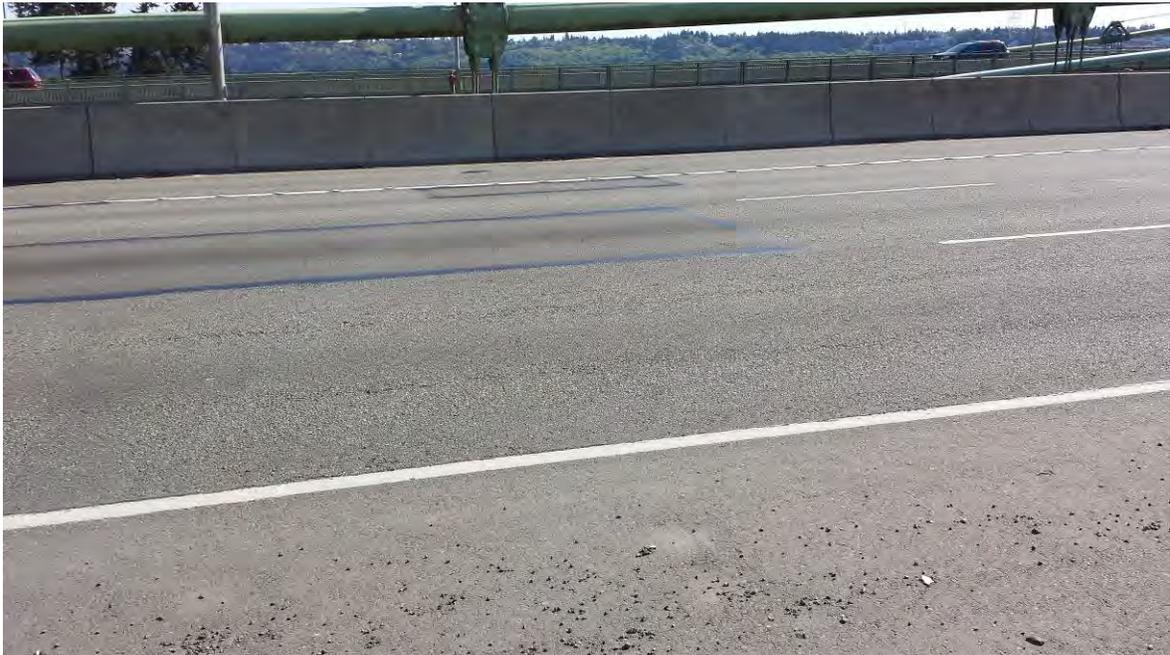
Figure 60. Severe raveling Lane 1, patches Lanes 2 and 3. (Photos from 5/1/14)

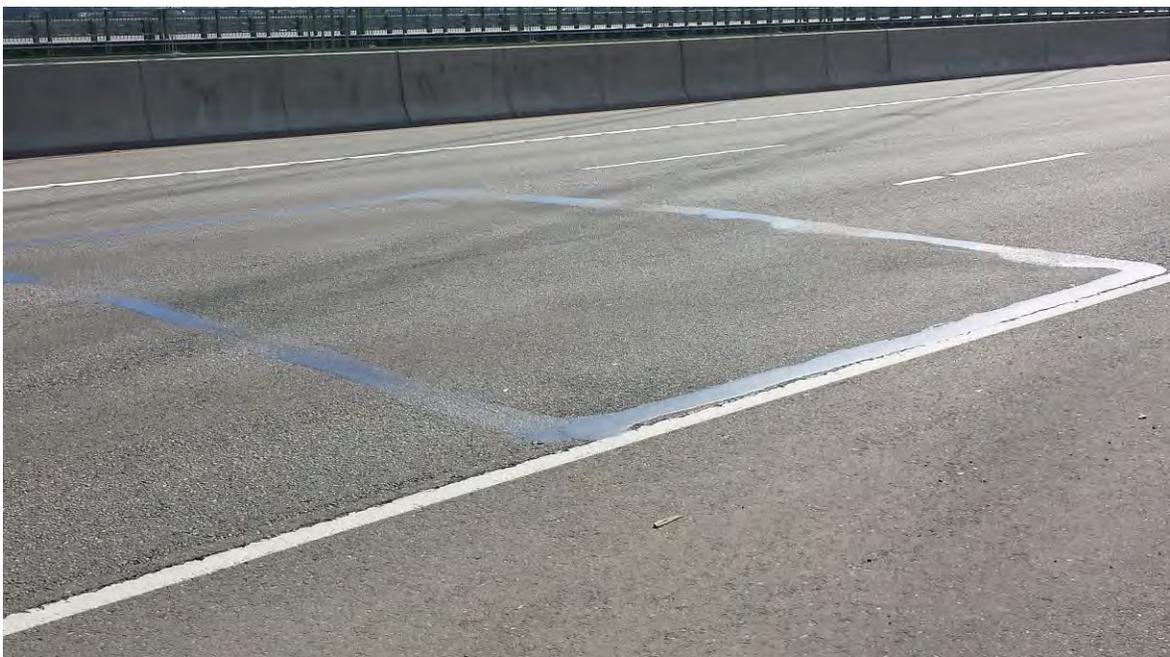
Figure 61. Patch Lane 1 and 2. Patch was done in July 2007 to repair problems caused by a solvent spill on the original overlay. Patch material was conventional HMA. (Photos from 5/1/14)

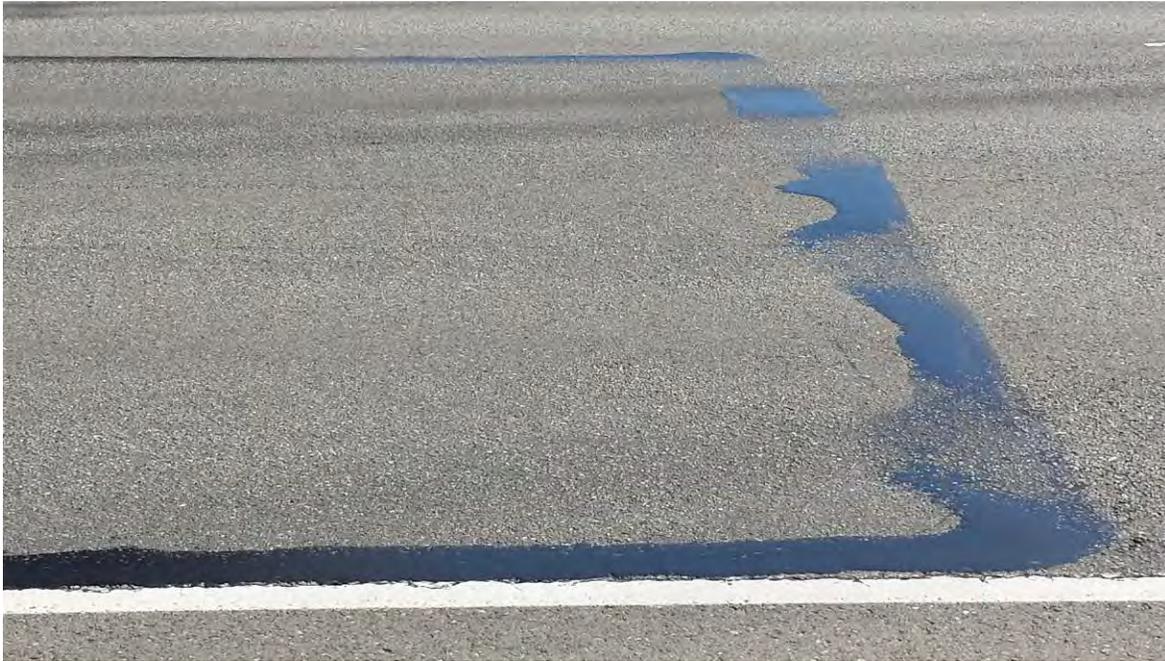
Figure 62. Close-up of HMA patch showing minimal raveling in the wheel paths. (Photos from 5/1/14)

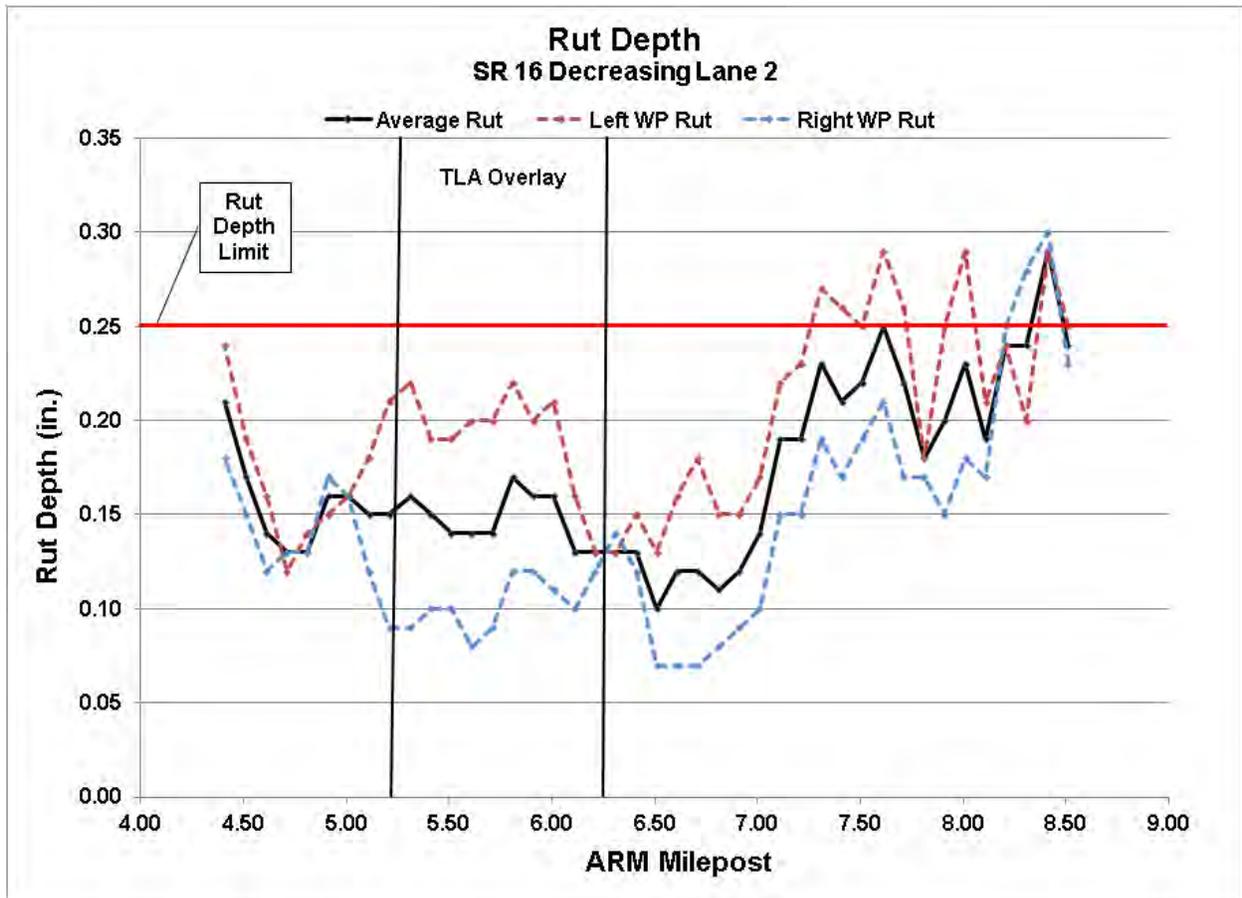
The rut depths were evaluated for all lanes using the above criteria, and in all cases the rut depth limits were not exceeded, except for one 1/10 mile segment in Lane 2 (decreasing direction). The data for this segment is shown in the graph below. As the data shows, several of the 0.1 mile rut measurements for the left wheel path slightly exceeded the 0.25 in. limit. However, the average rut depth is exceeded only for one 0.1 mile segment. WSDOT did not require the Contractor to repair this section.

Figure 64. Rut depth for Lane 2.
