# Evaluation of Tyregrip® High-Friction Surfacing

WA-RD 788.1

Post-Construction Report  
Experimental Feature 10-02

SR-14  
SE 164<sup>th</sup> Ave Interchange  
MP 7.93  
014 S2 00794 Ramp  
SE 164<sup>th</sup> Ave Southbound to SR 14 Westbound

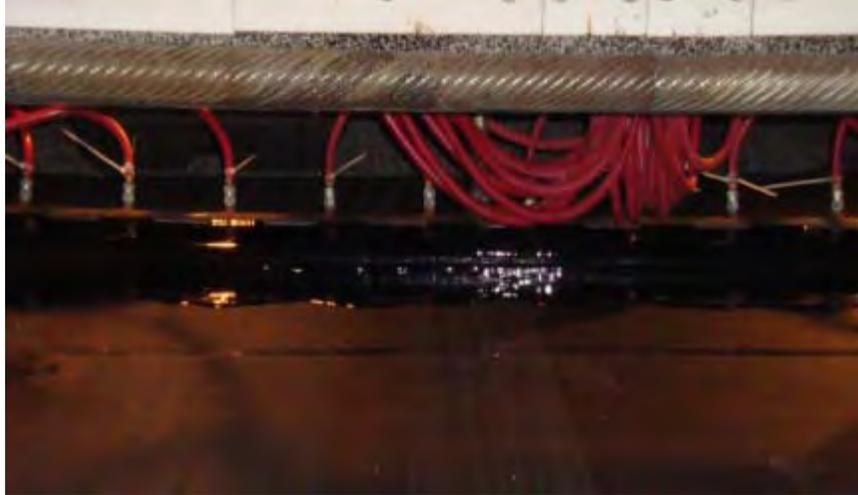
Figure 7. Epoxy resin extruded over spreader plate onto roofing material at startup location.

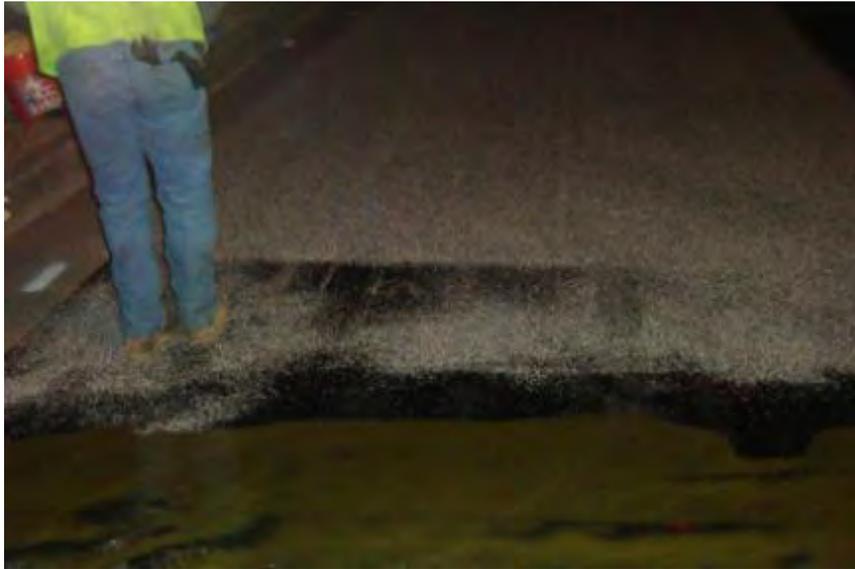
Distribution of the aggregate was slightly uneven at the start of the placement because the left side of the spreader box didn't distribute sufficient aggregate to the left side of the lane. This was addressed by hand placing aggregate onto the epoxy binder. As the paving continued, distribution was rather consistent until there was a problem with the spreader that prevented placement of sufficient aggregate. As a result a rather large area didn't receive enough aggregate material. Again, hand placement was needed and at this location the aggregate was not as uniformly placed across the pavement surface. There were two other locations that required hand placement of the aggregate. Once all the equipment was operating correctly, placement of the aggregate on top of the epoxy binder was uniform. Figures 7 to 10 show the non-uniformity of the aggregate placement at various locations and Figure 11 an area with uniform aggregate placement. The plan was to place two lifts of material on the first night; however, due to problems with the equipment, the second lift was applied the following night.

Figure 8. Hand placement of aggregate at beginning of project.

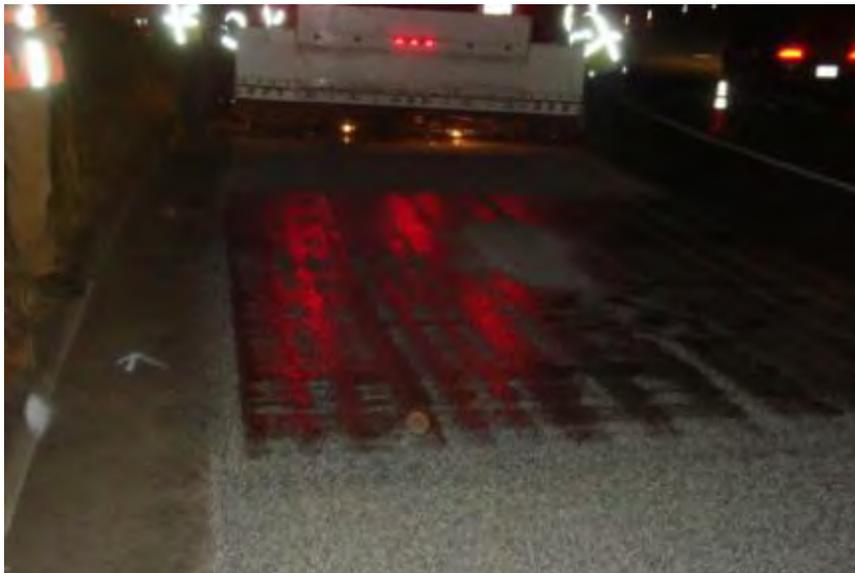
Figure 9. Location where aggregate spreader limited placement of material.

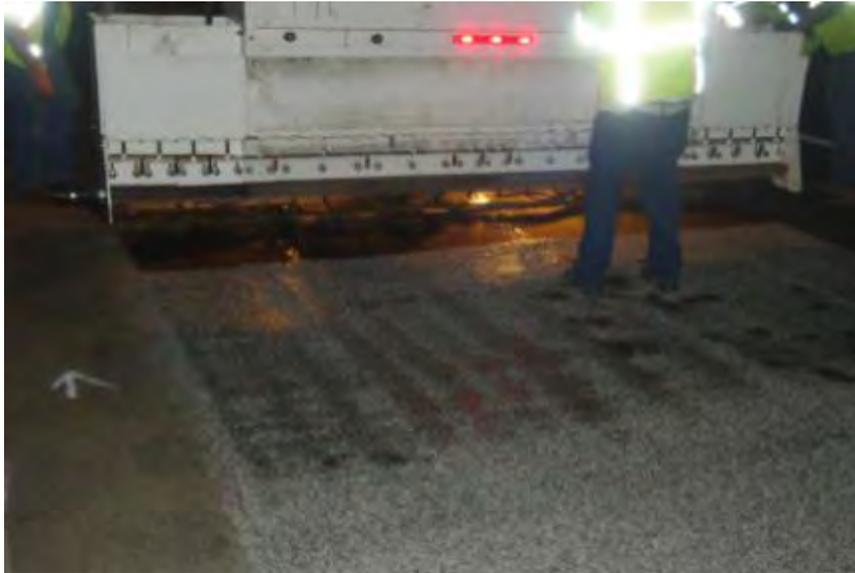
Figure 10. Streaking surface caused by inconsistency of the aggregate spreader.

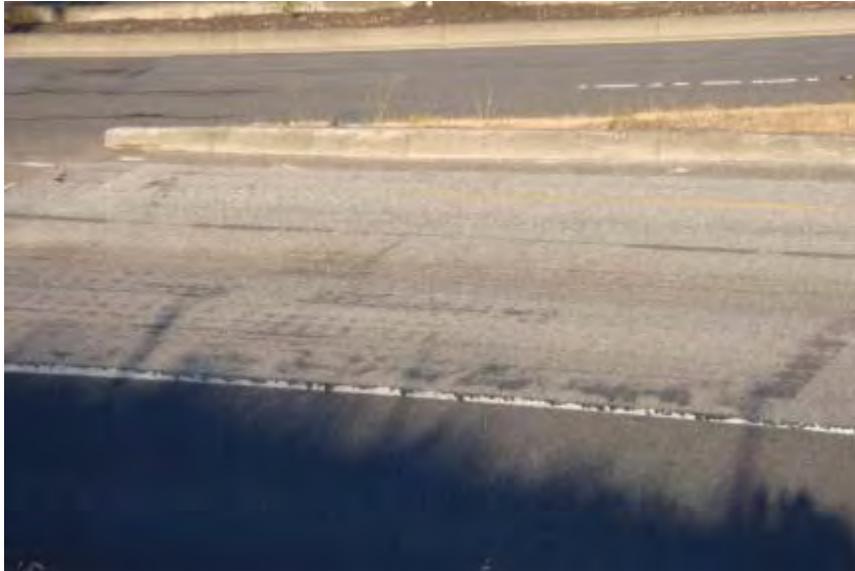
The second lift of the first application was placed on September 1, 2010. Figures 12 and 13 illustrate the condition of the surface prior to the second application of the Tyregrip®. The biggest problem with the first life was the lack of aggregate coverage mainly at the startup

Figure 12. Startup location after first night placement.

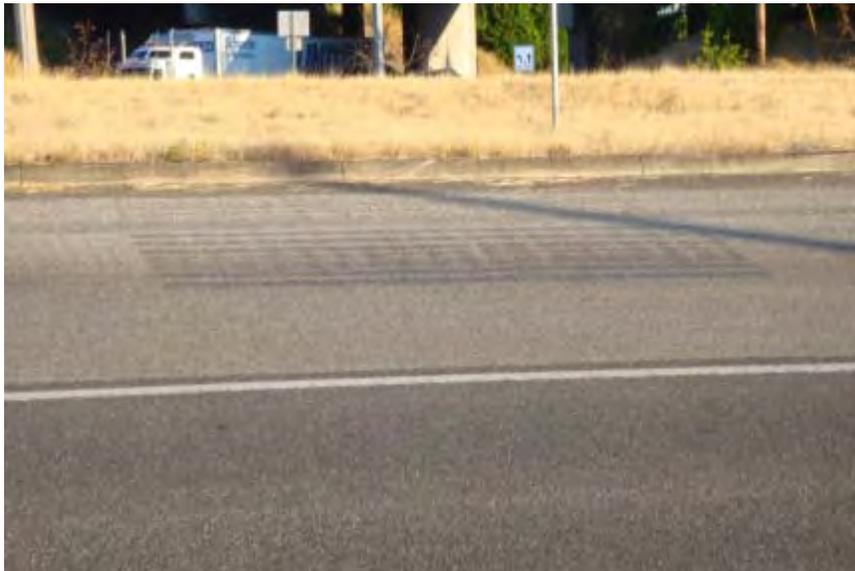
location. The remaining areas of insufficient aggregate cover resulted in only slight surface irregularities as shown in Figure 13.

Figure 13. Streaking in aggregate coverage.
