Alaskan Way Viaduct

Report of the

Structural Sufficiency Review Committee

June 28, 2001

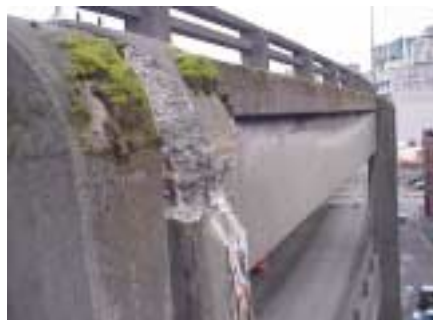
After the February 28 earthquake, the WSDOT Bridge office conducted a drive-through inspection of the structure to assess major structural condition. The most notable damage was to a curved bridge unit adjacent to Washington Street, comprised of bents 97 – 100.

Damage at Bent 100

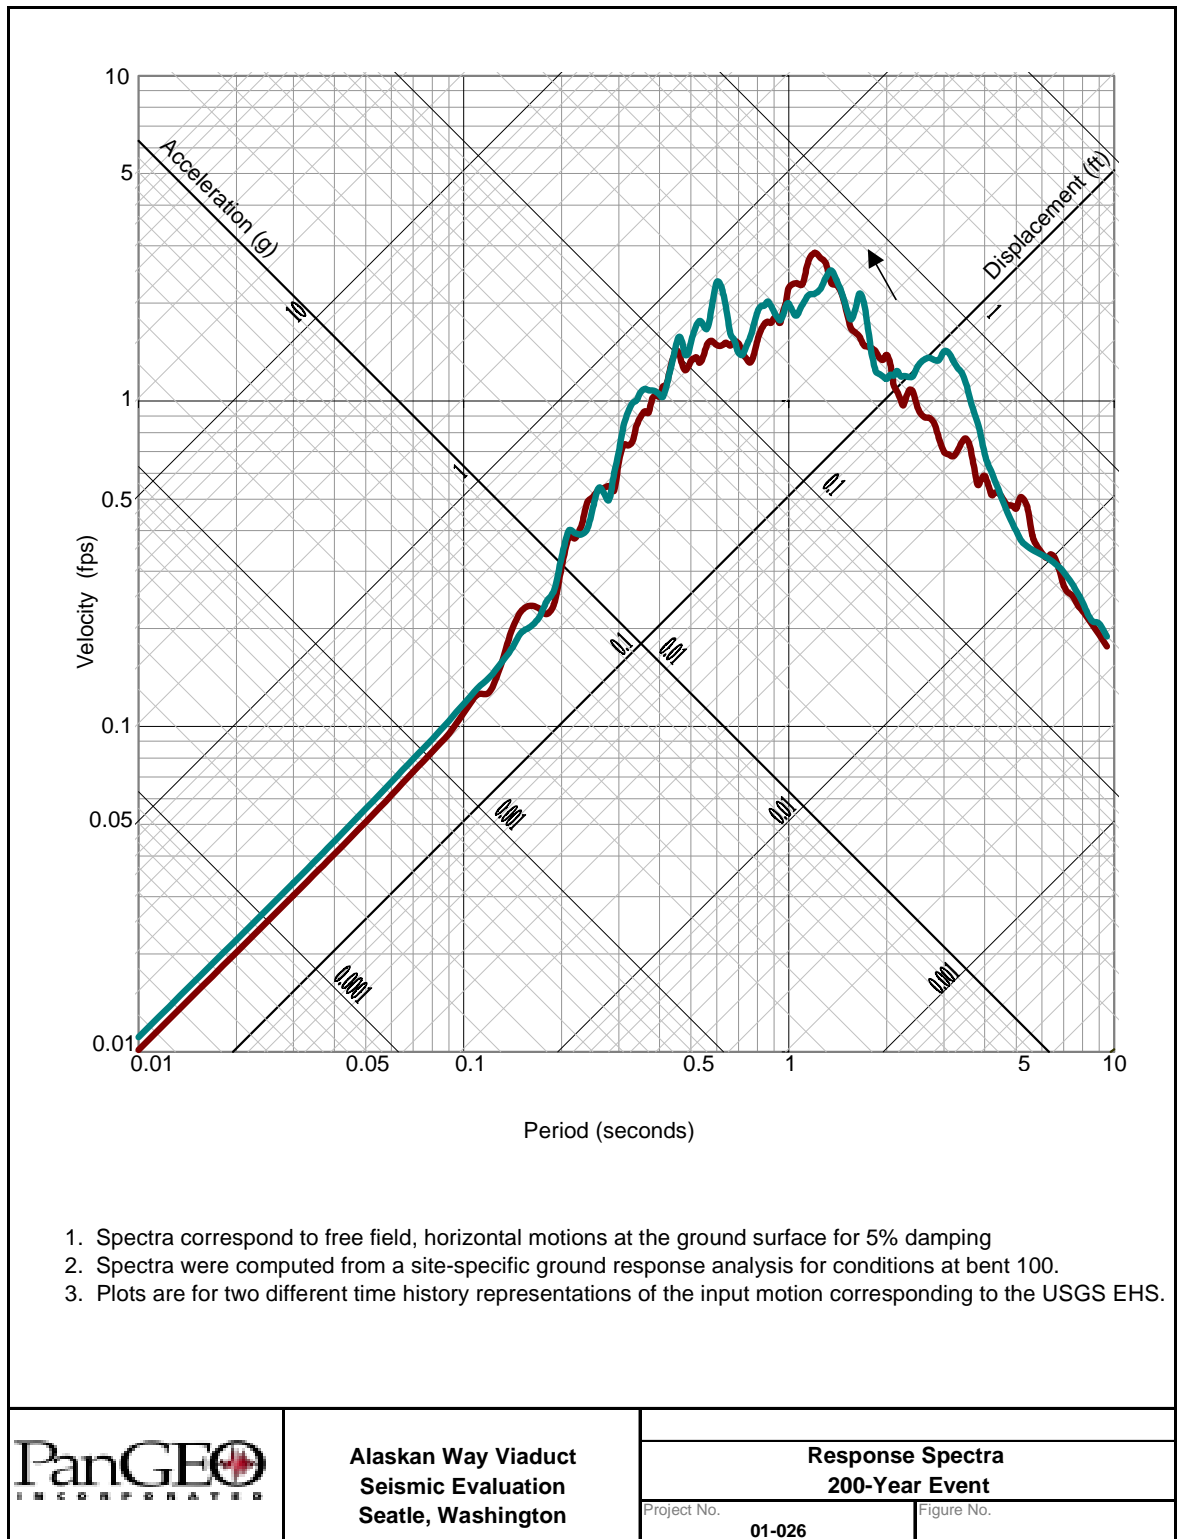
Figure 1

1. Spectra correspond to free field, horizontal motions at the ground surface for 5% damping
2. Spectra were computed from a site-specific ground response analysis for conditions at bent 100.
3. Plots are for two different time history representations of the input motion corresponding to the USGS EHS.

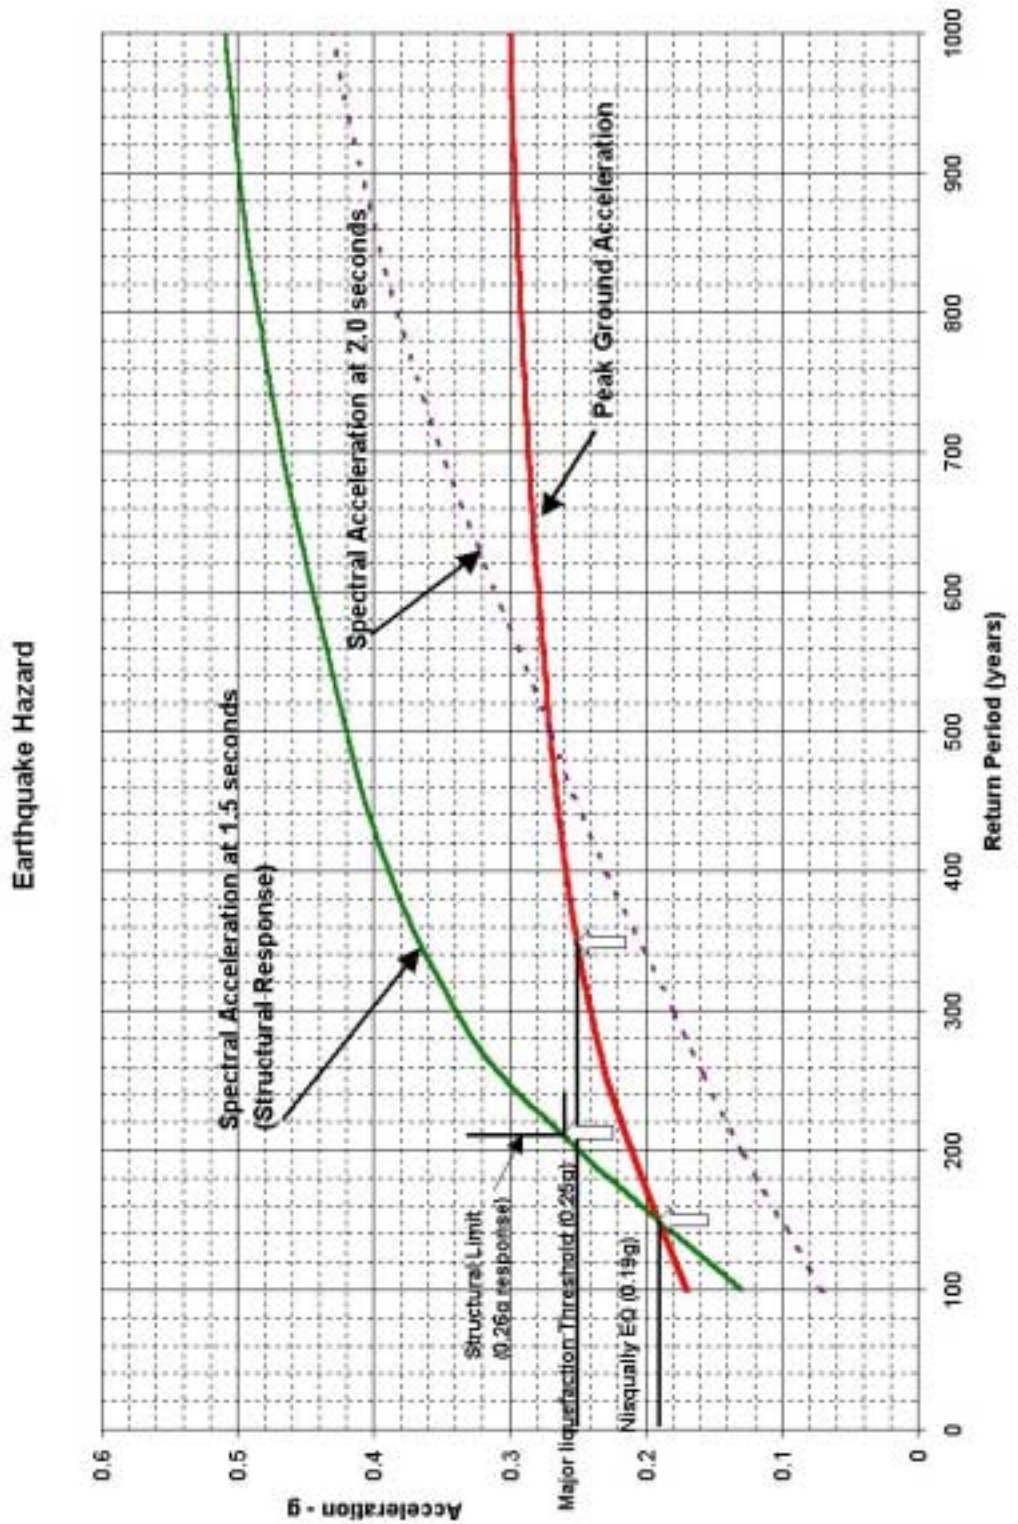
The hazard curve for ground motion presented in Figure 2 was developed from the results of the site specific ground response studies. The hazard curve contains approximations of the hazard data for peak ground accelerations at the ground surface. Two additional hazard curves are shown for spectral accelerations (structural response curves) corresponding to structural periods of 1.5 and 2.0 seconds.

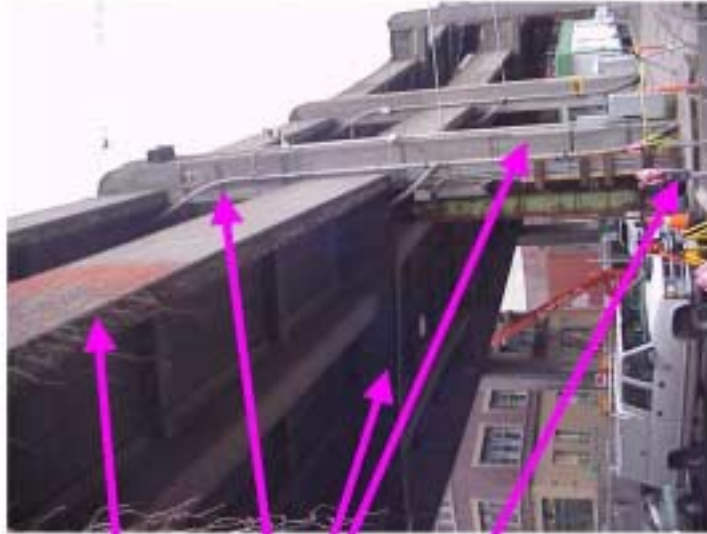
Figure 6

SCOPE OF FULL RETROFIT

1. Replace all of the longitudinal edge beams
2. Replace virtually all of the transverse frame structure
3. Reinforce footings and pile fndns by 'wrap-around' new structures
4. Deck slab is all that remains
