Root Cause Analysis and Recommendations

Investigation of July-29th Incident on Washington State Ferry - Tacoma

Raeey Regassa, P.E., Ph.D. Candidate
Siemens Industry, Inc.

Date: 10/24/2014

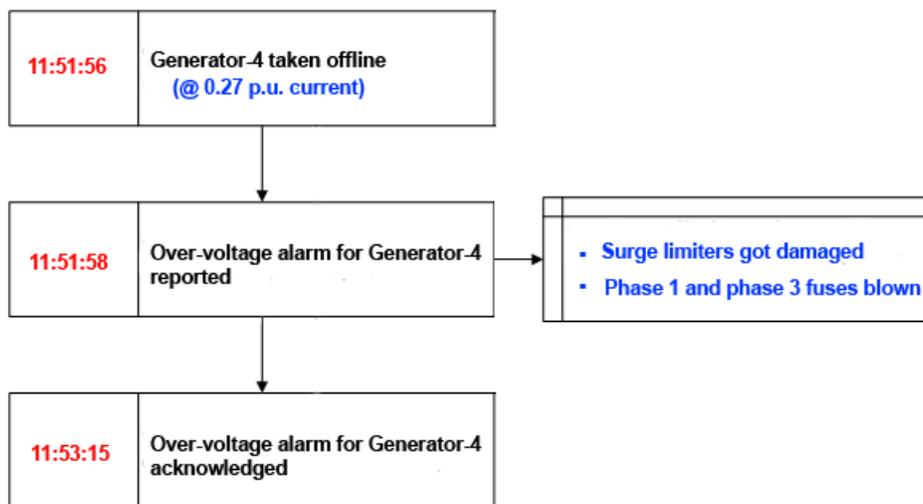
Figure 1: Sequence of events that occurred on Tacoma while at Seattle-Dock
Siemens Industry, Inc.

While the ferry was at Seattle-Dock on July 29th at 11:51:56 PDT, Generator-4 was taken offline. It was injecting current at 0.29 per unit (i.e. ~151A or ~630KW). At 11:51:58, overvoltage alarm for Generator-4 was reported. It is assumed that this voltage surge damaged the three surge limiters of Generator-4 and phases 1 and 3 high side fuses of Generator-4 PTs (voltage/potential transformers). At 11:53:15, overvoltage alarm for Generator-4 was acknowledged. Figure 1 shows the sequence of events that occurred on July 29th while Tacoma was at Seattle Dock.

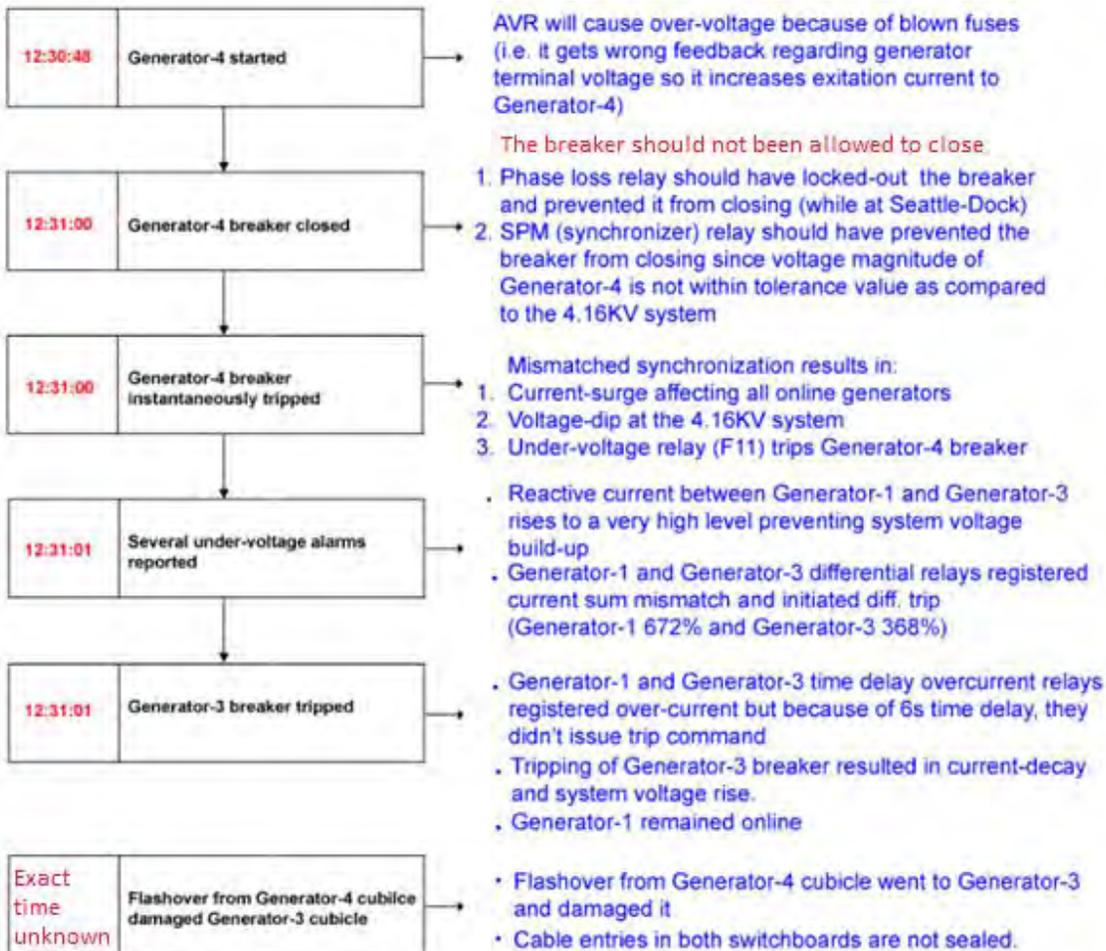
Figure 2: Sequence of events that occurred while Tacoma was approaching Bainbridge-Dock

Approaching Bainbridge-Dock, Generator-4 was started. The high side breaker that connects Generator-4 to the bus was closed at 12:31:00 but immediately opened due to an under-voltage trip signal from the under-voltage relay (F11). Several under-voltage alarms were reported at switchboards 1 and 2. The high side breaker of Generator-3 was tripped and differential trip signals were triggered by differential relays of Generator-3 and Generator-4. Over-current time delay relays of Generator-3 and Generator-4 registered over-current condition but since the time delay of 6 seconds didn't expire, they didn't issue trip commands.

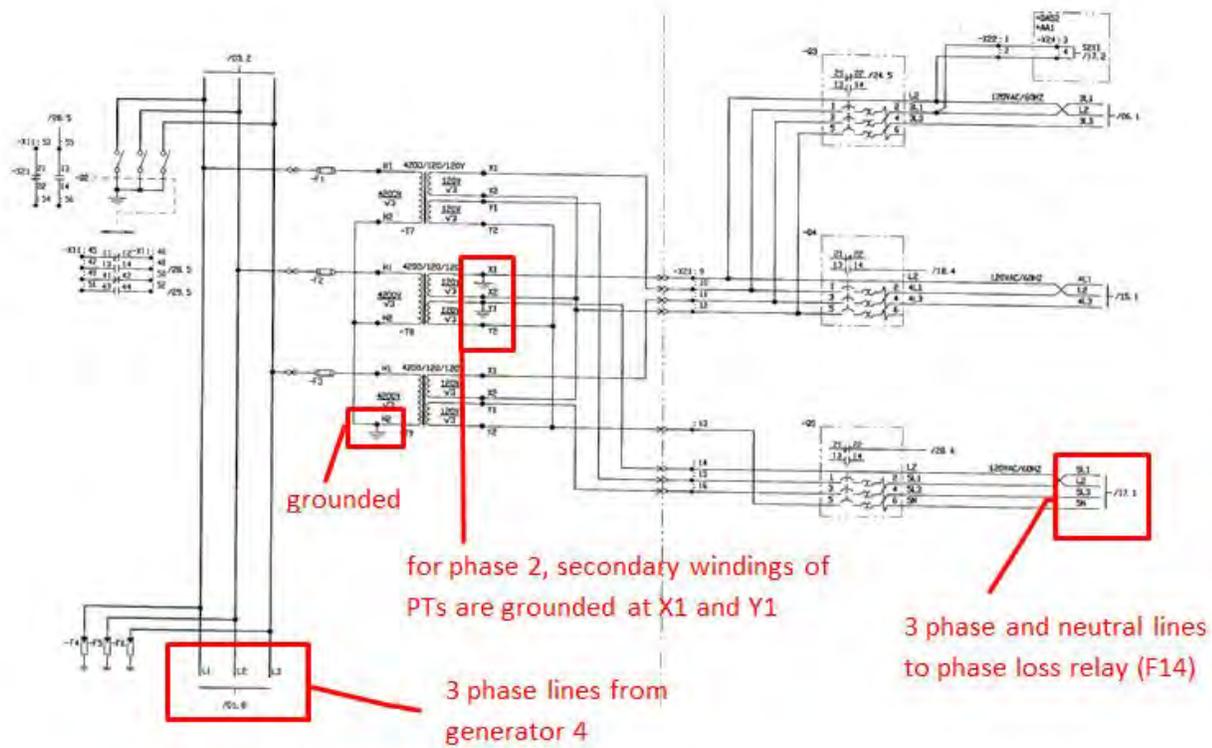
Figure 3: Generator-4 PT connection

The way the PTs are grounded, the burden on them, and the fact that the 4.16KV system is an isolated system, causes the line-to-neutral voltage measured by the F14 relay to be above the threshold value

when two of the three fuses burn out. Thus, the F14 relay in its current configuration can detect phase loss when any one of the fuses or all of the fuses blow out, but it is unable to detect phase loss if two of the three fuses burn out. Figure 3 shows connections of PTs on Generator-4, and figure 4 shows the connection diagram of F14 relay.

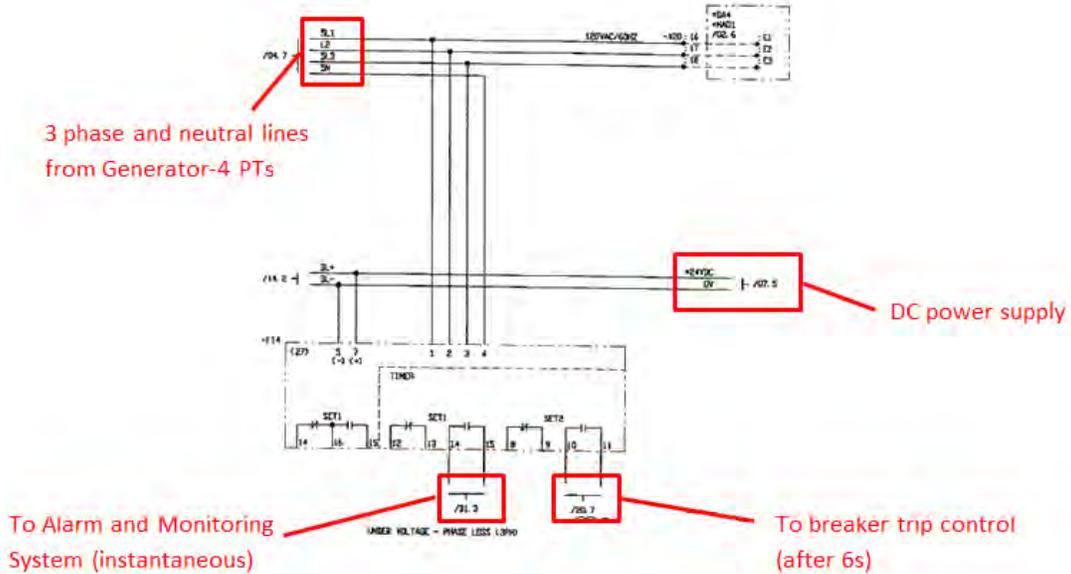
Figure 4: Connection diagram of the phase loss relay (F14)

As seen from figure 4, F14 relay is powered by a 24VDC power supply and it accepts phase voltages and the neutral as inputs. It compares each of the phase voltages (line-to-neutral) to a threshold voltage value of $42V_{rms}$ (voltage set value) and if the result is lower, it sends an instantaneous alarm signal, and after six seconds, it sends a signal to trip the breaker and isolate the generator.

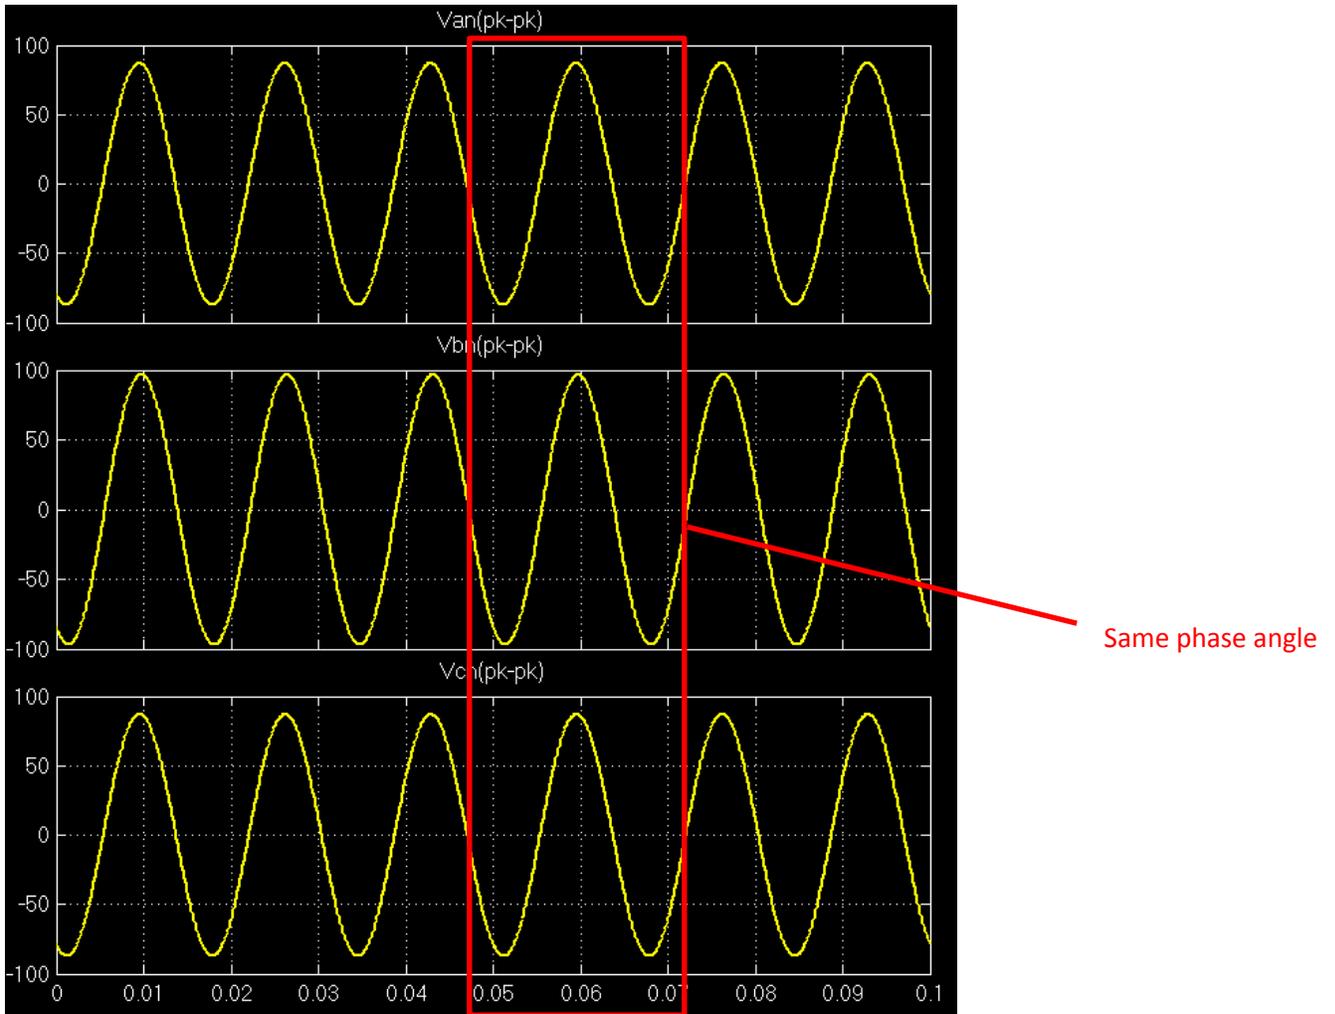
Figure 10: Line-to-neutral voltages measured by F14 relay when phases 1 and 3 fuses are blown

As seen from figure 10, the line-to-neutral voltages measured by F14 relay are almost $\sim 85V_{pk}$ ($\sim 60V_{rms}$) for all phases. In this particular case, the F14 relay will not trip the breaker since all measured voltages

are above the threshold value of $42 V_{rms}$. It is also observed that all measured voltages have identical phase angles (i.e. all of them have the same phase shift as phase 2).

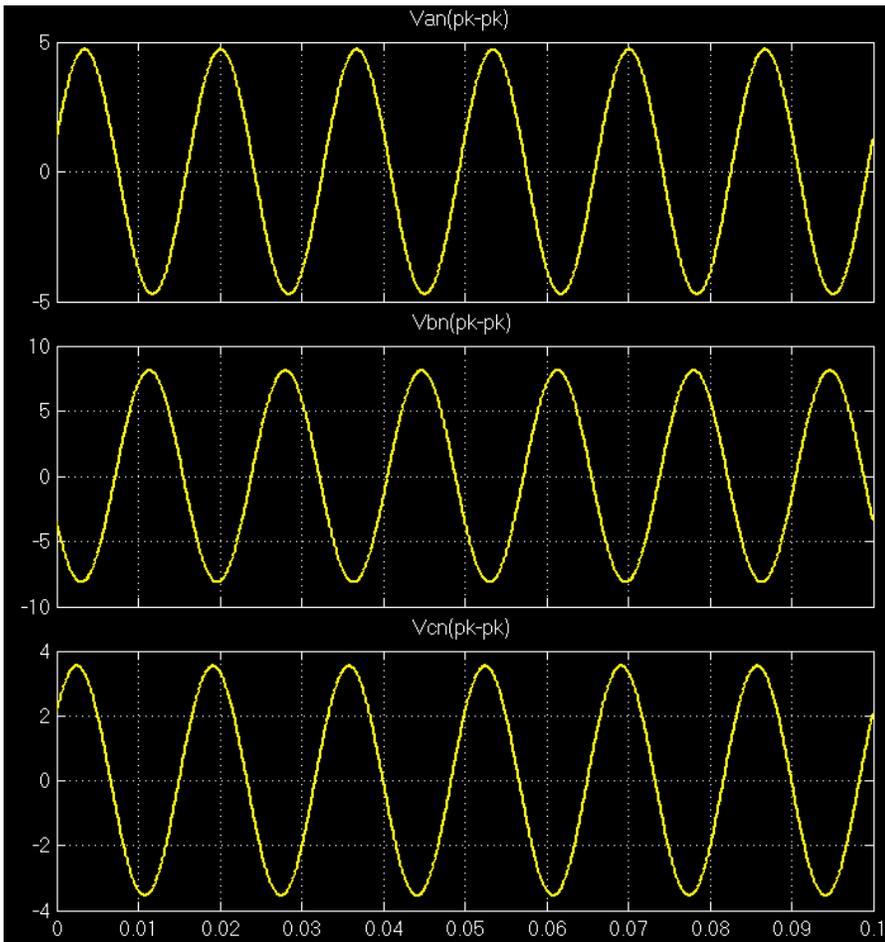
Figure 11: Line-to-line voltages measured when two phases and neutral cable are not connected

For this simulation, phases 1 and 3 fuses are opened and the neutral conductor is removed from terminals of F14 relay. As shown by the scope capture, line-to-neutral measured voltages by F14 relay when two fuses are blown and when neutral conductor removed are all less than $10 V_{rms}$

The phase loss relay (SIEMENS TYPE 7TU9914) can be configured to measure line-to-line voltages [3]. As seen from the simulation result and from the on-site test, the phase loss relay can detect any kind of phase loss if it is configured to measure line-to-line instead of line-to-neutral voltages. Figure 14 shows front and back side views of F14 relay in Generator-4 cubicle (low voltage cubicle).

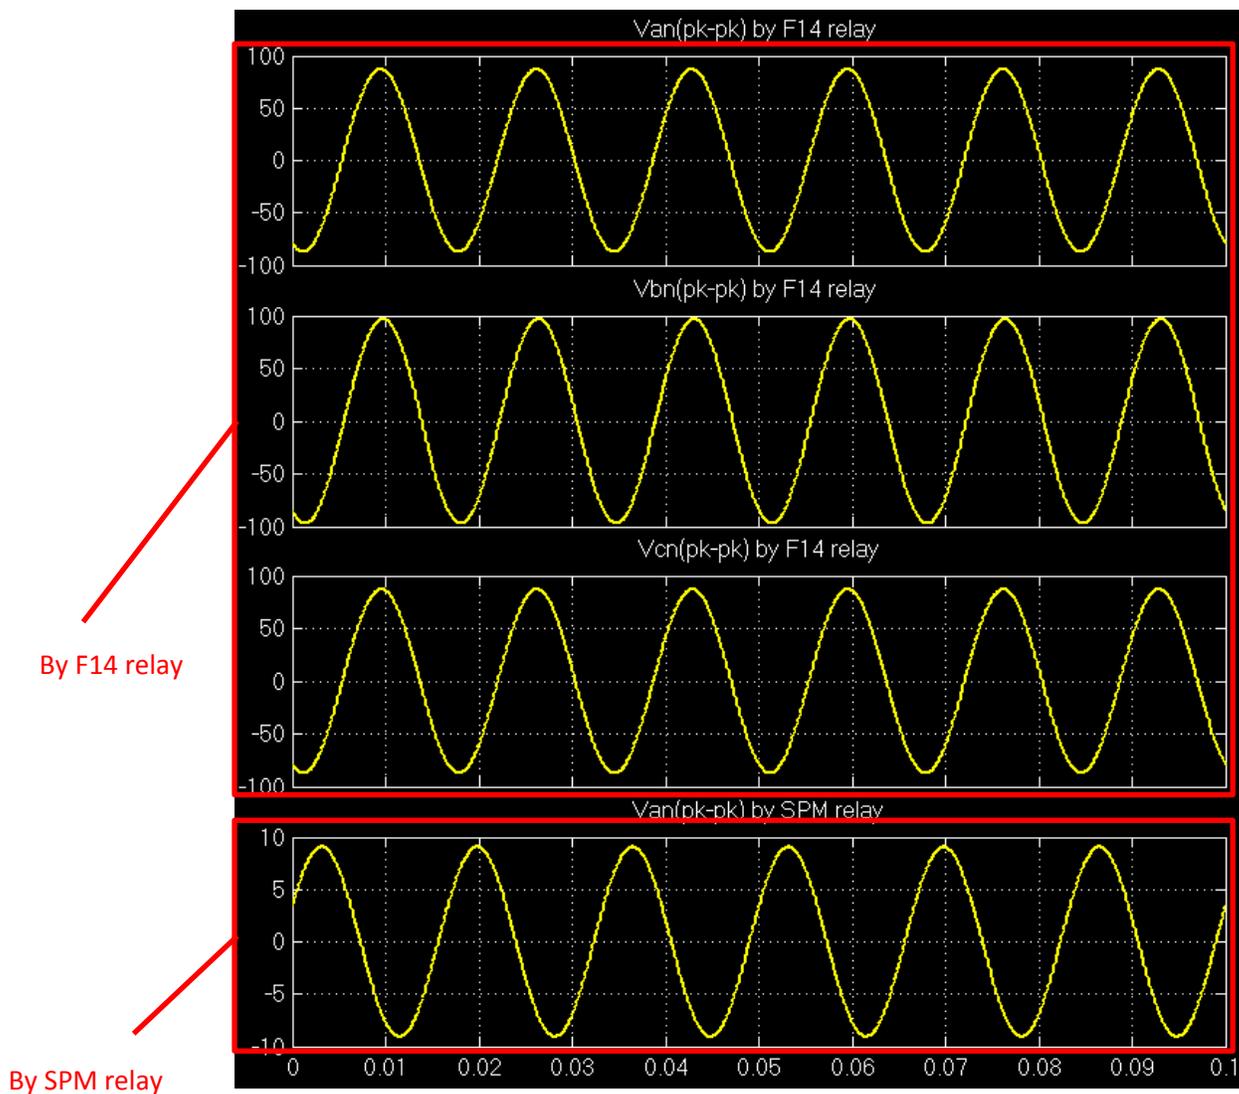
Figure 13: Voltages measured by F14 and SPM relays when two fuses are blown

The magnitude of voltage measured by the SPM relay is well below the line-to-neutral voltage value of $\sim 70V_{rms}$ (as shown in figure 13) when two of the three fuses burn out. If the SPM relay model installed on the ferry had a capability to compare voltage magnitudes besides phases, it would have caught the voltage magnitude difference between Generator-4 PTs and PTs on the 4.16KV bus 2. It would not have sent the “close” command to the PLC and the PLC in turn wouldn’t have closed Generator-4 breaker with such severe voltage mismatch.

recommends replacing the SPM relay with a WOODWARD SPM 9905-003 model that has the capability of checking both phase and voltage match (5% tolerance) between two lines.

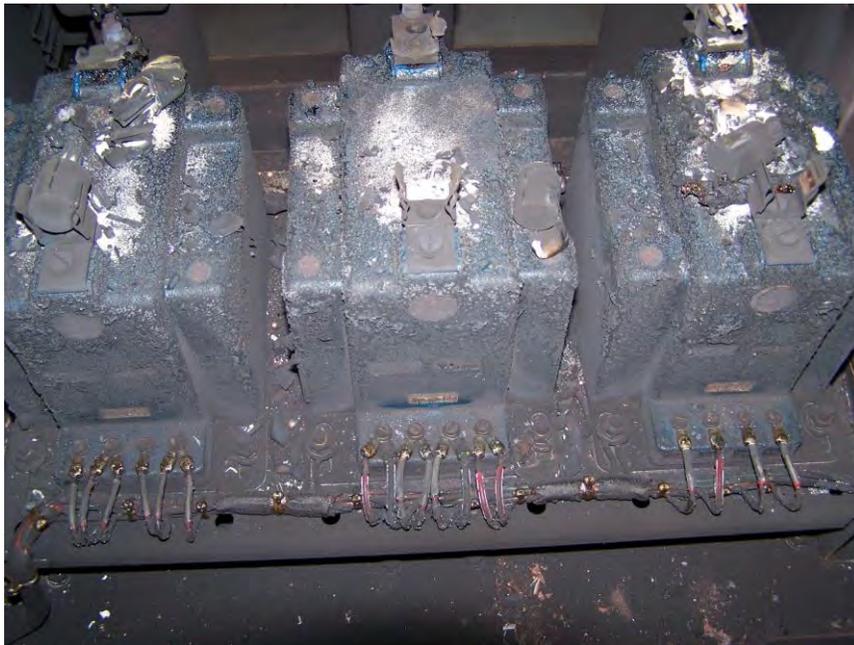
Figure 15: Generator-3 PTs and fuses got damaged

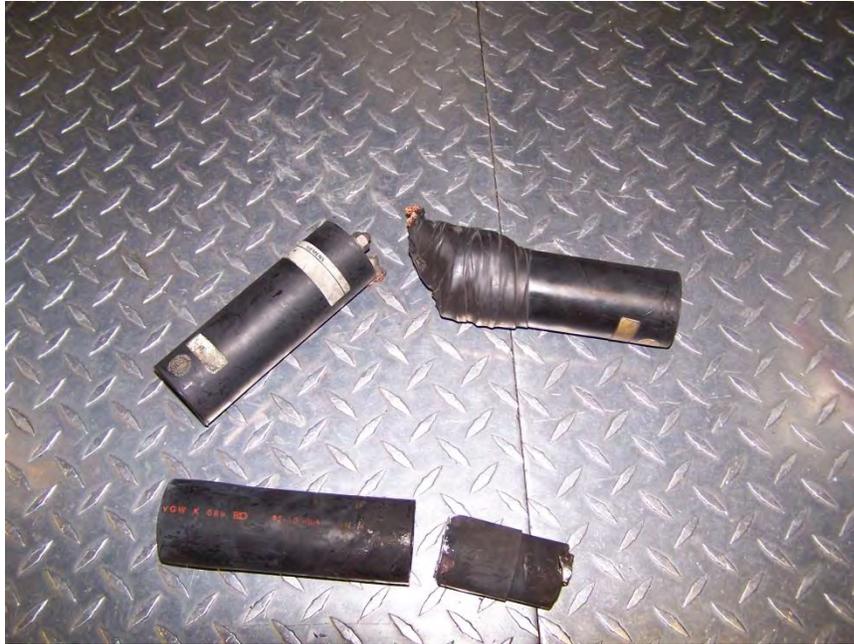
Figure 16: Surge limiters on Generator-4 and Generator-3 got damaged

When the blackout occurred, both 4.16KV switchboards were tied together and the surge limiters on all feeders might be stressed out. They have to be tested according to IEEE recommended practice for surge arrester test procedures. The existing surge limiters on the feeders do not have a maximum continuous operating voltage rating of 4.16KV (i.e. they are rated for $U_c = 3.6KV$) Therefore, Siemens recommends replacing the surge arresters on all feeders. The surge arresters on generators do not have the right energy discharge ratings and they need to be replaced with surge arresters recommended for generation type application. The following surge arrester types are recommended:

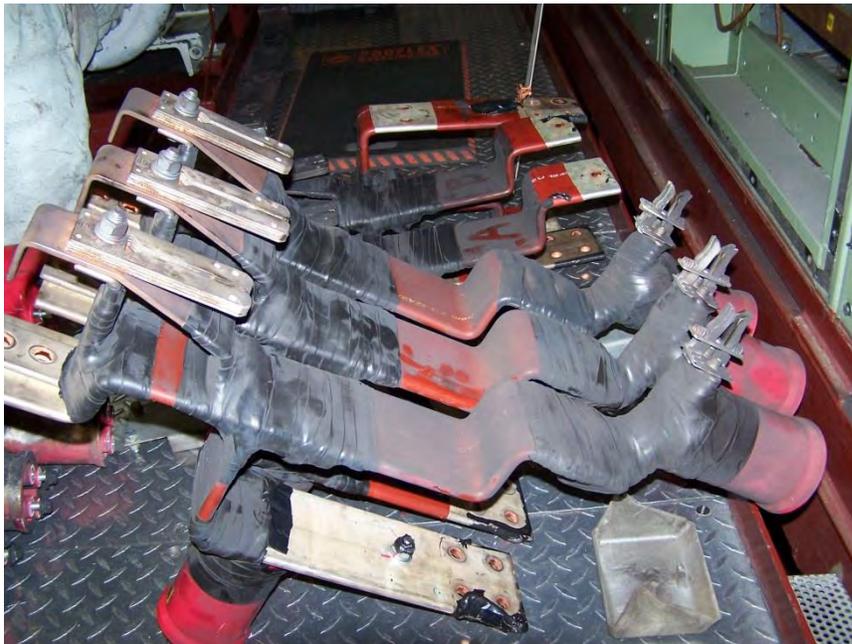
Figure 17: 5KV insulators, PT connection fingers and CT connectors got damaged

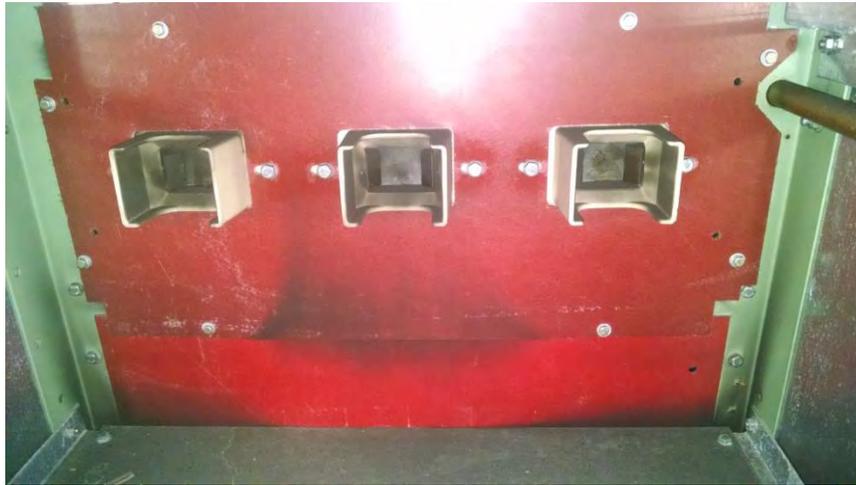
Figure 18: Single phase shutters and glastic board got damaged

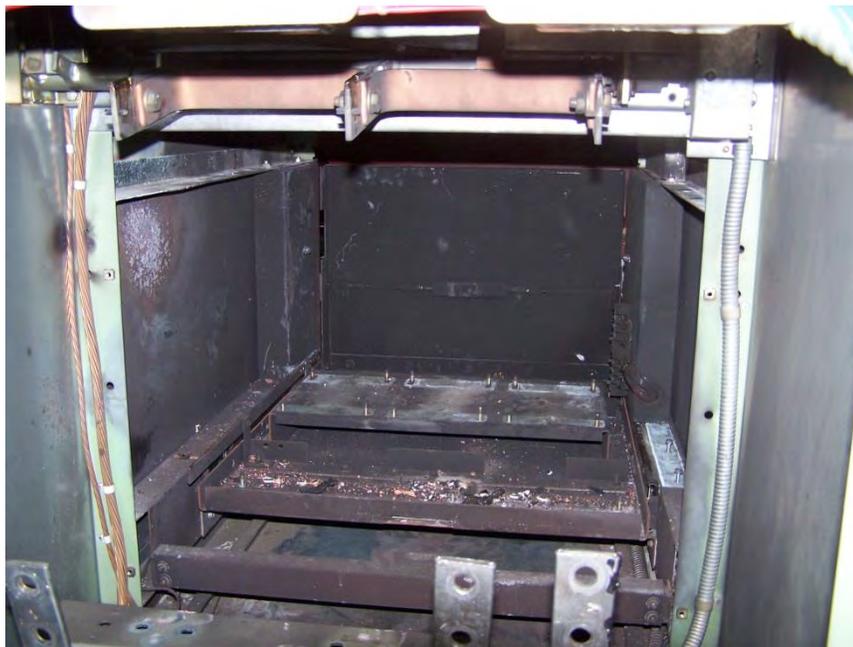
Cable entries in all cubicles in both switchboards are not sealed. Flashover from Generator-4 cubicle went to Generator-3 cubicle and damaged it. This could have been prevented if all cable entries were sealed and proper pressure relief mechanism installed in the cubicles.

Figure 19: High voltage cubicles of Generator-3 and Generator-4 got damaged

Siemens recommends sealing these cable entries and verifying proper pressure venting.

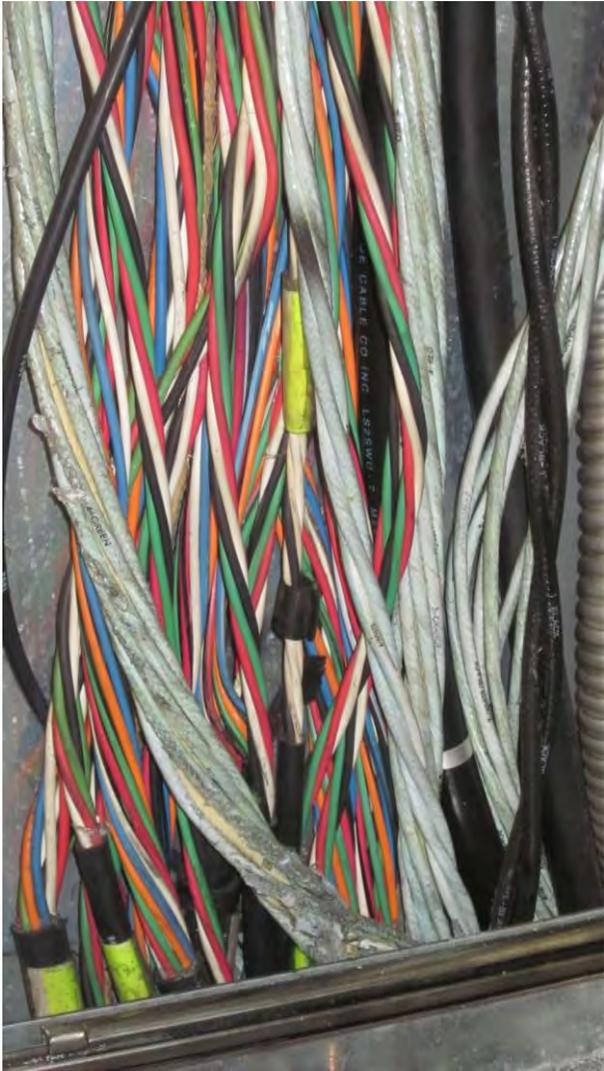
Figure 20: Control-wire harness damaged
