PAVEMENT RESEARCH  
at the  
WASHINGTON STATE UNIVERSITY  
TEST TRACK

DO NOT REMOVE  
From Research Office  
VOLUME THREE  
EXPERIMENTAL RING NO. 3: A STUDY OF UNTREATED,  
EMULSION TREATED, AND ASPHALTIC-CEMENT TREATED BASES

Research Project Y-993

Report to the Washington State Department of Highways  
on Research Project Y-993

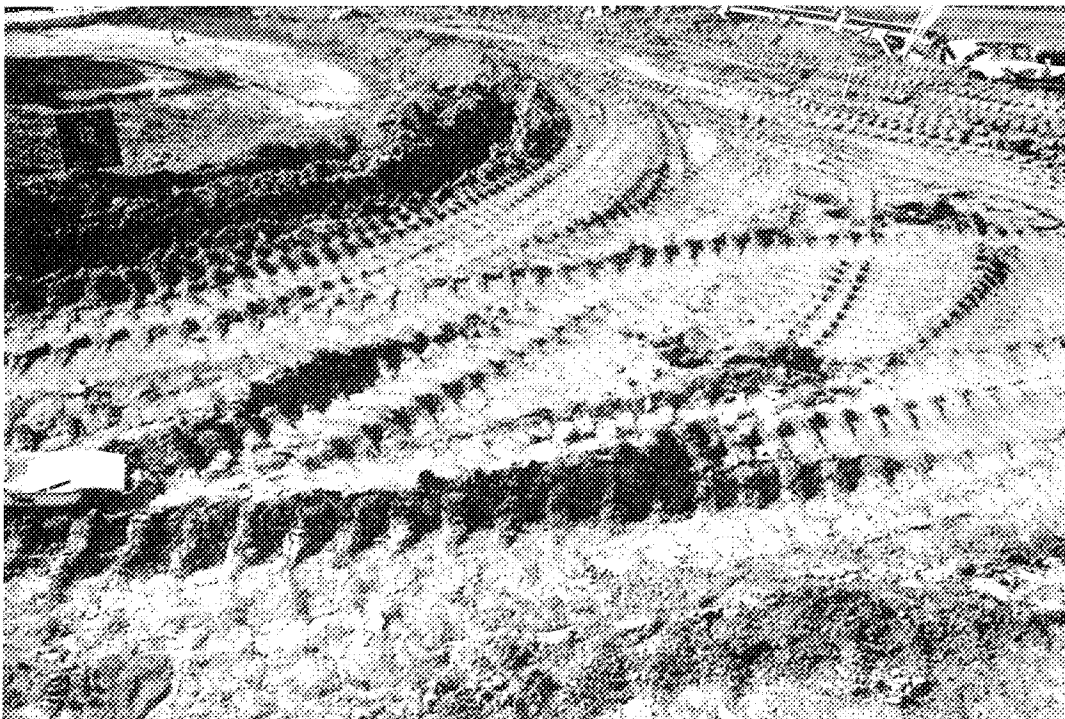
FIGURE 10. THIS SHOWS THE APPEARANCE OF THE SUBGRADE AFTER RING #2 PAVEMENT WAS REMOVED. NOTE THE TIRE TRACKS INDICATING THE SATURATED CONDITION OF THE PALOUSE SILT.

When the old test pavements of Ring #2 were removed, the subgrade was found to be non-uniformly wet. Moisture contents varied from section to section as shown in Table 5. The moisture content was found to be above optimum in most sections, and some were at a saturated level. The contractor, United Paving, Inc., excavated the subgrade to the 110-foot elevation and tried to dry it so that specified compaction and moisture levels could be reached. This proved to be unsuccessful. Figure 10 shows the appearance of wet subgrade. Other methods, such as scarification, were tried to obtain compaction and uniform moisture without success.

A work order arrangement was agreed upon with contractor which called for excavation of the subgrade to elevation 108 feet and where needed, to further excavate the non-uniform subgrade areas. The subgrade was excavated to the 108-foot elevation. Non-uniform spots were found in sections 10-11, 1-2-3, and 5-6 and were excavated to 106-, 105- and 107-foot elevations respectively. At these elevations, the subgrade was found to be uniform in moisture. New silt material was used to build up the subgrade to the 108-foot elevation. A 10-ton, 9-pneumatic rubber-tired roller was used for compaction, which was checked by nuclear density equipment. This work order cost \$3,802.07 and caused a delay of over a month.

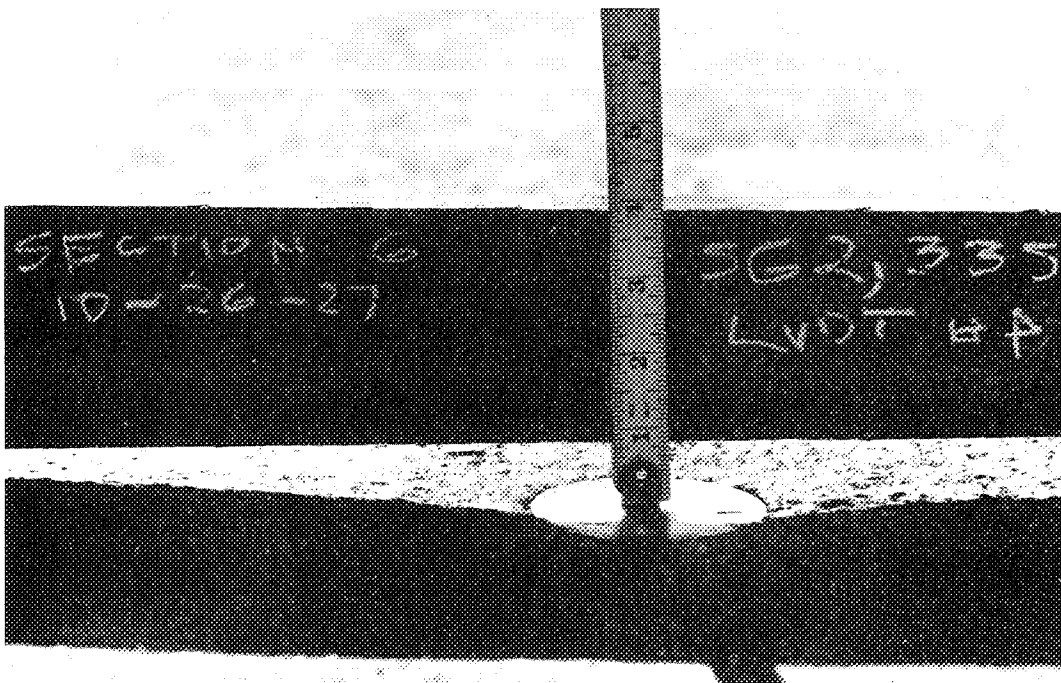
FIGURE 27. PERMANENT SETTLEMENT OF PAVEMENT IN SECTION 6 ON LINE E AFTER 562,335 WHEEL LOAD REPETITIONS, OCTOBER 26, 1967.

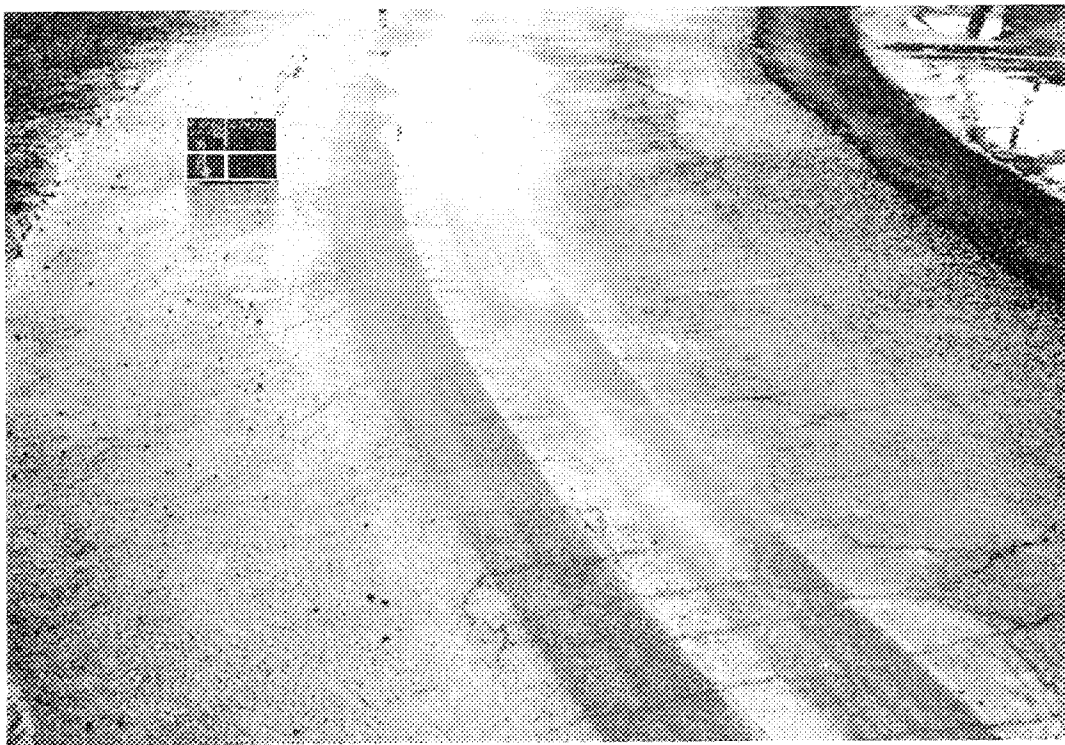
FIGURE 29. "ULTIMATE" FAILURE IN SECTION 6 AFTER 679,107 WHEEL LOADS ON NOVEMBER 10, 1967. NOTE LONGITUDINAL CRACKS AT BOTH WHEEL PATH EDGES, THE UNIFORM ALLIGATOR CRACKING PATTERN AND THE WATER IN THE CENTER.

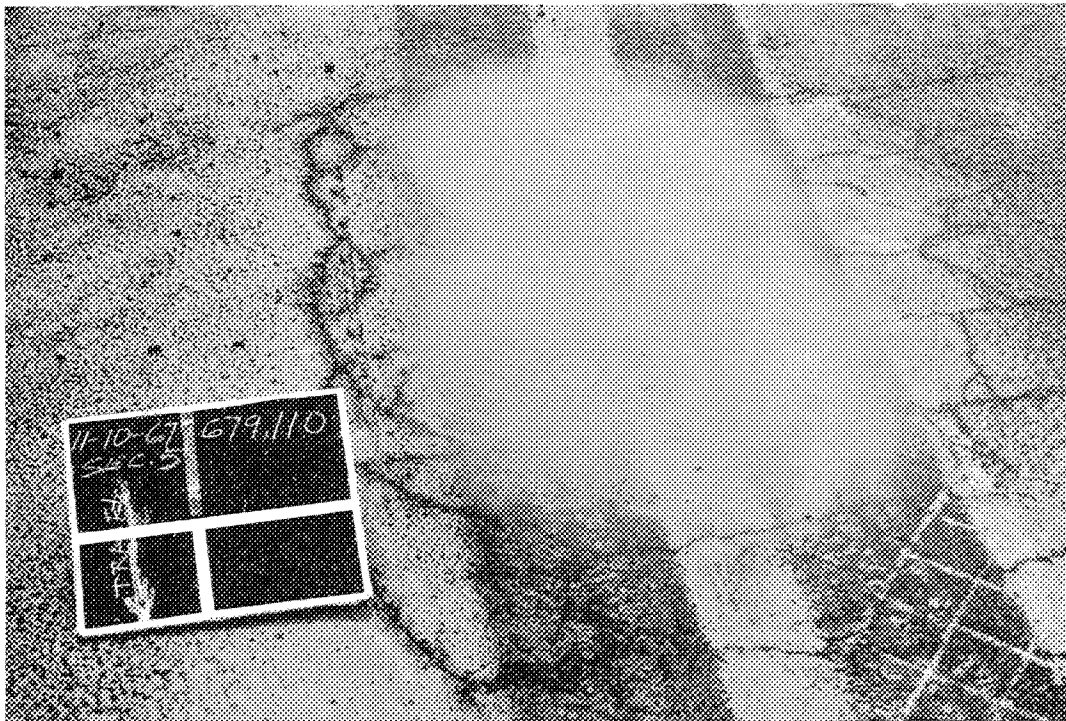
FIGURE 30. THE APPEARANCE OF SECTION 5 (4.5 INCHES OF UNTREATED BASE) AT "ULTIMATE" FAILURE AT 679,107 WHEEL LOAD REPETITIONS. THIS WAS LOCALIZED AROUND LINES E AND D.

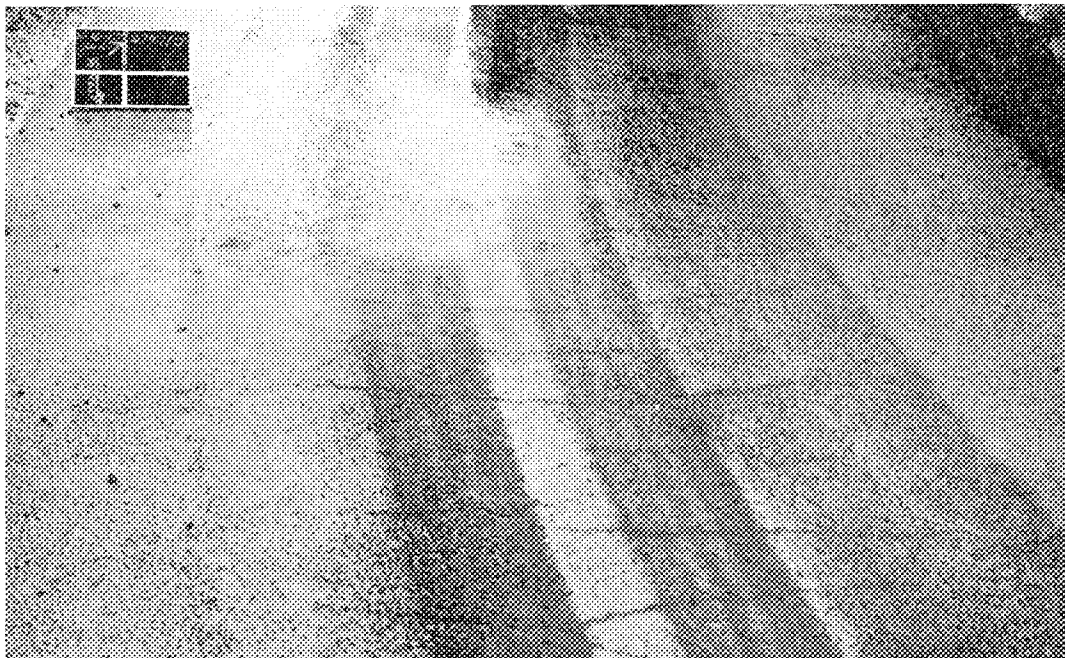
FIGURE 31. APPEARANCE AND FAILURE IN THE TRANSITION ZONE BETWEEN SECTIONS 6 AND 7 (9.5 INCHES OF UTB) AFTER 679,107 WHEEL LOAD REPETITIONS. AN ASPHALT OVERLAY WAS PUT OVER THIS AREA.

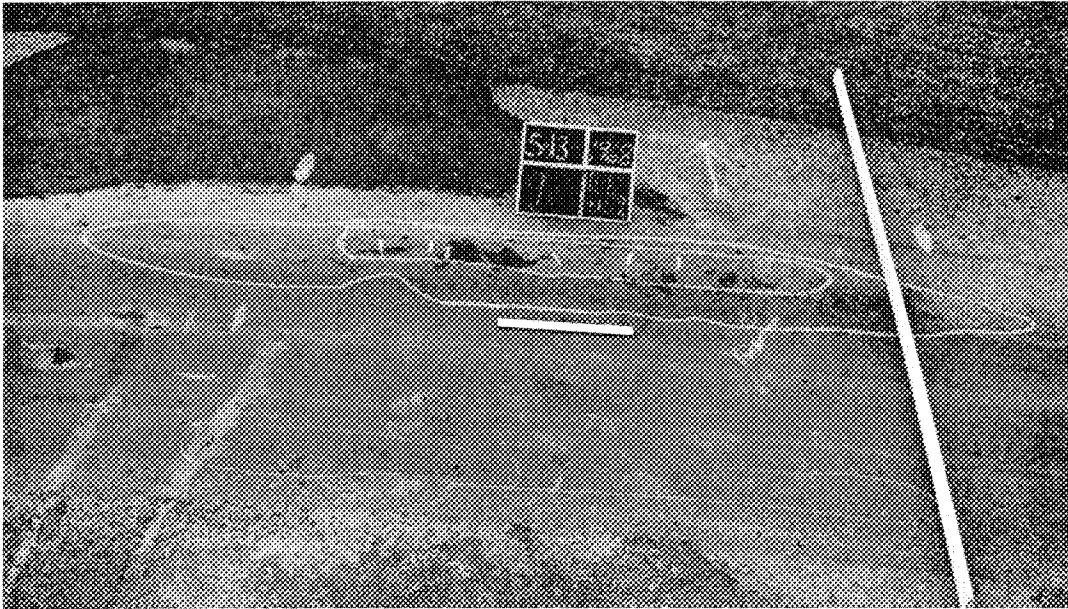
FIGURE 32. THE START OF FAILURE IN SECTION 9 (3.5 INCHES OF ETB) AFTER 736,896 WHEEL LOAD REPETITIONS. NOTE THE START OF LONGITUDINAL SHEAR CRACKS ALONG THE EDGE OF WHEEL PATH. THE INNER CHALK OUTLINED AREA WAS MARKED EARLIER AT 736,737 WHEEL LOADS ON MAY 13, 1968.
