# Evaluation of Tieback Performance

WA-RD 269.1

Final Technical Report  
January 1993

**Washington State Department of Transportation**

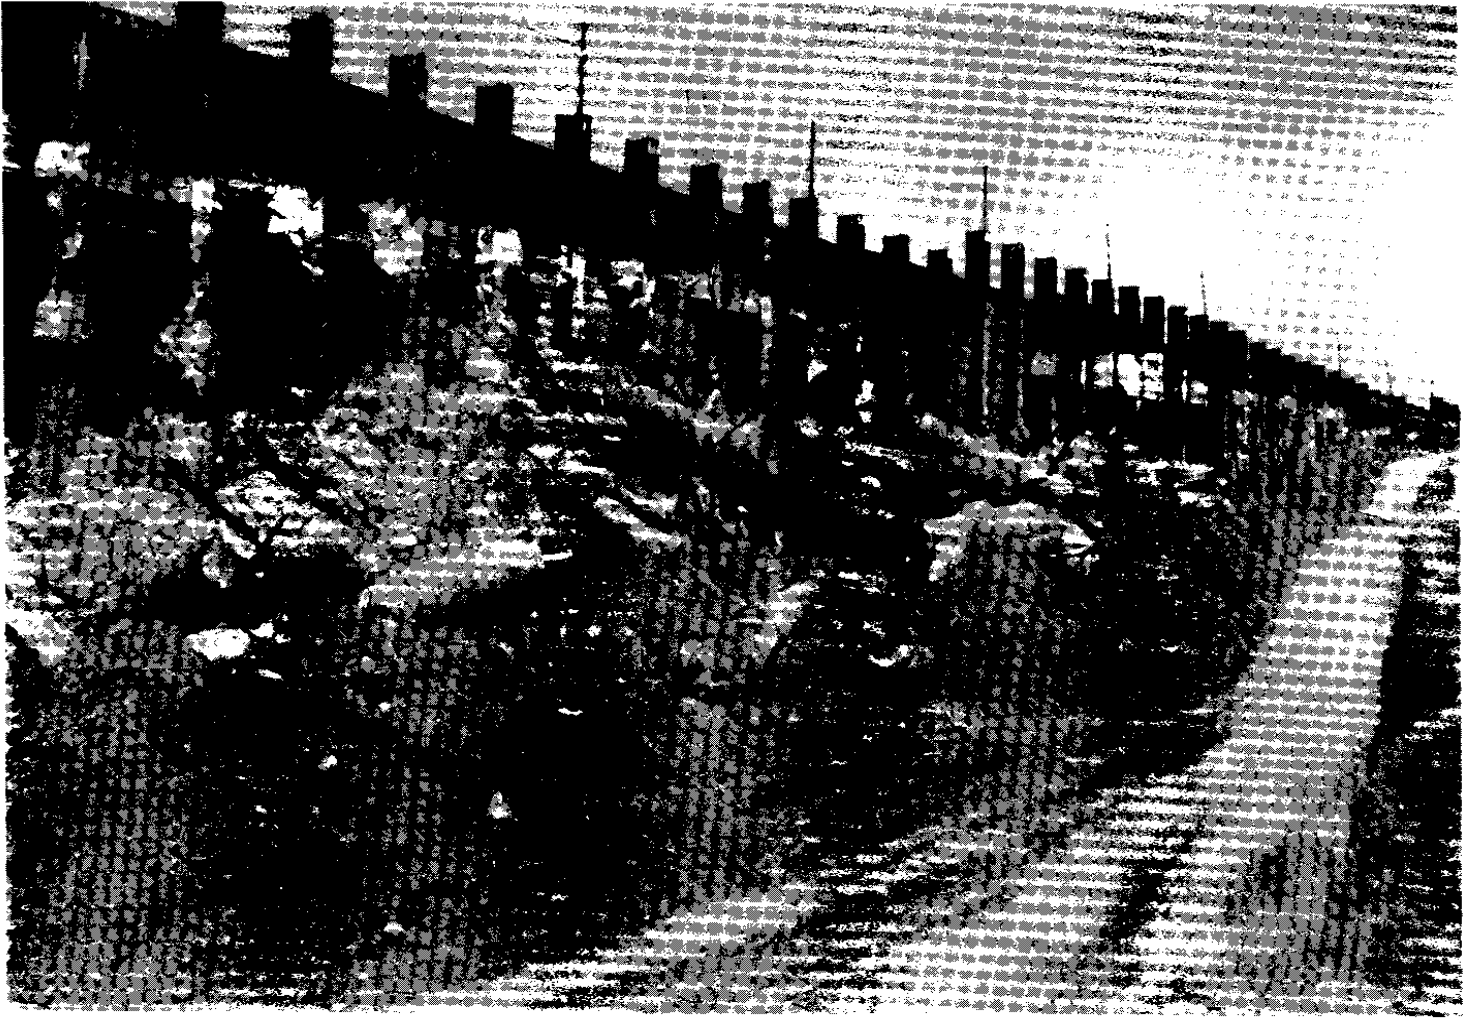
Figure 8. Typical Disturbance Caused by Mass Excavation with Bulldozers and Backhoes

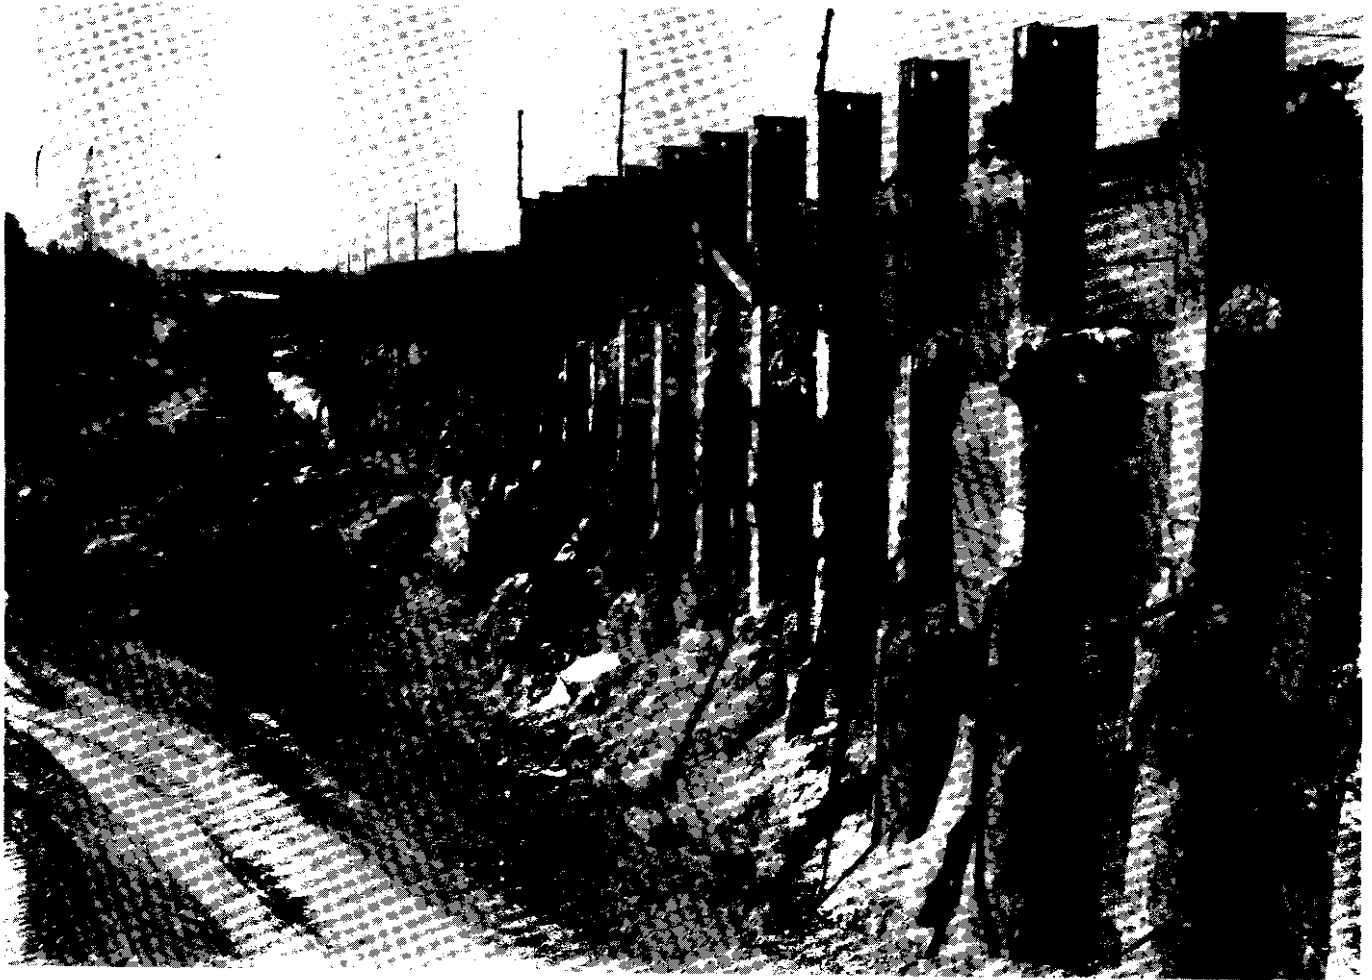
Figure 15. Highly Disturbed Anchor Tendons in No-Load Zone

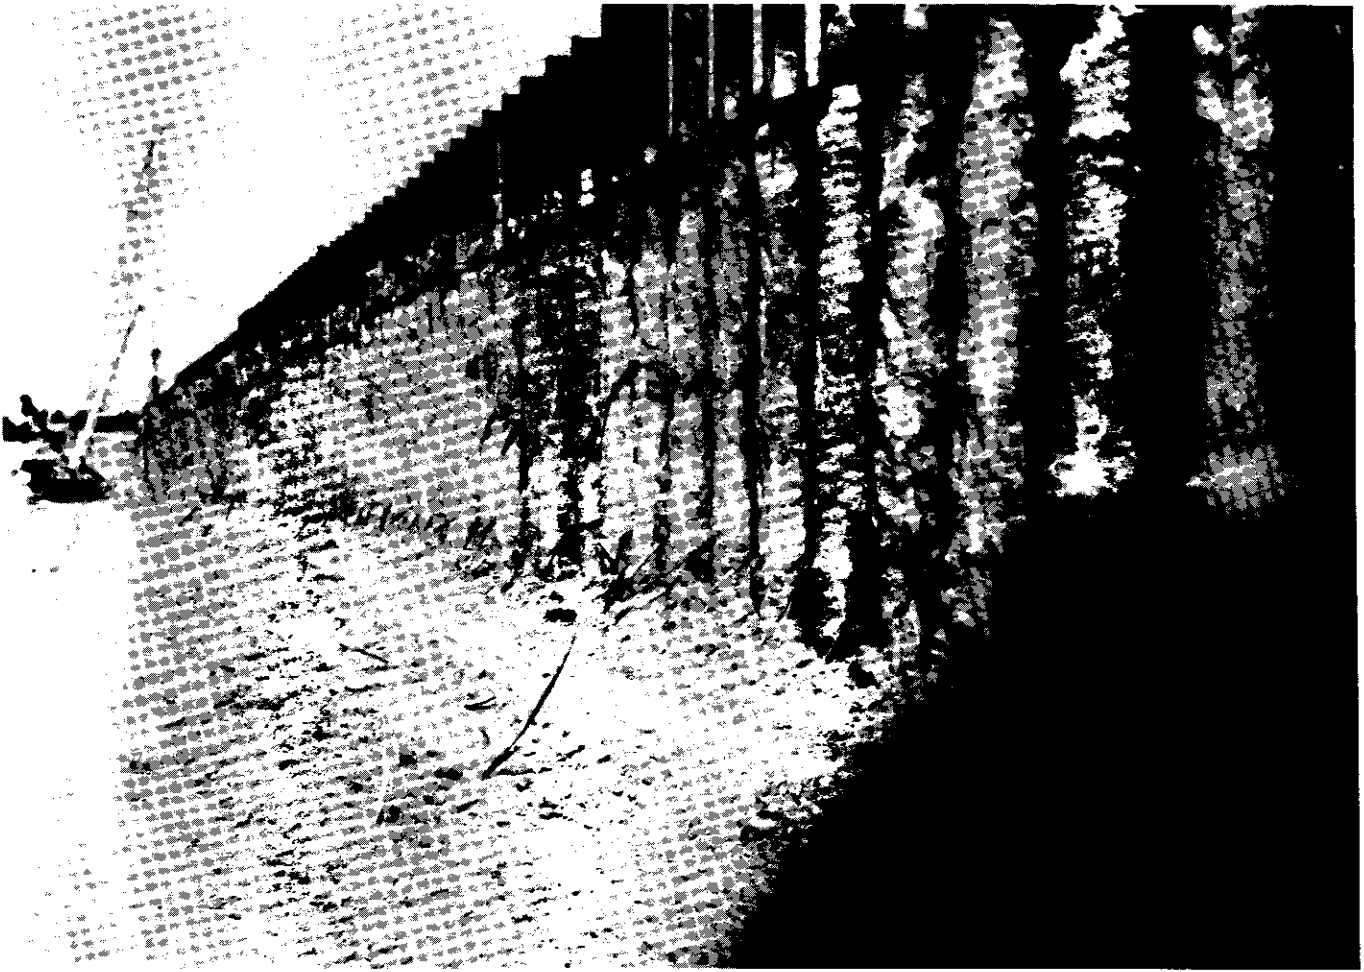
Figure 16. Anchor Tendons Cut Such That Characteristics in No-Load Zone Could Not Be Observed

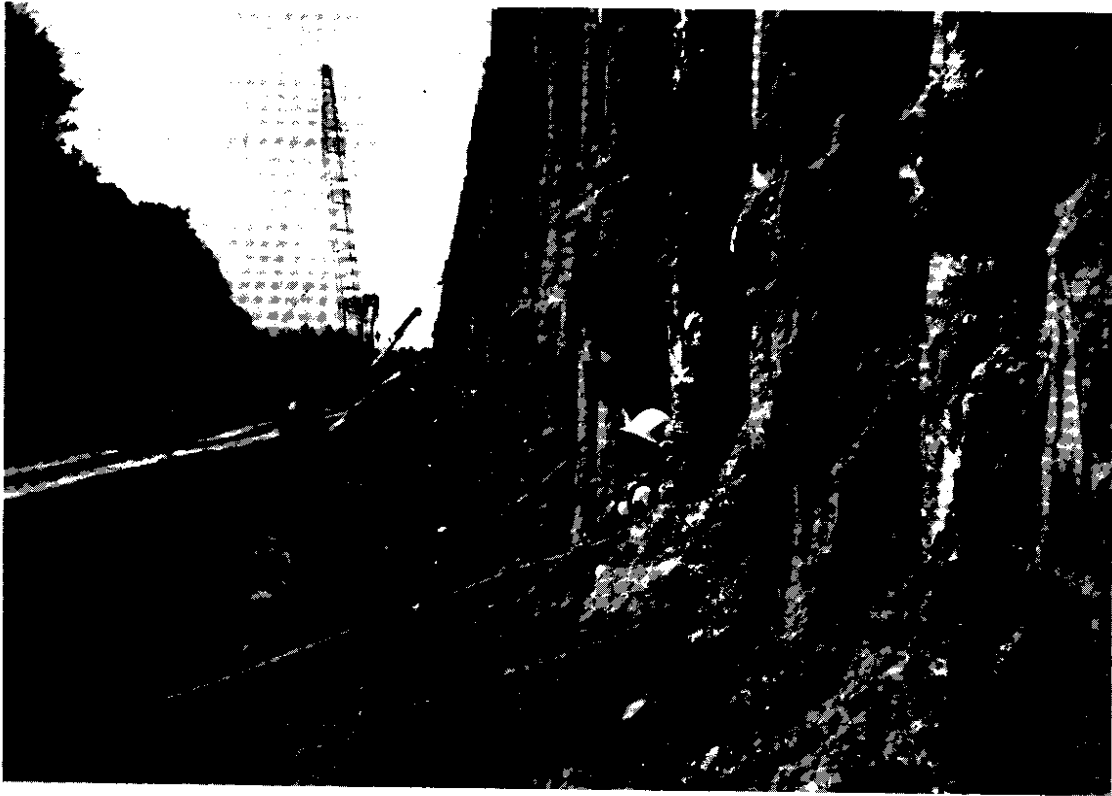
As a result, the general state of disturbance of each tieback was also noted to identify any correlation between disturbance and other characteristics. As illustrated in Figure 17, disturbance of the tiebacks ranged from negligible to severe.

Figure 17. Variable Tieback Disturbance in Anchor Head/Trumpet Zone

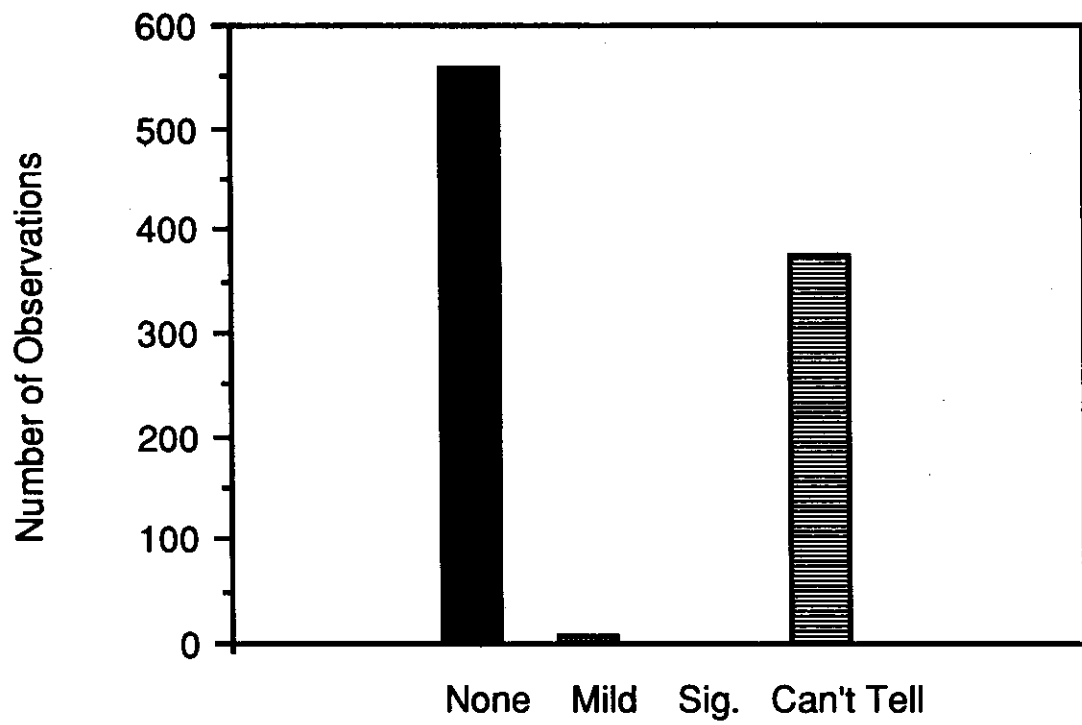
The observations of anchor tendon corrosion were notable for the lack of significant corrosion. In 375 of the 944 tiebacks that the researchers attempted to observe, it was impossible to determine whether corrosion had occurred. Of the remaining 569 anchor tendons, however, no corrosion was observed in 560 (98.4 percent). Evidence of mild corrosion was observed on only 9 (1.6 percent) anchor tendons, and *significant corrosion was not observed on any anchor tendon*. The distribution of observed tieback corrosion is shown graphically in Figure 19.

Figure 19. Observations of Anchor Tendon Corrosion
