Final Summary Report
Research Project Agreement No. T9233, Task 41
Seismic Vulnerability of the Alaskan Way Viaduct Phase II

**SEISMIC VULNERABILITY OF THE ALASKAN
WAY VIADUCT: SUMMARY REPORT**

July 1995

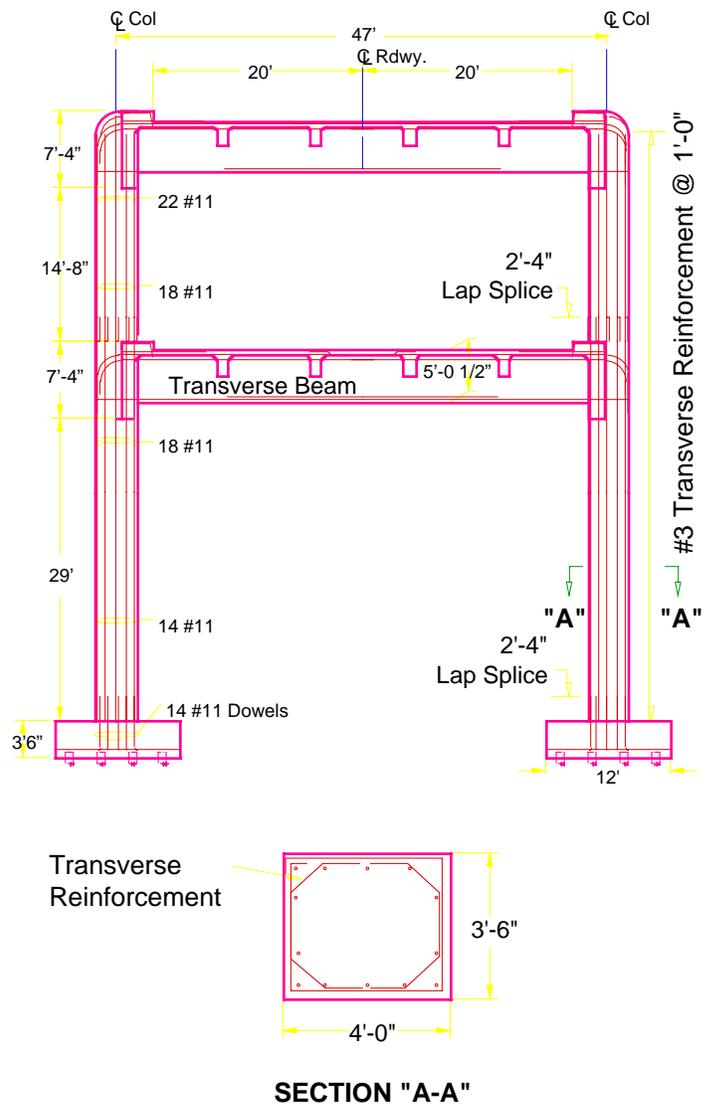
Figure 2. Elevation of Typical Interior Transverse Frame

Another difference between the Alaskan Way Viaduct and modern construction is the presence of longitudinal column reinforcement splices at the column bases and directly above the first deck (Fig. 2). The lap splices are much shorter than those required by current standards, are enclosed by inadequate transverse reinforcement, and

are located in regions that are likely to undergo large flexural demands during an earthquake. Other significant differences between the viaduct and new construction are that the bottom transverse beam and longitudinal girder reinforcement extends into the columns only a short distance, and the footings have no top reinforcement.
