Deception Pass Log Rail

WA-RD 642.1

Research Report
November 2004

Deception Pass Timber Barrier

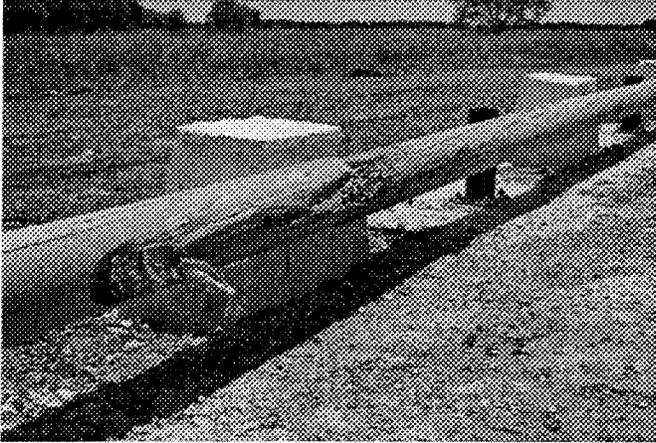
FIGURE 4 Barrier damage from test 400561-1.

Damage to the log rail was primarily to the timber log element, as shown in Figure 4. The log element was gouged to a maximum depth of 0.8" near bollard 5. Tire marks extended 3.5" under the log element just downstream

of the splice at bollard 5. Bollard 5 was pushed toward the field side 0.4". The vehicle was in contact with the log element for 11.5'. Maximum dynamic deflection was not measurable.

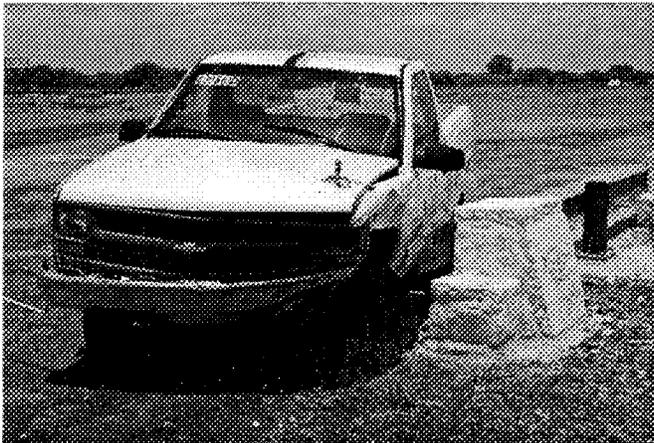
FIGURE 5 Vehicle damage from test 400561-1.

The left front quarter of the pickup truck sustained most of the damage, as shown in Figure 5. Structural damage was imparted to the left upper and lower A-arm, left outer tie rod, and left frame rail. Also damaged were the front bumper, grill, left front quarter panel, left front tire and wheel rim, left door, and left rear wheel rim. Maximum exterior crush to the vehicle was 25.0" in the frontal plane at the left front corner near bumper height. Maximum occupant compartment deformation was 2.3" in the center front floorpan over the transmission tunnel

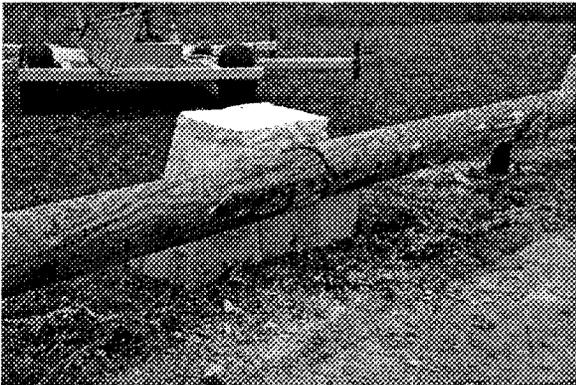
FIGURE 6 Barrier damage from test 400561-2.

Damage to the log rail was primarily to the timber log element, as shown in Figure 6. The log element was gouged and tire marks extended along the face of the log. Bollard 6 was disturbed only. The vehicle was in contact with the log element 12.5 ft. Maximum dynamic deflection was not measurable.

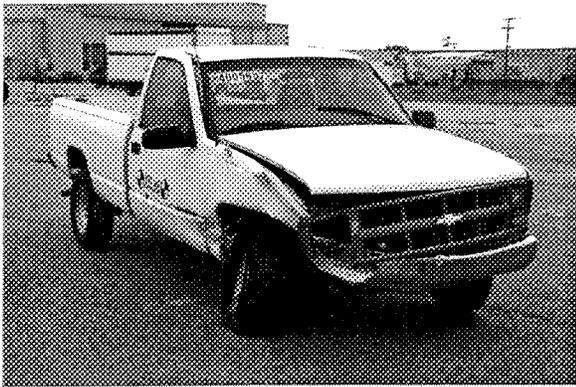
FIGURE 7 Vehicle damage from test 400561-2.

The right front quarter of the pickup truck sustained most of the damage, as shown in Figure 7. Structural damage was imparted to the right upper A-arm, right side floor pan, and right frame rail. Also damaged were the front bumper, grill, right front quarter panel, right front tire and wheel rim, and right door. Maximum exterior crush to the vehicle was 23.6" in the frontal plane at the left front corner near bumper height. Maximum occupant compartment deformation was 2.5" in the center front floor pan over the transmission tunnel.

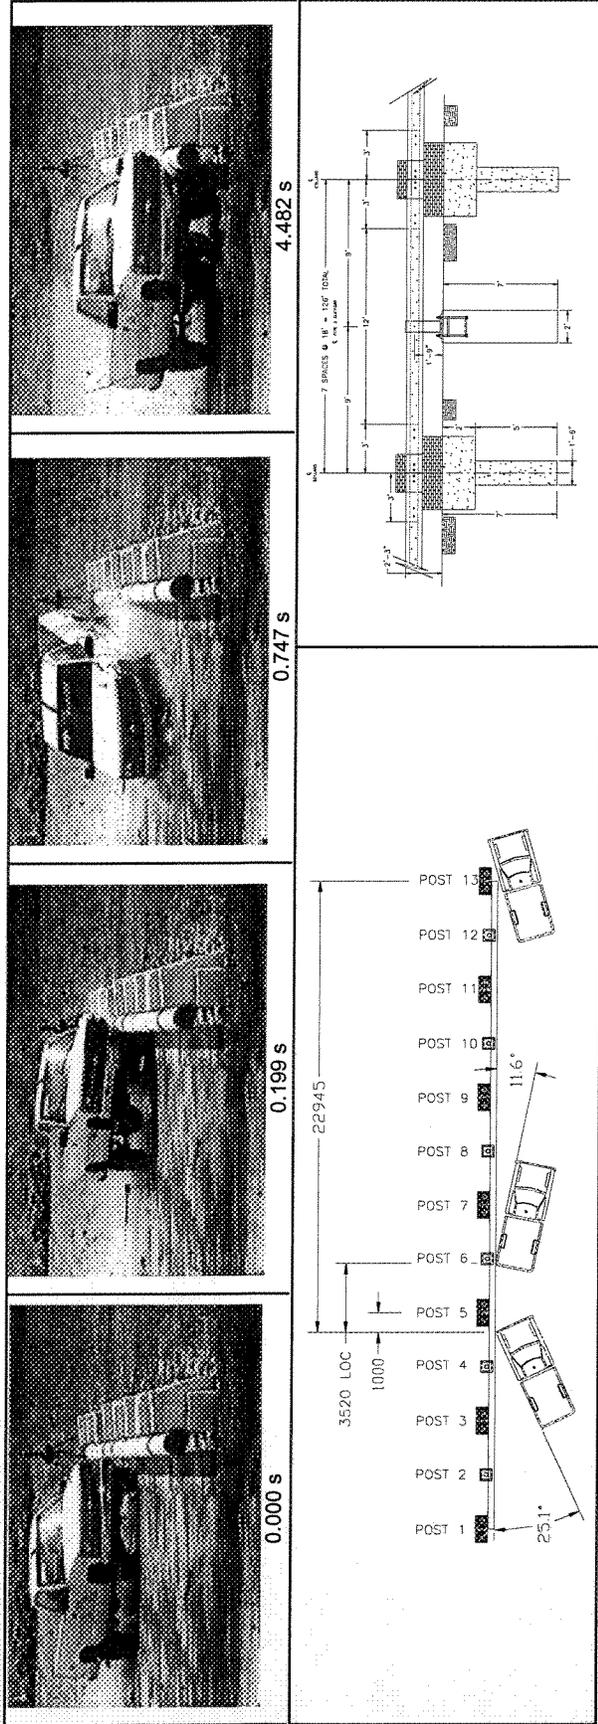
FIGURE 9 Summary of test results – Test 400561-1.

This test met all of the evaluation criteria in NCHRP Report 350. A summary of the test information is shown on Figure 9.

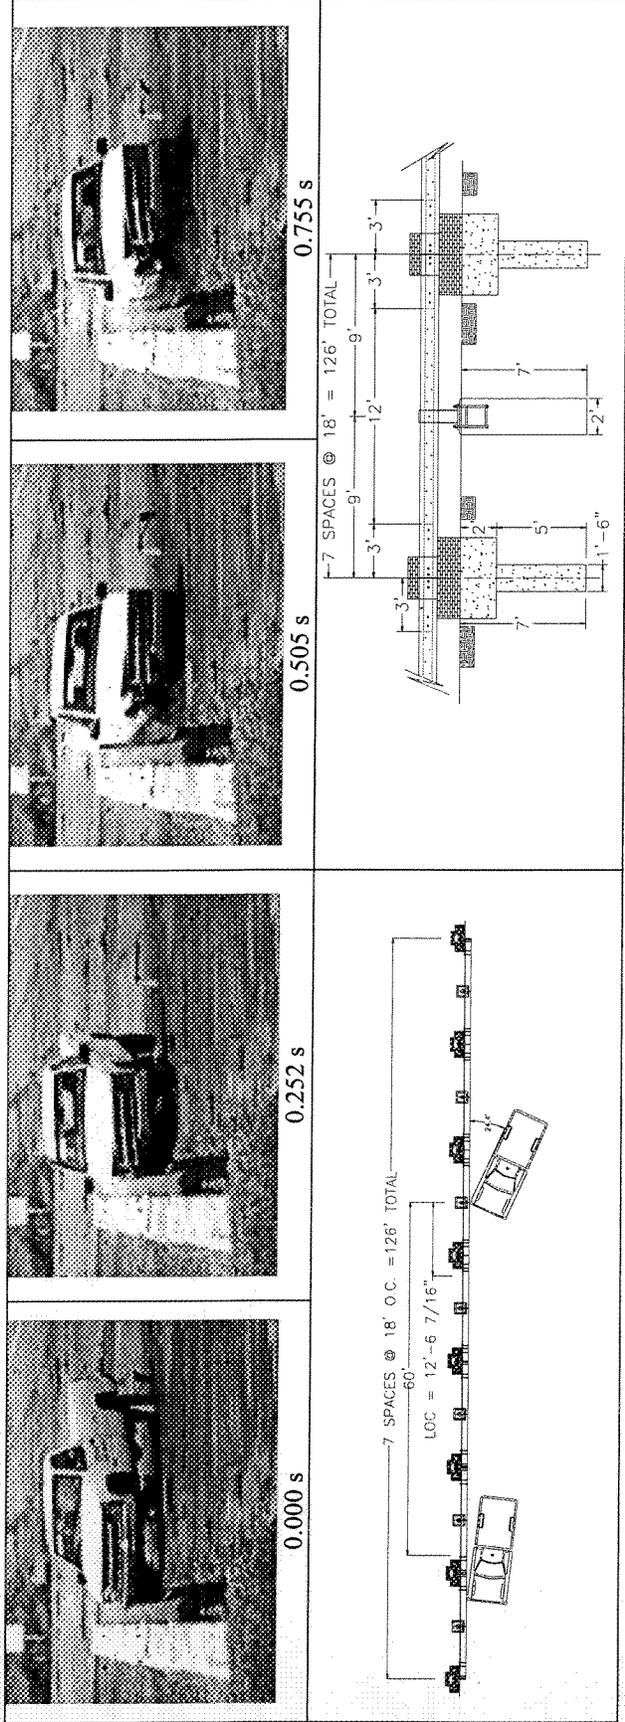
FIGURE 10 Summary of test results -- Test 400561-2.

This test met all of the evaluation criteria in NCHRP Report 350. A summary of the test information is shown on Figure 10.
