## **NCHRP REPORT 350 TEST 3-11 OF THE LONG-SPAN GUARDRAIL WITH 5.7 M CLEAR SPAN AND NESTED W-BEAMS OVER 11.4 M**

Contract No. T4541-AA  
Report/Test No. 405160-1-1  
Test Date: May 24, 2006

**Roadside Safety Research Program Pooled Fund  
Study No. TPF-5(114)**

**TEXAS TRANSPORTATION INSTITUTE  
THE TEXAS A&M UNIVERSITY SYSTEM  
COLLEGE STATION, TEXAS 77843**

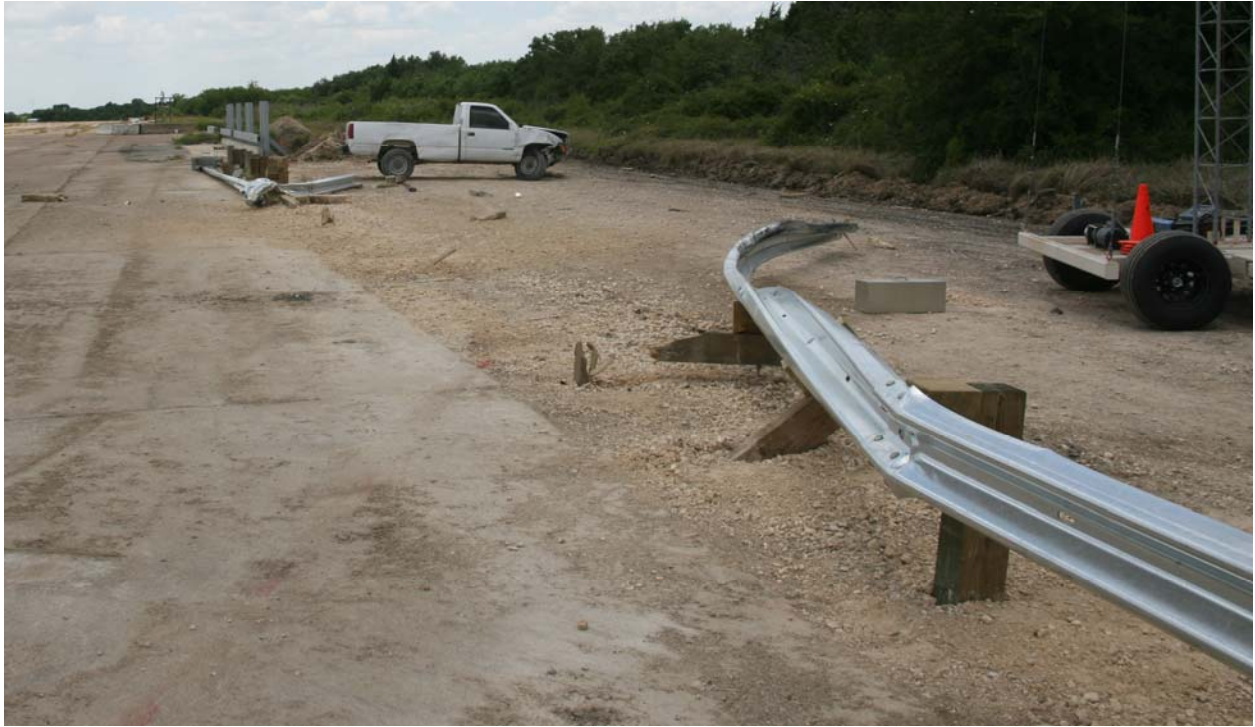
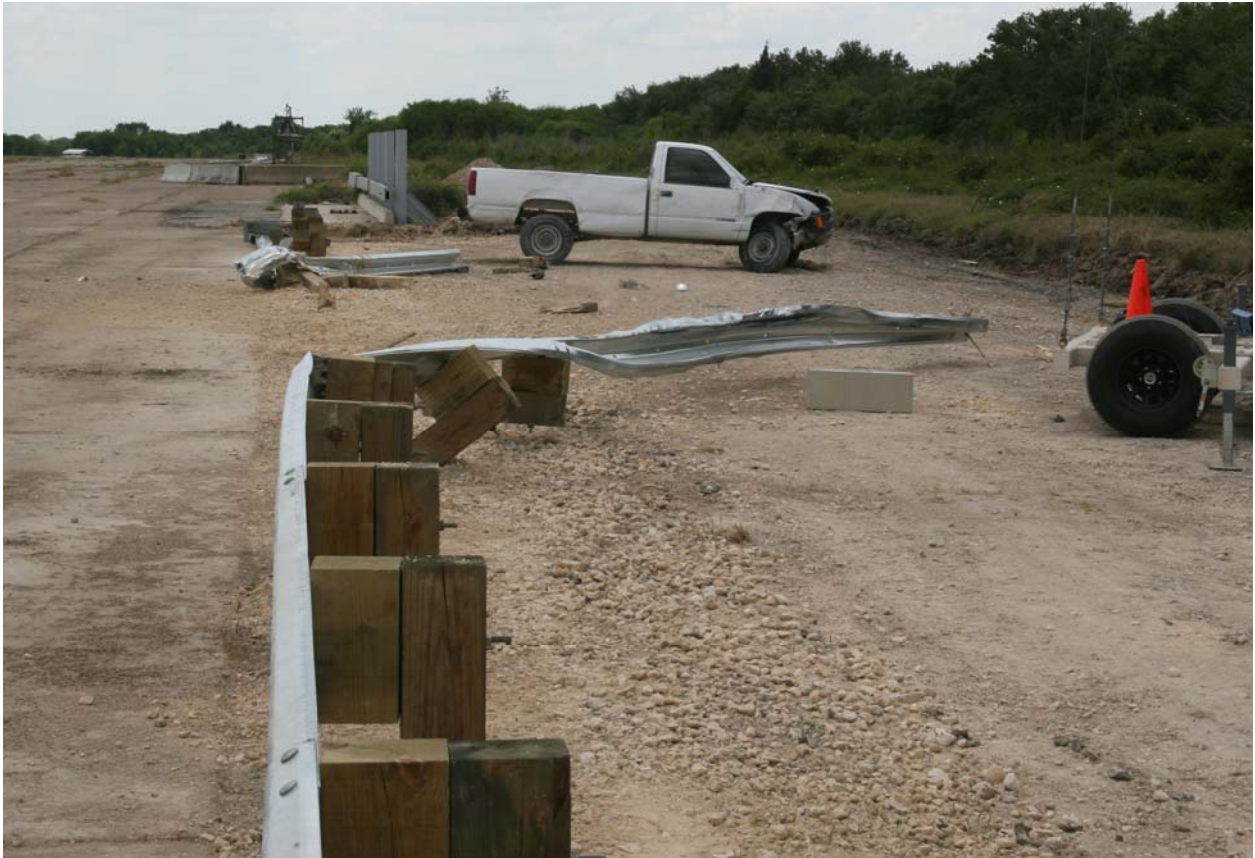
Figure 9. Vehicle trajectory path after test 405160-1-1.

Results: The Long-Span Guardrail did not contain or redirect the vehicle. The vehicle penetrated the rail element with a maximum dynamic deflection of 1.45 m before the rail ruptured. (FAIL)

Results: The vehicle rolled 90 degrees and then came to rest upright. (FAIL)

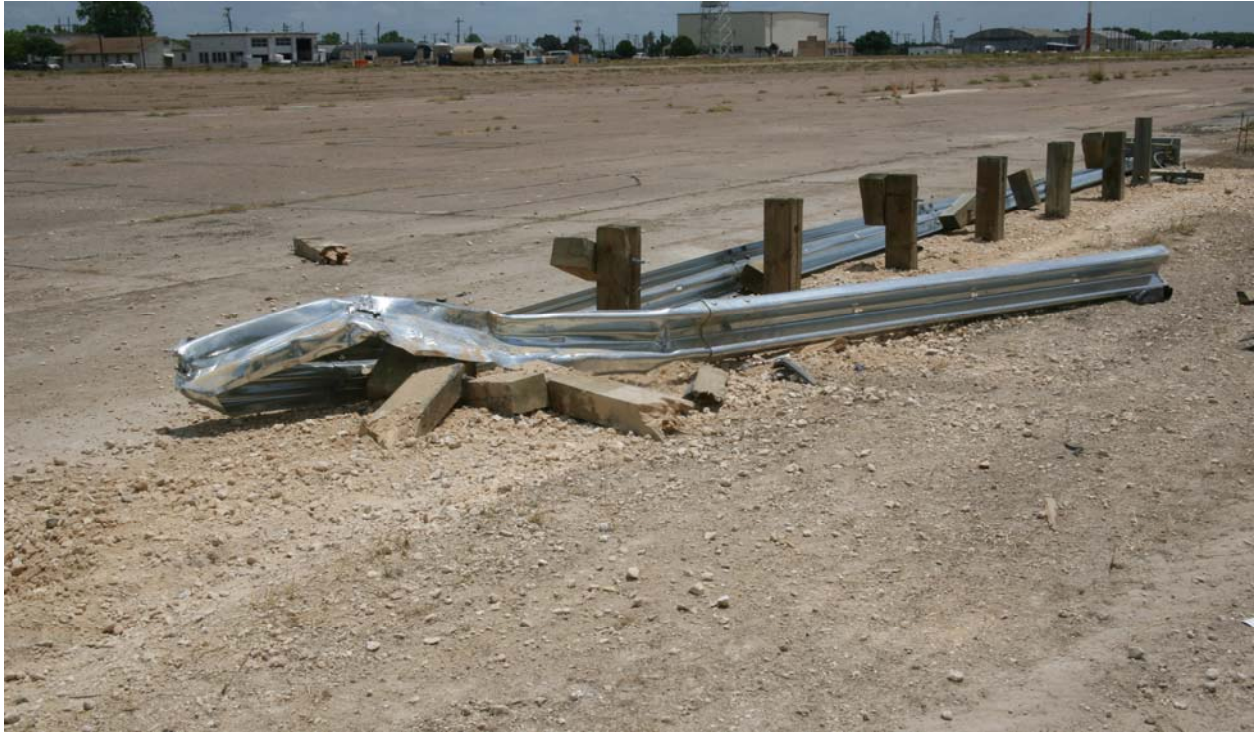
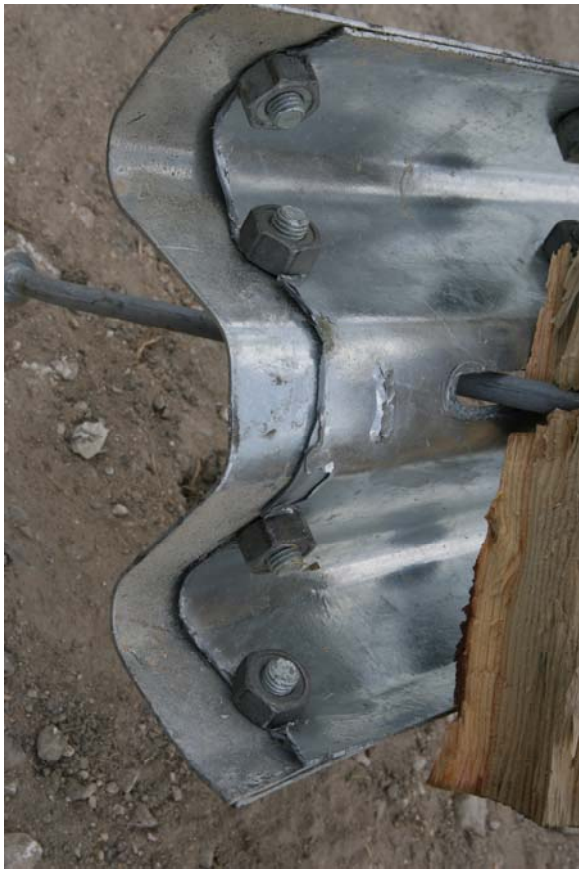
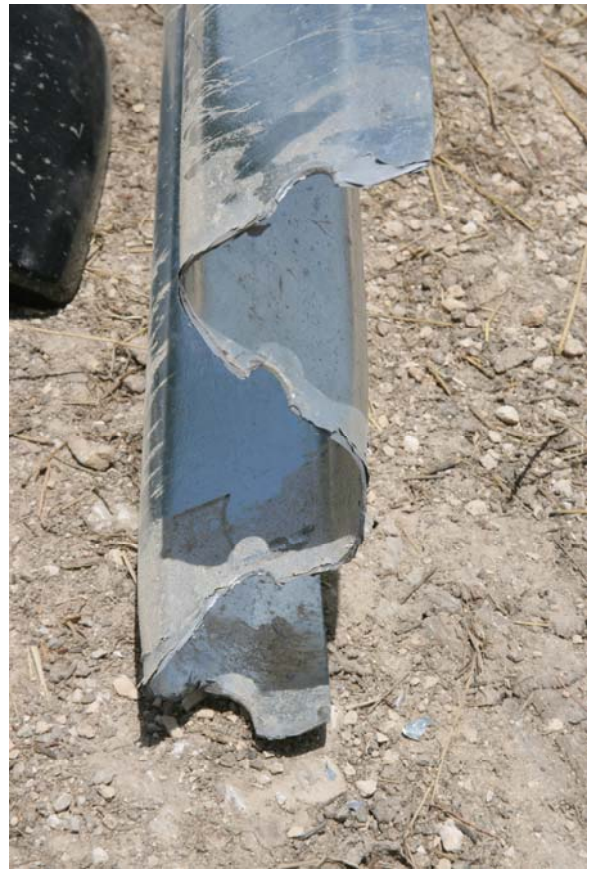
Figure 10. Installation after test 405160-1-1.

Damage to the installation is shown in figures 9 and 10. The rail ruptured at post 13, where the section changed from nested to single layer. Posts 1 and 2 were disturbed, post 3 was pulled downstream 10 mm, and posts 4-5 were disturbed. Posts 6 and 7 were pulled upstream 10 mm, and posts 8 through 10 were disturbed and post 10 was partially split longitudinally. Posts 11 and 12 were pulled toward field side 100 mm and 540 mm, respectively. Post 13 through 19 fractured at ground level and posts 14 through 18 were separated from the rail element. Post 14 was resting 3.8 m on the traffic side forward of the traffic face of the rail. The rail element was also separated from posts 20 through 25, but remained attached to post 26. The blockouts were separated from posts 21, 23 and 24. Post 25 was split longitudinally. Prior to exiting the view of the overhead camera, the working width was 4.1 m. Prior to rupture of the rail element, the maximum deflection of the rail was 1.45 m.

The rail element ruptured and allowed the vehicle to penetrate the rail system. The vehicle subsequently rolled onto its side. Therefore, the rail failed evaluation criteria for *NCHRP Report 350* test 3-11, as shown in table 1. The abrupt change in stiffness of the rail element where it changes from two layer of W-beam (nested) to a single layer may have contributed to rupture of the single layer rail element.

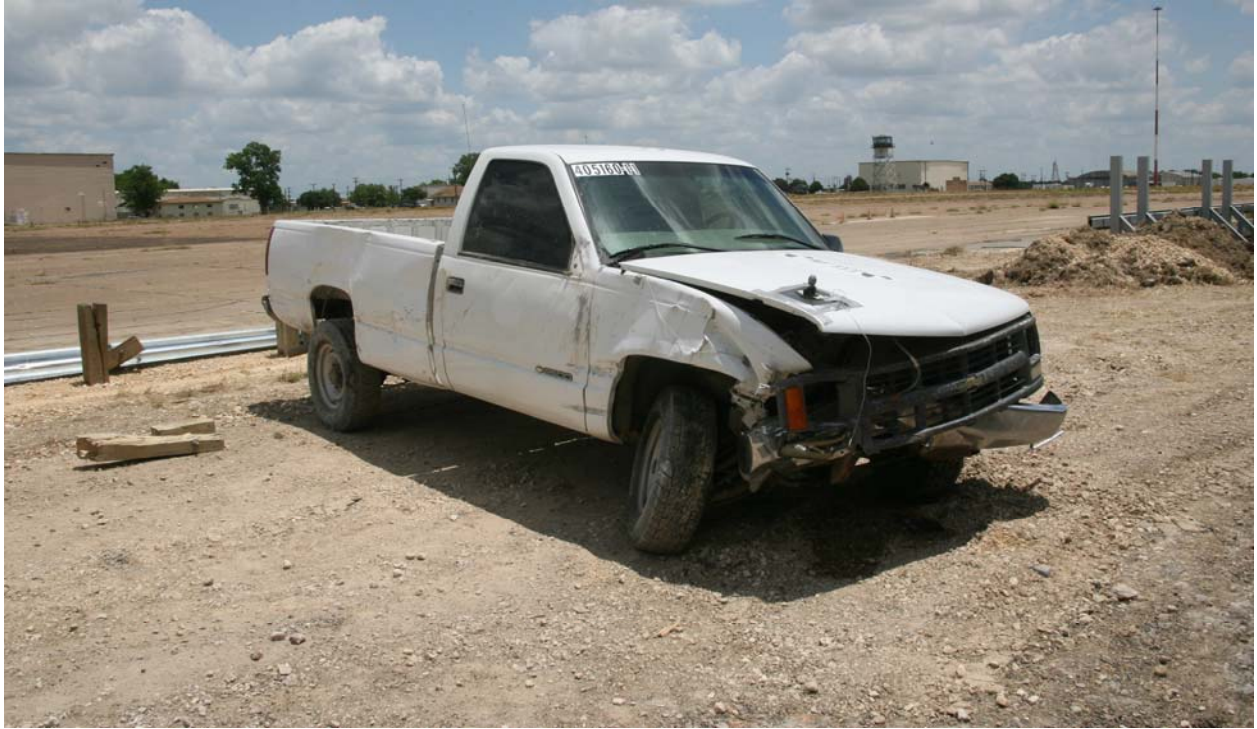
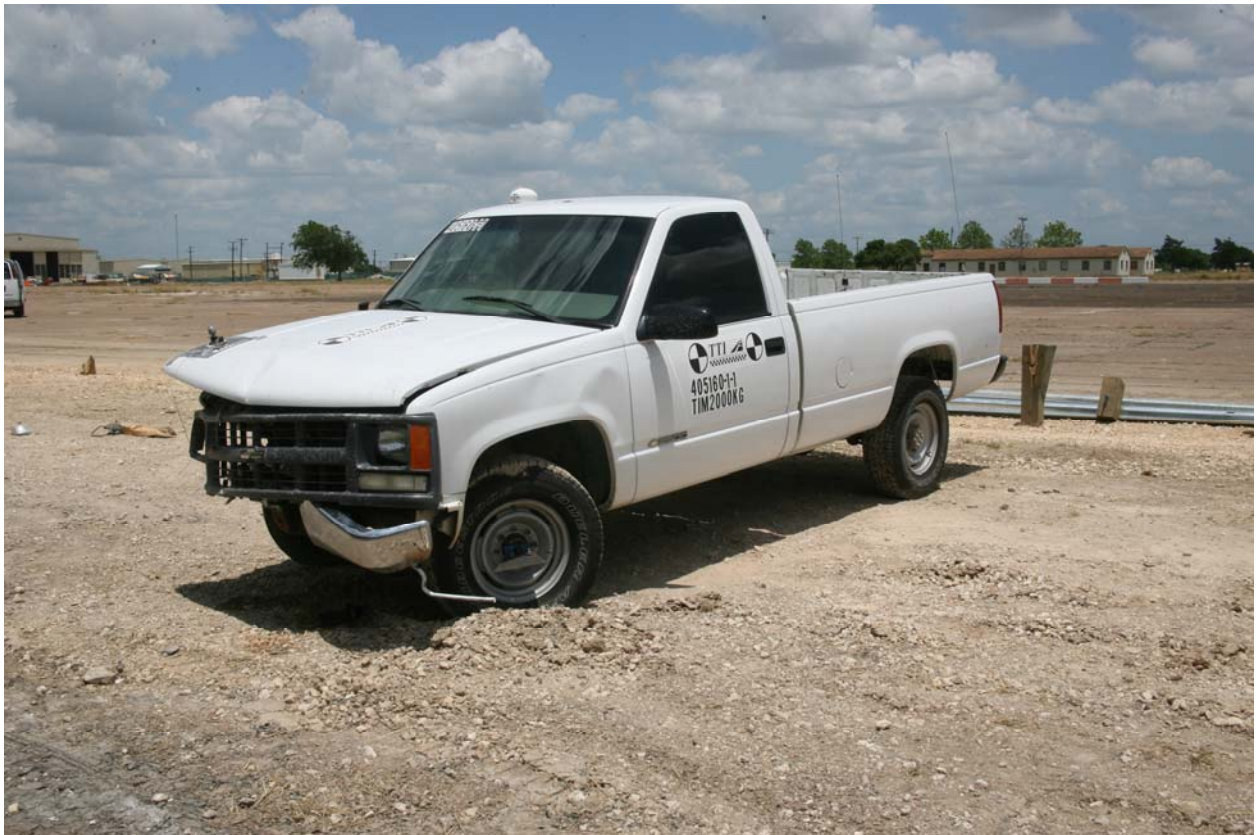
Figure 11. Vehicle after test 405160-1-1.

The vehicle sustained damage to the right side of the vehicle as shown in figure 11. The right upper and lower A-arm and right side frame rail were deformed. Also damaged were the front bumper, hood, grill, right front quarter panel, right door, right exterior bed, and right rear bumper. Maximum exterior crush to the vehicle was 540 mm in the frontal plane just to the right of centerline at bumper height. Maximum occupant compartment deformation was 16 mm in the right floor pan to instrument panel area. Photographs of the interior of the vehicle are shown in figure 12. Exterior vehicle crush and occupant compartment measurements are shown in appendix B, tables 2 and 3.

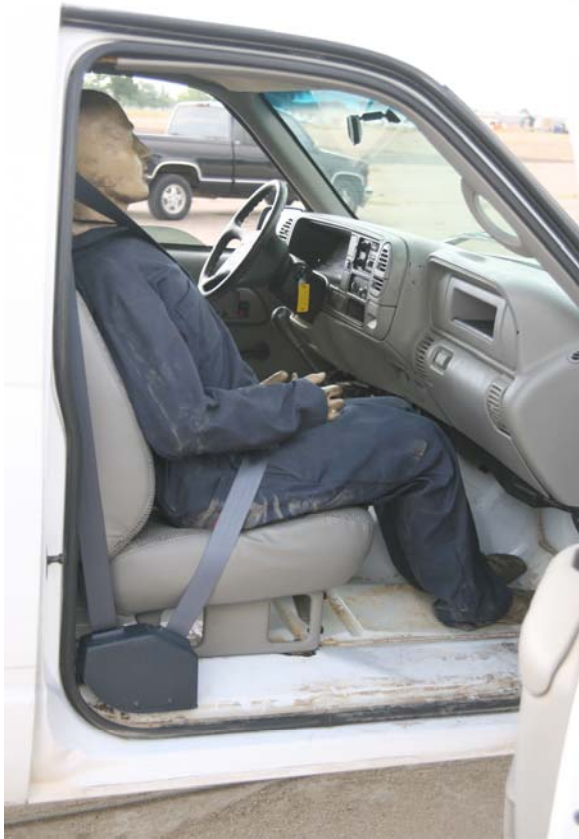
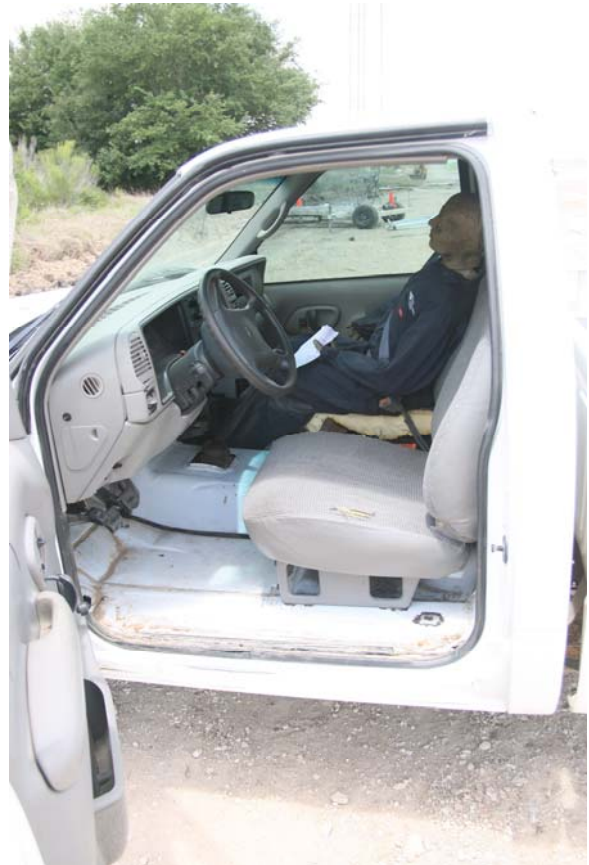
Figure 12. Interior of vehicle for test 405160-1-1.

Results: Some of the posts fractured and post 14 was resting 3.8 m on the traffic side of the rail. These debris did not penetrate nor show potential for penetrating the occupant compartment. Maximum occupant compartment deformation was 16 mm in the right floor pan to instrument panel area. (PASS)
