Experimental Feature Report

PCCP Texture Modification Using the Skidabrader

I-5

Tukwila to Lucile Street

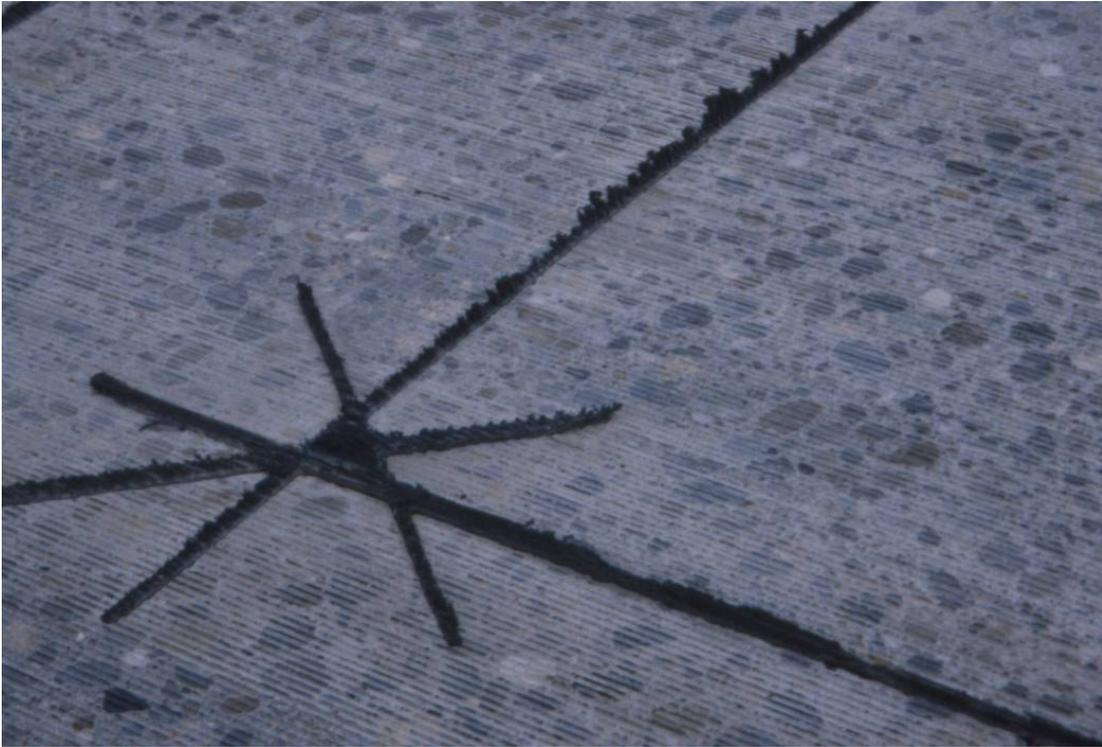
corduroy texture and reducing the glare. A copy of the work plan is included as Appendix A. Figure 1 shows the pavement prior to the use of the Skidabrader. The fins left by the diamond grinding are clearly visible, especially in the foreground of the photo.

Figure 1. Pavement prior to the Skidabrader resurfacing showing the fins left by the diamond grinding operation. July 1998.

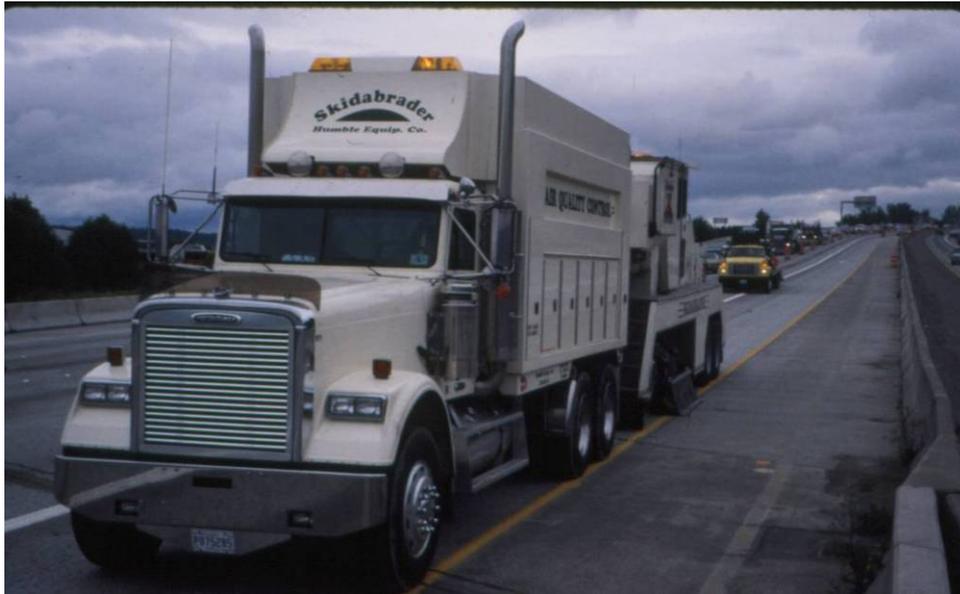
Figure 2. Skidabrader in operation. July 1998.

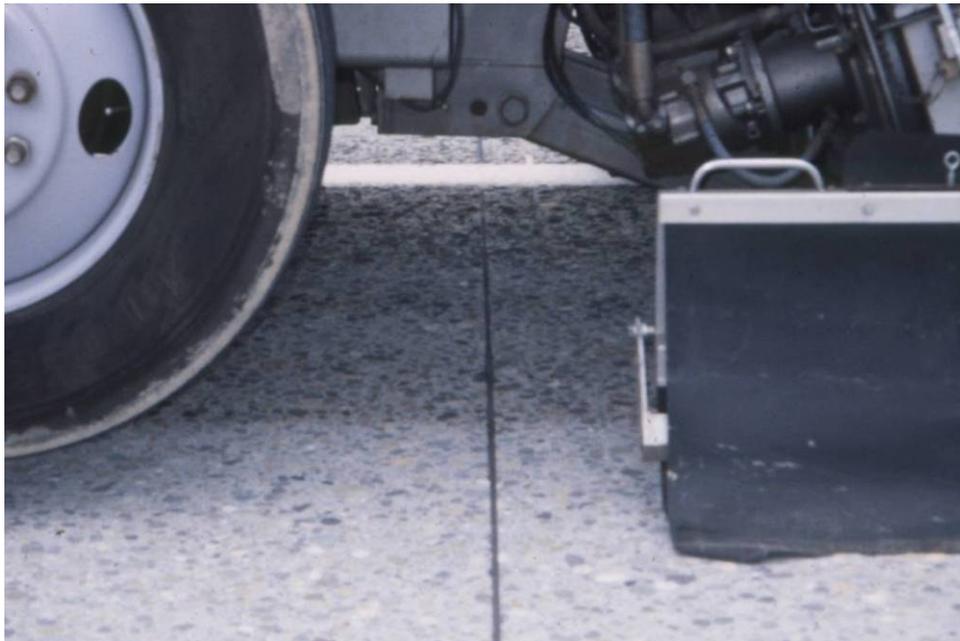
Figure 3. Close-up of Skidabrader showing the area just behind the where the steel shot impact the pavement. July 1998.

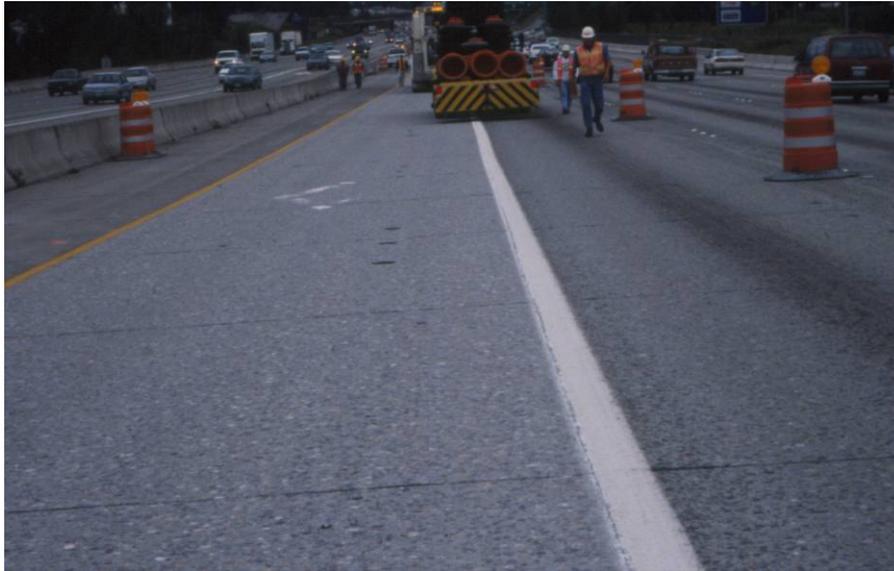
Figure 4 is a distance view of the pavement after treatment and Figure 5 a close-up showing that the fins of pavement have been reduced in size or completely removed.

Figure 4. Long distance view of the pavement after the Skidabrader. July 1998.

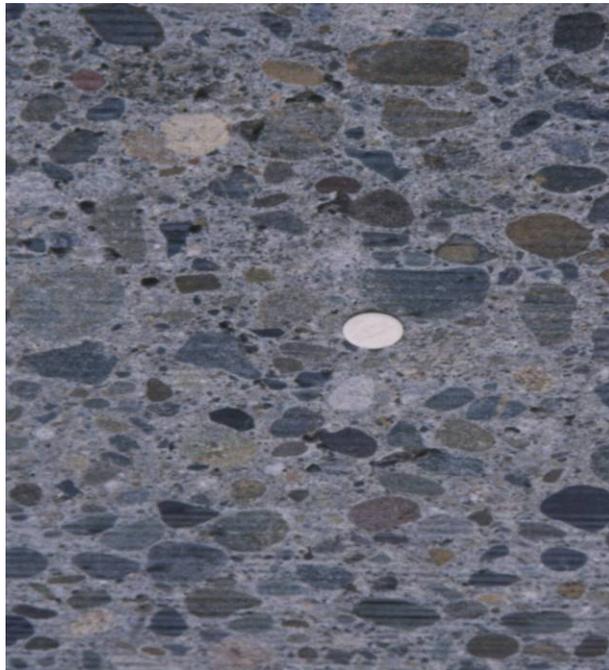
Figure 5. Close-up of showing absence of fins left by the diamond grinding. July 1998.
