# Assessment of the I-5 Portland Cement Concrete Pavement in King County: Executive Summary

WA-RD 682.2

December 2007

# **A Summary Assessment of Interstate 5 PCCP in King County October 2007**

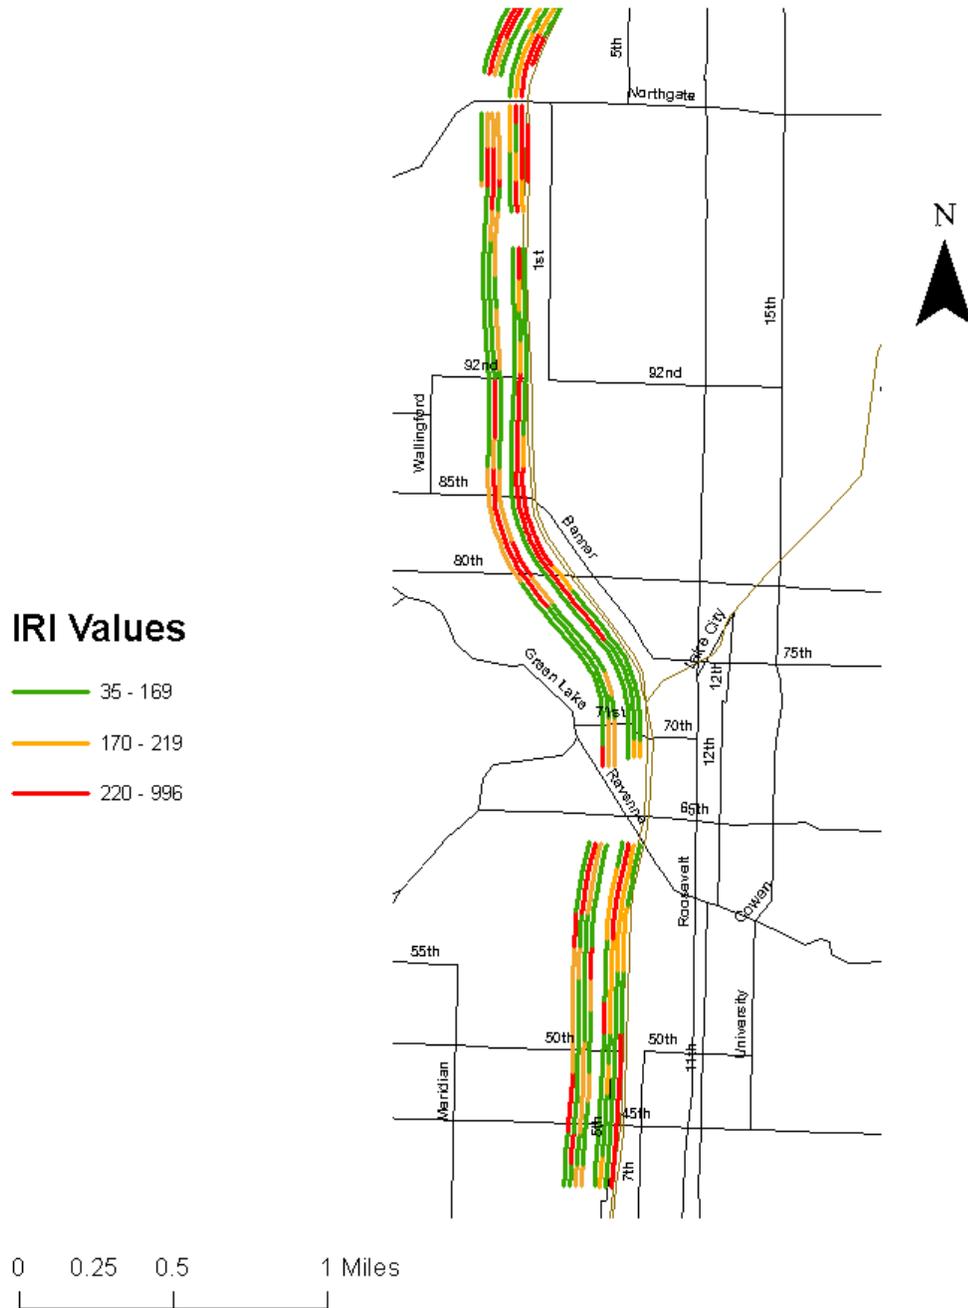
Figure 1. IRI Values, Ship Canal Bridge to Northgate Way

Plan views were prepared that illustrate existing conditions. Figures 1 through 4 show IRI (roughness), transverse joint faulting, wheelpath wear depths, and slab cracking for a section of I-5 from the Ship Canal Bridge to Northgate Way. As expected, the conditions of the separate lanes are not uniform. The orange and red portions indicate conditions that are marginal to critical. The full report (WA-RD 682.1) contains similar illustrations but for all of I-5 within King County.

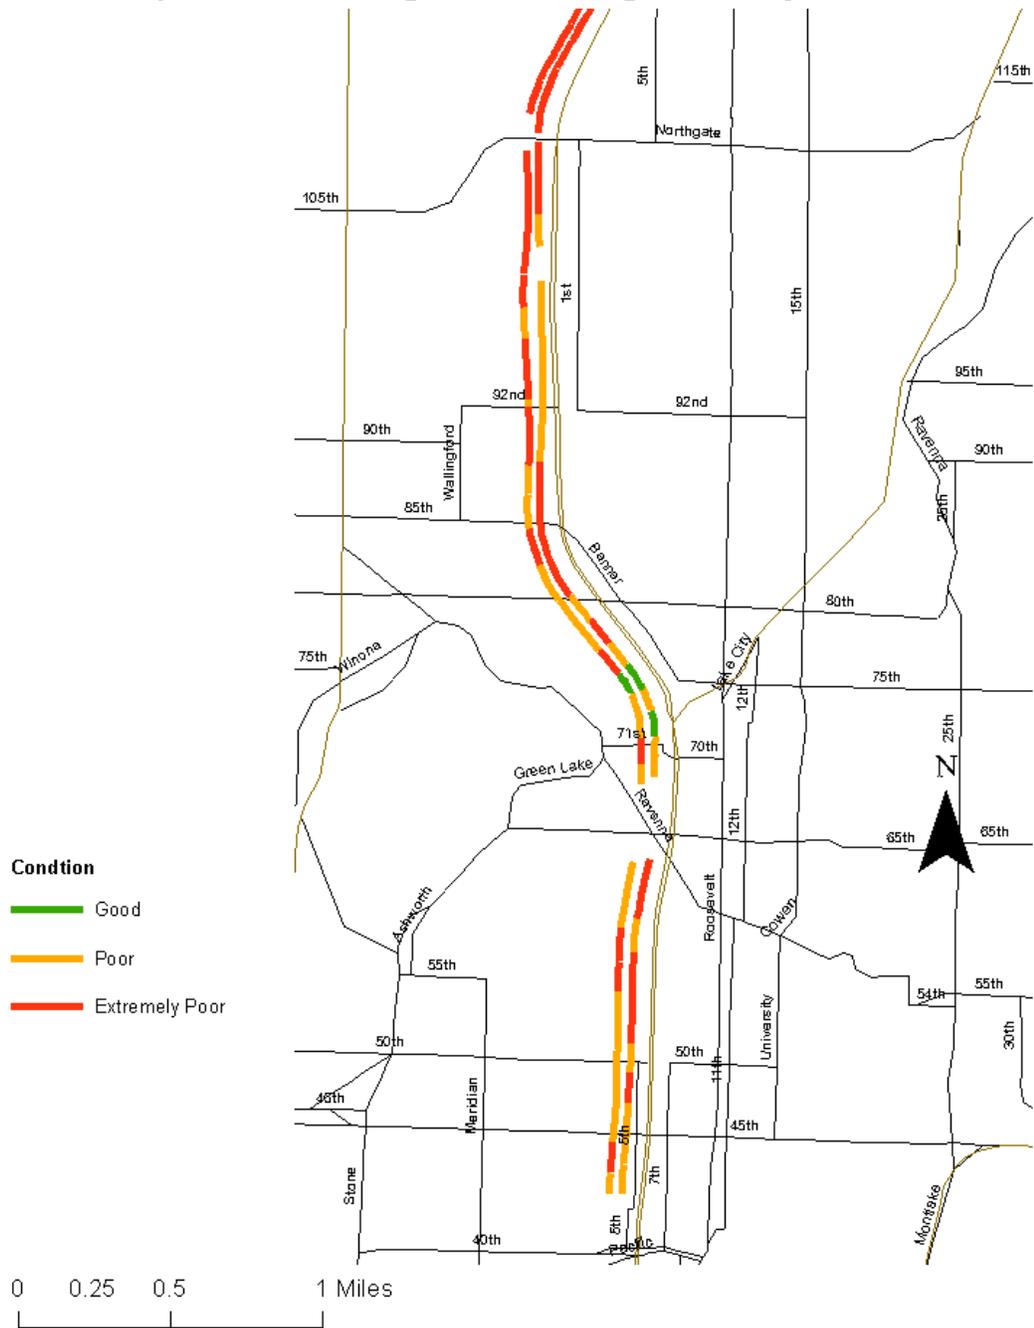
**Figure 5. Worst Condition Illustration, Ship Canal Bridge to Northgate Way**

Worst of the worst is based on the concept that all lanes of a roadway are controlled by the condition of the single worst lane—which is likely preferable since reconstruction or major rehabilitation is rarely done on just one or two lanes. The worst condition observed for any lane for a 1/10-mile section was selected to represent the pavement condition of that section of I-5. This method depicted I-5 pavements in their worst-case condition. Figure 5 provides an example of the images for the pavement conditions resulting from the worst of the worst method (all images for I-5 in King County are contained in the full report WA-RD 682.1). This figure, like [figures 1 through 4](#), covers the portion of I-5 from [Northgate Way to the Ship Canal Bridge](#) that is in the worst condition of all I-5 segments through King County.

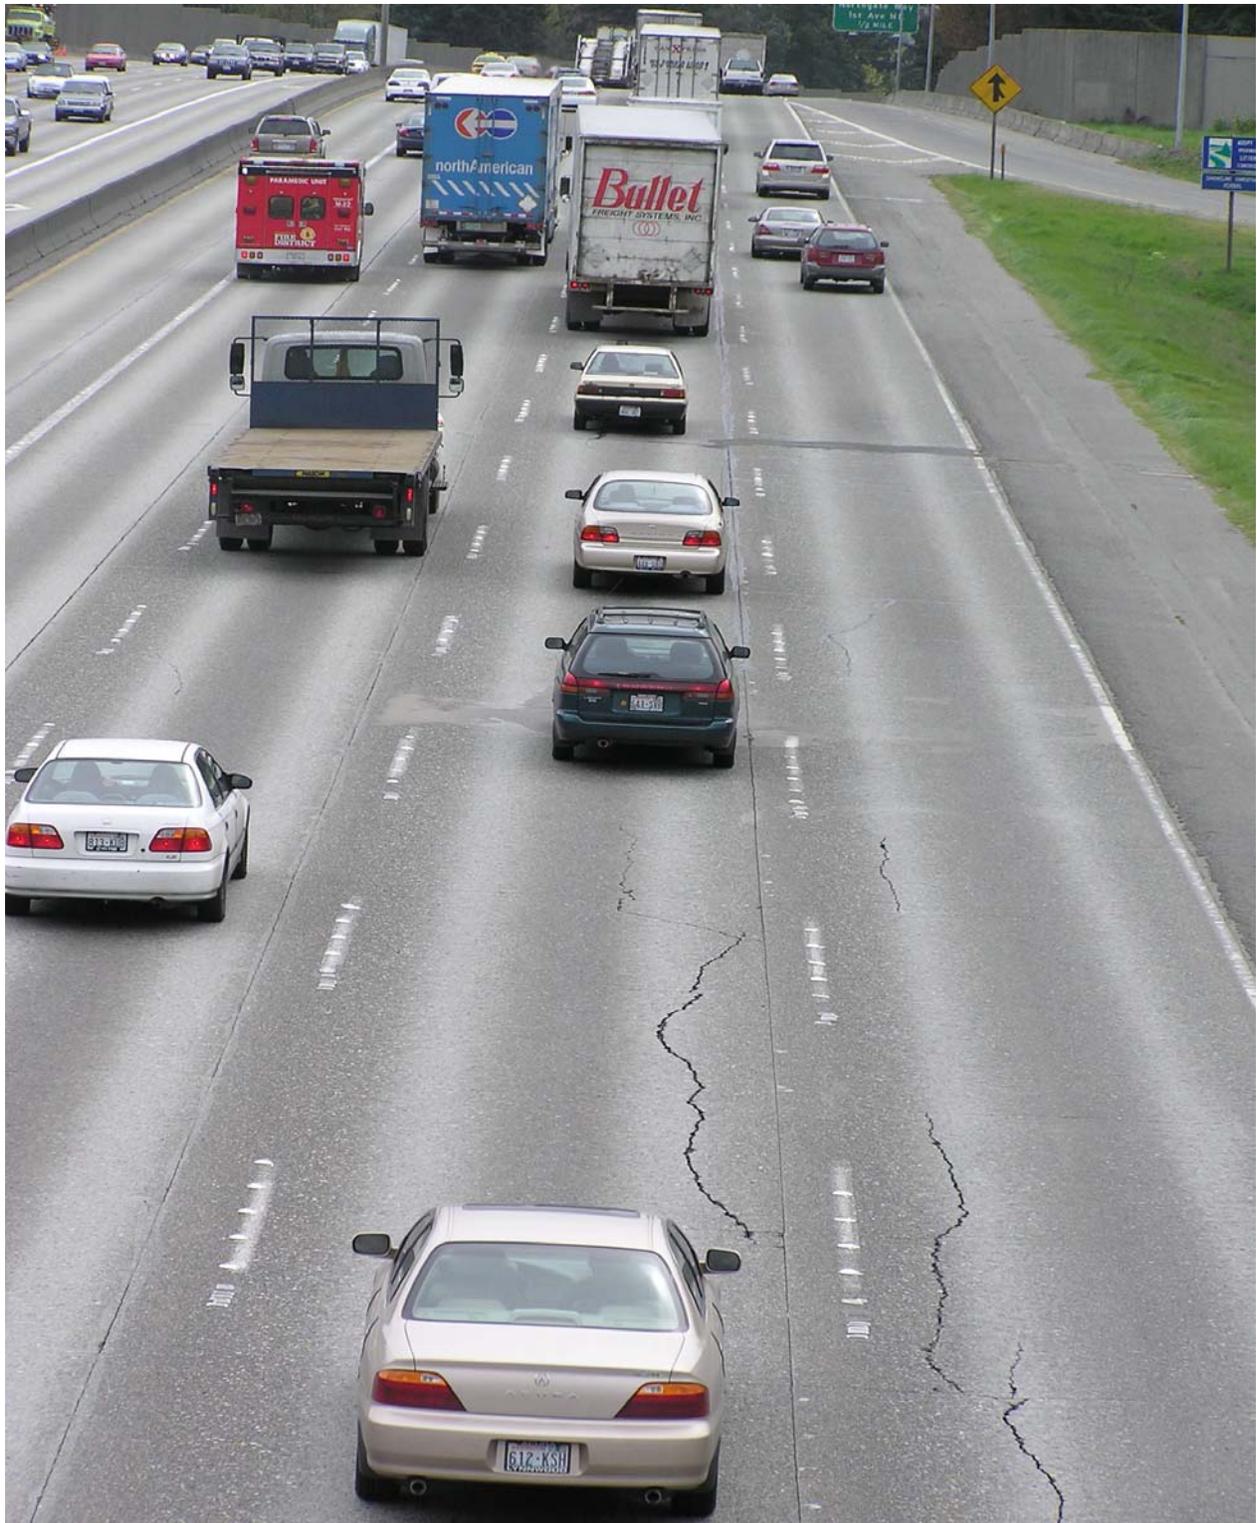
Figure 6. I-5 at NE 130<sup>th</sup> in Seattle—view is to the north.

A selection of photos, figures 6 through 8, is provided to illustrate current pavement conditions.
