## **EVALUATION OF TRINIDAD LAKE ASPHALT OVERLAY PERFORMANCE**

**Contract 6441**  
**SR-16**  
**Tacoma Narrows Bridge – Eastbound**  
**MP 7.28 to 8.41**

| 4. TITLE AND SUBTITLE<br><b>Evaluation of Trinidad Lake Asphalt Overlay Performance</b> | | | | 5. REPORT DATE<br><b>September 2008</b> | |

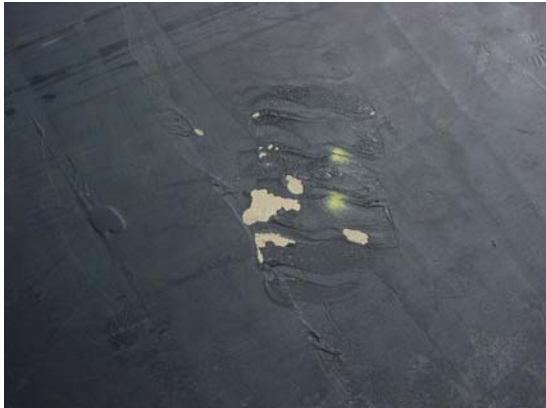
In many places the polymer modified bituminous hot melt adhesive had been damaged by equipment. Repair of these areas consisted of applying additional polymer modified bituminous hot melt adhesive the morning of the paving. Before paving, the area to be paved was cleaned of debris by hand broom.

**Figure 7.** Damage to adhesion layer.

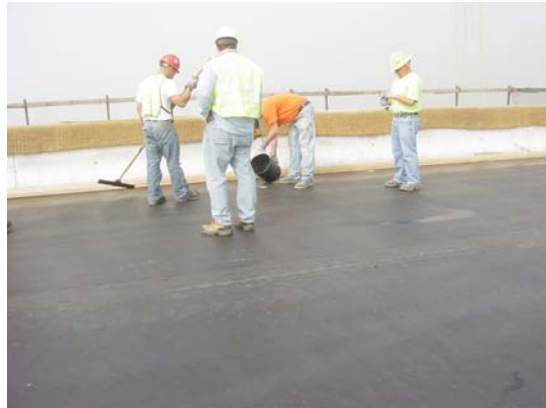
**Figure 8.** Repairing adhesion layer.

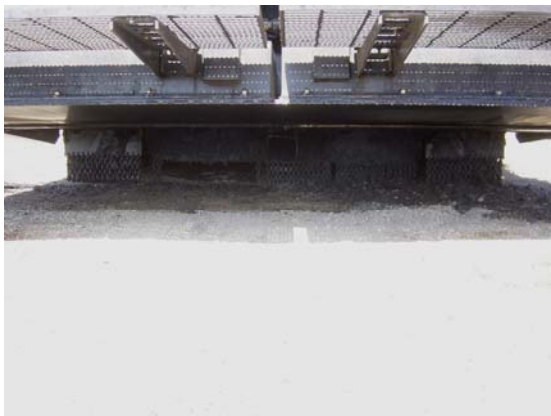
Paving was accomplished using an Ingersoll-Rand/Blaw-Knox PF-4410 paver (Woodworth equipment number 703) and a Terex/Cedarapids CR 662RM Road Mix transfer vehicle. Inspection of the paver revealed that it was missing a section of the mix management kit (MMK). The MMK is a retrofit which consists of a series of chains that help to contain the mix in front of the screed in order to prevent segregation. Without the MMK retrofit, less mix is distributed to the area in front of the gear box which can leave a segregated streak in the center of the mat. It is not clear if the missing section contributed to the streaks in the mat (See Streaks in Pavement). From June 21 onward, the paver was replaced by another Blaw-Knox PF-4410 paver (Woodworth equipment number 710) which had an intact retrofit kit.

**Figure 11.** Missing chains on MMK retrofit on Ingersoll-Rand Blaw-Knox PF-4410 paver.

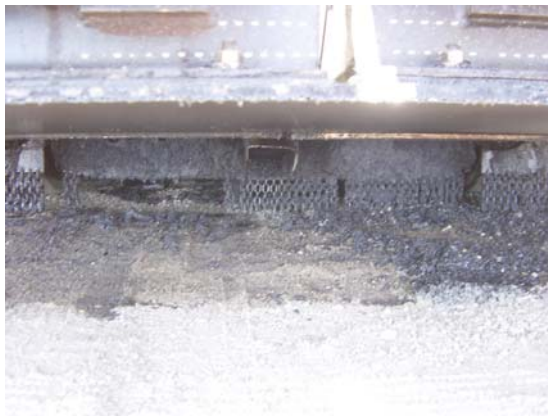
**Figure 12.** Missing chains on MMK retrofit.

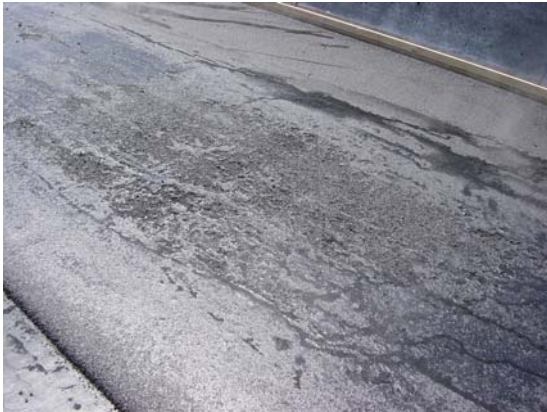
During placement of the job control strip for the base course the large rollers began picking up mix from the newly laid mat. Pickup occurred between 300 and 700 feet from the west end of the bridge. The mix had to be removed from the roller drums before the roller could continue, delaying the compaction operation. Voids left in the mat were repaired by carrying mix back to the damaged area in shovels and a wheelbarrow. Despite the repair efforts voids and open areas remained in the mat. The voids were more or less centered about 6.5 feet from the

face of the barrier. The problem ceased when the large rollers were removed from the paving operation and replaced by smaller rollers.

**Figure 16.** Mix pickup area immediately after rolling.

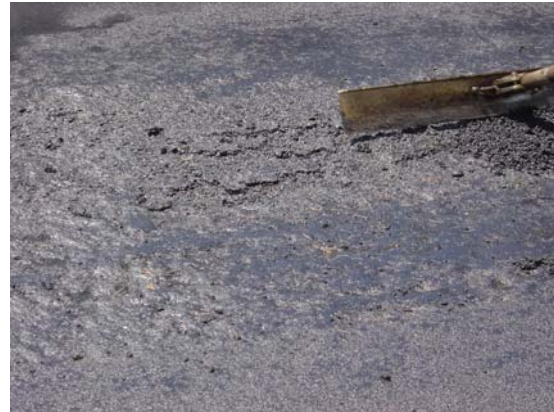
**Figure 17.** Raking in mix to repair pickup area.

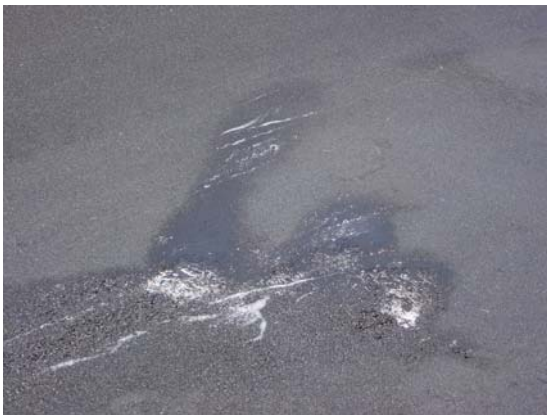
**Figure 18.** Area of mix pickup after completion of rolling.

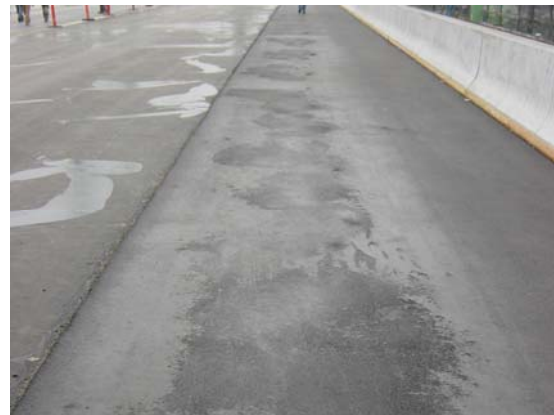
**Figure 19.** Area of mix pickup prior to the next days paving.

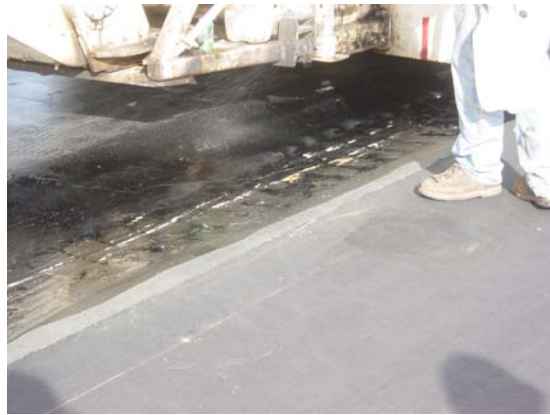
During placement of the base course the Contractor applied water using hand held sprayers ahead of truck tires and vehicle tracks in order to prevent damage to the polymer modified bituminous hot melt adhesive. One area of tack coat incurred damaged by the track on the Terex transfer vehicle. The area may have been more susceptible to damage since it had

been repaired earlier in the day. Otherwise this method appeared successful in preventing damage.

**Figure 21.** Adhesion layer damaged by track.

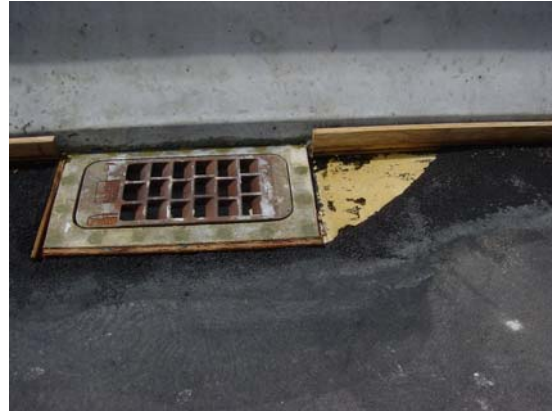
After completing paving the base course in Lane 2 at the west end of the bridge the Contractor turned the paving train around and began paving eastbound in Lane 3. A water truck sprayed water on Lane 2 to cool it enough to allow trucks which were delivering mix to pave Lane 3 to drive on Lane 2. At this time Lane 1 had only been paved to within about 250 feet of the east end of the bridge which left the bridge drains two inches higher than the current grade. The water flowed to the east end of the bridge and accumulated adjacent to the barrier in Lane 1 since it could not get into the bridge drains. After completion of paving Lane 3 the contractor proceeded to pave the remaining base course in the east end of Lane 1. The contractor attempted to remove the excess water that had accumulated in Lane 1 using leaf blowers prior to paving, but water was still present near the curb and over parts of the lane during paving.

Portions of the base course and tack layer were affected by the water and had to be removed around the bridge scuppers. The repair consisted of reapplying the bonding layer and replacing the base course material at the end of the next days paving.

**Figure 23.** Area removed near scupper due to water damage.

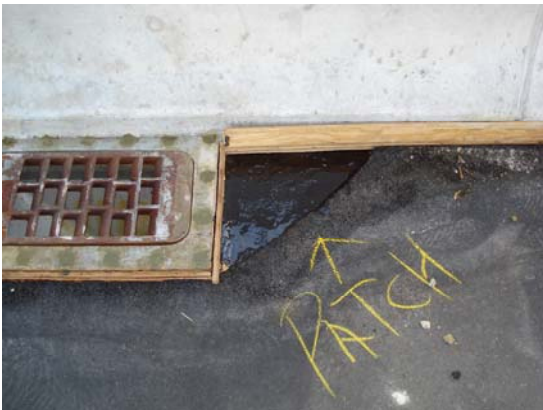
**Figure 24.** Adhesion layer repaired.

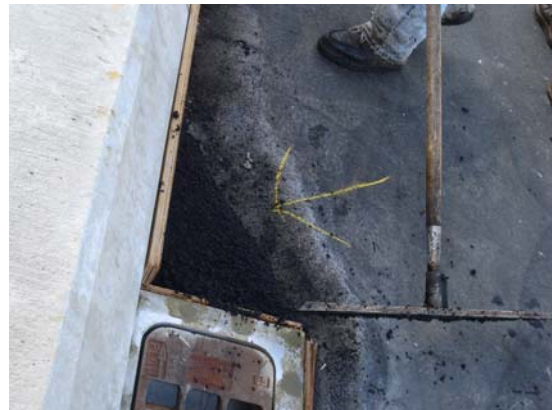
**Figure 25.** Repaired pavement.

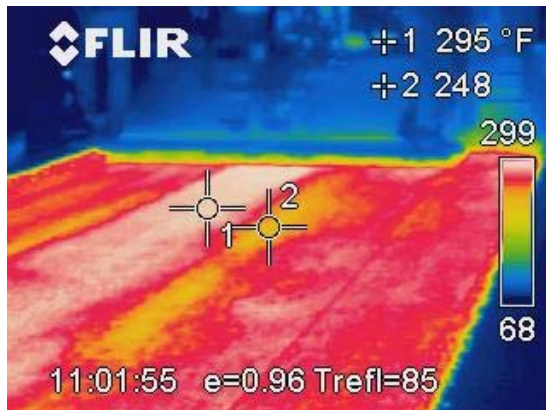
Infrared imaging was used during HMA placement to check for differences in temperature that could lead to potential density differentials. The imaging revealed temperature differentials ranging from 10°F to more than 40°F. Temperature differentials can lead to areas of inadequate compaction in the mat. They are usually caused by mix inside the haul vehicle cooling on the outside of the load faster than in the center. If the mix is not remixed before it passes through the paver, areas of cooler mix will be present in the mat. Temperature differentials on the TNB appeared as longitudinal streaks as opposed to periodic cooler patches which are usually associated with end dumping directly into the paver.

**Figure 27.** Temperature differential of 47°F in top course.

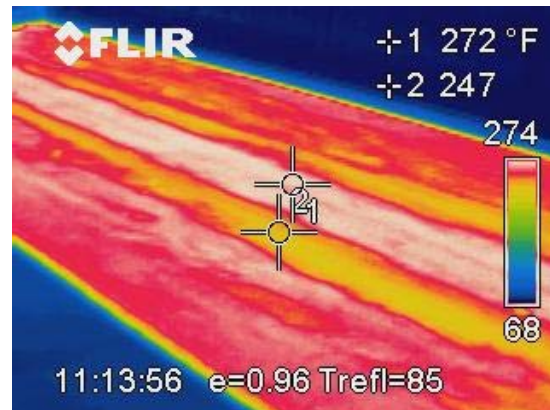
**Figure 28.** Warmer center in base course.

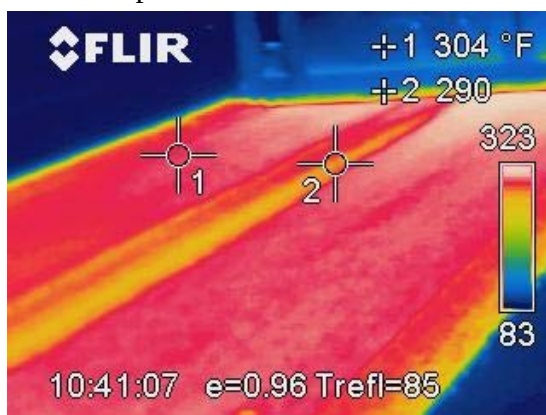
**Figure 29.** Mat with cooler center recorded on June 20.

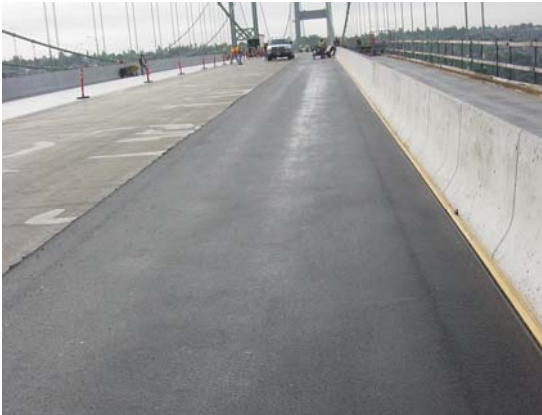
Both lifts in all lanes displayed some level of visible streaking after paving. Some of the streaks appear to be located at the screed extensions while others seem to be associated with cool streaks in the mat visible on the infrared photographs. It was not clear if the streaks are superficial or represent defects in the mat.

**Figure 31.** Steaks in base course on lane one.

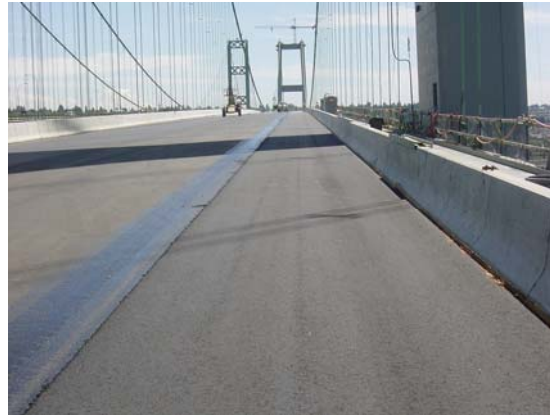
**Figure 32.** Streaks in top course on lane one.

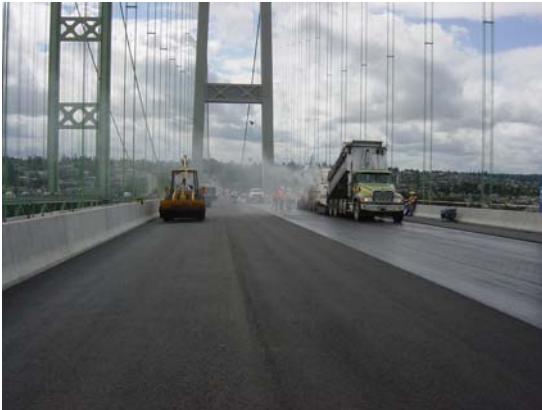
**Figure 33.** Streaks in top course on lanes four and five.

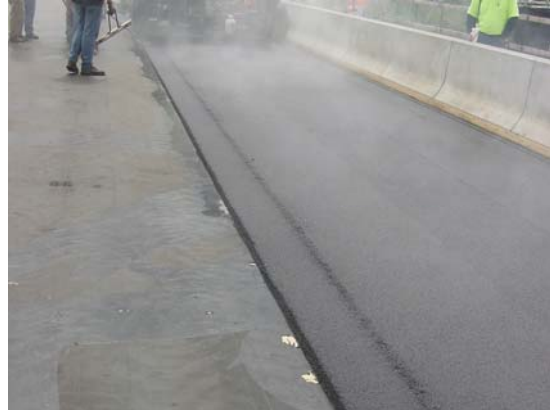
**Figure 34.** Streak left by screed extension.

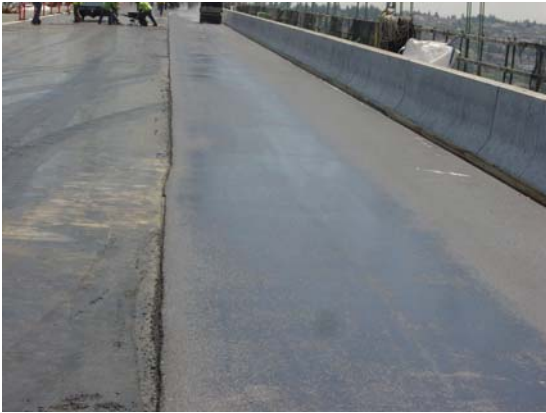
**Figure 35.** Flushing in lane one immediately after paving.

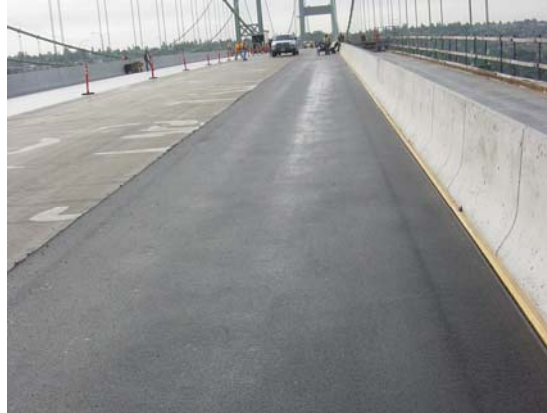
**Figure 36.** Flushing in lane one several days after paving.

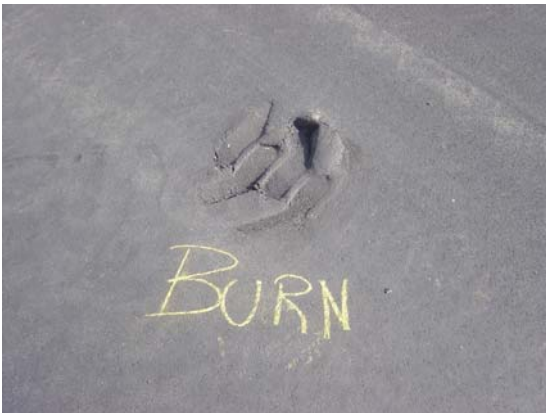
There were many areas where tires from equipment sitting on the bridge left indentations in the base course. These areas were repaired by heating with a weed burner and reshaping before placing the next lift.

**Figure 37.** Indentation in base course left by equipment tire.

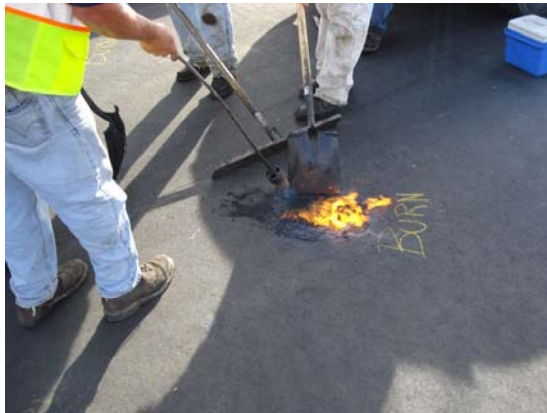
**Figure 38.** Repairing indentation.

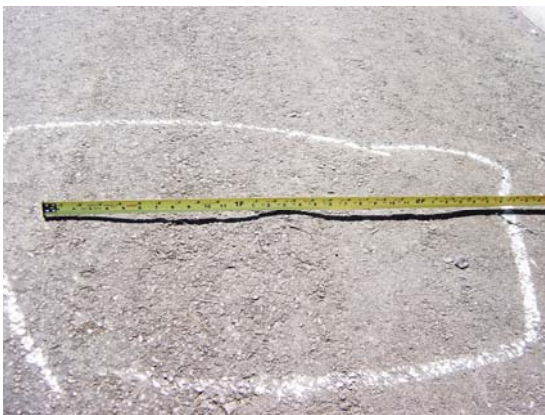
An inspection on July 9<sup>th</sup> revealed that there were many indentations in the top course caused by construction activities. Some of the indentations were clearly due to equipment tires or the outrigger supports for a 300 ton Demag crane while the cause of others could not be identified. Cracks were associated with some of the indentations where the mix appeared to have been sheared by the object causing the indentation.

**Figure 39.** Tire indentation near west end.

Numerous indentations, cracks and spills were present on the mat after it was complete. Most if not all of these can be attributed to the construction activities occurring on the bridge after placement of the overlay. Some of the damaged areas were superficial but many required repair by methods which likely will affect the performance of the pavement. In order to avoid this type of damage in the future, paving should not begin until work on or above the bridge deck is complete.

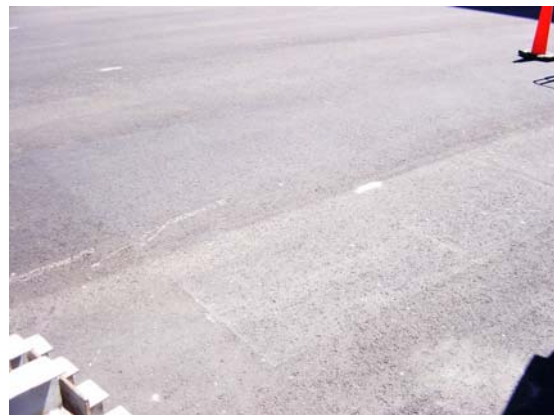
**Figure 40.** Indentation left by Demag crane pad.

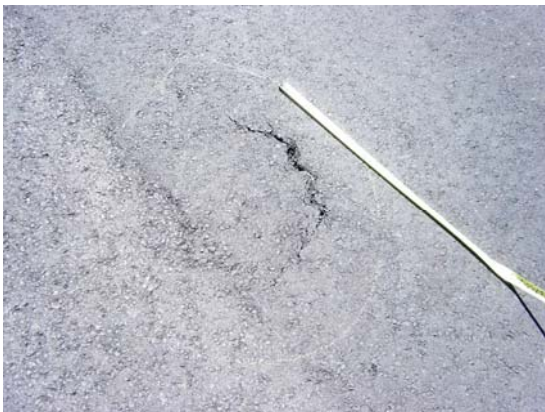
**Figure 41.** Indentation with crack near midspan.

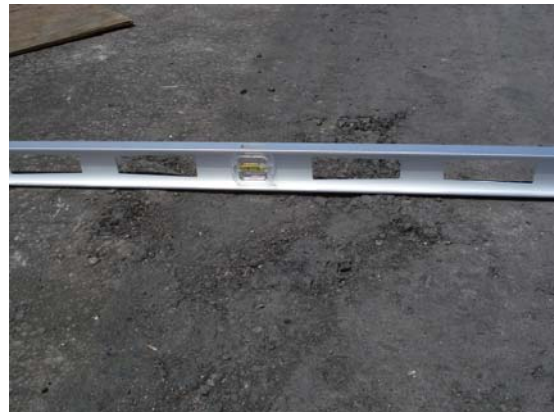
**Figure 42.** Possible repaired area.

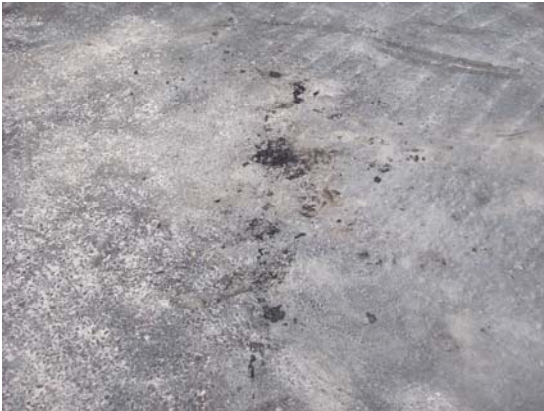
Solvent spilled from the west tower onto the completed overlay in Lanes 2 and 3 which required the pavement to be removed and replaced. Repair included rotomilling the damaged pavement, repairing the three layer membrane system and repaving with conventional asphalt.

**Figure 43.** Solvent spill.

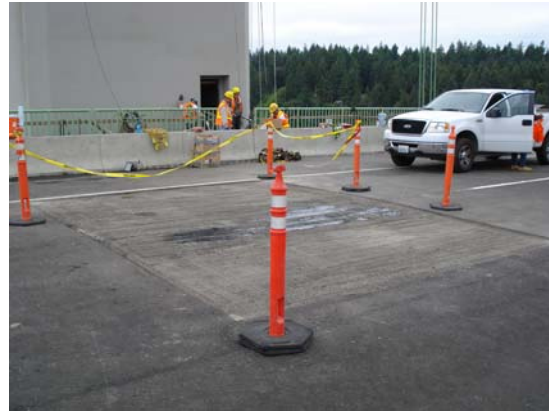
**Figure 44.** Damaged pavement removed from lane 2 and 3.

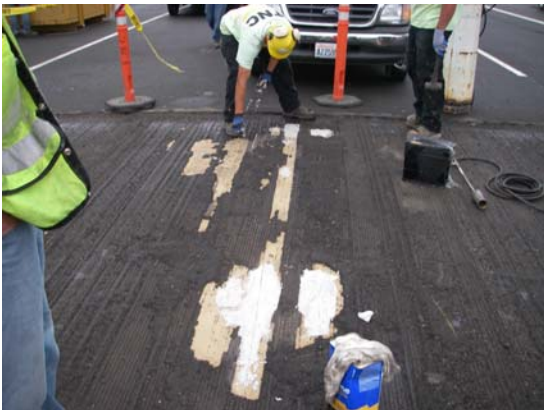
**Figure 45.** Repairing isolation layer.

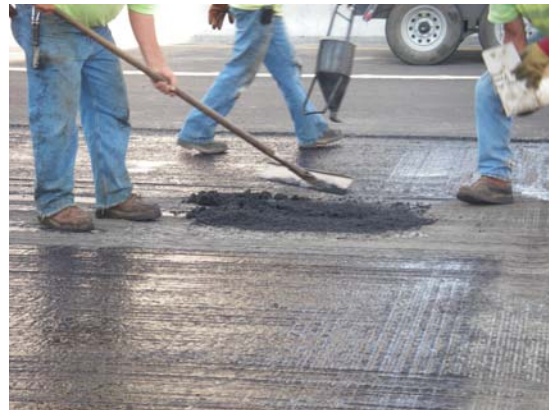
**Figure 46.** Repairing base course.

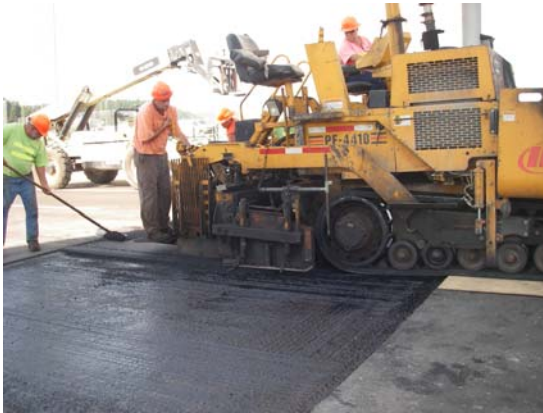
**Figure 47.** Replacing top course.

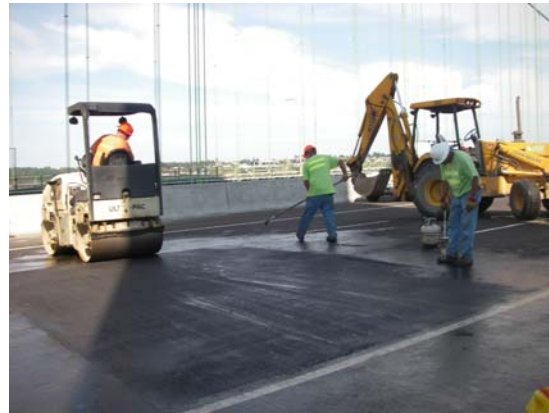
**Figure 48.** Finished patch.
