# Trinidad Lake Asphalt Overlay Performance Final Report

WA-RD 710.2

July 2014

**Contract 6441**  
**SR-16**  
**Tacoma Narrows Bridge – Eastbound**  
**MP 7.28 to 8.41**

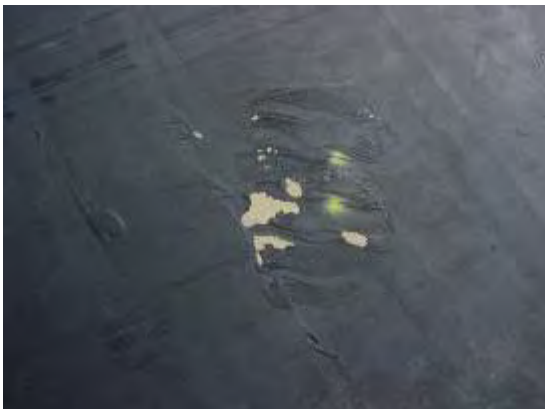
Figure 9. Damage to adhesion layer.

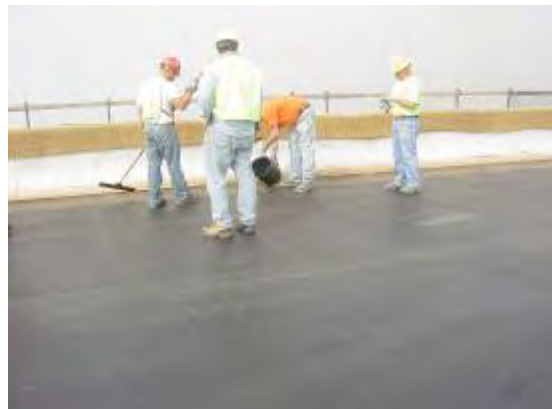
Figure 10. Repairing adhesion layer.

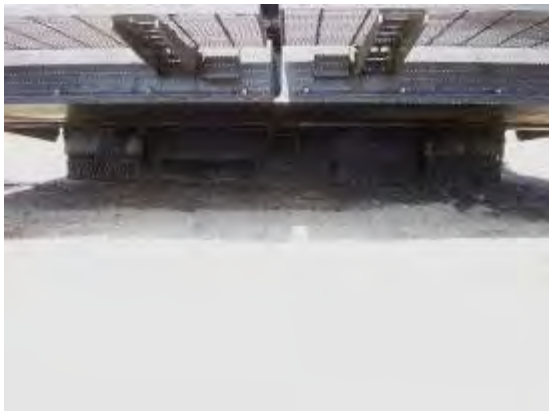
Figure 13. Missing chains on MMK retrofit on I-R/Blaw-Knox PF-4410 paver.

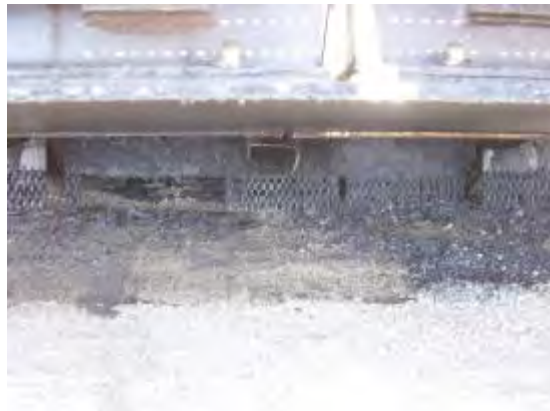
Figure 14. Missing chains on MMK retrofit.

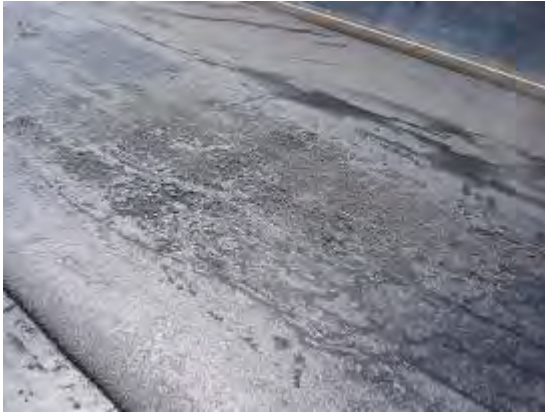
During placement of the job control strip for the base course the large rollers began picking up mix from the newly laid mat. Pickup occurred between 300 and 700 feet from the west end of the bridge. The mix had to be removed from the roller drums before the roller could continue, delaying the compaction operation. Voids left in the mat were repaired by carrying mix back to the damaged area in shovels and a wheelbarrow. Despite the repair efforts voids and open areas remained in the mat. The voids were more or less centered about 6.5 feet from the face of the barrier. The problem ceased when the large rollers were removed from the paving operation and replaced by smaller rollers.

Figure 16. Mix pickup area immediately after rolling.

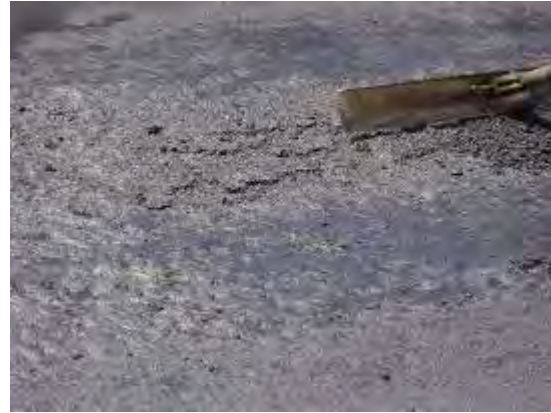
Figure 17. Raking in mix to repair pickup area.

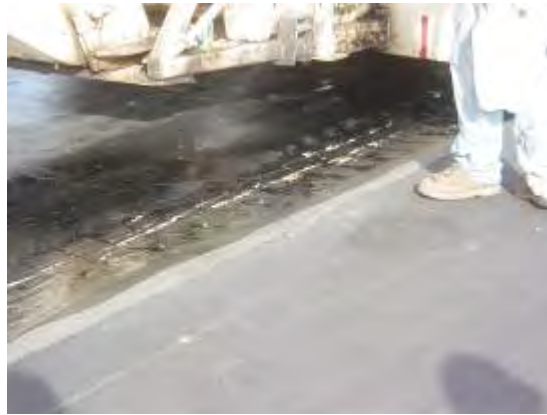
During placement of the base course the Contractor applied water using hand held sprayers ahead of truck tires and vehicle tracks in order to prevent damage to the polymer modified bituminous hot melt adhesive. One area of tack coat incurred damaged by the track on the Terex transfer vehicle. The area may have been more susceptible to damage since the adhesion layer had been repaired earlier in the day. Otherwise this method appeared successful in preventing damage.

Figure 21. Adhesion layer damaged by track.

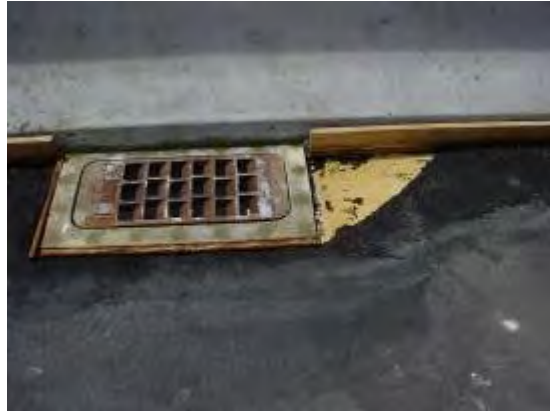
Portions of the base course and tack layer were affected by the water and had to be removed around the bridge scuppers. The repair consisted of reapplying the adhesion layer and replacing the base course material at the end of the next day's paving.

Figure 23. Triangle of adhesion layer removed near scupper due to water damage.

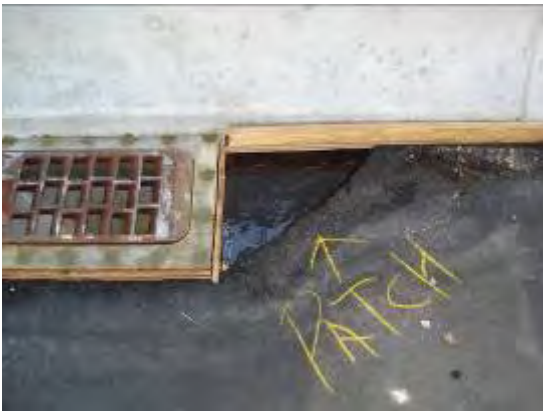
Figure 24. Adhesion layer repaired.

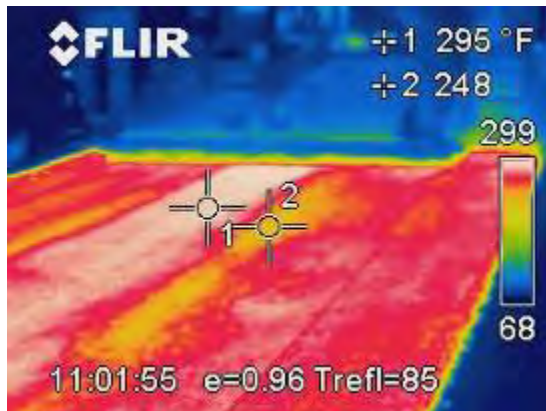
Infrared imaging was used during HMA placement to check for differences in temperature that could lead to potential density differentials. The imaging revealed temperature differentials ranging from 10°F to more than 40°F. Temperature differentials can lead to areas of inadequate compaction in the mat. They are usually caused by mix inside the haul vehicle cooling on the outside of the load faster than in the center. If the mix is not remixed before it passes through the paver, areas of cooler mix will be present in the mat. Temperature differentials on the TNB appeared as longitudinal streaks as opposed to periodic cooler patches which are usually associated with end dumping directly into the paver.

Figure 27. Temperature differential of 47°F in top course.

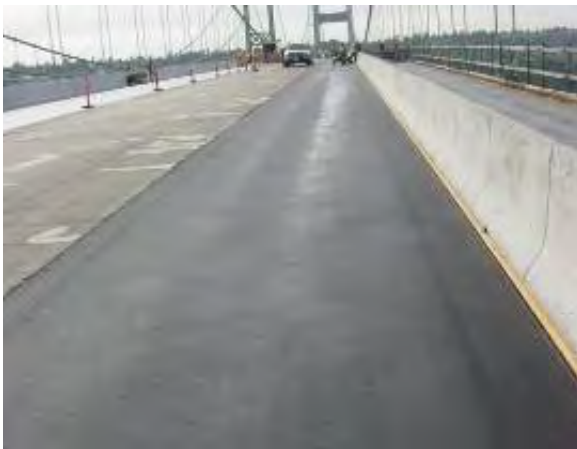
Both lifts in all lanes displayed some level of visible streaking after paving. Some of the streaks appear to be located at the screed extensions while others seem to be associated with cool streaks in the mat visible on the infrared photographs. It was not clear if the streaks are superficial or represent defects in the mat.

Figure 31. Steaks in base course on Lane 1.

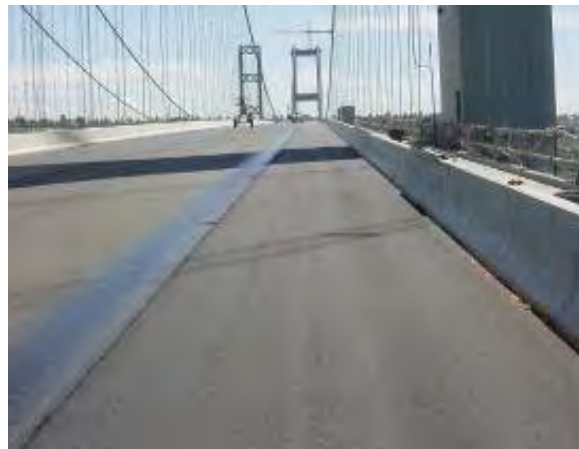
Figure 32. Streaks in top course on Lane 1.

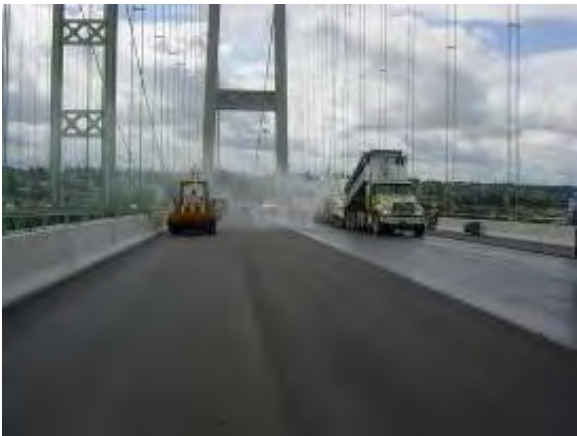
Figure 33. Streaks in top course on Lanes 4 and 5.

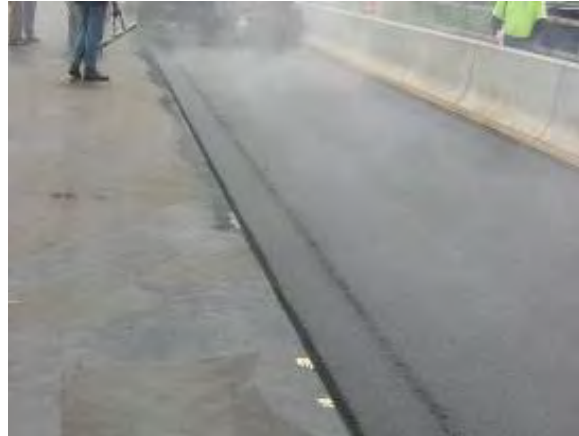
Figure 34. Streak left by screed extension.

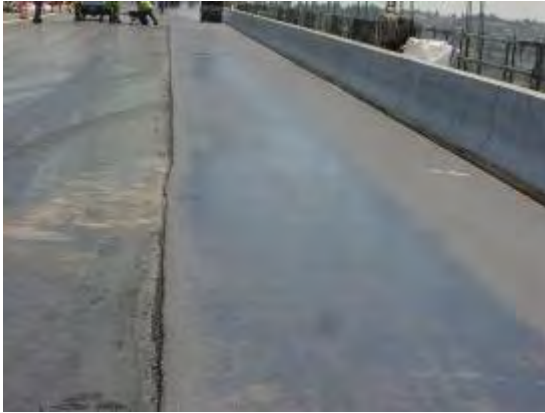
Slight flushing occurred after placement of the job control strip. Flushing appeared to be isolated to the section between 3.5 feet from the face of barrier to the edge of the paved lane at 10.5 feet. The flushing seems to correspond to high asphalt content test results on Lane 1.

Figure 35. Flushing in Lane 1 immediately after paving.

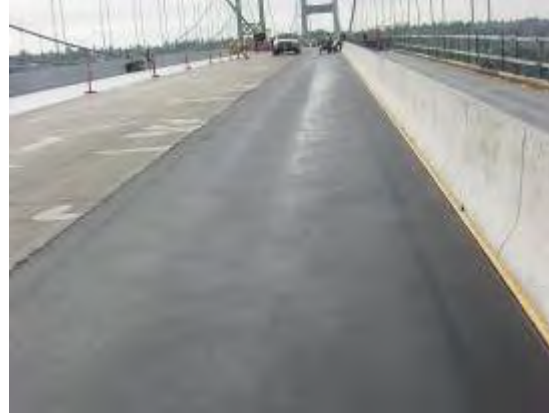
Figure 36. Flushing in Lane 1 several days after paving.

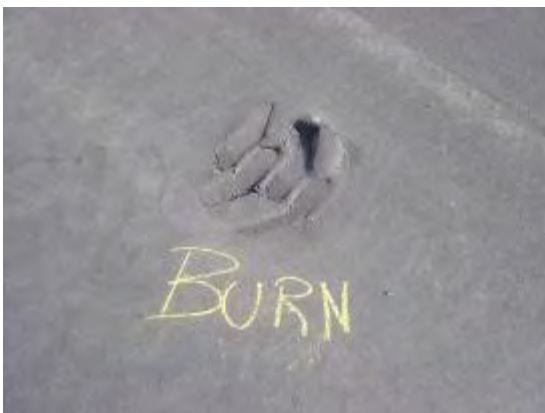
Figure 37. Indentation in base course left by equipment tire.

There were many areas where tires from equipment sitting on the bridge left indentations in the base course. These areas were repaired by heating with a weed burner and reshaping before placing the next lift.

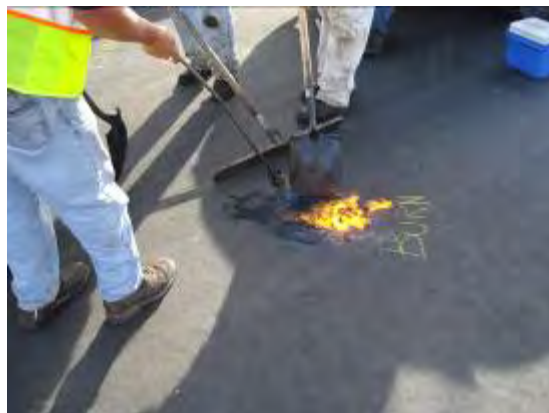
Figure 38. Repairing indentation.

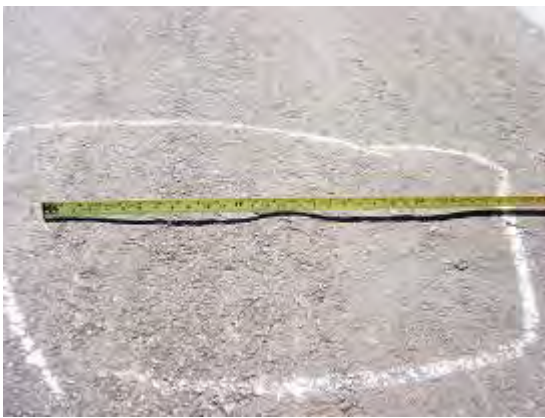
An inspection on July 9<sup>th</sup> revealed that there were many indentations in the top course caused by construction activities. Some of the indentations were clearly due to equipment tires or the outrigger supports for a 300 ton Demag crane while the cause of others could not be identified. Cracks were associated with some of the indentations where the mix appeared to have been sheared by the object causing the indentation.

Figure 39. Tire indentation near west end.

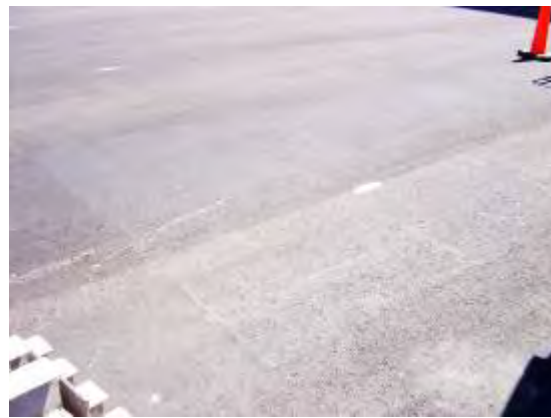
Figure 40. Indentation left by Demag crane pad.

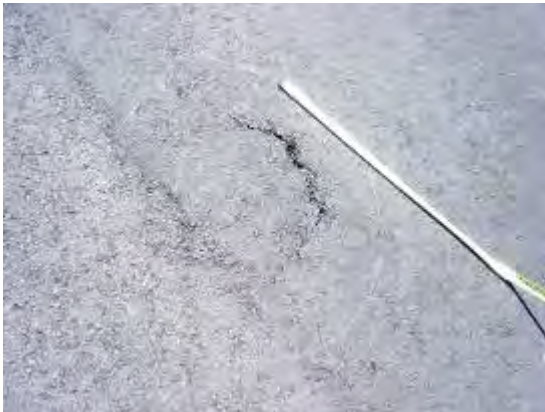
Figure 41. Indentation with crack near midspan.

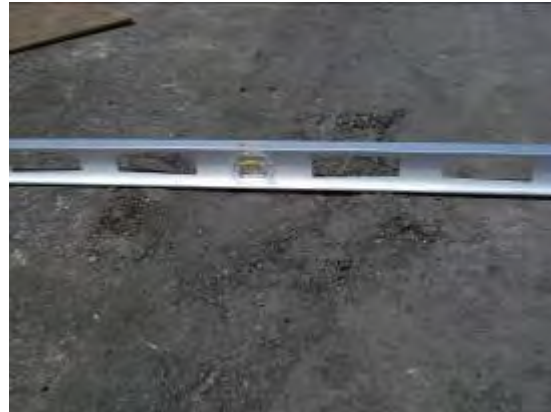
Figure 42. Possible repaired area.

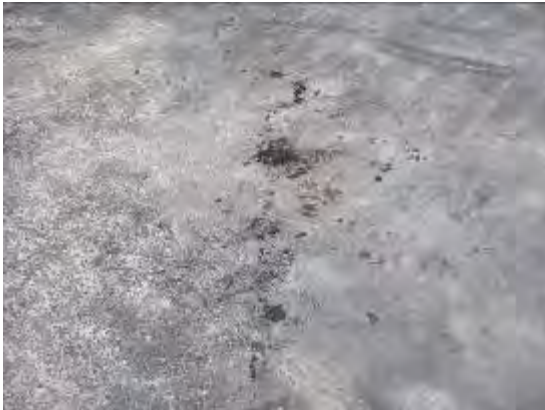
Solvent spilled from the west tower onto the completed overlay in Lanes 2 and 3 which required the pavement to be removed and replaced. Repair included rotomilling the damaged pavement, repairing the three layer membrane system and repaving with conventional HMA.

Figure 43. Solvent spill.

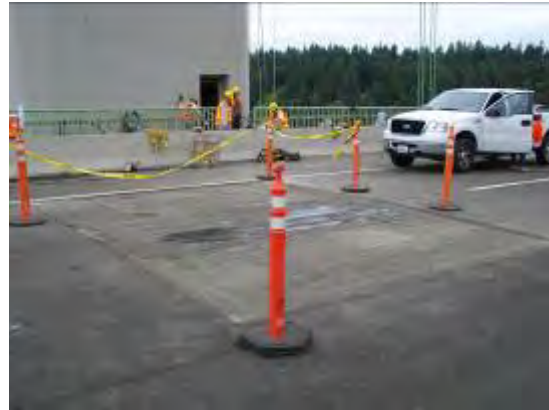
Figure 44. Damaged pavement removed from Lane 2 and 3.

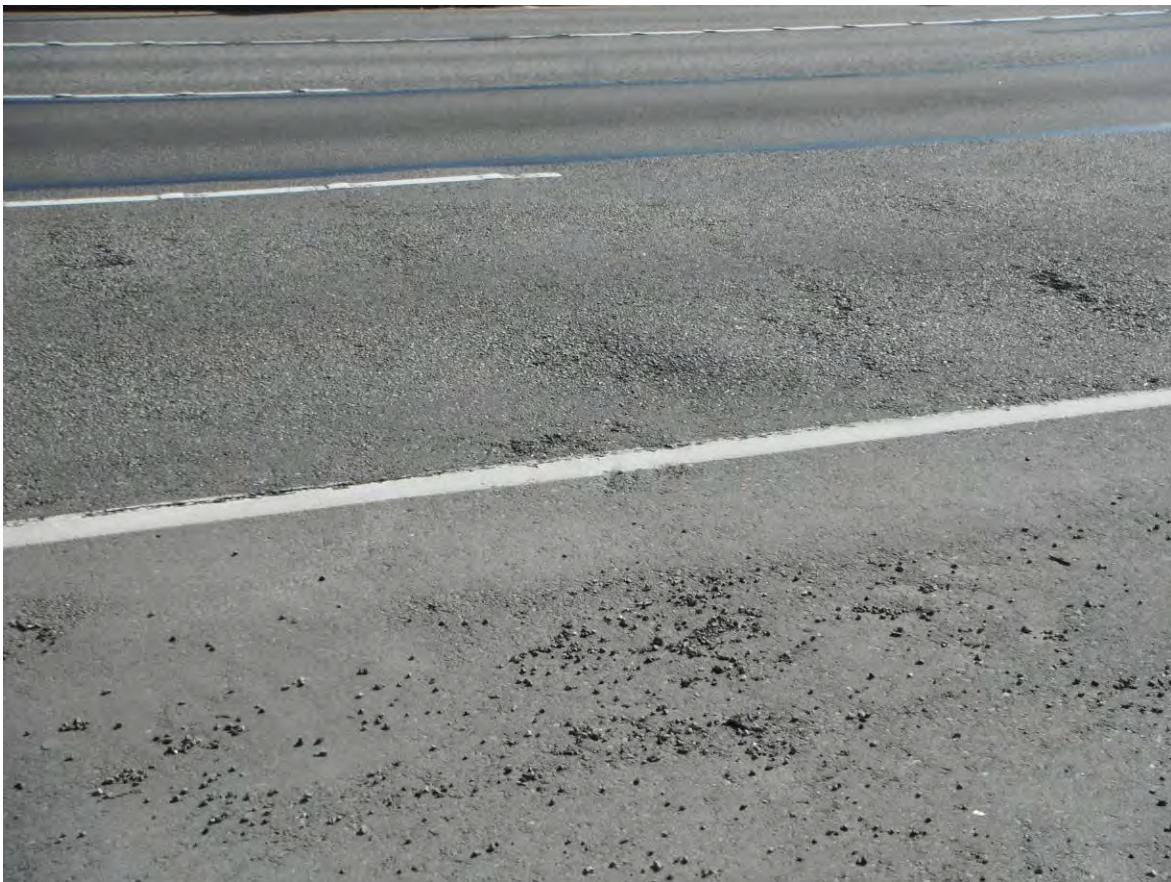
A visual survey was conducted on May 1, 2014 to document the condition of the wearing course at the end of 82 months (2 months shy of seven years). The most noticeable feature of the wearing course was raveling in the wheel paths on all of the lanes and patching in Lanes 2 and 3. The raveling was consistent in the wheel paths of all lanes with linear areas where the aggregates were missing giving the impression of it being a longitudinal crack. Lane 2 of the three general purpose lanes contained a multitude of patches in the wheel paths indicating that the raveling was greatest in this lane. Photos of the pavement on May 1, 2014 are included in Figures 53 to 62.

Figure 53. Severe raveling in the wheel paths of Lane1 and patch in Lane 2. Note accumulation of gravel on the shoulder. (Photo from 5/1/2014)

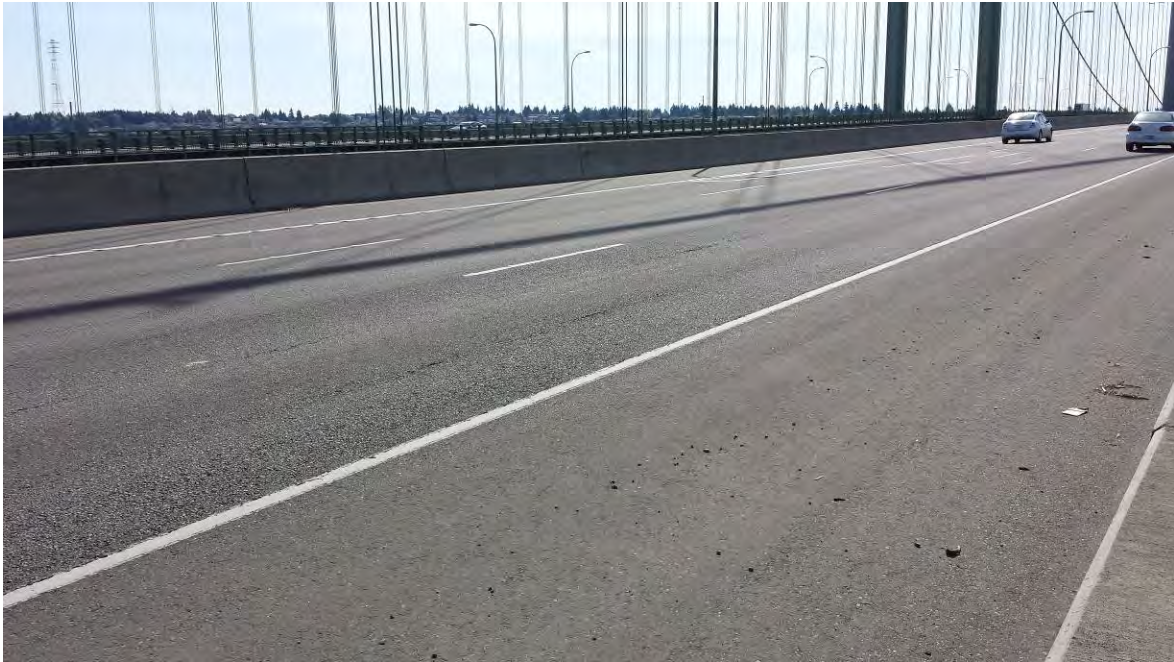
Figure 54. Severe raveling in the wheel paths of Lane 1. Note linear nature of the raveling in left wheel path of Lane 1. (Photo from 5/1/2014)

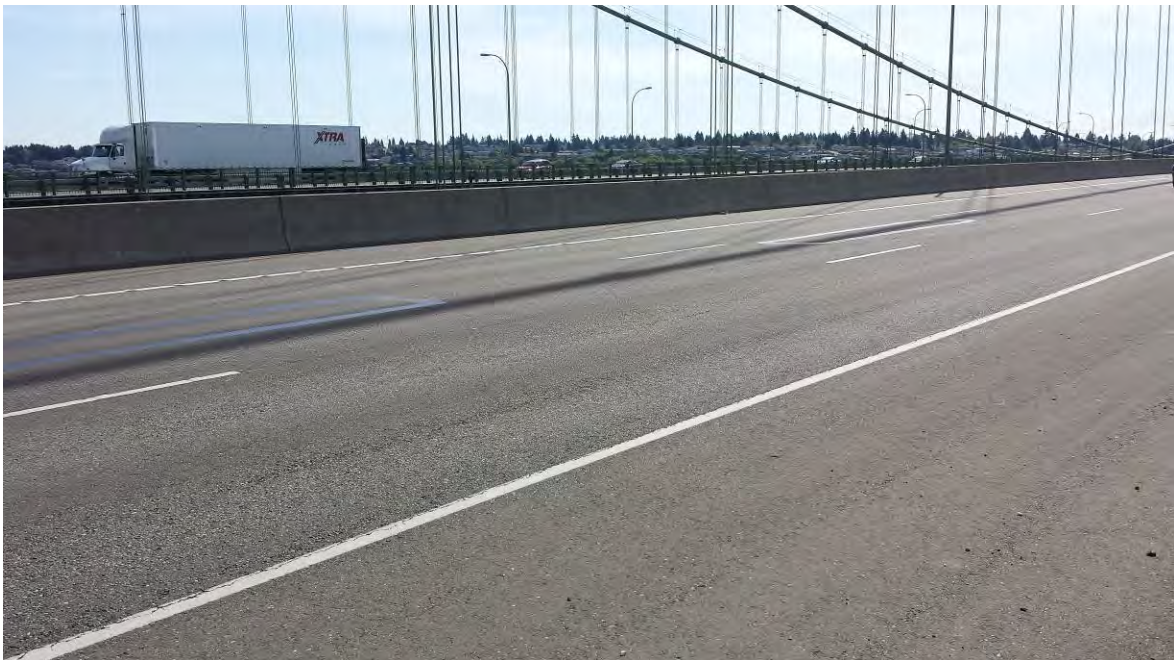
Figure 55. Severe raveling in Lane 1, patch in Lane 2. (Photo from 5/1/2014)

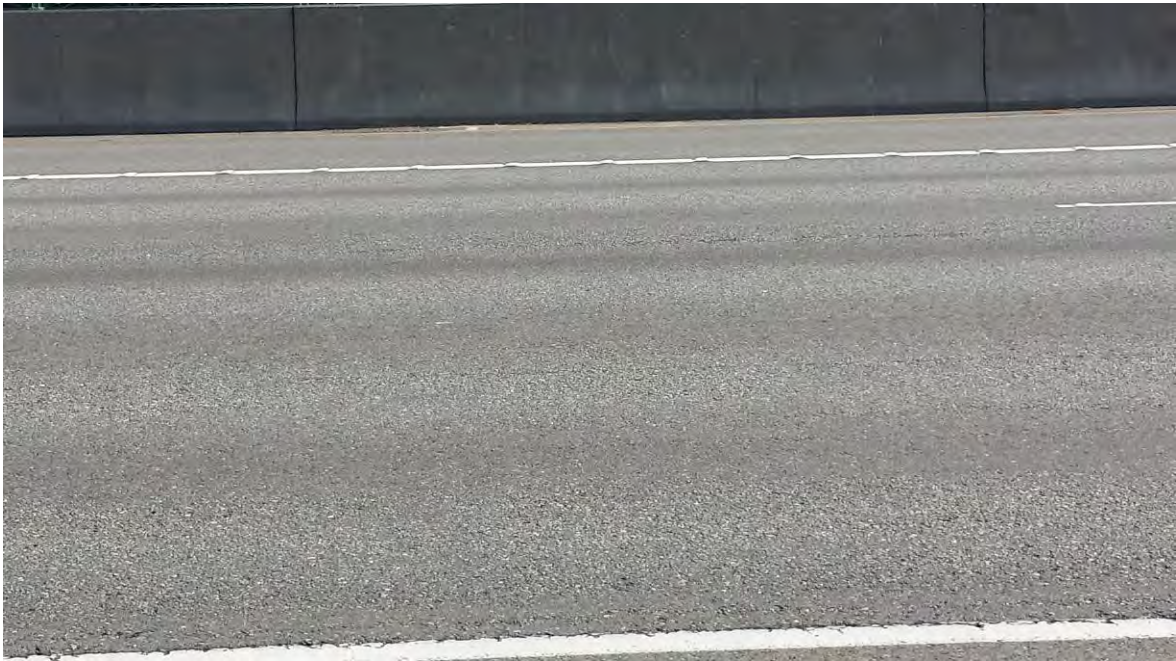
Figure 56. Moderate raveling in all lanes. (Photo from 5/1/2014)

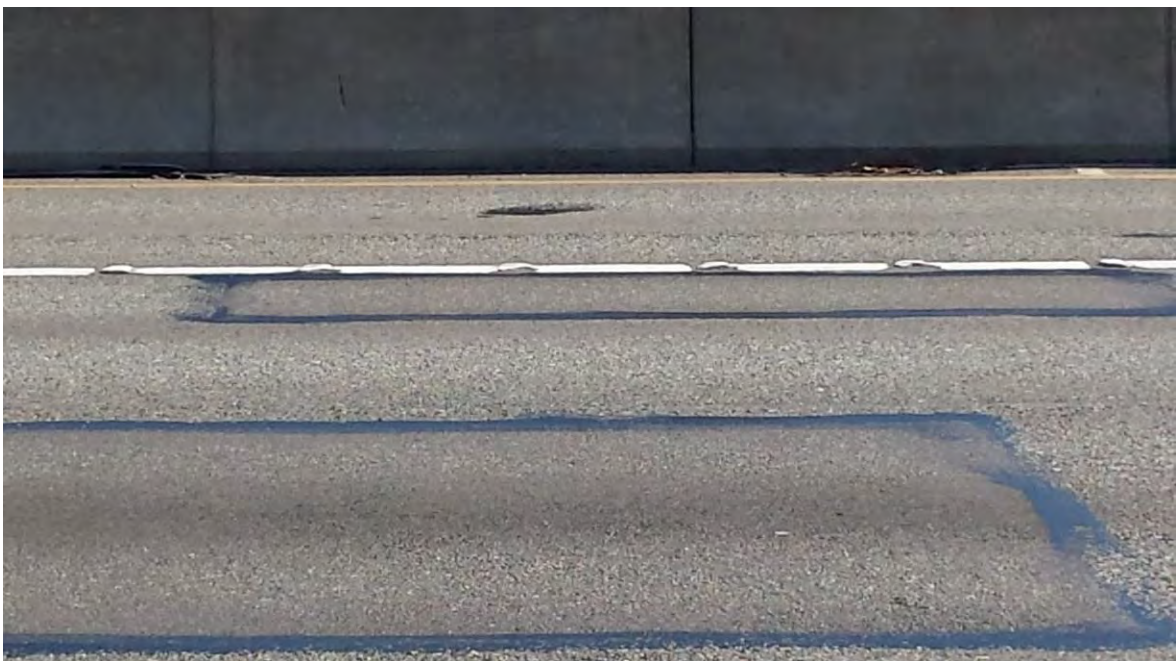
Figure 57. Patches in Lane 3, pothole and raveling in HOV Lane. (Photos from 5/1/14)

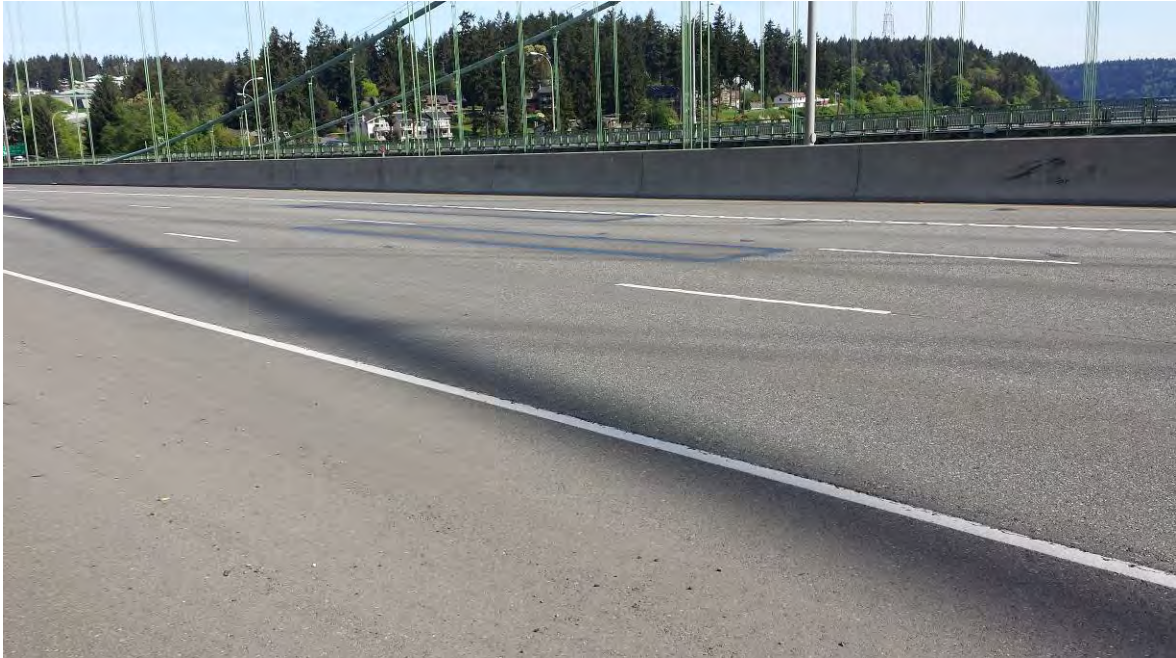
Figure 58. Patches in Lanes 2 and 3. (Photos from 5/1/14)

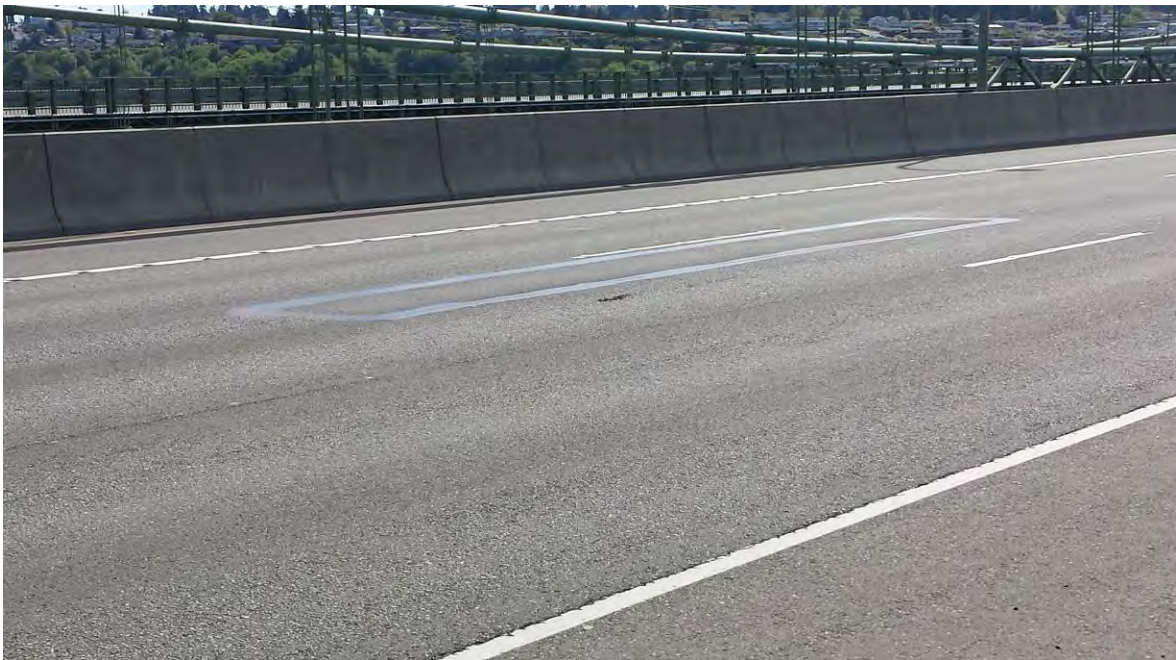
Figure 59. Patch and severe raveling in Lane 2. (Photos from 5/1/14)

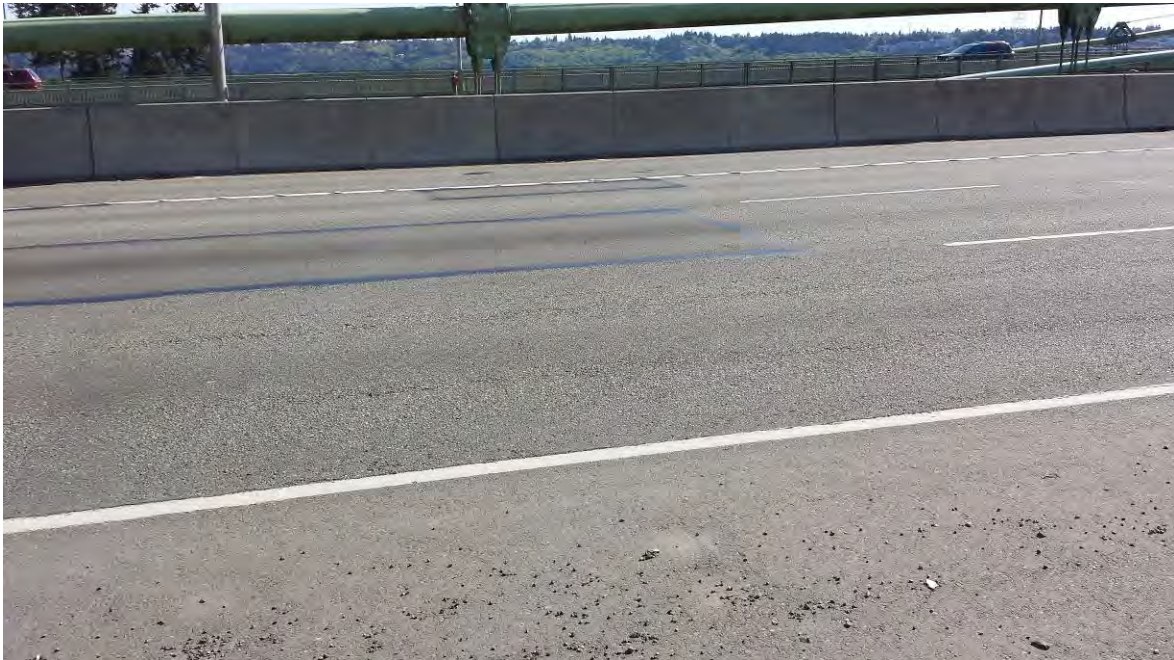
Figure 60. Severe raveling Lane 1, patches Lanes 2 and 3. (Photos from 5/1/14)

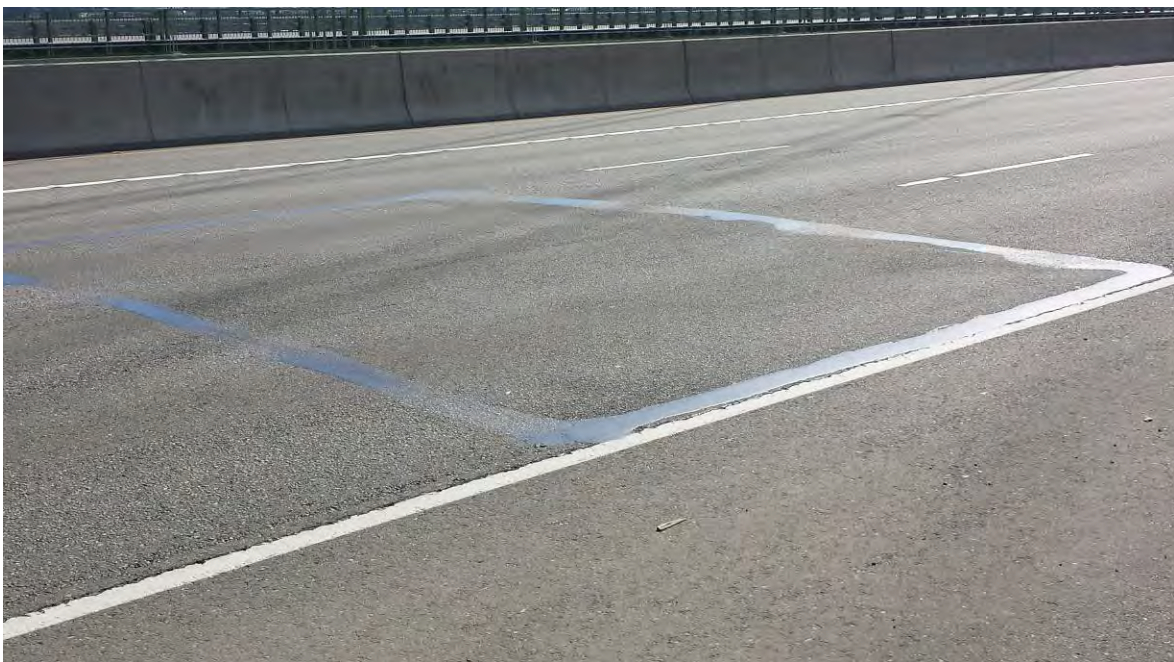
Figure 61. Patch Lane 1 and 2. Patch was done in July 2007 to repair problems caused by a solvent spill on the original overlay. Patch material was conventional HMA. (Photos from 5/1/14)

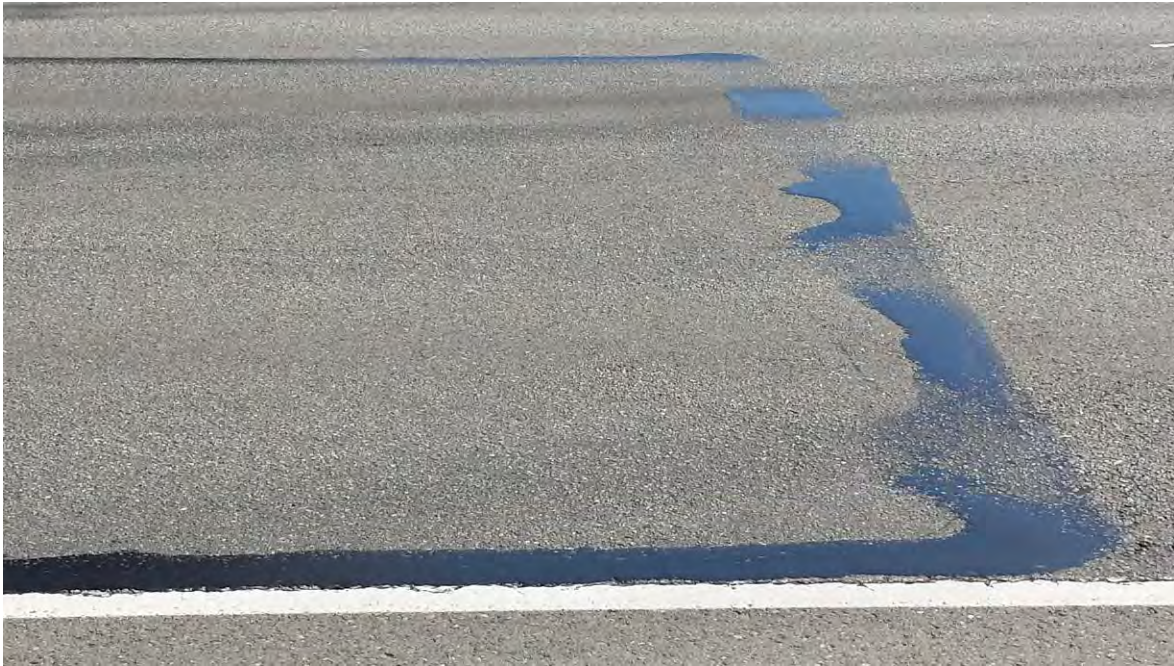
Figure 62. Close-up of HMA patch showing minimal raveling in the wheel paths. (Photos from 5/1/14)

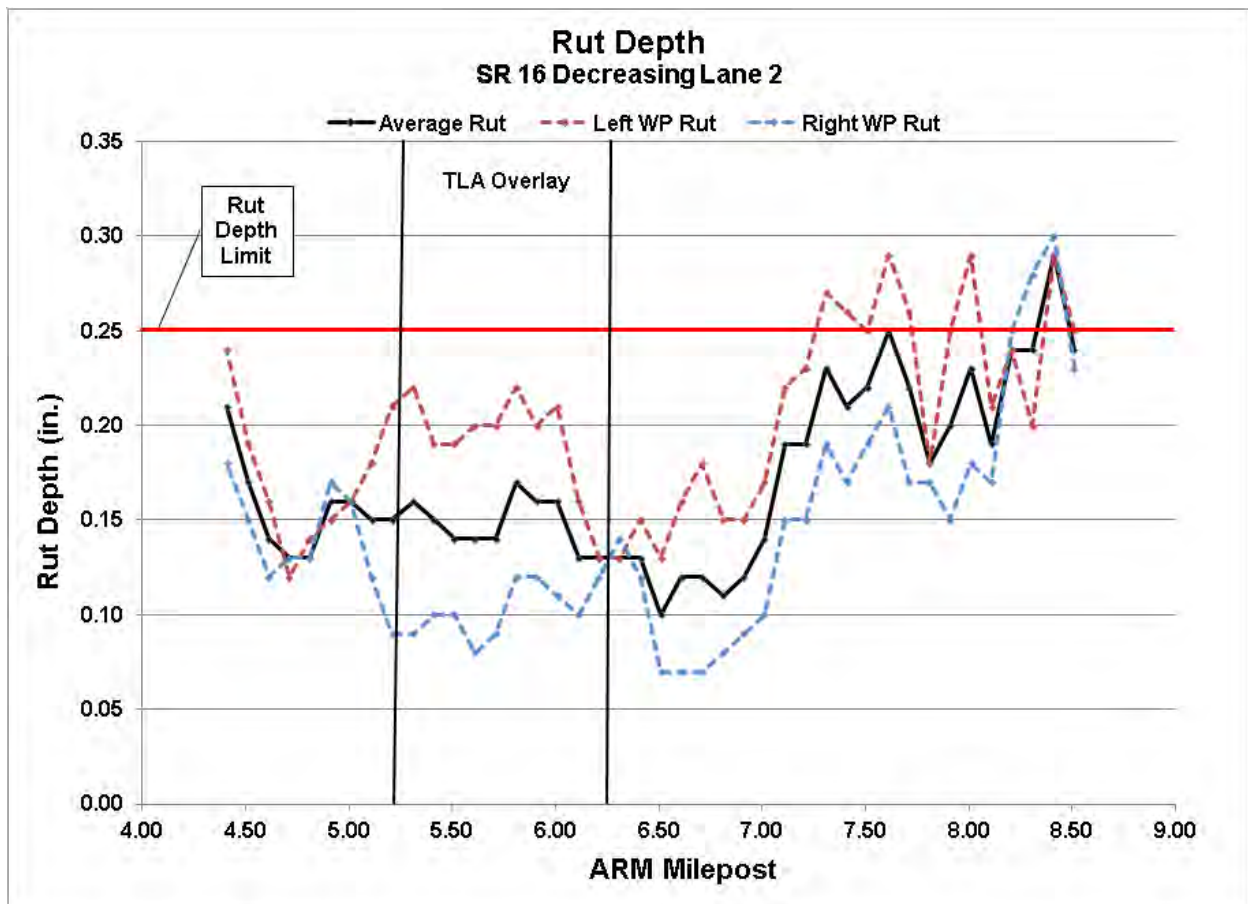
The rut depths were evaluated for all lanes using the above criteria, and in all cases the rut depth limits were not exceeded, except for one 1/10 mile segment in Lane 2 (decreasing direction). The data for this segment is shown in the graph below. As the data shows, several of the 0.1 mile rut measurements for the left wheel path slightly exceeded the 0.25 in. limit. However, the average rut depth is exceeded only for one 0.1 mile segment. WSDOT did not require the Contractor to repair this section.

Figure 64. Rut depth for Lane 2.
