Detection of Voids in Prestressed Concrete Bridges using Thermal Imaging and Ground-Penetrating Radar

WA-RD 717.1

December 2008

Research Report

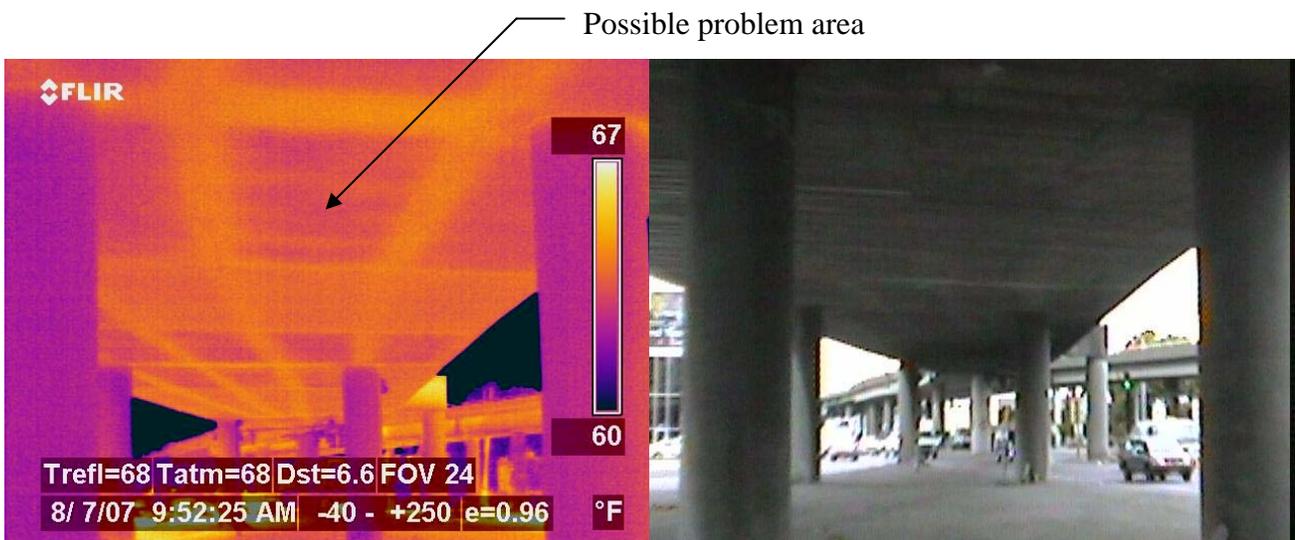
Figure 18 – Thermal image and photo of box girder bridge under ambient conditions

conditions from which a heating location might be determined. The arrow points to a location which should be a solid color inside a rectangle of yellow indicating a uniform temperature distribution. The yellow areas in the image signify locations of interior webs of the box girder. However, a closer look at the image reveals a few areas with higher surface temperatures than the surrounding concrete within the rectangle. This signal of inconsistency may indicate a problem area.

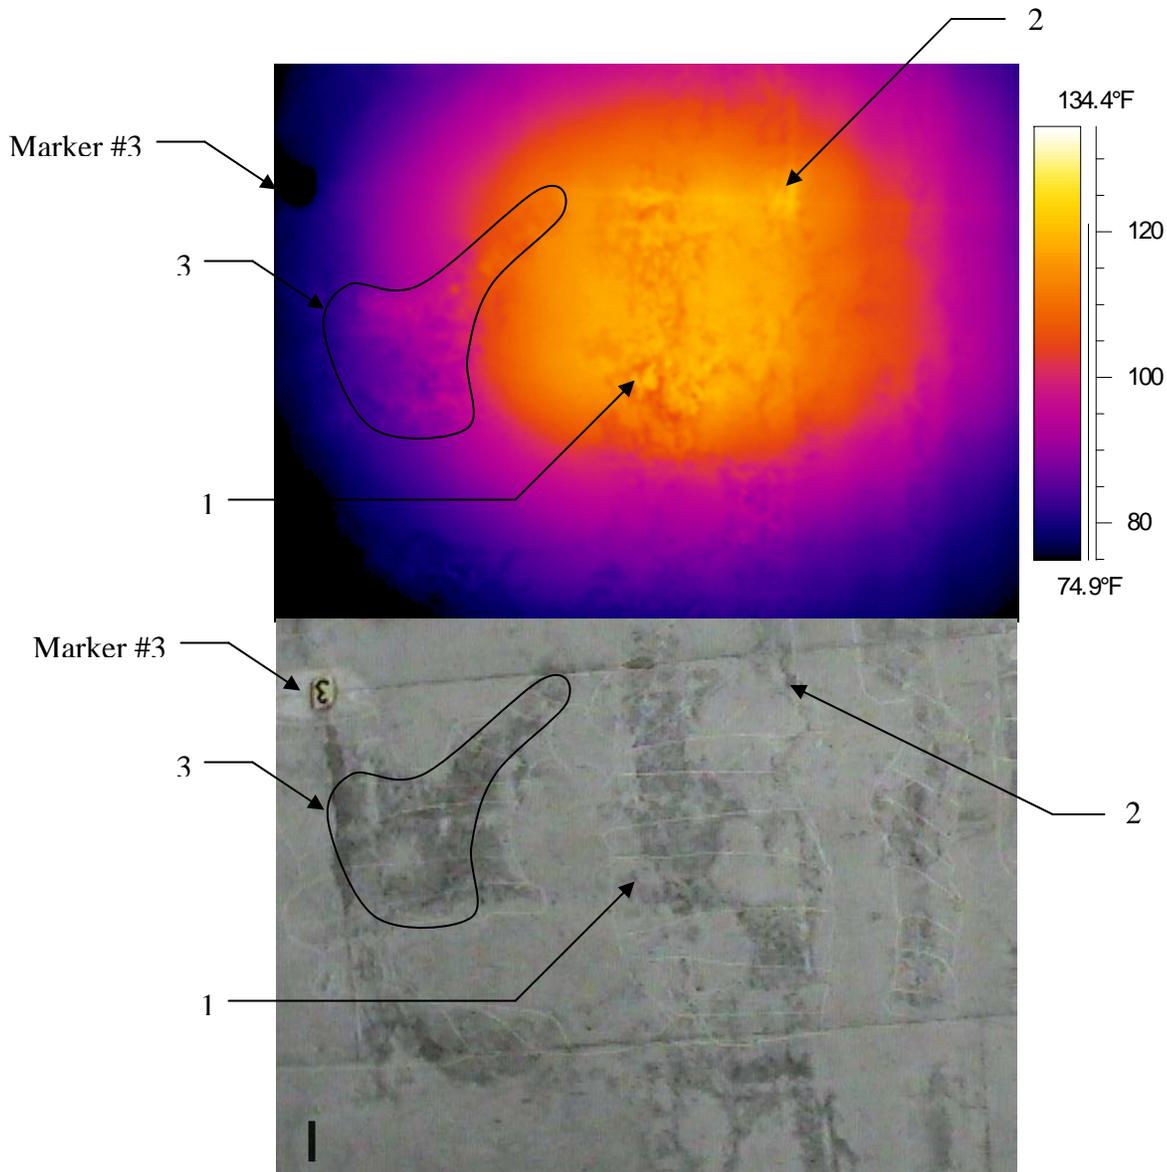
Figure 20 – Thermal image and photo of Heating Location # 1

Heating Location # 1 was inspected on August 6th, 2007 using inspection Method 2. The inspection position was in Span 11 between marker # 1 and marker # 3 (markers were attached to the surface during prior WSDOT inspections). The surface was heated for a time span of 1:45 (hh:mm). The top of the heater was placed approximately 76 cm (30 in.) from the heated surface, which was 7.1 m (23.2 ft.) from the ground. This location was chosen because it was an area that had already been inspected by WSDOT, as indicated by the white chalk in Figure 20. The objective was to see how the thermal images displayed what was previously discovered. Figure 20 shows a thermal image and a corresponding photo of the heated surface. The figure also shows three regions of interest on the heated surface. These regions are clearly shown in both the photo and the thermal image as locations with thermal anomalies.

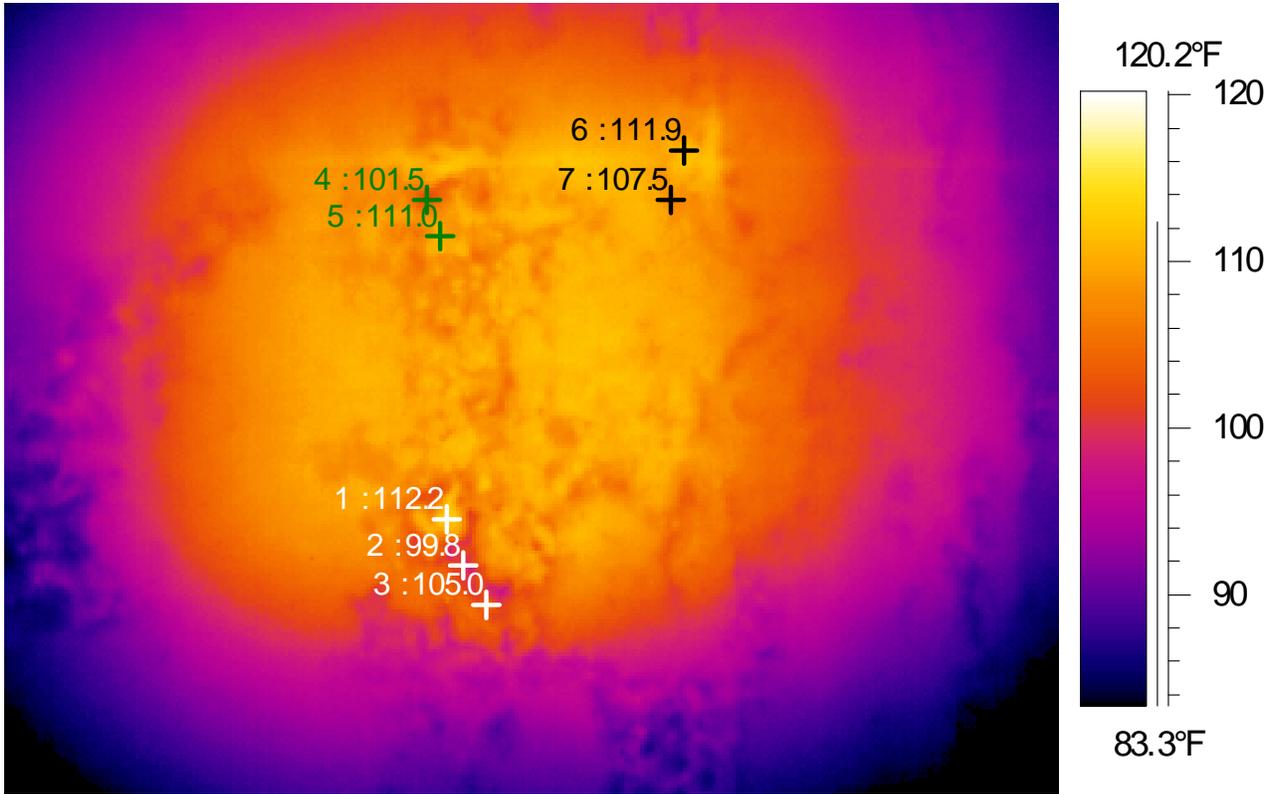
Figure 21 – Thermal image of Heating Location # 1

away from the heated center. This shows that there was an irregularity at this location, which was at approximately the same location as region 1 in Figure 20.

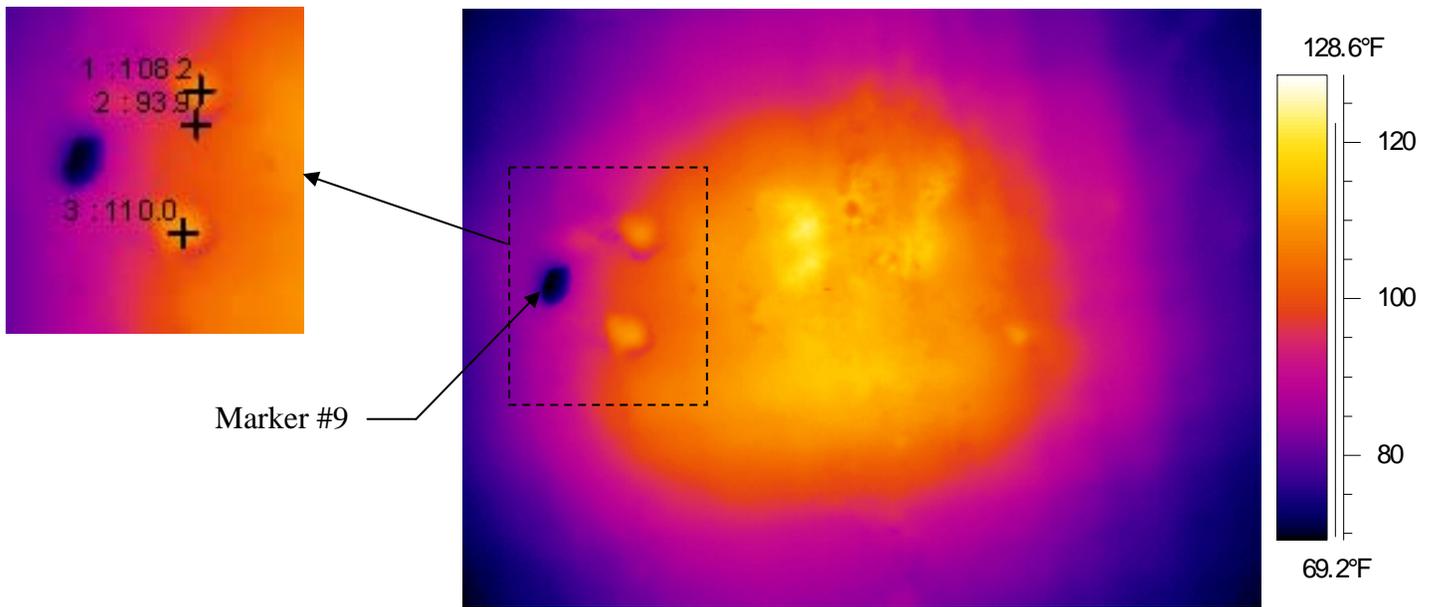
Figure 22 – Thermal image and enlarged area showing spot temperatures of Heating Location # 2

Figure 22 shows a thermal image of Heating Location # 2. The black mark on the left side of the image is marker # 9, and marker # 7 would be on the right side if it were within the viewing range. This image is a very good example of delamination, as indicated by the two “spots” located to the right of the marker # 9. These two areas look like hot spots because of the delamination (separated layers within the concrete) that keeps the heat from propagating farther into the floor of the box girder. The heat propagates at a slower rate due to a layer of air present at the delamination interface. The air acts as an insulator, keeping more heat within the layer of concrete nearest the heat source. The delaminations in the thermal image were confirmed by WSDOT inspectors through tapping the surface with a hammer after the thermal imaging was completed. Figure 22 also shows three points that demonstrate the temperature differences in the vicinity of hot spots. The temperature difference between points 1 and 2 is approximately 14 °F and can be attributed to the delamination occurring between the two points.

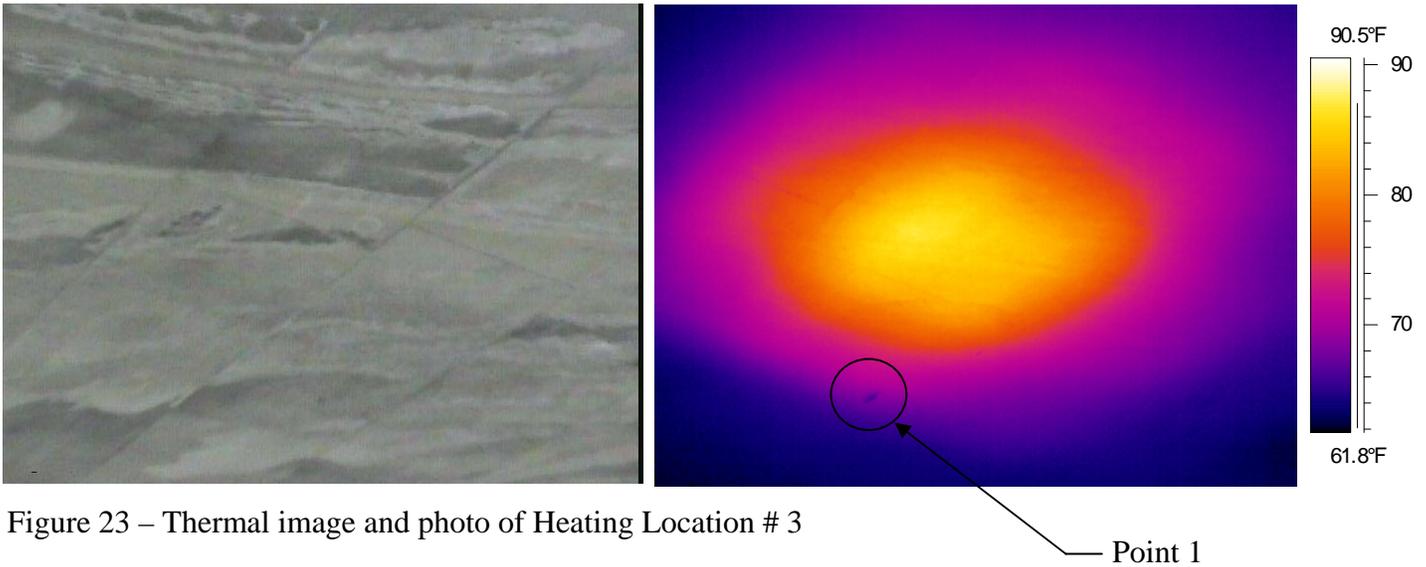
Figure 23 – Thermal image and photo of Heating Location # 3

small temperature change and the lack of other irregularities around the point, it would probably not be classified as a point of significance. Heating Location # 3 would therefore be a good example of a surface with no apparent problems after inspection.

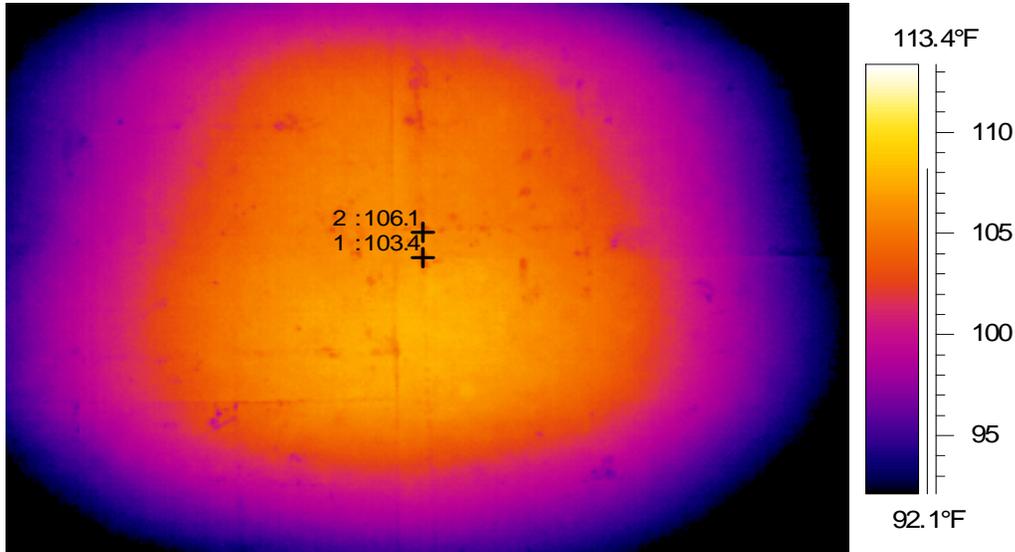
Figure 24 – Thermal image of Heating Location # 4

Figure 24 shows a thermal image of Heating Location # 4. Many small irregularities were detected in this image. An example is at points 1 and 2 in the middle of the image. Point 1 is closer to the heated center than point 2, but it is almost 3 °F cooler. Based on more analysis of the image with the thermal imaging software, most of the other irregularities were found to be approximately 2 to 3 °F cooler as well. Since the irregularities are not substantially different in

terms of temperature, one can conclude that they are just surface marks or areas where a small amount of concrete has spalled off.

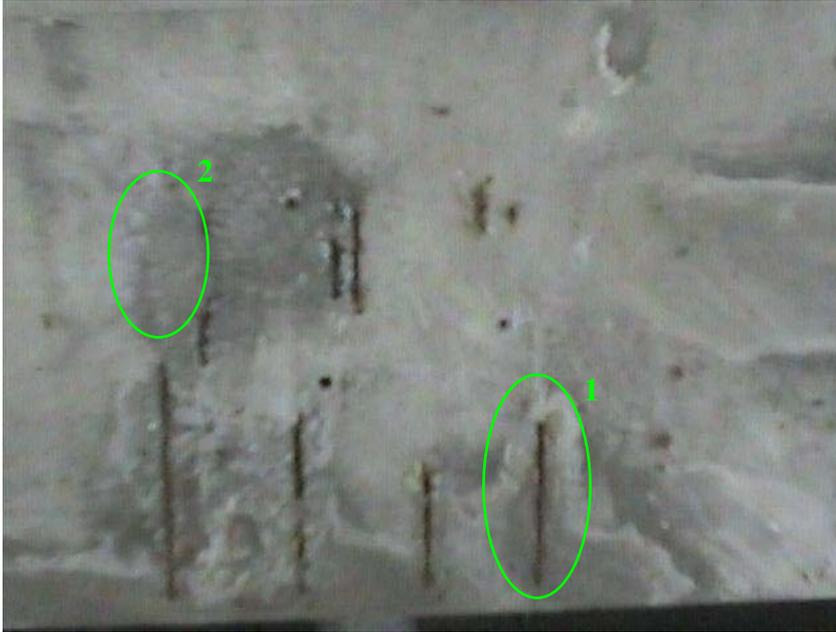
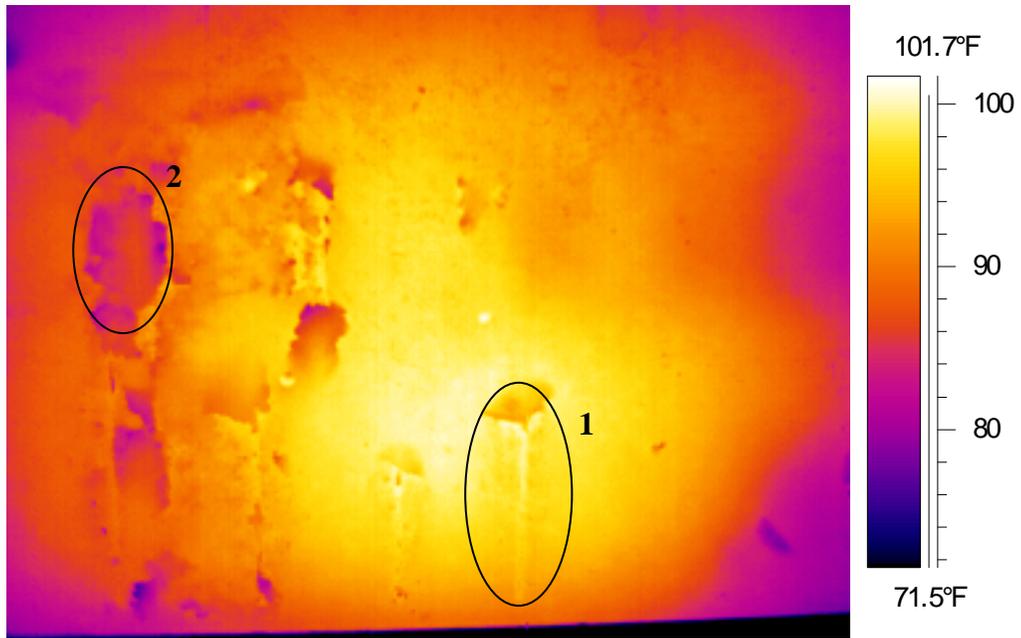
Figure 26 –Thermal image and photo of Heating Location # 5

Figure 26 shows both a photo and thermal image of Heating Location # 5. This figure is helpful because one can see exactly how each area in the photo appears in the thermal image. An example is the steel reinforcement. It is seen exposed in the photo, and then as a warmer line in the image, designated by circled area 1 in the figure. Most of the longitudinal rebar can be traced in a similar manner.

Circled area 2 in Figure 26 shows an interesting irregularity. The area doesn't display anything significant in the photo except a small amount of discoloration, but the thermal image demonstrates inconsistencies in the material in the form of great temperature differences. The thermal imaging software showed an approximate 5 °F difference between areas within the circle. This may be due to delamination, poorly consolidated concrete, or another irregularity, but there is no way to be certain of the specific cause until further tests are completed (either "sounding" with a hammer, or chipping out the loose concrete). This does, however, reveal that there may be a problem at this location. There are also a few other areas in the figure that exhibit similar temperature anomalies.

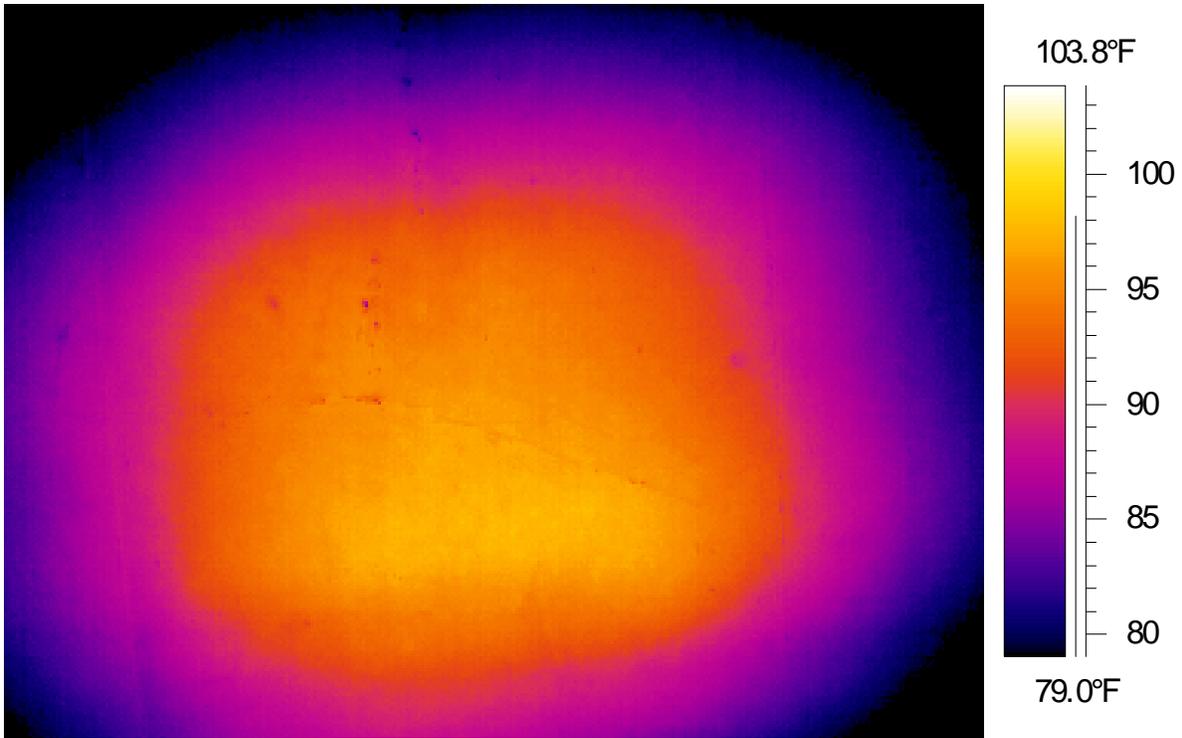
Figure 27 – Thermal image of Heating Location # 6

Figure 27 shows a thermal image of Heating Location # 6. This inspection did not detect any irregularities. The concrete surface seems to have no flaws. However, the inspection does show some of the surface texture characteristics. In the center of the thermal image, for example, is an area where concrete protrudes a very short distance beyond the flat surface. The surface feature looks like a line with a downward slope. The thermal image also demonstrates how very small surface defects can be detected.

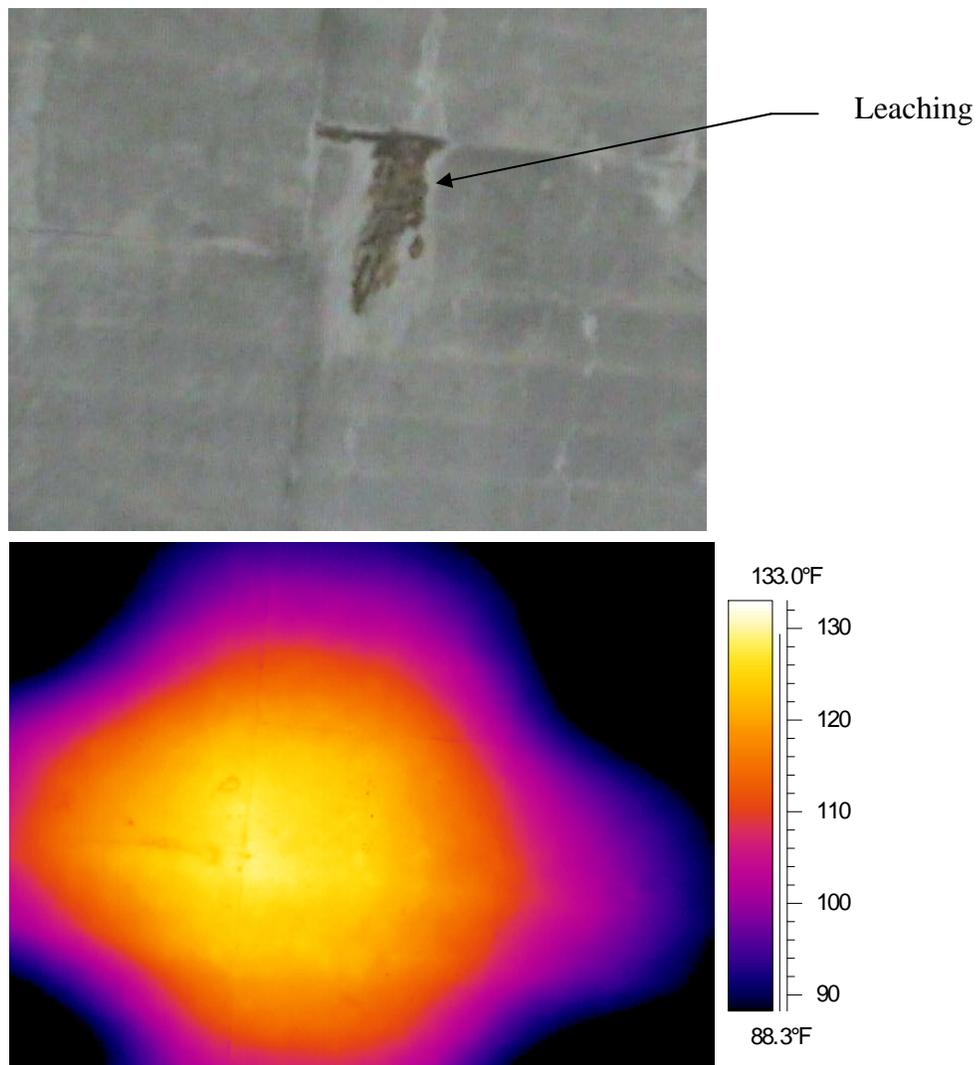
Figure 28 – Thermal image and photo of Heating Location # 7

Figure 28 shows a thermal image and photo of the unheated surface from Heating Location # 7. This area was chosen because of discoloration due to leaching on the bottom surface of the box girder. The leaching may have been caused by water pooling inside the box girder at this location, and then leaching through. However, the thermal image in Figure 28 does not show any irregularities. This indicates that there are no delaminations or air voids near the surface of the concrete.

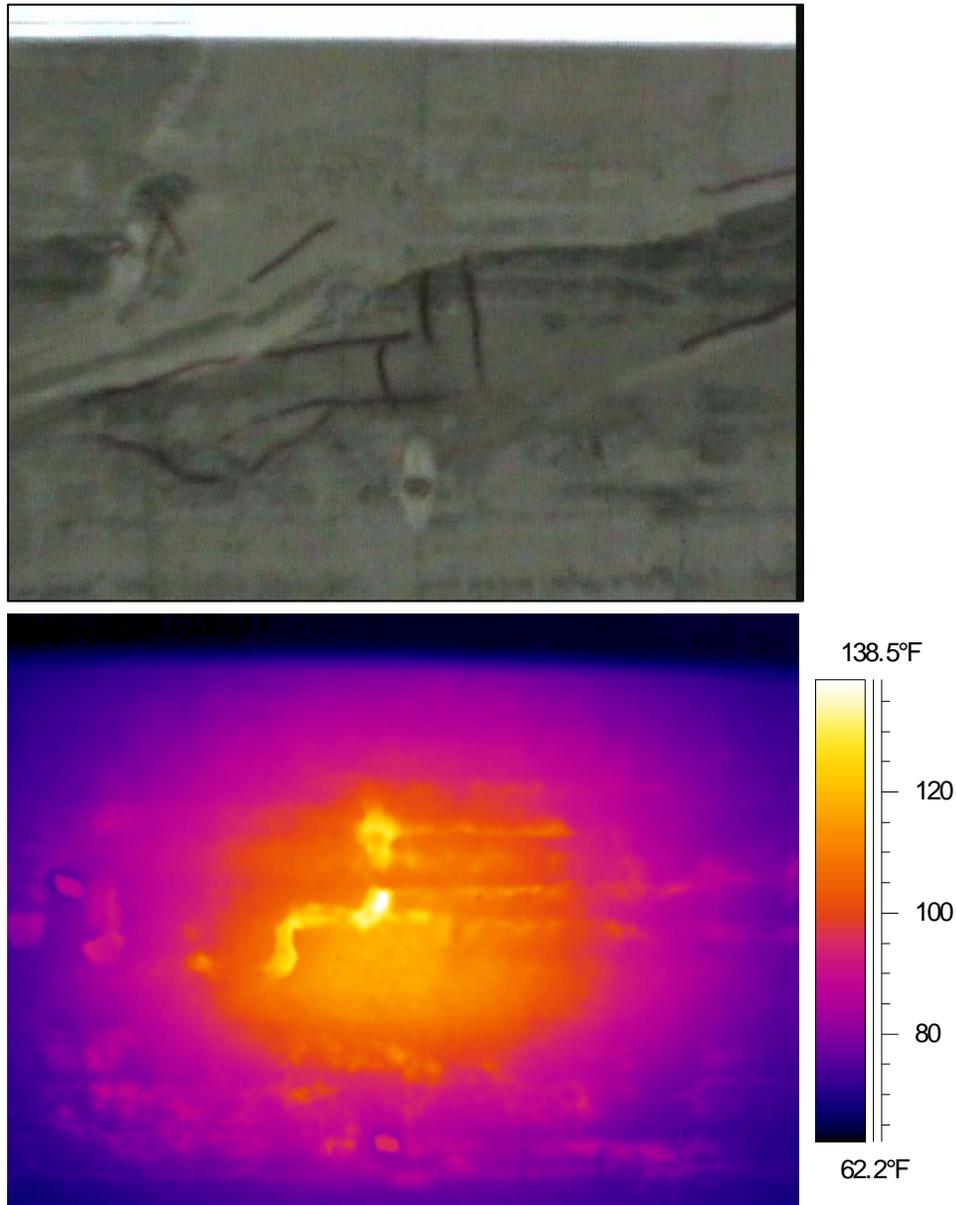
Figure 29 – Thermal image and photo of Heating Location # 8

Figure 29 shows a photo and thermal image of Heating Location # 8. From the photo, one can see that the surface had been marked during previous WSDOT inspection. The markings were somewhat unclear, or at least they did not match up with anything in the thermal image. The image, however, does show a great deal about the surface. In the middle of the heated surface area were a few flaws that varied greatly from the areas around them. Temperature differences ranged from approximately 12 °F to 24 °F between the irregularities and the surrounding concrete. The left side of the image revealed some flaws as well, but they were not very clear because heat was not directly applied to that area. The flaws on the left side of the thermal image do demonstrate, however, that a lot of direct heat is not necessary for flaws to be detected.

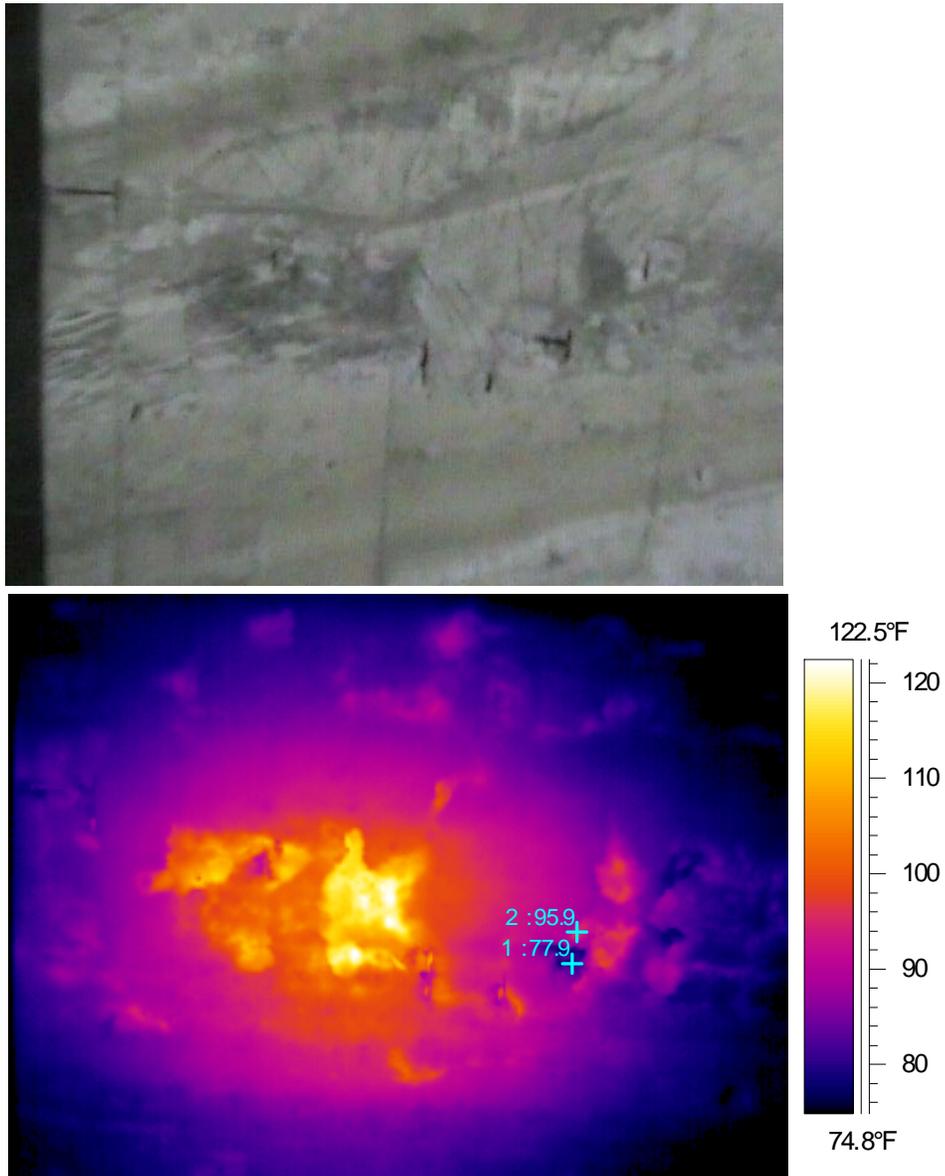
Figure 31 – Thermal image and photo of Heating Location # 10

Figure 31 shows a thermal image and photo of Heating Location # 10. This image exhibits a lot of temperature variation. An example exists with points 1 and 2 on the right side of the image. Point 1 is located on a cool spot at 77.9 °F, while just a few inches above, point 2 is warmer at 95.9 °F. This is a temperature difference of 18 °F. There are more variations like this throughout the image, thus irregularities are present. Also, around the edges of the heated area, small regions of elevated temperature are visible in the thermal image. They show inconsistencies in the concrete surface. When looking at both the thermal image and the photo, it appears that temperature variations occur where visual discoloration is present.

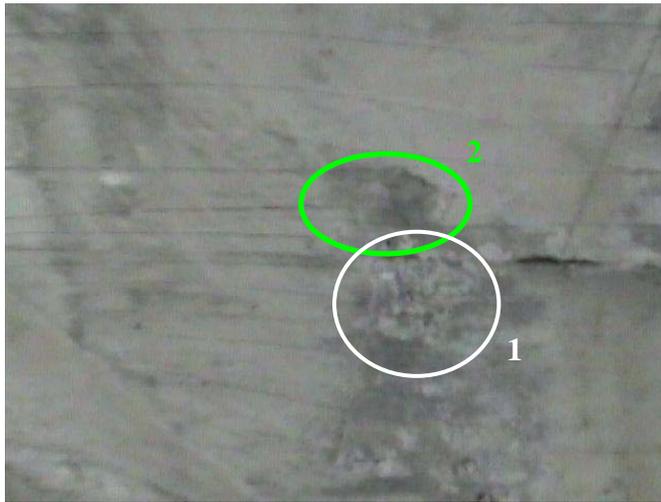
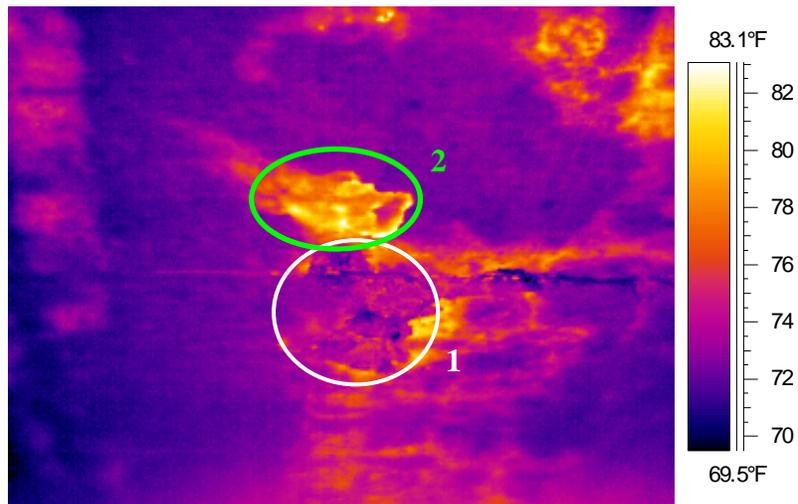
Figure 32 – Thermal image and photo of Heating Location # 11 approximately 10 minutes after heating began

Figure 32 shows a thermal image and photo of Heating Location # 11 that were taken approximately 10 minutes after heating began. Visible flaws were present on the heated surface and temperature differences between warm and cool areas were approximately 7 °F. The thermal image shows that not much heat time is needed to detect surface irregularities and obtain a significant temperature variation. Figure 32 also shows what looks like spalled concrete (denoted by circle 1) and an area of delamination (denoted by circle 2).

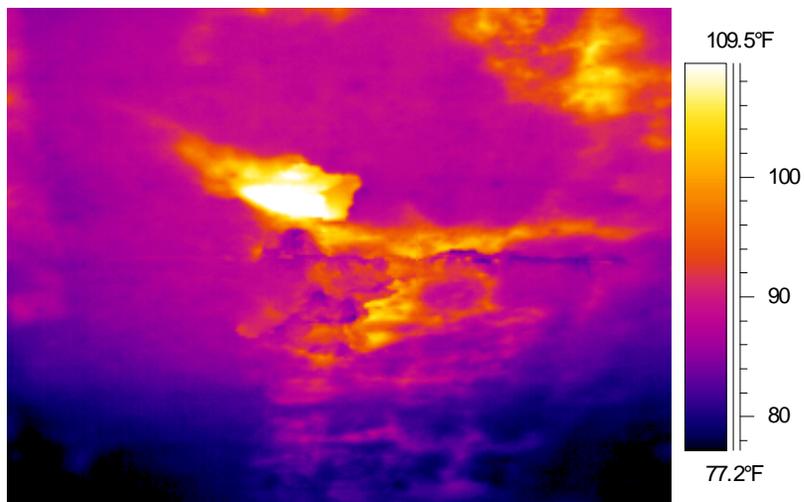
Figure 33 – Thermal image of Heating Location # 11 approximately 40 minutes after heating began

Figure 33 shows a thermal image of Heating Location # 11 taken approximately 40 minutes after heating commenced. When comparing Figures 32 and 33, it is evident that a lot of surface detail was lost as the heating time increased. This is likely due to the camera's automatic adjustment to a broader temperature range. Broader temperature ranges result in less detailed images.

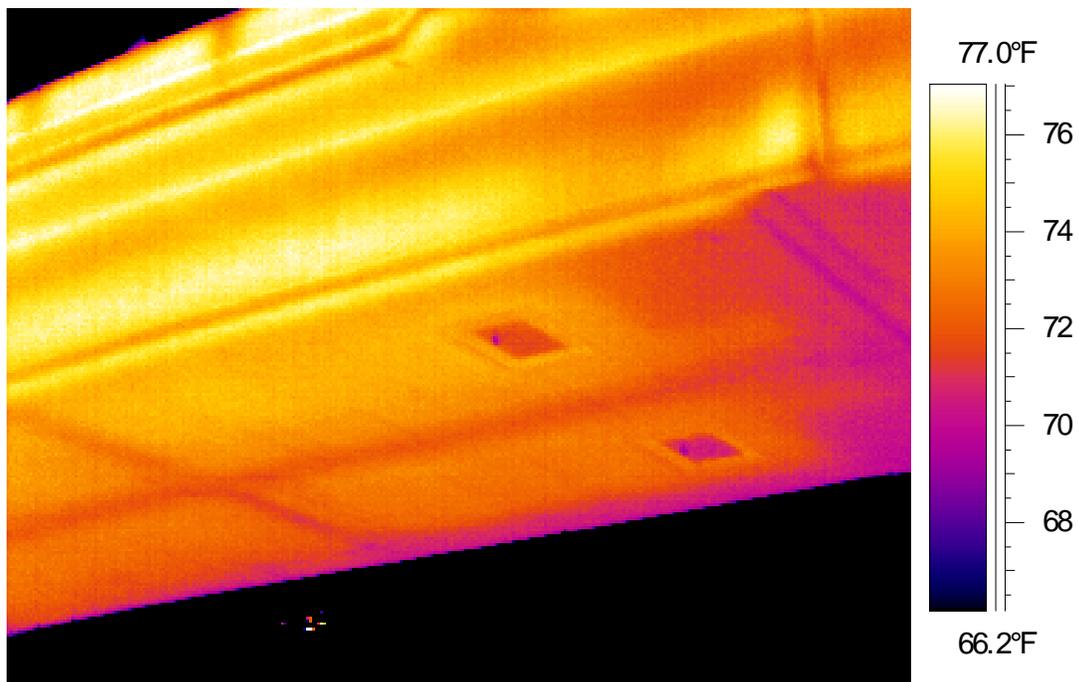
Figure 34 – Thermal image of Bridge 5/537E-N under ambient conditions

Before any inspections took place, thermal images of the bottom surface of the box girder under ambient conditions were analyzed to see if problem areas could be identified. Figure 34 shows a thermal image of the bridge under ambient conditions that encompasses most of Span 4. This thermal image displays the access hatches used during one inspection (Heating Location # 2). However, it does not reveal any specific problem areas. Without thermal identification to locate problem areas, visual analysis was used, in conjunction with access limitations, to determine heating locations. The positioning limits were based on access provided by WSDOT

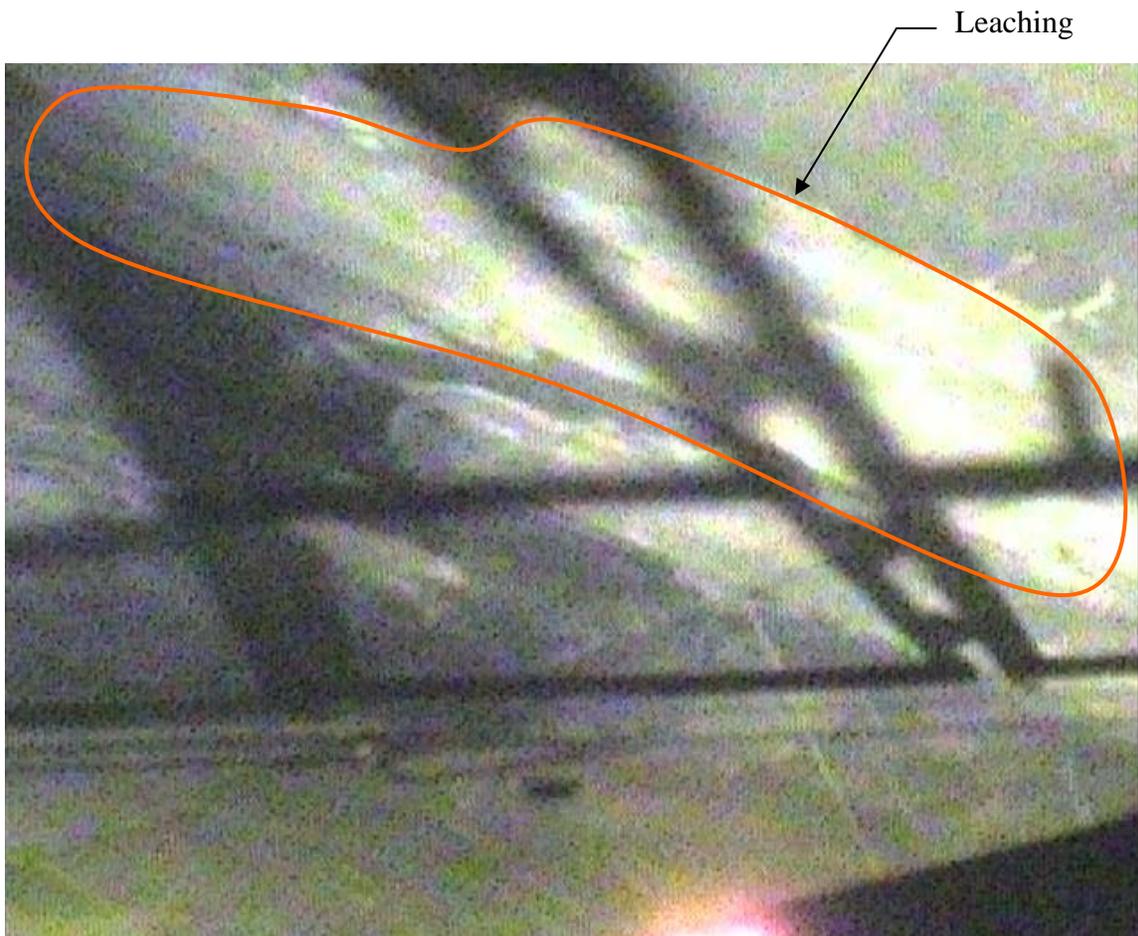
Figure 35 – Photo of Heating Location # 1 with extensive discoloration due to leaching

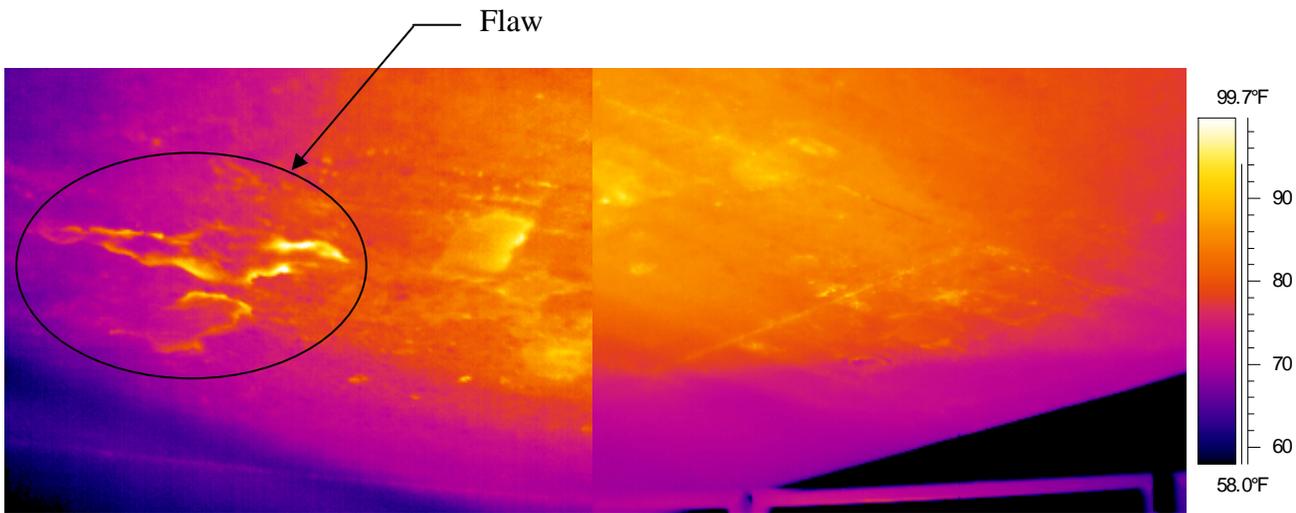
Figure 36 – Thermal images of Heating Location # 1, side by side

With this inspection, thermal images were taken throughout the heating process. The camera was placed on the lift platform approximately 3 m (10 ft.) to one side of the heater. Figure 36 shows two thermal images side by side that were taken approximately four minutes after heating began. The circled region demonstrates that after a fairly short heat time, surface characteristics and flaws were visible in thermal images. There were also other visible irregularities in the middle of the figure.

The thermal images in Figure 36 were taken in order to help locate areas that, with further heat input, might reveal subsurface flaws. The circled region shows what looks like a flaw, so the heater was moved so that its center was directly underneath this region, and then heating commenced again. From here, thermal images were taken every two minutes. Figure 37 shows a typical image progression during heating, or what one would see from the camera display. Figure 38 shows a single image from the progression.

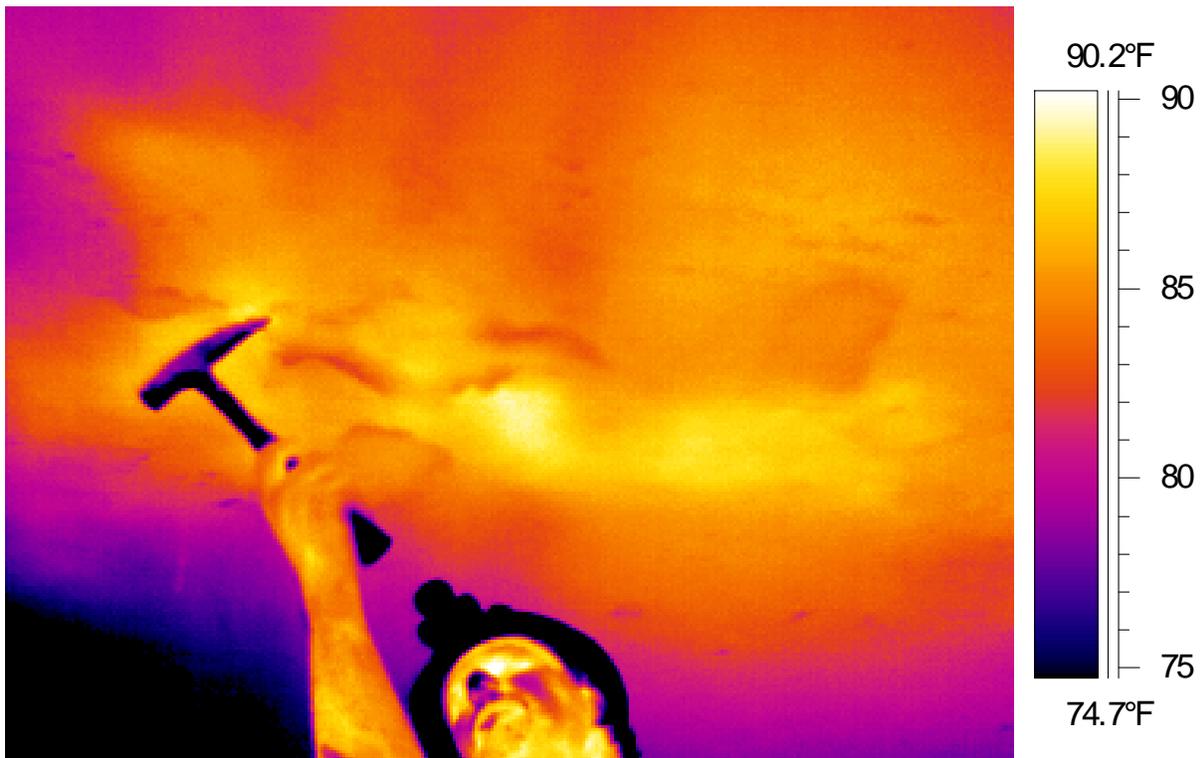
Heating Location # 1 was a very important inspection because, after heating was stopped, the surface was examined with a rock hammer. Tapping confirmed what was seen in the thermal images. A WSDOT inspector tapped part of the surface that had no apparent flaws (either visually or thermally) and then tapped at suspected flaw locations. Sound differences were easily discernable between the two locations, and then the pick end of the hammer was used to remove surface concrete and excavate the flaw. Delamination and poorly consolidated concrete (small air voids) were discovered. Figure 39 shows a thermal image of a WSDOT employee excavating the delaminated concrete at the flaw location shortly after thermal imaging inspection. This was the first inspection location where flaws discovered thermally were confirmed using physical means (tapping and excavation).

Figure 39 – Thermal image of Heating Location # 1: excavating a detected flaw

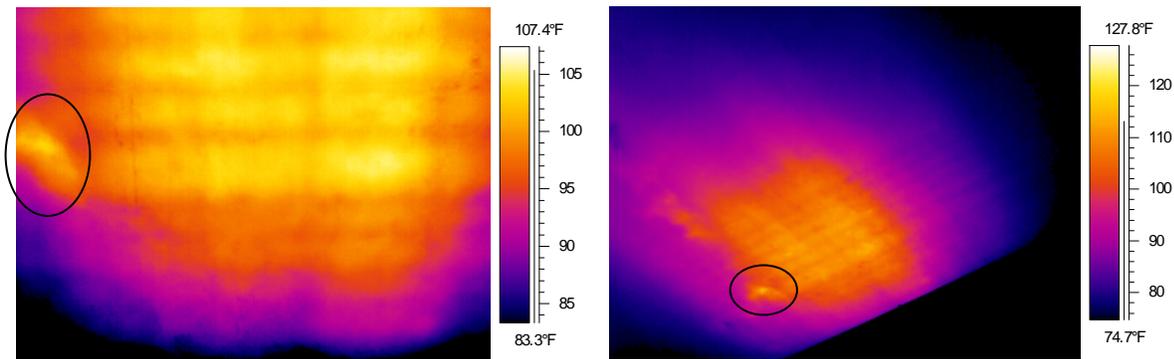
Figure 40 – Thermal images of Heating Location # 2

Thermal images from Heating Location # 2 do not reveal anything about the leaching or the unheated surface. Steel reinforcement inside the concrete is the only thing shown in the images. Figure 40 is comprised of two thermal images that show the reinforcing steel as cool lines between warmer regions. There is one hot spot, which is located inside the circled region in both thermal images.
