# Long-Term Performance of a Hot In-Place Recycling Project — Final Report

WA-RD 738.2

## Long-Term Performance of a Hot In-Place Recycling Project Final Report

Contract 7648  
SR-542  
Britton Road to Coal Creek Bridge Vicinity  
MP 3.38 to MP 19.27

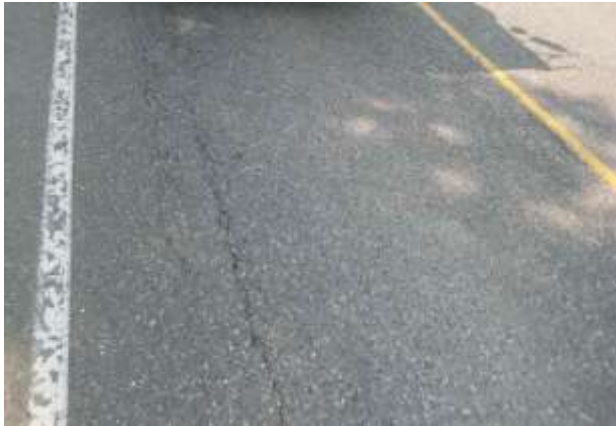
Figure 21. Pre-construction longitudinal cracking. (0776)

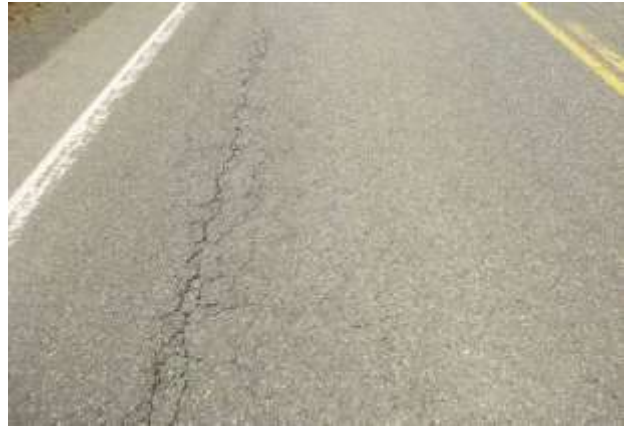
Figure 22. Pre-construction alligator cracking. (1363)

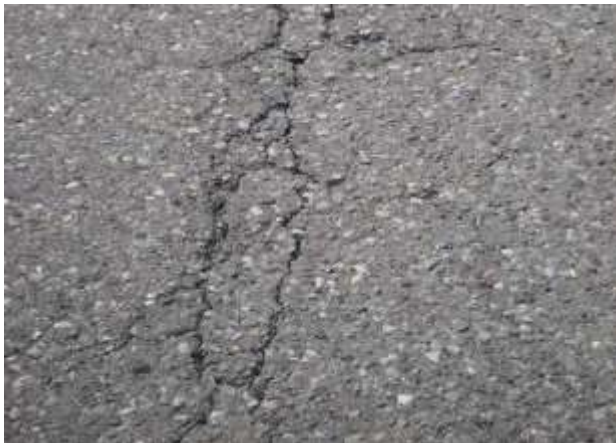
Figure 23. Pre-construction alligator cracking. (1364)

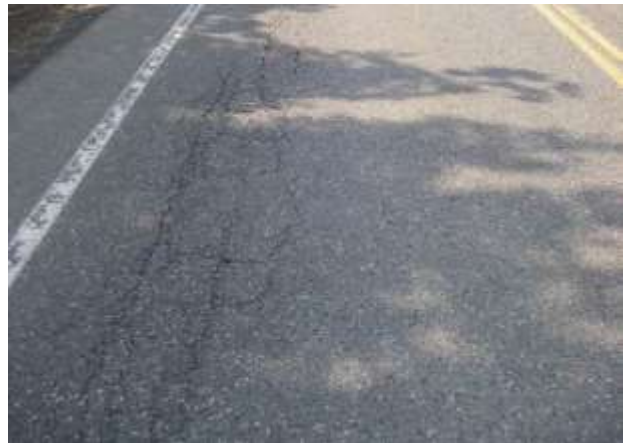
Figure 24. Pre-construction alligator and longitudinal cracking. (1365)

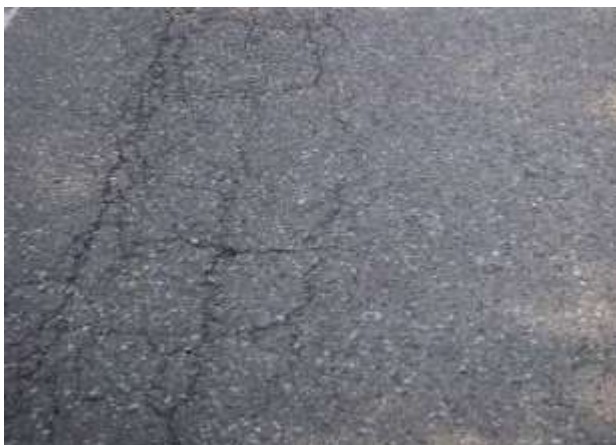
Figure 25. Pre-construction alligator and longitudinal cracking. (1366)

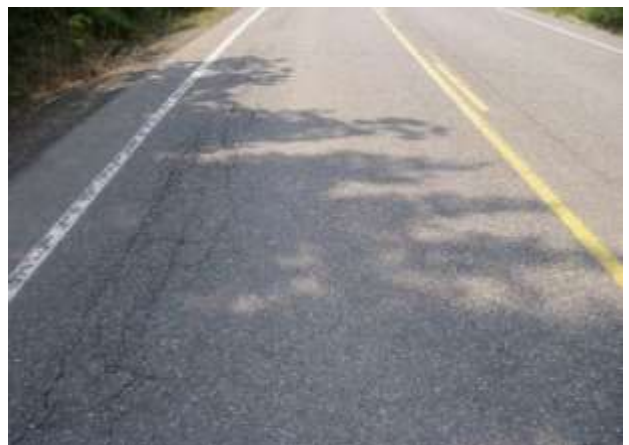
Figure 26. Pre-construction alligator and longitudinal cracking. (1367)

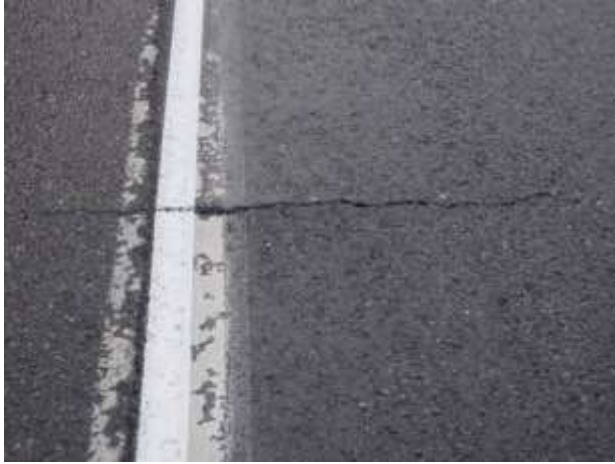
Figure 27. Transverse crack at MP 14.10. (4826)

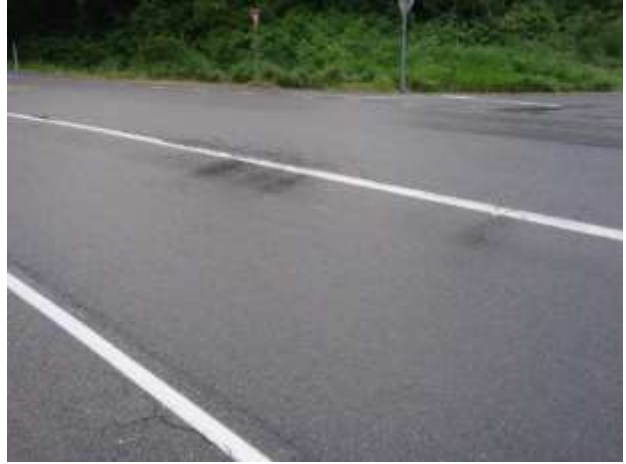
Figure 28. Alligator cracking at MP 14.5. (4818)

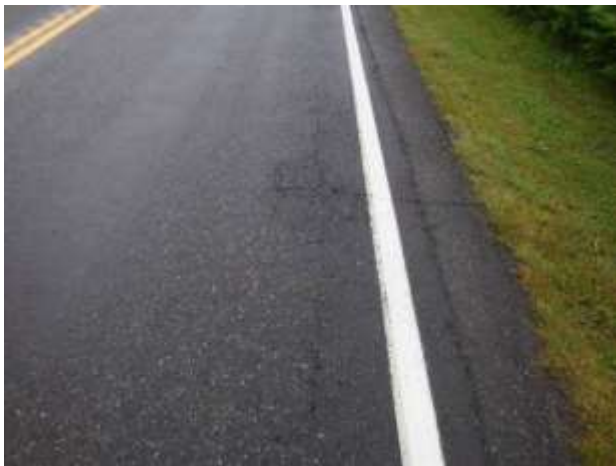
Figure 29. Alligator and longitudinal cracking at MP 17.2. (4807)

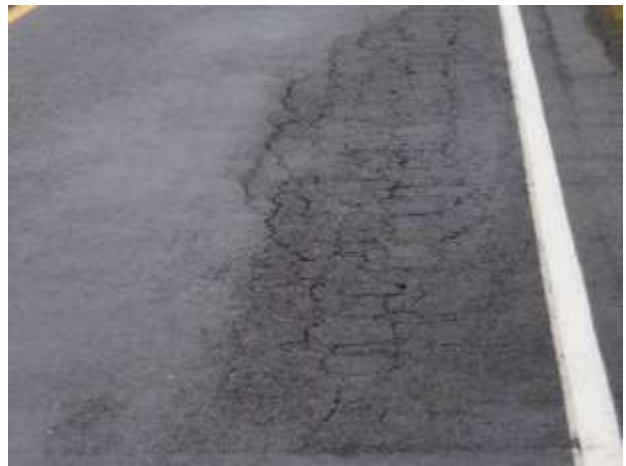
Figure 30. Close-up of alligator cracking at MP 17.2. (4870)

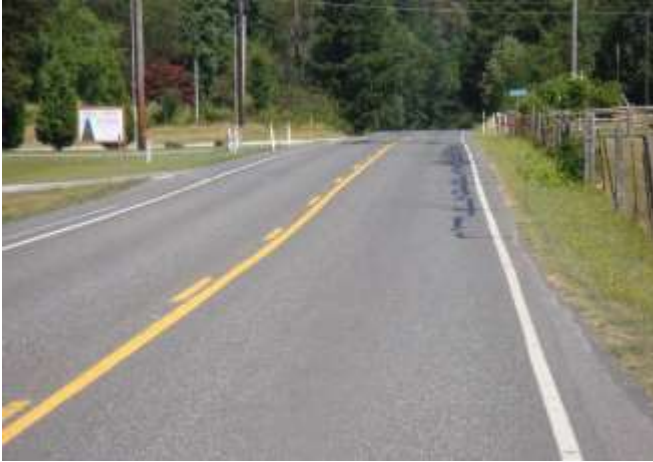
Figure 31. Sealed alligator cracking at MP 17.24. (6593)

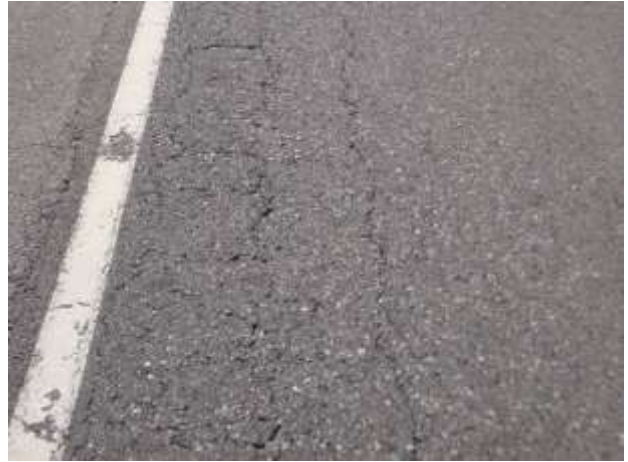
Figure 32. Alligator and long. cracking at unknown location. (6594)

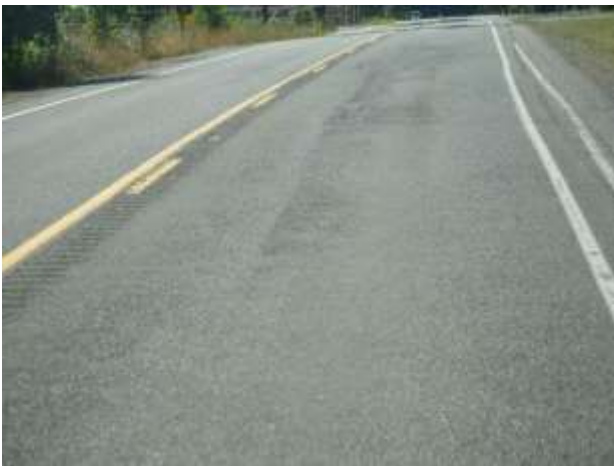
Figure 33. Alligator cracking at unknown location. (6590)

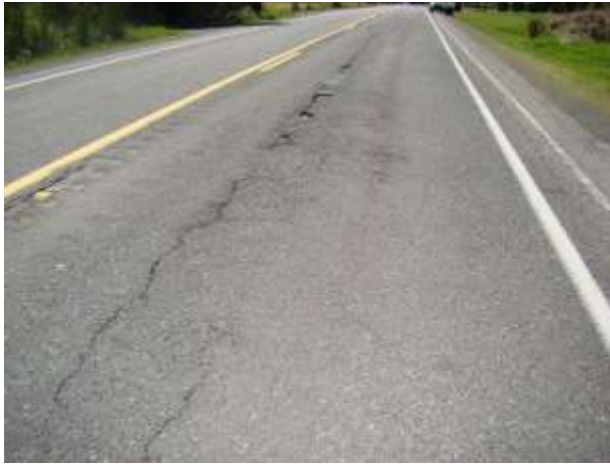
Figure 34. Alligator, longitudinal cracking and potholes in the westbound lane at MP 17.2 in May 2013. (1334)

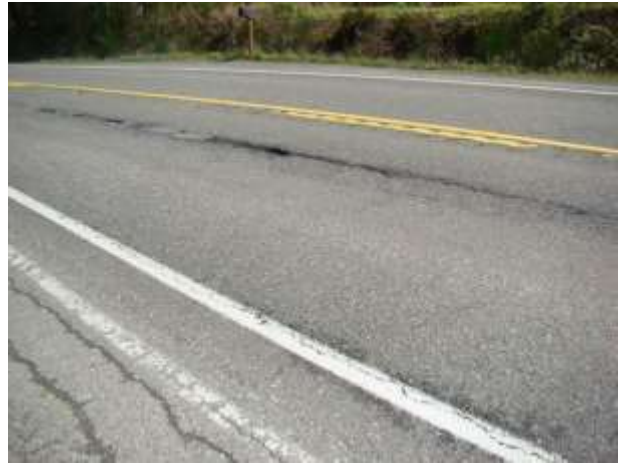
Figure 35. Alligator, longitudinal cracking and potholes in the westbound lane at MP 17.2 in May 2013. (1335)

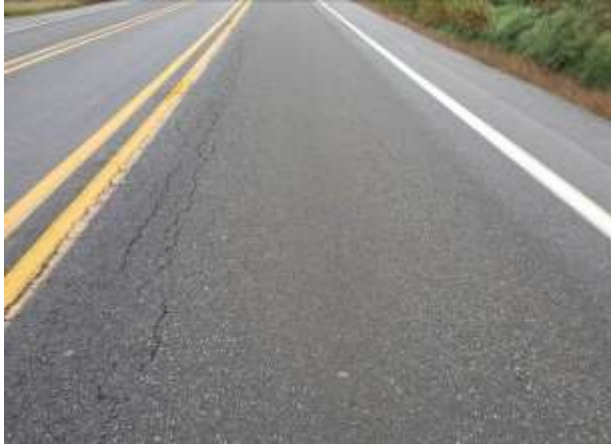
Figure 36. Longitudinal and alligator cracking at MP 4.8. (85258)

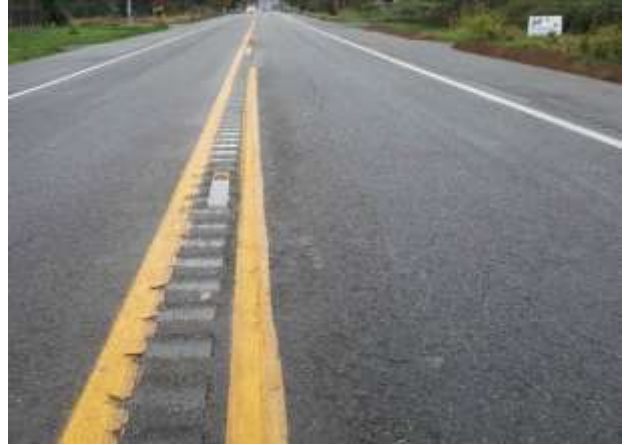
Figure 37. Open-texture and raveling at MP 10.1. (90232)

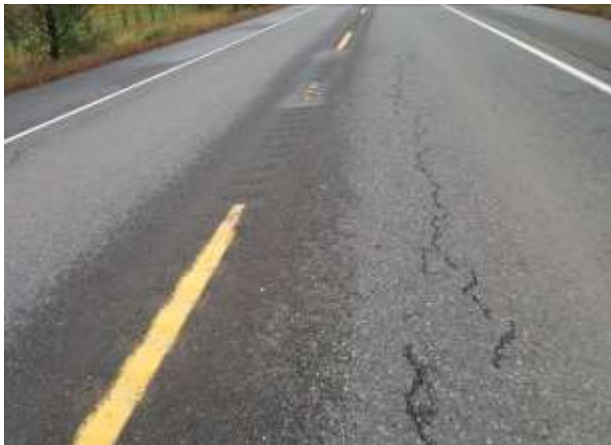
Figure 38. Open-texture, raveling and longitudinal cracking at MP 11.8. (90910)

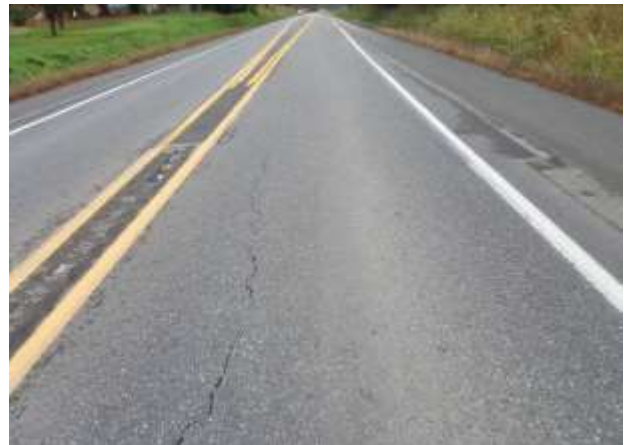
Figure 39. Open-texture, raveling and longitudinal cracking at MP 13.15 (90910)

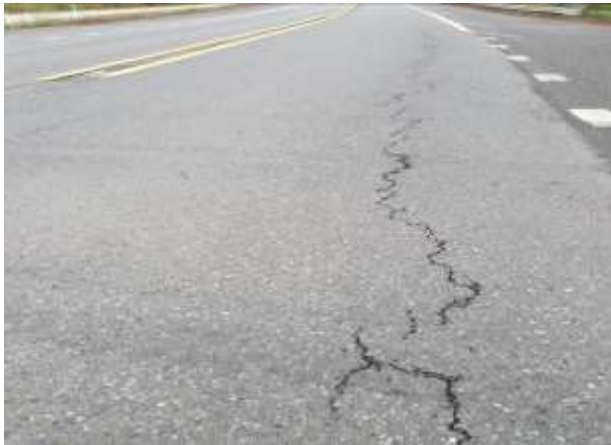
Figure 40. Open-texture, raveling, alligator and longitudinal cracking at MP 14.1. (92525)

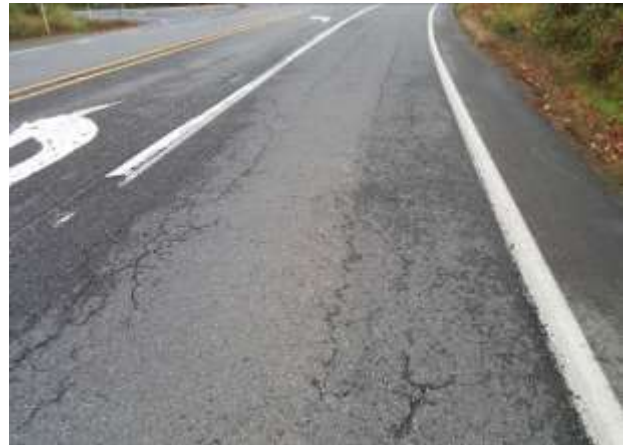
Figure 41. Open-texture, raveling, alligator and longitudinal cracking at MP 14.6. (93117)

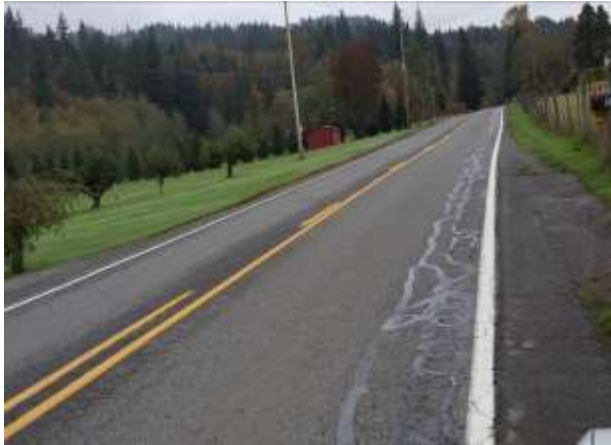
Figure 42. Sealed cracks at MP 17.1. (93723)

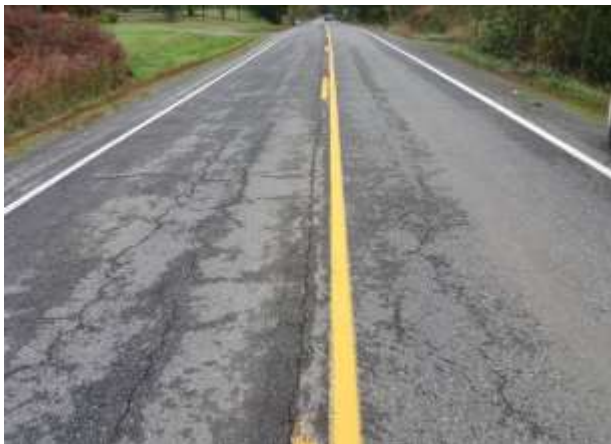
Figure 44. Alligator and longitudinal cracking at MP 17.3. (94210)

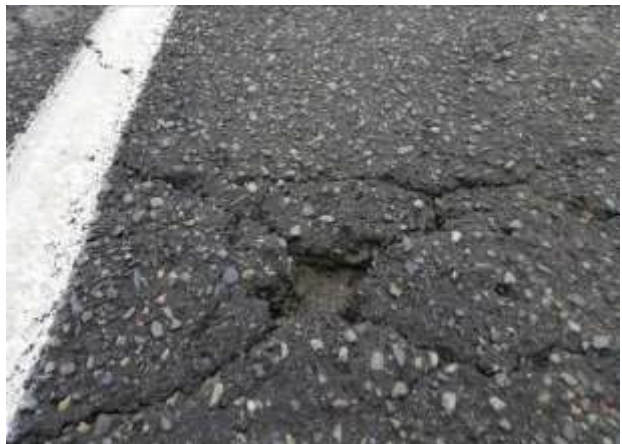
Figure 45. Alligator cracking, raveling and pothole at MP 17.3. Note erosion of the binder surrounding the aggregate. (94527)

- The poor performance of the pavement produced by the HIPR process was due to insufficient asphalt binder in the mix that resulted in premature aging, raveling, cracking and pot holing.
- The HIPR process may have been a contributing factor due to the aging of the binder of the existing pavement, but was not the primary cause of the pavement's poor performance.

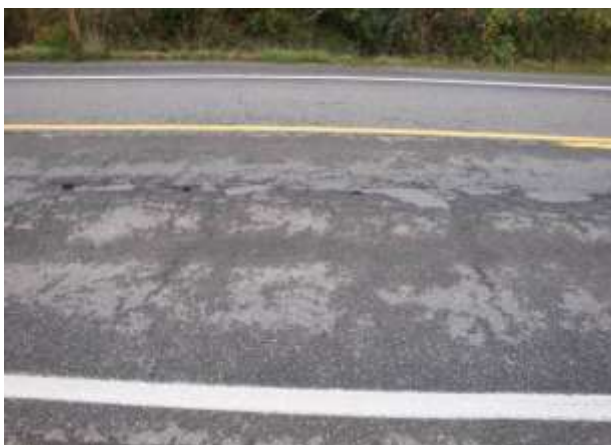
Figure 46. Alligator and transverse cracking and potholes at MP 17.3. (00562)

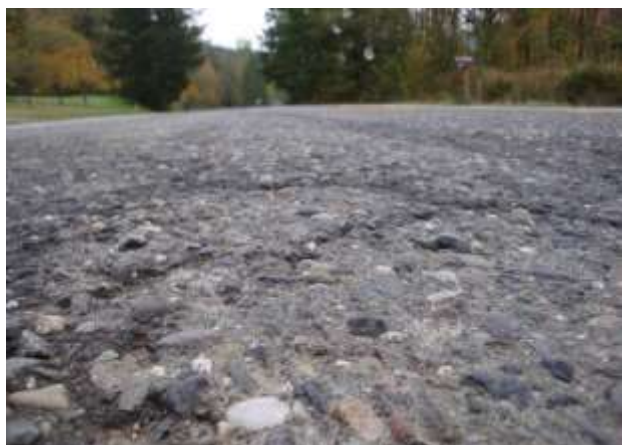
Figure 47. Close-up of raveled surface of pavement at MP 17.3. (00559)

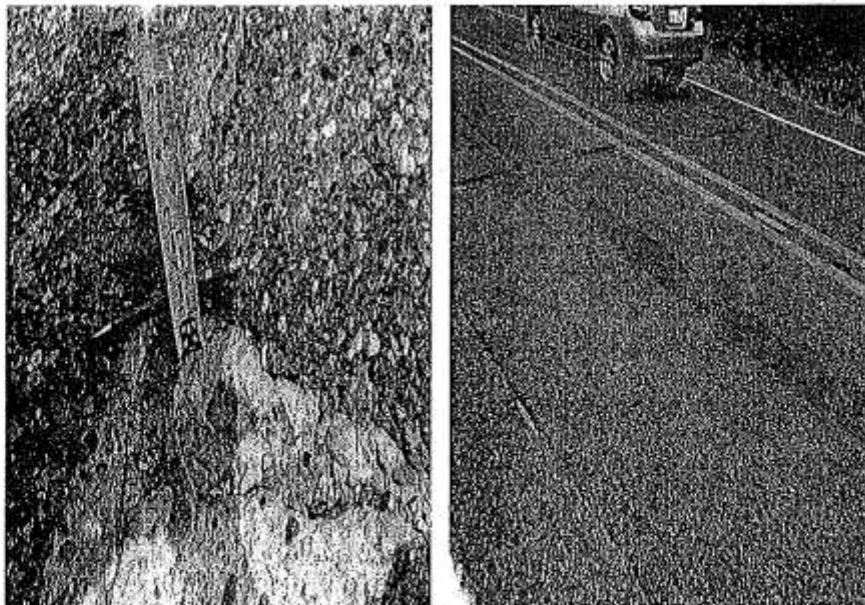
Photos 1 & 2 (~MP 3.10): ACP over the PCCP slabs has low to medium severity longitudinal and transverse cracking. The HMA layer thickness was measured ~.08'.

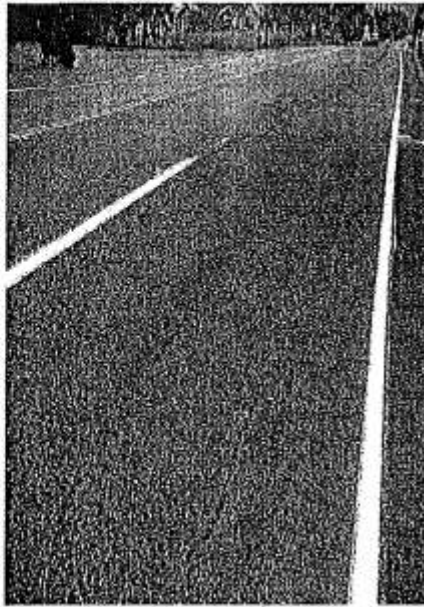
**Photo 3** (~MP 4.8): Low to medium severity transverse & longitudinal reflective cracking.

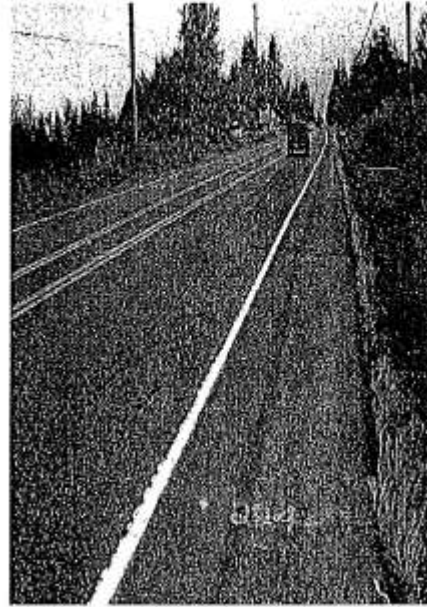
**Photo 4** (~MP 7.05): Medium to high severity transverse and longitudinal cracking

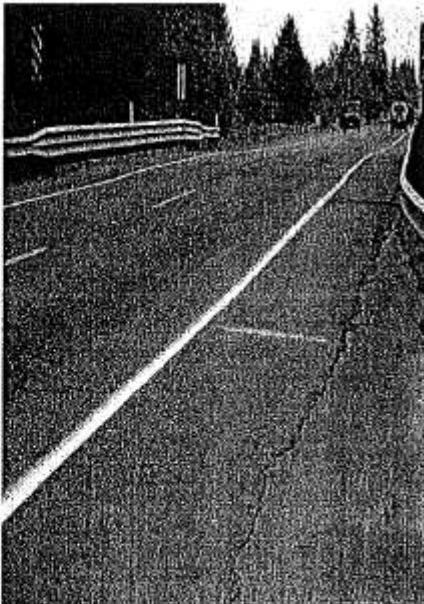
**Photo 5** (~MP 11.29): Maintenance patching of HMA over the bridge deck # 542/016.

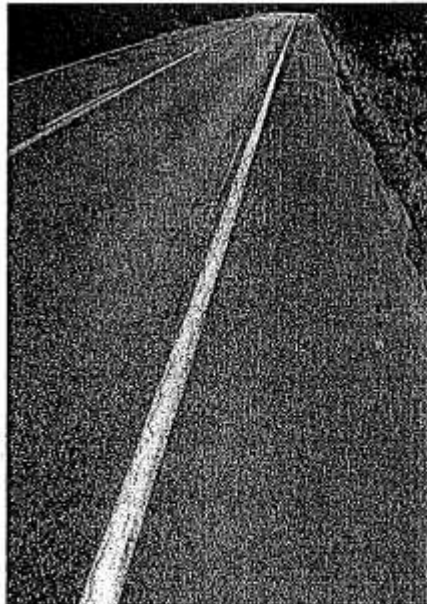
**Photo 6** (~MP 14.27): Medium to high severity alligator cracking along the fog line and shoulder on WB lane.

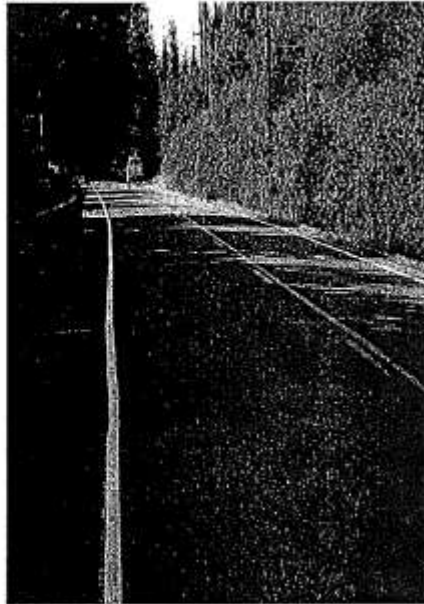
**Photo 7 (~MP 16.65):** Medium severity transverse and longitudinal cracking that was patched with HMA by maintenance crews.

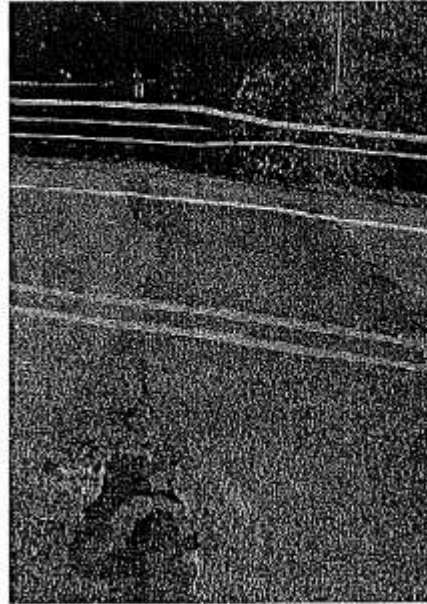
**Photo 8 (~MP 17.65):** High severity alligator cracking and settlement that was patched with HMA by maintenance at both ends of the bridge #542/21.

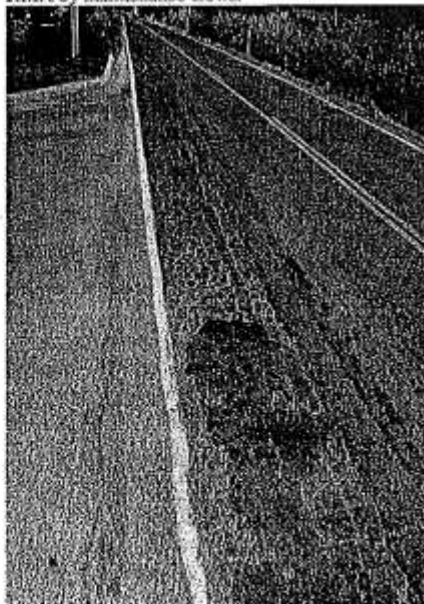
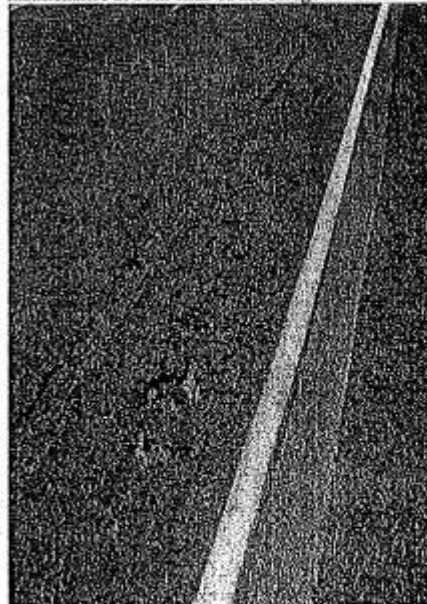
**Photos 9 & 10 (SR 9 at ~ MP 84.06):** Medium to high severity alligator cracking occurring in the wheel path between the edge of the PCCP panels and HMA pavement.
