# Use of a Double Chip Seal to Correct a Flushing Hot Mix Asphalt Pavement in Washington State – Final Report

WA-RD 760.2

September 2016

Contract 7915  
SR 20  
Eastern Region Chip Seal 2010  
MP 363.61 to MP 372.84

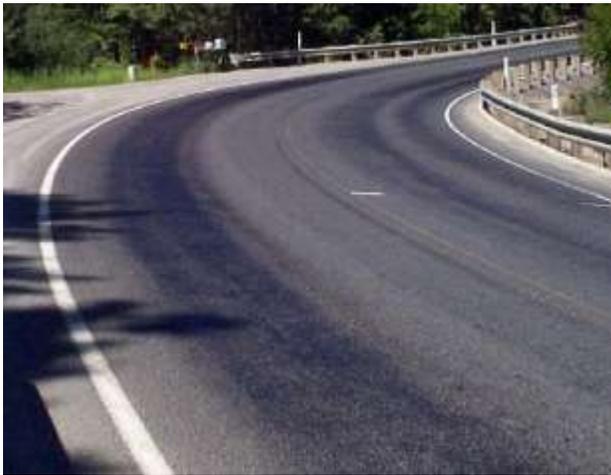
Figure 1. Flushing HMA on SR 20 soon after placement.

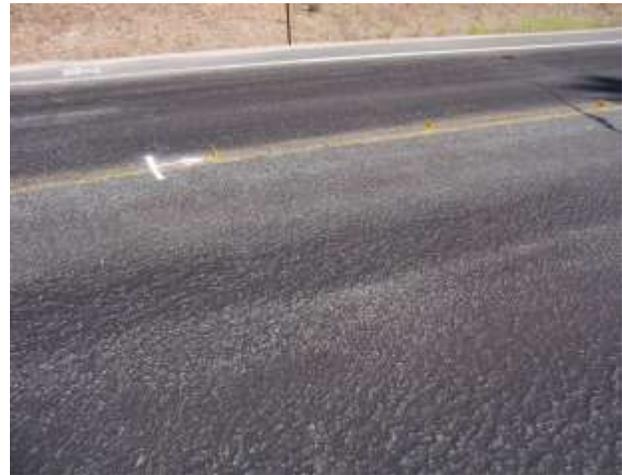
Figure 2. Condition of flushing pavement before placement of the double chip seal.

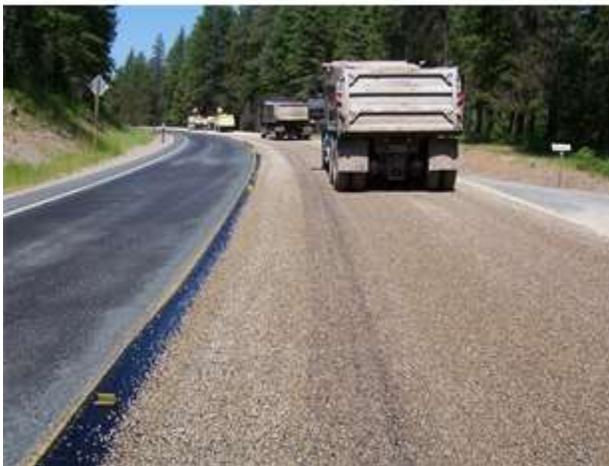
Checking embedment after the first applications of aggregate gave an indication of the affect the flushing pavement would have on the chip seal (Table 1). Binder application rates should be adjusted so that embedment is between 50 and 70 percent (Jackson, Jackson and Mahoney). Higher embedment rates indicate too much binder and could result in flushing. As expected, the embedment measurements for the first application were higher than they would be if the existing pavement surface was not flushing. There were also some indications of bleeding during construction especially in the sections with higher binder application rates (Figures 4-5).

Figure 4. Chip seal placement on Test Section 1 (on right) with 0.27 gal/ yd<sup>2</sup> showing slight flushing in the wheel path after the first application.

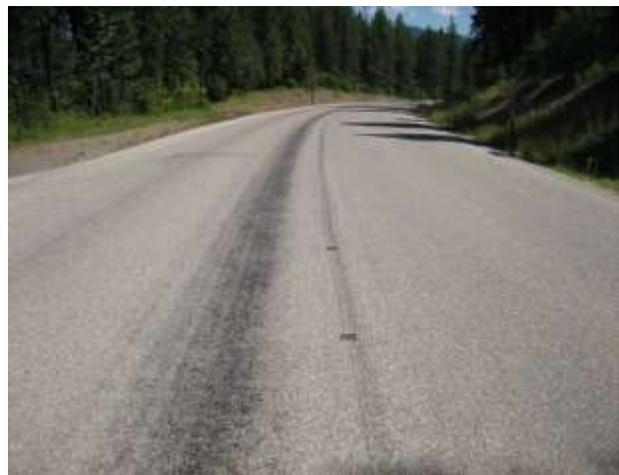
Figure 5. Test Section 1 (on left) with 0.27 gal/ yd<sup>2</sup> shows flushing in the wheel path after construction while no flushing was present in Test Section 3 (on right) at 0.20 gal/ yd<sup>2</sup>.

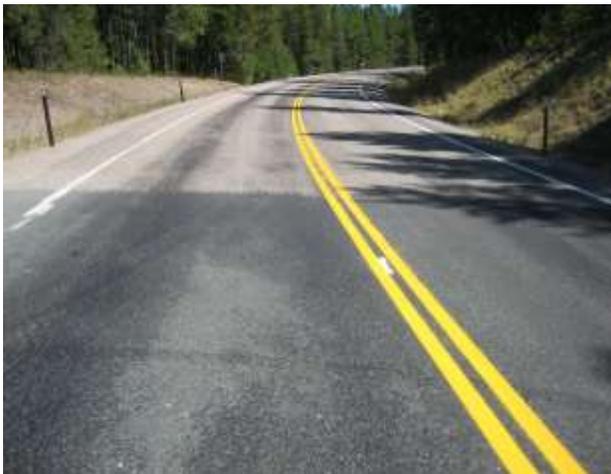
Monitoring the test sections for two years after construction revealed wheel path flushing had occurred in many locations. Test Sections 1 and 2, which had higher binder application rates during the first application than Test Sections 3 and 4, appeared to have the more severe flushing (Figures 6 through 9). Despite the overall lower flushing severity, Test Sections 3 and 4 still had many severely flushed areas presumably where the flushing of the underlying pavement was more severe. By 2009 the embedment was 100 percent in the flushed areas of lanes 1 and 2 (Figure 8) but was reported to be in the 70 percent range in Test Sections 3 and 4 which had the lower binder application rates for the first application (Stephen Van De Bogert email, 2009). The test sections showed that the lower application rates for the first application of CRS-2P seal reduced the flushing and could produce an acceptable pavement. The test sections also showed that the application rates for the first application of CRS-2P would need to be varied depending on the flushing present on the existing surface.

Figure 6. West end of Test Section 1 (on left) with 0.27 gal/ yd<sup>2</sup> and Test Section 3 (on right) with 0.20 gal/ yd<sup>2</sup> for the first application one year after placement.

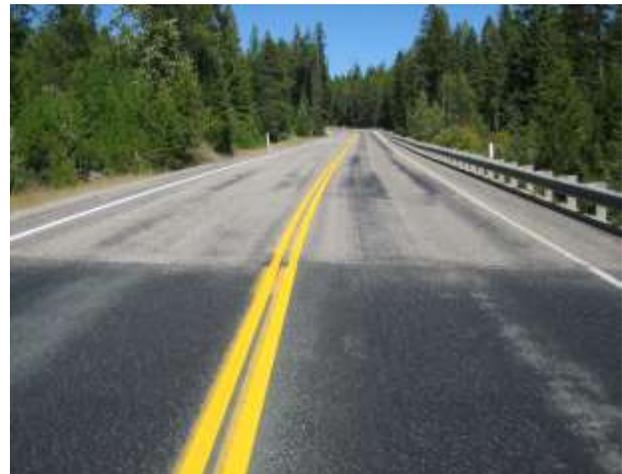
Figure 7. East end of Test Section 4 (on the left) with 0.20 gal/ yd<sup>2</sup> and Test Section 2 (on the right) with 0.28 gal/ yd<sup>2</sup> for the first application.

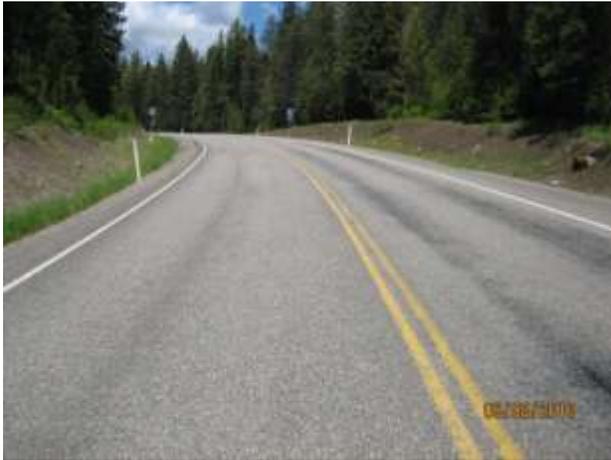
Figure 8. Test Section 4 (on left) with 0.20 gal/ yd<sup>2</sup> shows minimal flushing while Test Section 2 (on right) with 0.28 gal/ yd<sup>2</sup> shows flushing in wheel paths two years after construction.

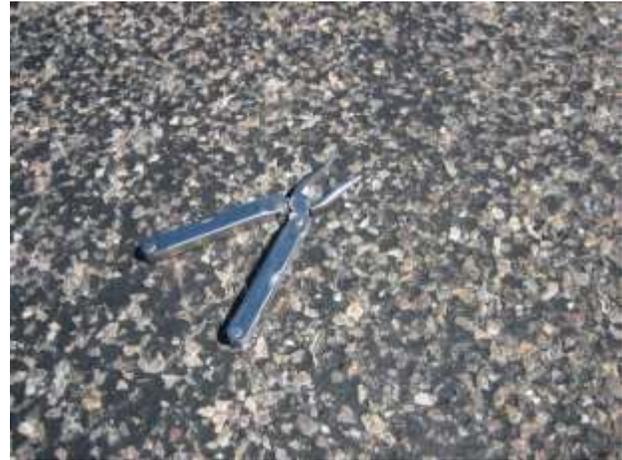
Figure 9. Typical 100% embedment area in Test Sections 1 and 2, one year after construction.

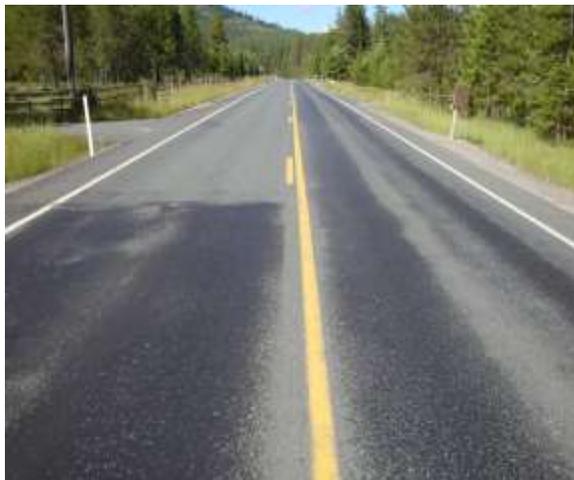
Figure 10. Upper left – Rating 1 (No Flushing), Bottom left – Rating 4 (Entire lane flushing) and Right – Rating 3 (Consistent wheel path flushing).

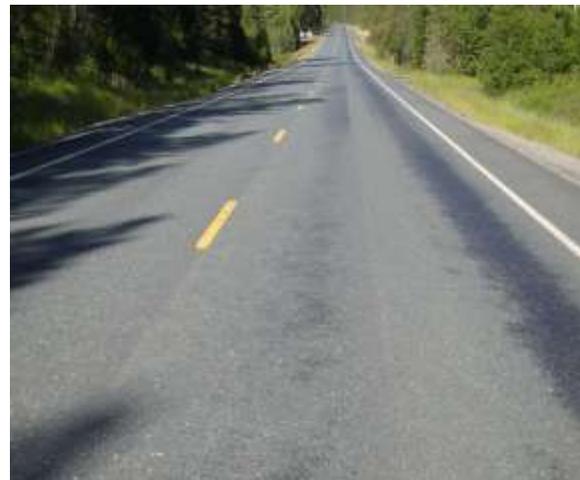
Figure 11. Left – Rating 1 (No flushing) and Right – Rating 2 (Intermittent flushing in wheel path).

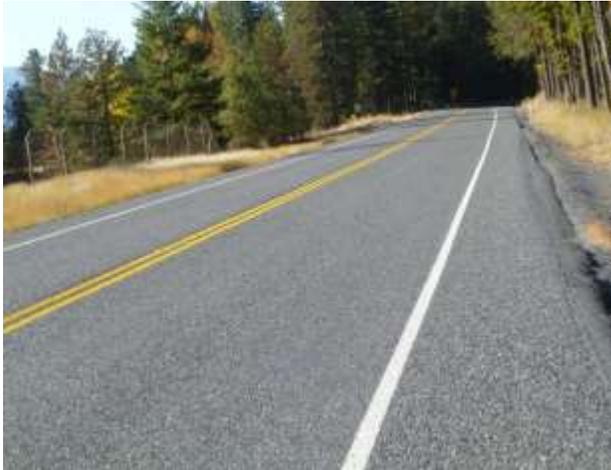
After three months in service the double chip seal appeared to be performing well with only a few areas in the wheel paths where the embedment appeared to be near 100 percent (Figures 12 and 13).

Figure 12. Appearance of the double chip seal three months after construction.

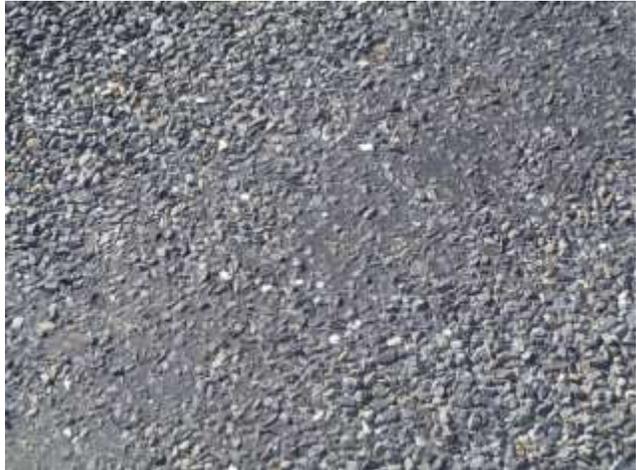
Figure 13. Area with embedment near 100 percent three months after construction.

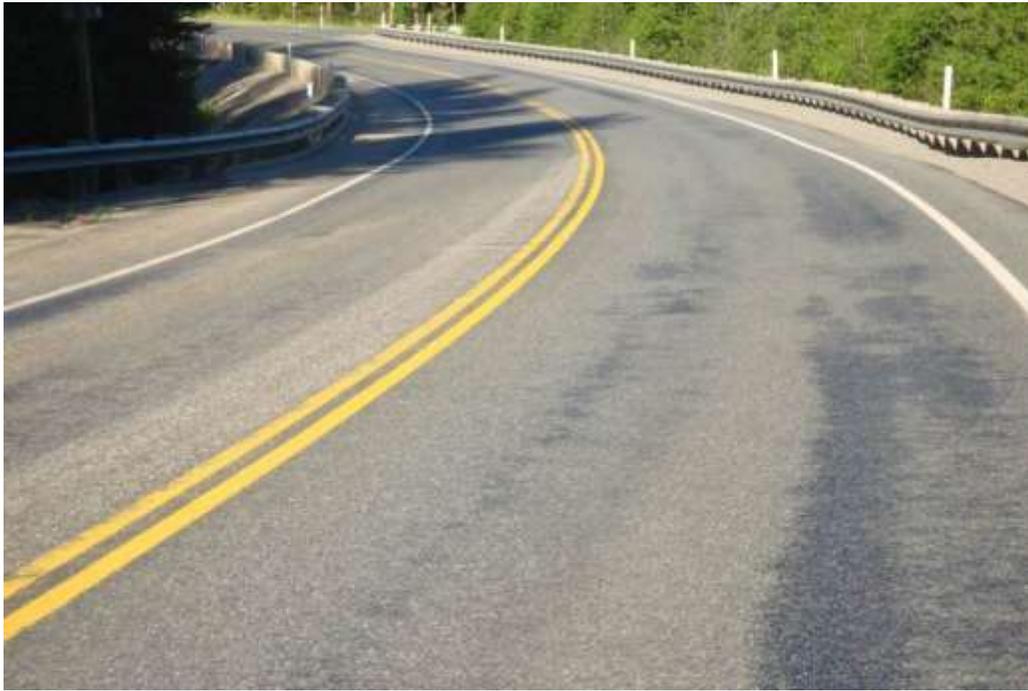
Figure 24. MP 372.5 vicinity, pre-construction rating 2 on the left EB lane, 1 on the right lane. The June 2015 ratings were 3 on the left, 2 on the right.

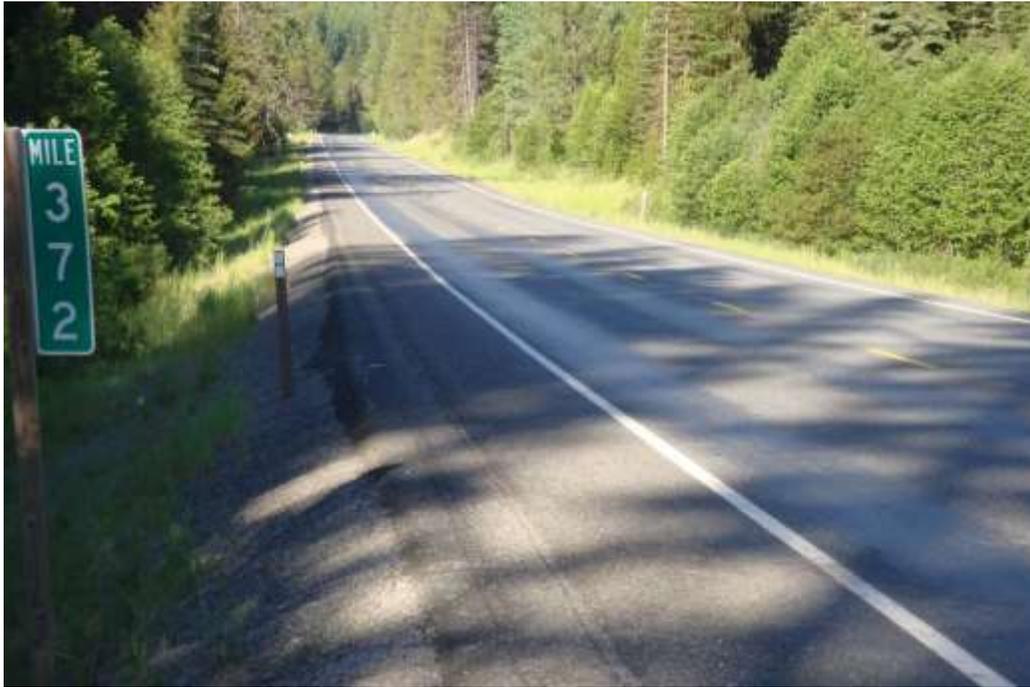
Figure 25. MP 372.0 pre-construction rating 2 on the left EB lane. June 2015 rating was 3 on the left lane.

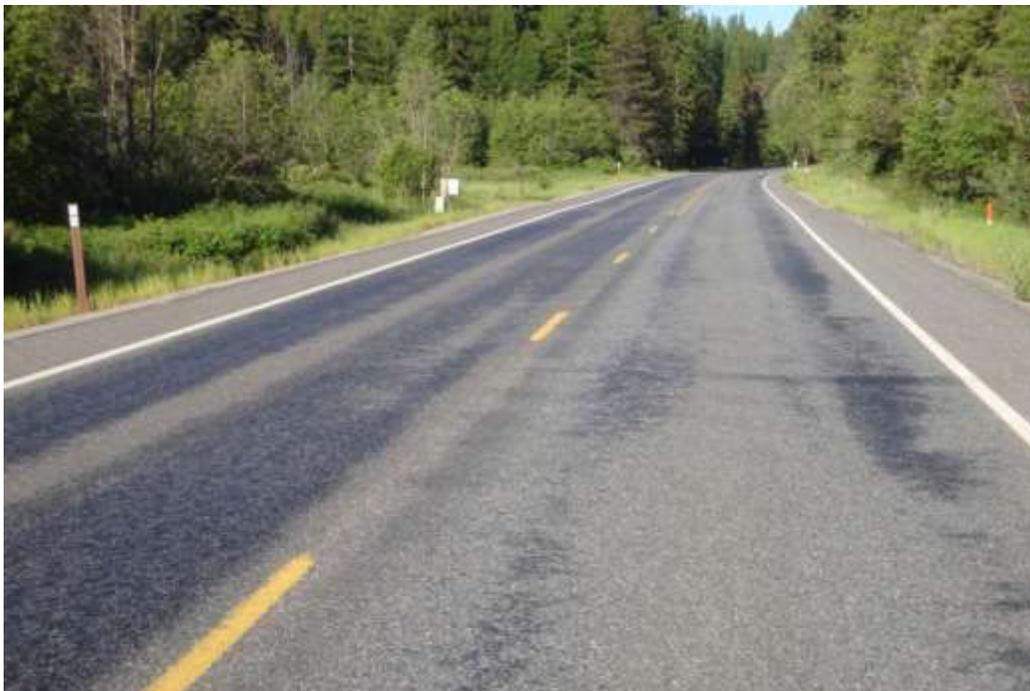
Figure 26. MP 371.5 pre-construction rating 2 on the left EB lane, 1 on the right WB lane. June 2015 ratings were 4 on the left lane, 2 on the right lane.

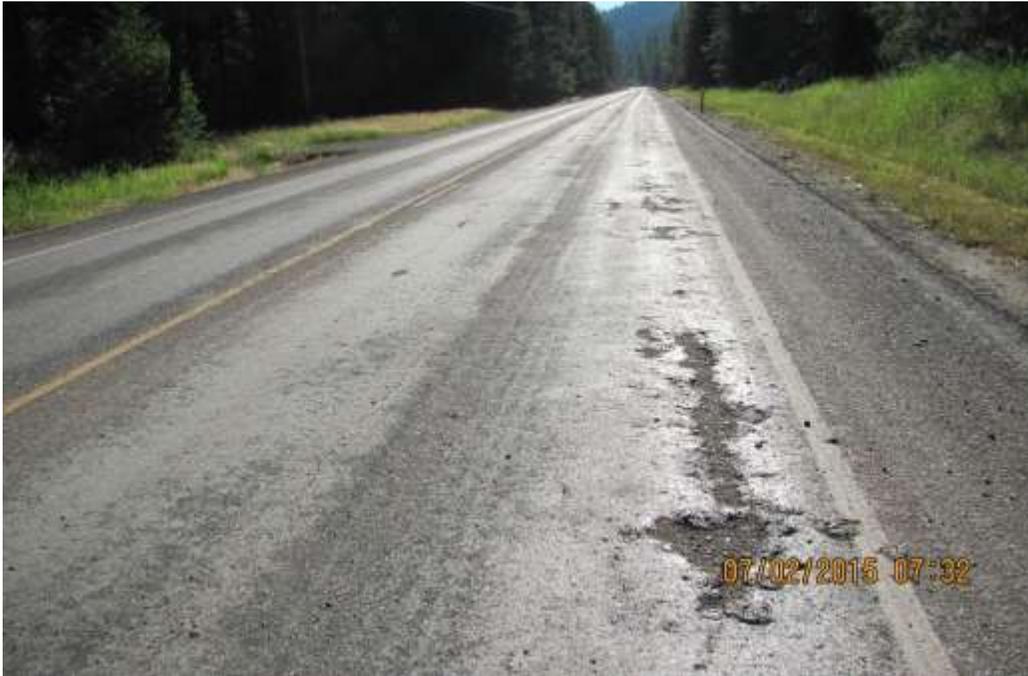
Figure 27. MP 371.25 pre-construction rating 2 on the left EB lane, 3 on the right WB lane. June 2015 ratings were 4 on both lanes. Severe raveling in the right lane.

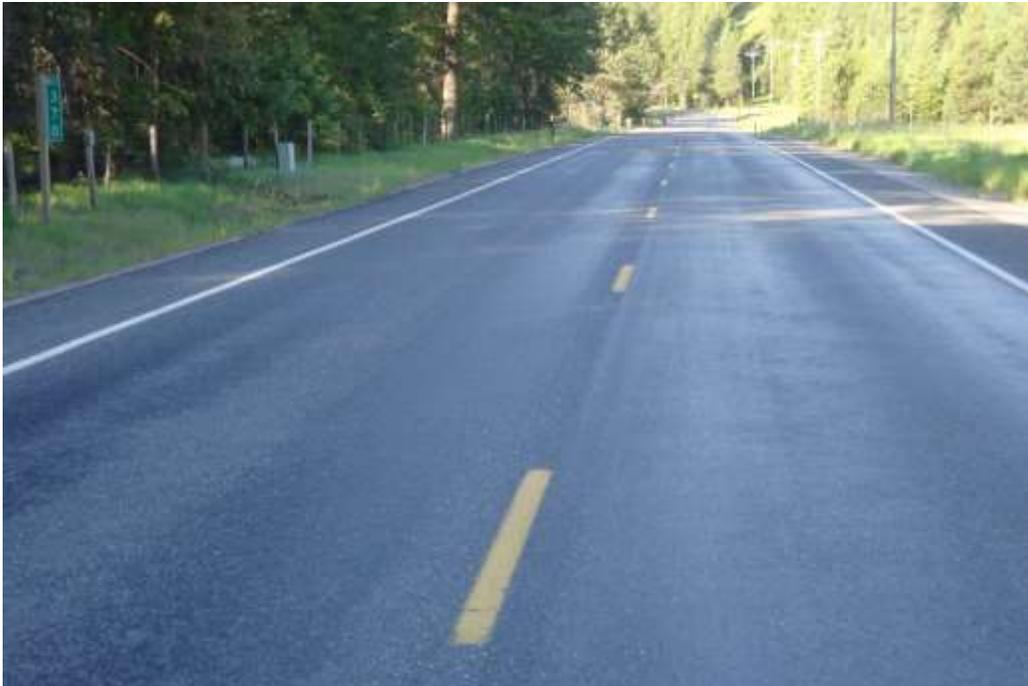
Figure 28. MP 370.0 pre-construction rating 3 on the left EB lane, 4 on the right WB lane. June 2015 ratings were 4 on both lanes.

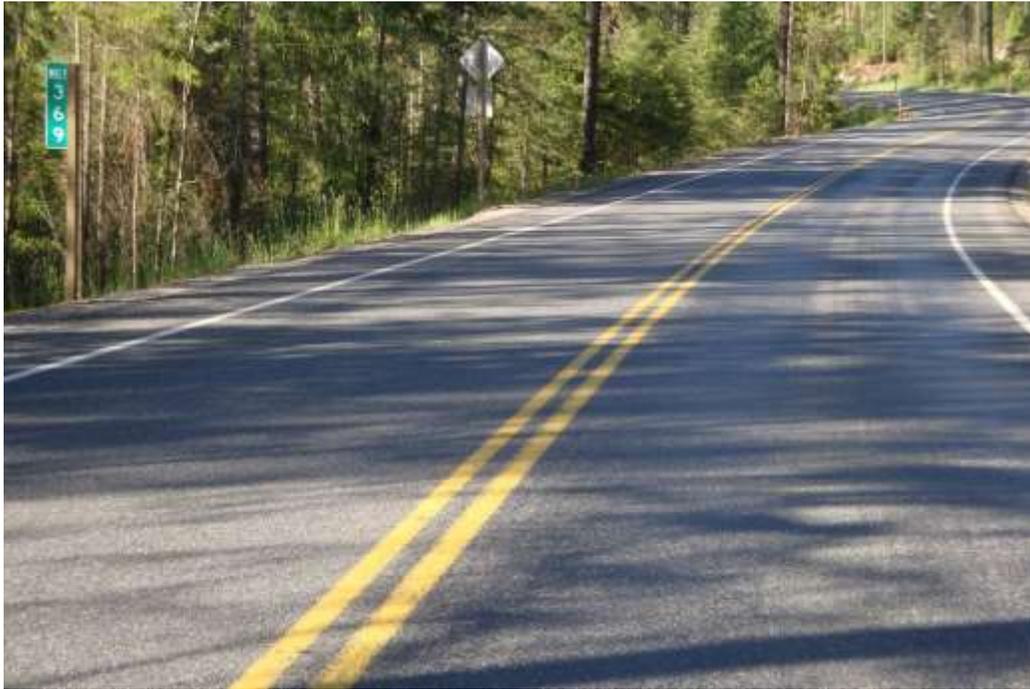
Figure 29. MP 369.0 pre-construction rating 4 on the right WB lane. June 2015 rating was 4 on the right lane. Left lane cannot be seen well enough to rate.

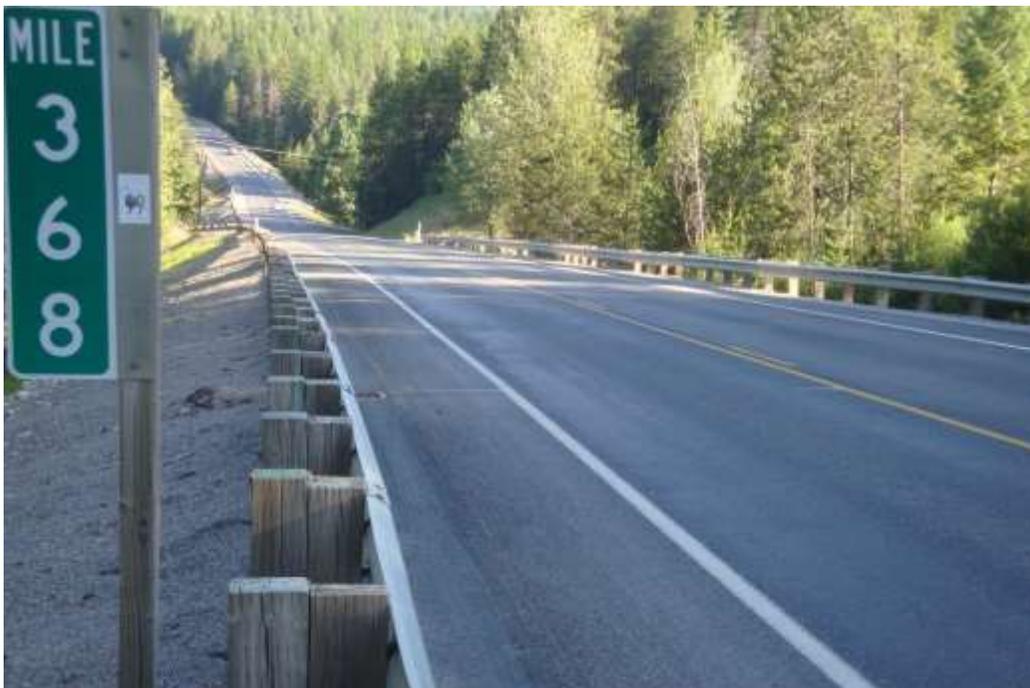
Figure 30. MP 368.0 pre-construction rating 3 on the left EB lane, 4 on the right WB lane. June 2015 rating was 4 on both lanes.

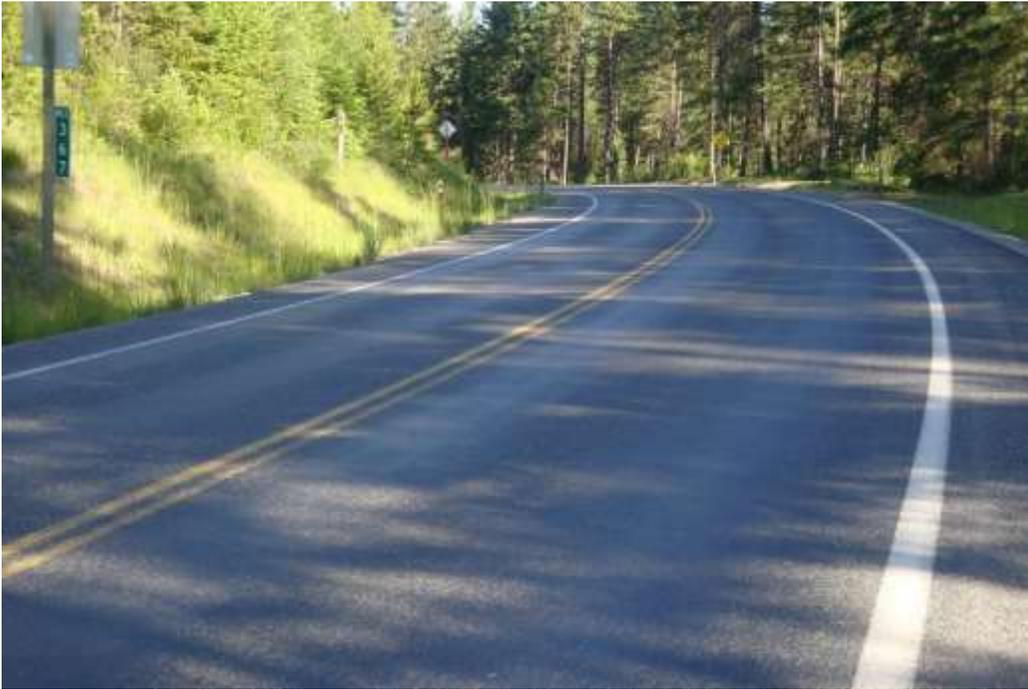
Figure 31. MP 367.0, pre-construction rating 1 on the left EB lane, 2 on the right WB lane. June 2015 rating was 4 on both lanes.

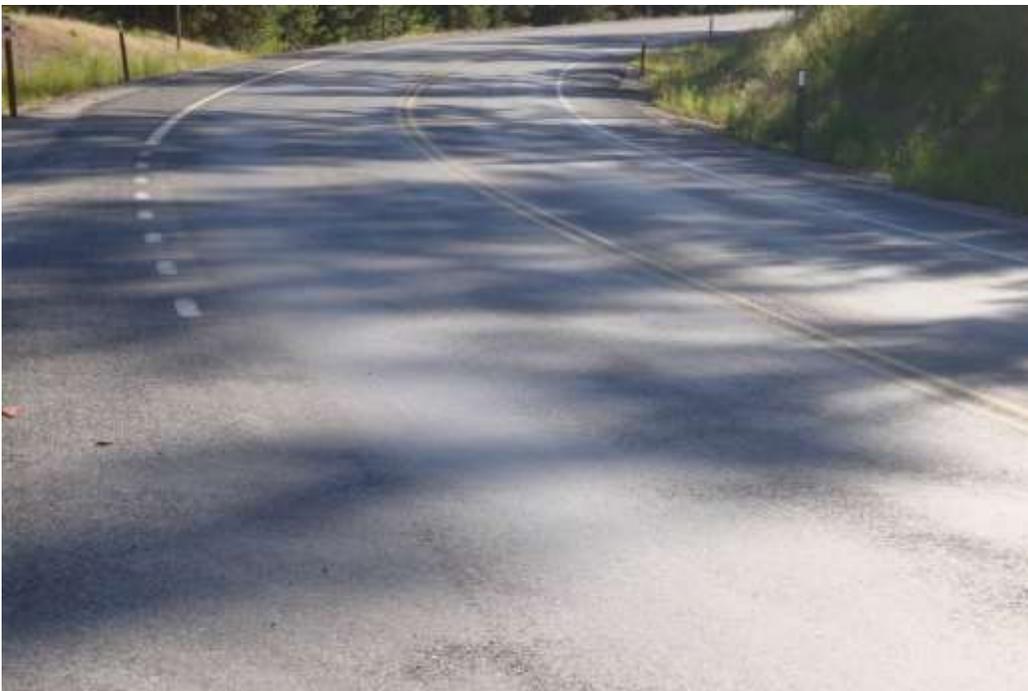
Figure 32. MP 366.7, pre-construction rating 1 on the left EB lane, 2 on the right WB lane. June 2015 rating was 4 on both lanes.

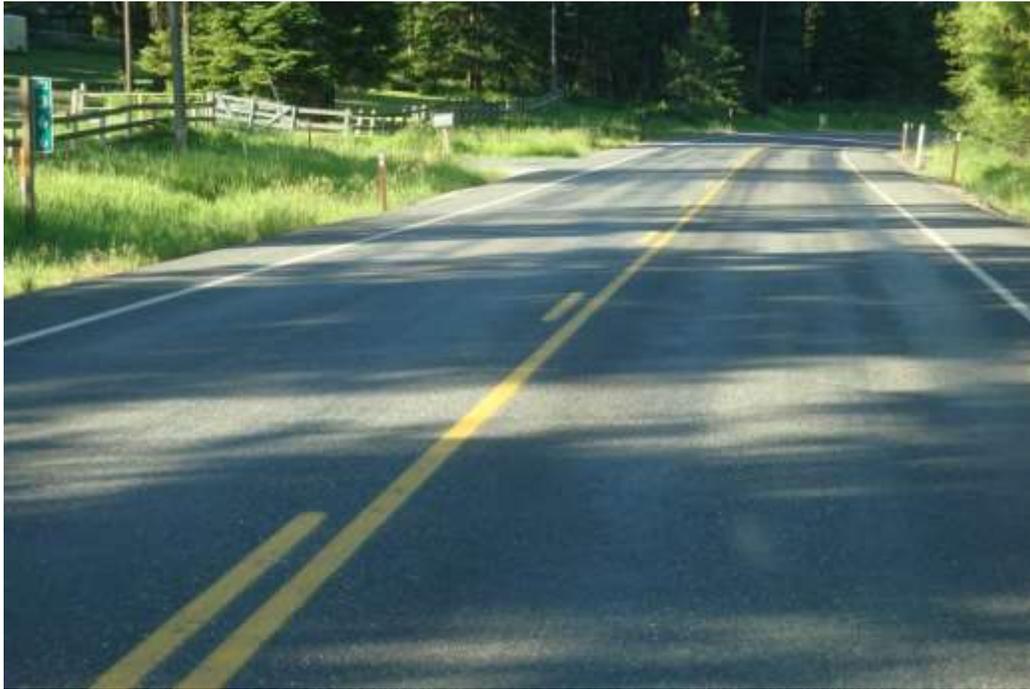
Figure 33. MP 366.0, pre-construction rating 4 on both left EB and right WB lanes pre-construction. June 2015 rating was 4 on both lanes.

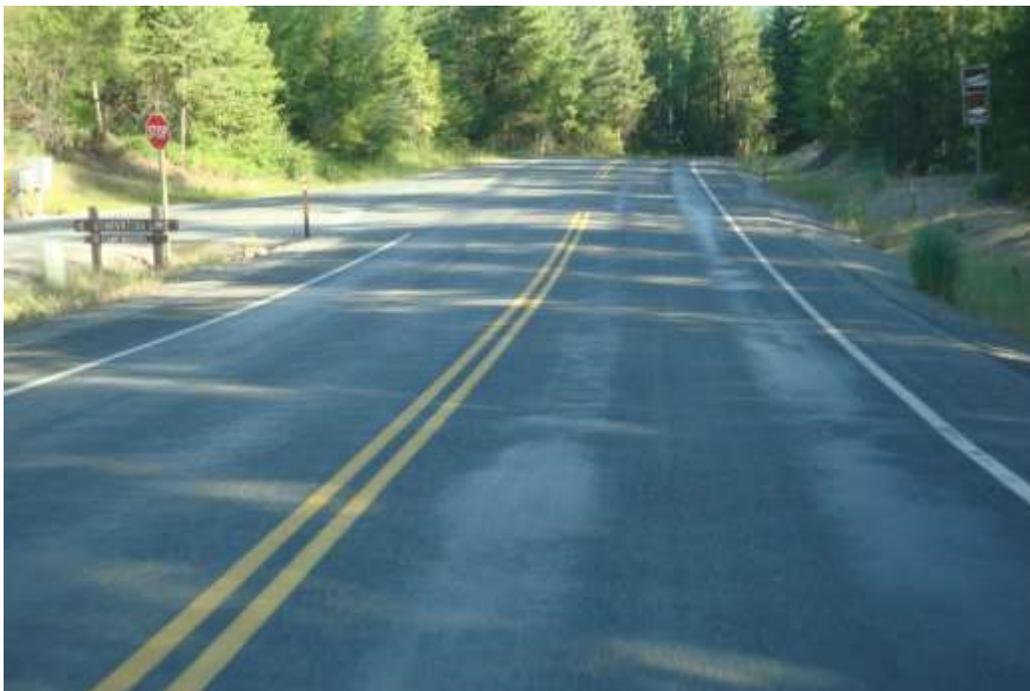
Figure 34. MP 364.9, pre-construction rating 3 on both left EB and right WB lanes. June 2015 rating was 3 on both lanes.

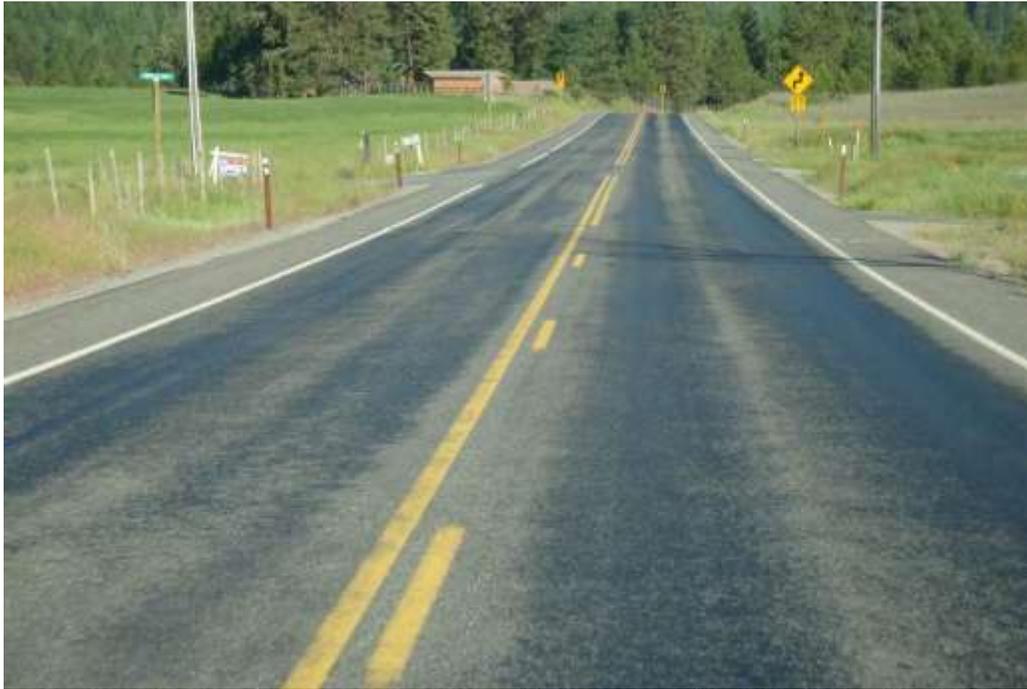
Figure 35. MP 364.3, pre-construction rating 3 on both left EB and right WB lanes. June 2015 rating was 4 on both lanes.

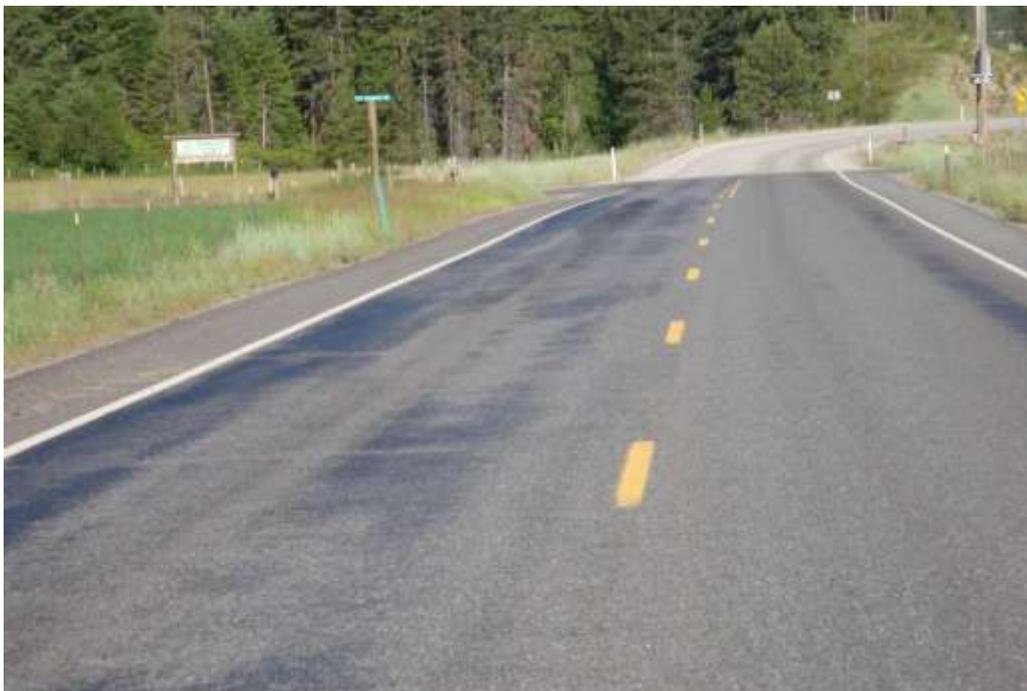
Figure 36. MP 363.6, pre-construction rating 3 on the left EB lane, 1 on the right WB lane. June 2015 rating was 3 on the left lane 2 on the right lane.
