Evaluation of Tyregrip® High-Friction Surfacing

WA-RD 788.1

Post-Construction Report
Experimental Feature 10-02

SR-14
SE 164th Ave Interchange
MP 7.93
014 S2 00794 Ramp
SE 164th Ave Southbound to SR 14 Westbound

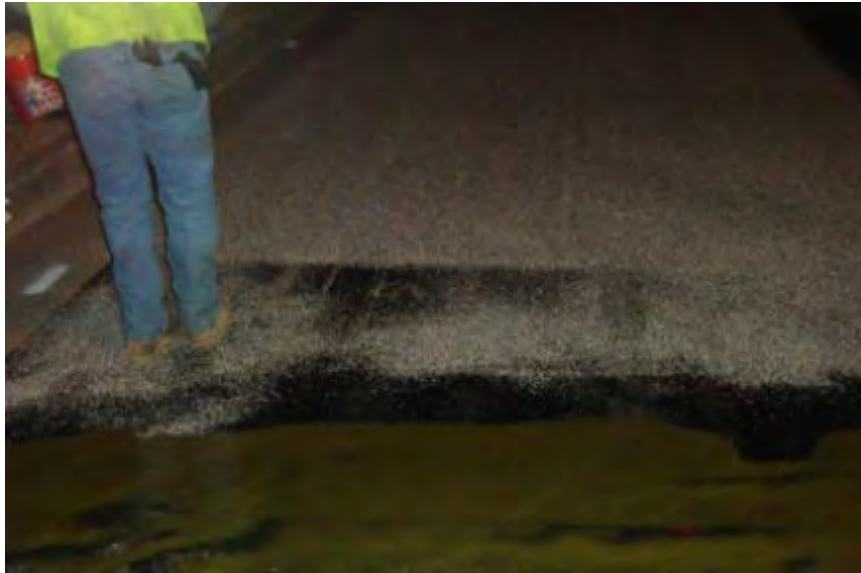
Figure 8. Hand placement of aggregate at beginning of project.

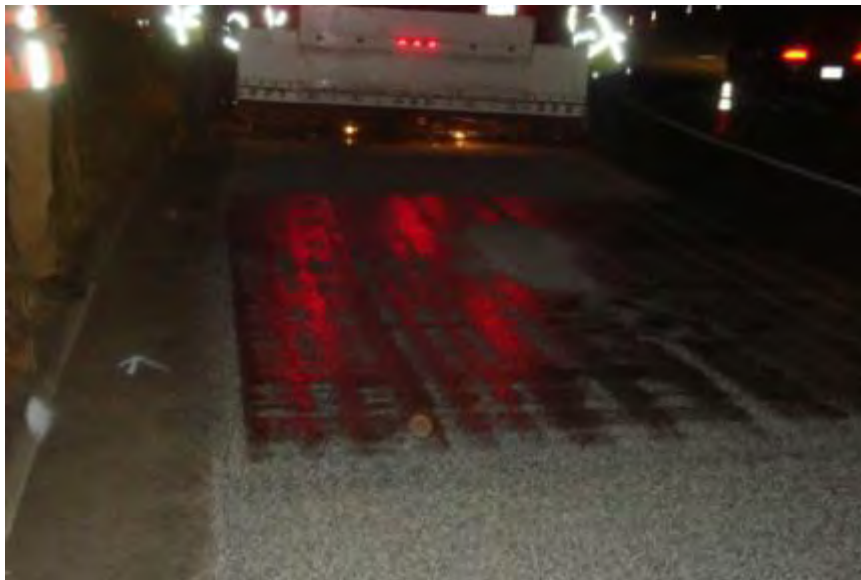
Distribution of the aggregate was slightly uneven at the start of the placement because the left side of the spreader box didn't distribute sufficient aggregate to the left side of the lane. This was addressed by hand placing aggregate onto the epoxy binder. As the paving continued, distribution was rather consistent until there was a problem with the spreader that prevented placement of sufficient aggregate. As a result a rather large area didn't receive enough aggregate material. Again, hand placement was needed and at this location the aggregate was not as uniformly placed across the pavement surface. There were two other locations that required hand placement of the aggregate. Once all the equipment was operating correctly, placement of the aggregate on top of the epoxy binder was uniform. Figures 7 to 10 show the non-uniformity of the aggregate placement at various locations and Figure 11 an area with uniform aggregate placement. The plan was to place two lifts of material on the first night; however, due to problems with the equipment, the second lift was applied the following night.

Figure 9. Location where aggregate spreader limited placement of material.

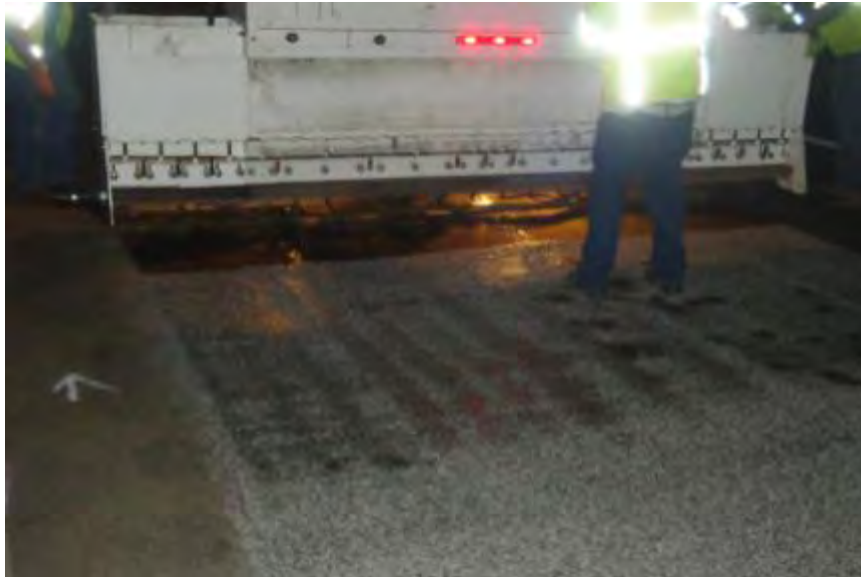
Figure 10. Streaking surface caused by inconsistency of the aggregate spreader.

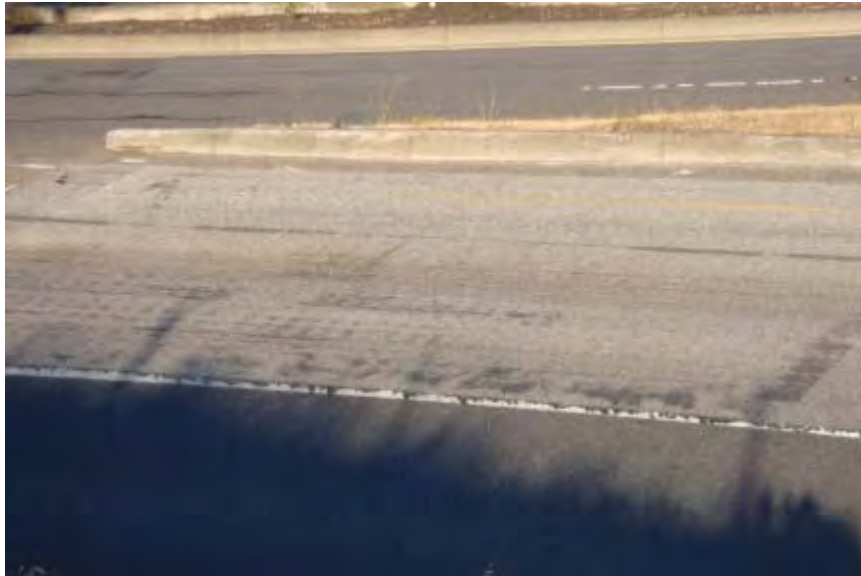
The second lift of the first application was placed on September 1, 2010. Figures 12 and 13 illustrate the condition of the surface prior to the second application of the Tyregrip®. The biggest problem with the first life was the lack of aggregate coverage mainly at the startup

Figure 12. Startup location after first night placement.

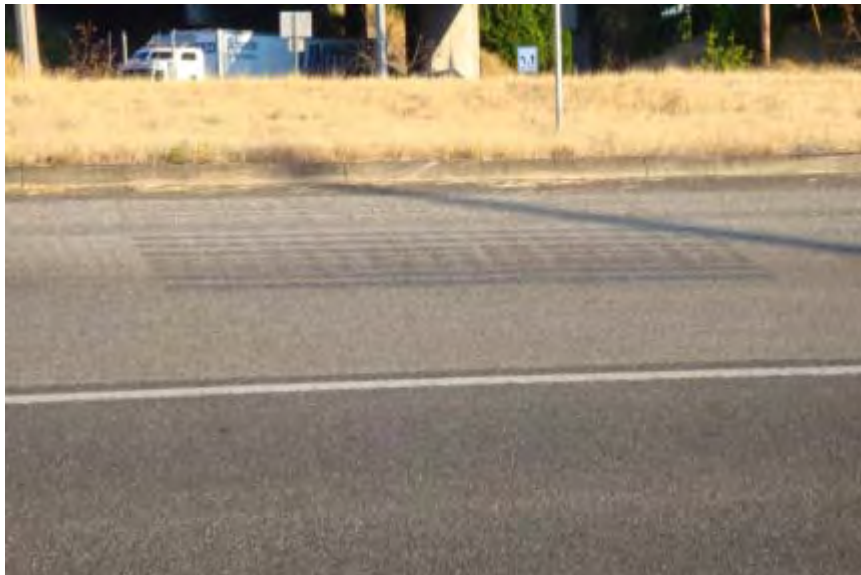
location. The remaining areas of insufficient aggregate cover resulted in only slight surface irregularities as shown in Figure 13.

Figure 13. Streaking in aggregate coverage.
