# Evaluation of Tyregrip® High-Friction Surfacing -- Final Report

WA-RD 788.2

Experimental Feature 10-02

014 S2 00794 Ramp

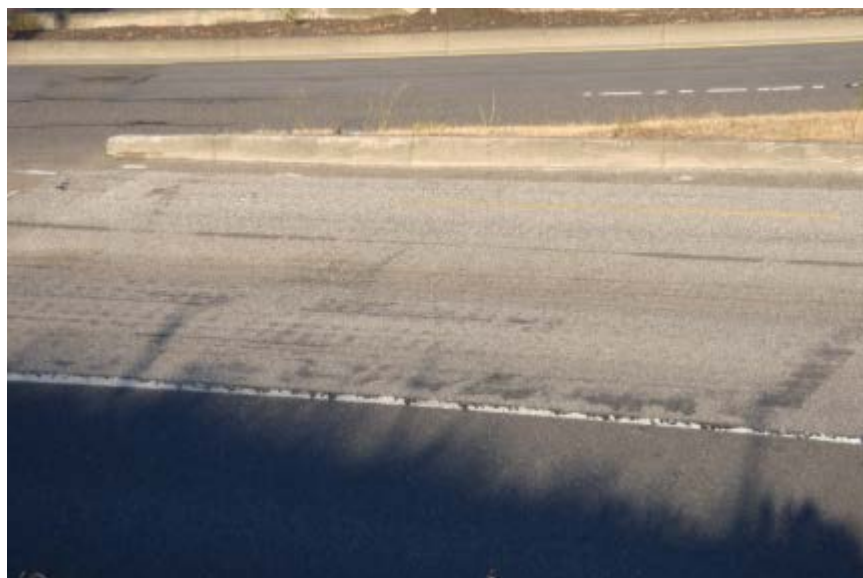
The second lift of the first application was placed on September 1, 2010. Figures 12 and 13 illustrate the condition of the surface prior to the second application of the Tyregrip®. The biggest problem with the first lift was the lack of aggregate coverage mainly at the beginning of the project. The remaining areas of insufficient aggregate cover resulted in only slight surface irregularities as shown in Figure 13.

Figure 12. Startup location after first night placement.

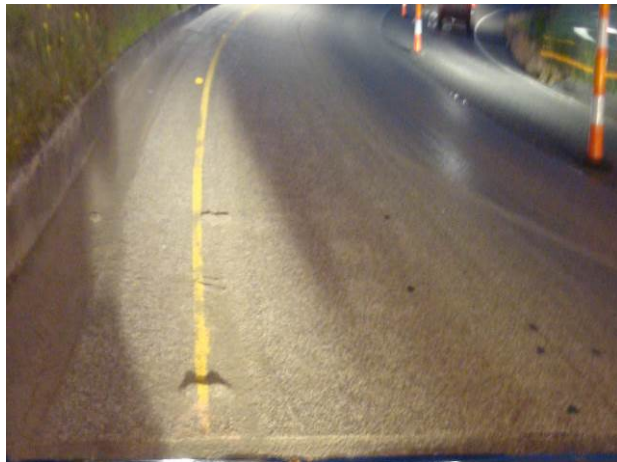
Figure 25. Excess aggregate on overlay.

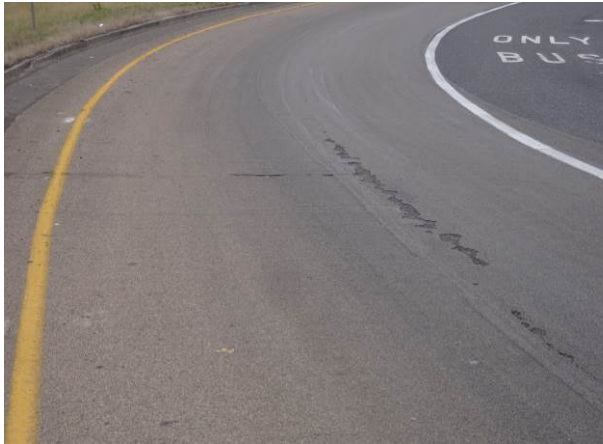
Photographs were acquired immediately after installation, 2 years and five years after installation as shown in the following sets of figures. The photos show that cracking and delamination of the Tyregrip® overlay began in 2013, 2 years after installation, and increased significantly in severity and extent by the end of the five-year evaluation period.

Figure 27. Longitudinal joint delamination.

The problems with cracking and delamination of the Tyregrip® may have been caused in part by the poor condition of the underlying pavement. A FHWA brochure on high friction surface treatments (HFST) indicates that they can be installed on both asphalt and concrete surfaces. The pavement must be in good structural condition with no or few cracks that are correctable by remedial sealing (FHWA, 2016). AASHTO PP 79-14, Standard Practice for High-Friction Surface Treatment for Asphalt and Concrete Pavements, recommends that all cracks greater than 1/4 inch in width and depth be filled with the mixed resin binder to be used for the overlay (AASHTO, 2016).

The delamination problem may also have been caused by placing the overlay on a pavement that was contaminated by oils dripping from vehicles. The Contractor used a broom/sweeper to clean the pavement prior to the installation of Tyregrip® on this project. AASHTO recommends that surfaces that are contaminated with oils, greases, or other deleterious materials be washed with a mild detergent solution, rinsed with clean water, and dried prior to a general cleaning with mechanical sweepers and high pressure air. There is no proof one way or the other regarding contamination but merely mentioned as a possibility.

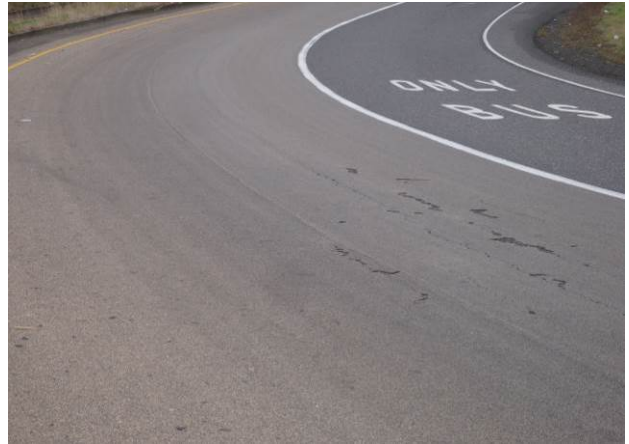
Figure 28. Random delamination.

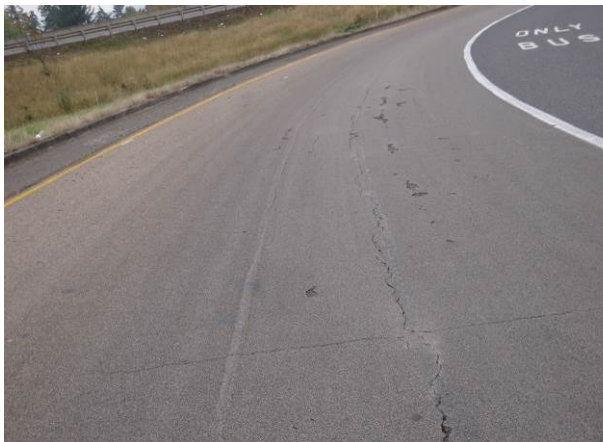
Figure 29. Longitudinal and transverse cracking and minor delamination.

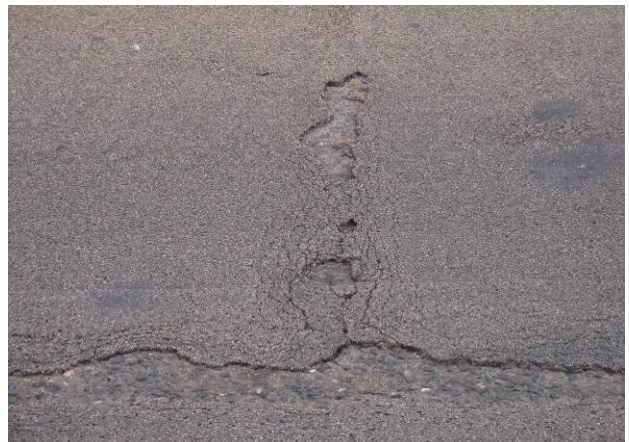
Figure 30. Transverse crack and delamination.

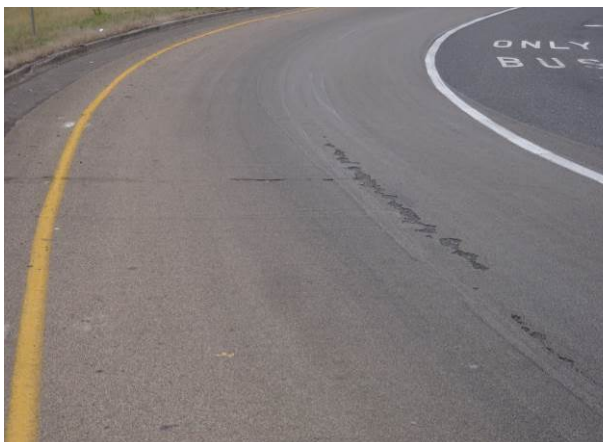
Figure 31. Wheel path delamination.

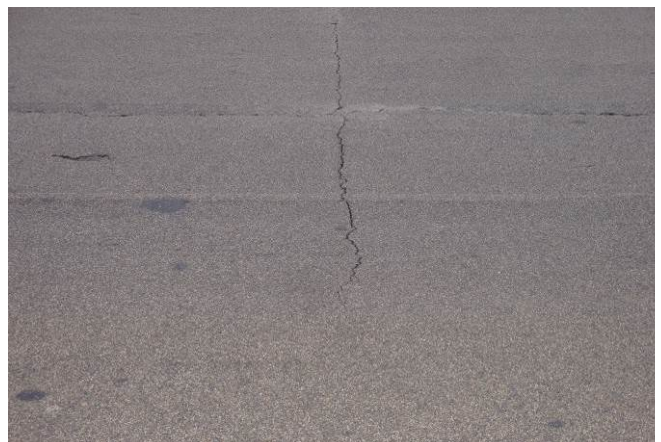
Figure 32. Transverse crack.

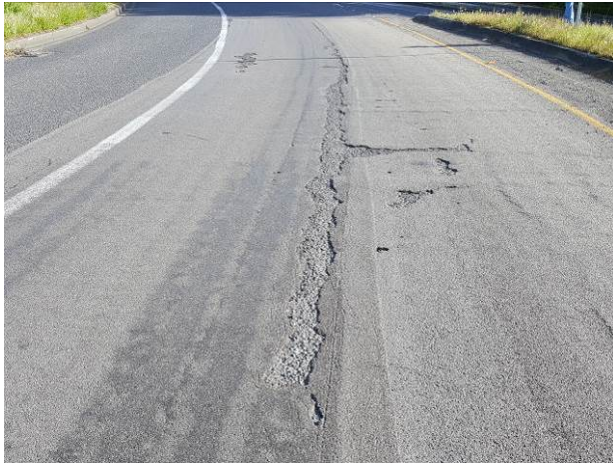
Figure 33. Wheel path delamination.

The cause of the cracking and delamination of the HFST has not been positively determined but the evidence points to a substrate failure caused either by the accumulation of moisture in the underlying HMA or high shear forces developing in the HMA from vehicle tires on the HFST's higher friction surface.

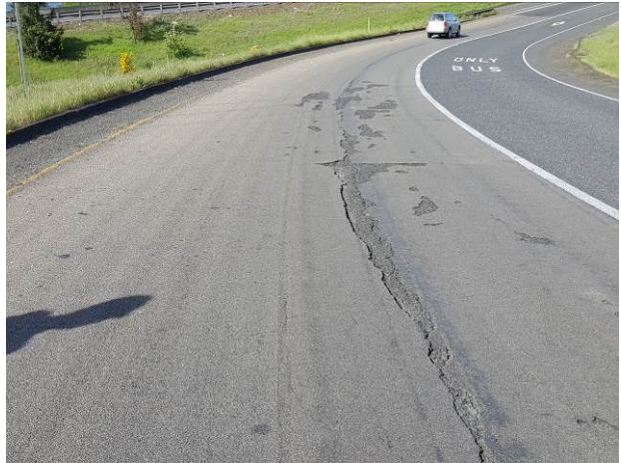
Figure 34. Wheel path delamination.

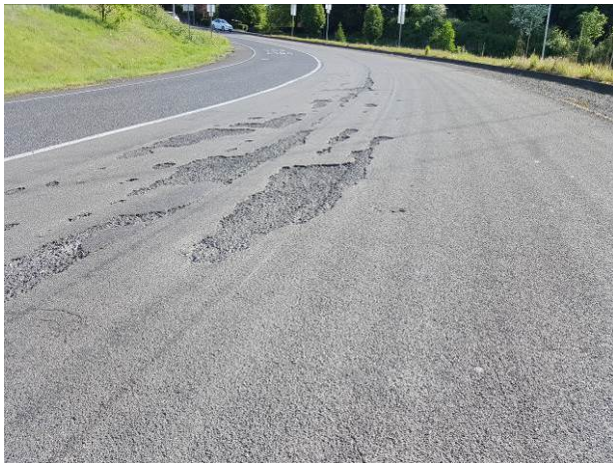
Figure 35. Delamination across lane.

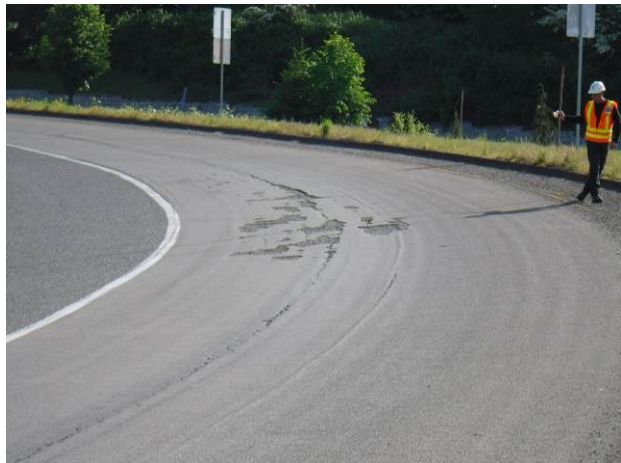
Figure 36. Delamination across lane.

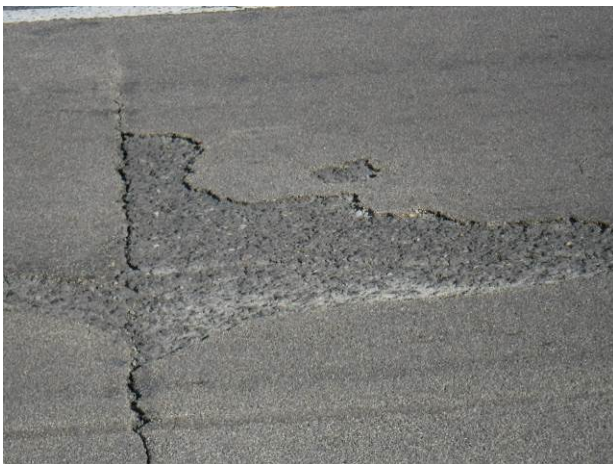
Figure 37. Delamination and transverse crack.

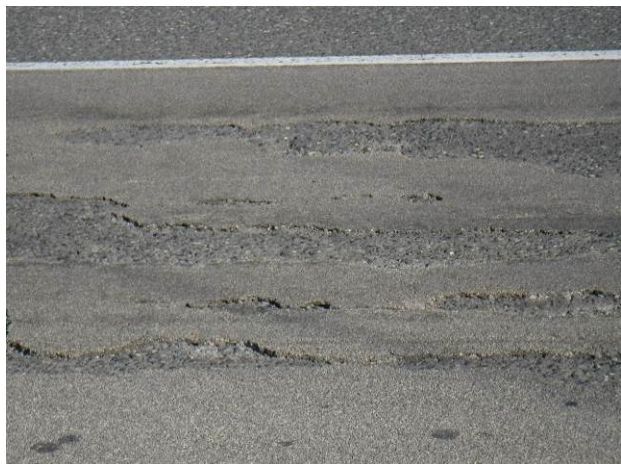
Figure 38. Delamination close-up.

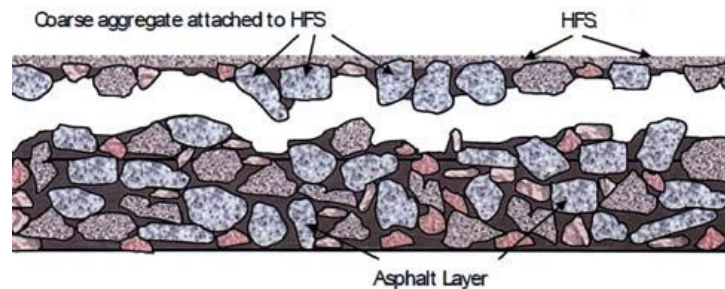
The final possibility is that the HFST caused a shallow substrate failure in the underlying HMA (Wilson and Mukhopadhyay, 2016)<sup>1</sup>. Wilson and Mukhopadhyay describe this type of failure can be in two modes: (1) top-down tearing, and (2) shallow horizontal tearing. Possible causes include; (1) HFST applied to an already weakened pavement, (2) the location has traffic that is stopping or making slow turns, (3) stress induced by temperature, and (4) a thick and stiff HFST application. Top-down tearing occurs when the HFST is applied to a weak pavement. The shear transfer from vehicles breaking and turning accelerates deterioration in the underlying

pavement resulting in shallow cracks. Shallow horizontal tearing (see Figure 39) can be caused by thermal incompatibility or stripping (moisture accumulation in the pavement)

Figure 39. Shallow tearing (Wilson and Mukhopadhyay, 2016).
