Preventive Maintenance Study - Final Report

WA-RD 871.2

Preventive Maintenance Study

Washington State – Statewide Locations

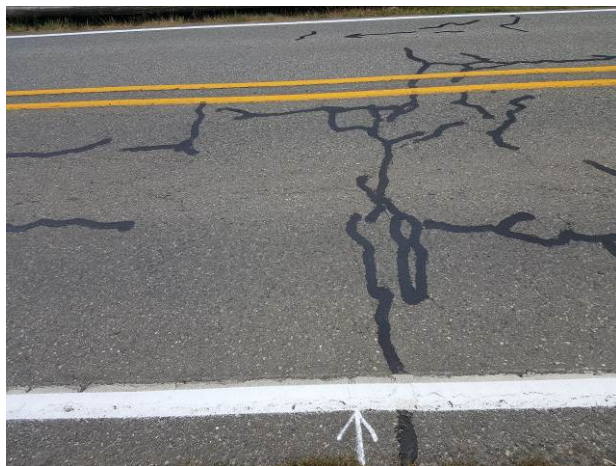
Figure 13. OR34, SR302, Good, age 15 months.

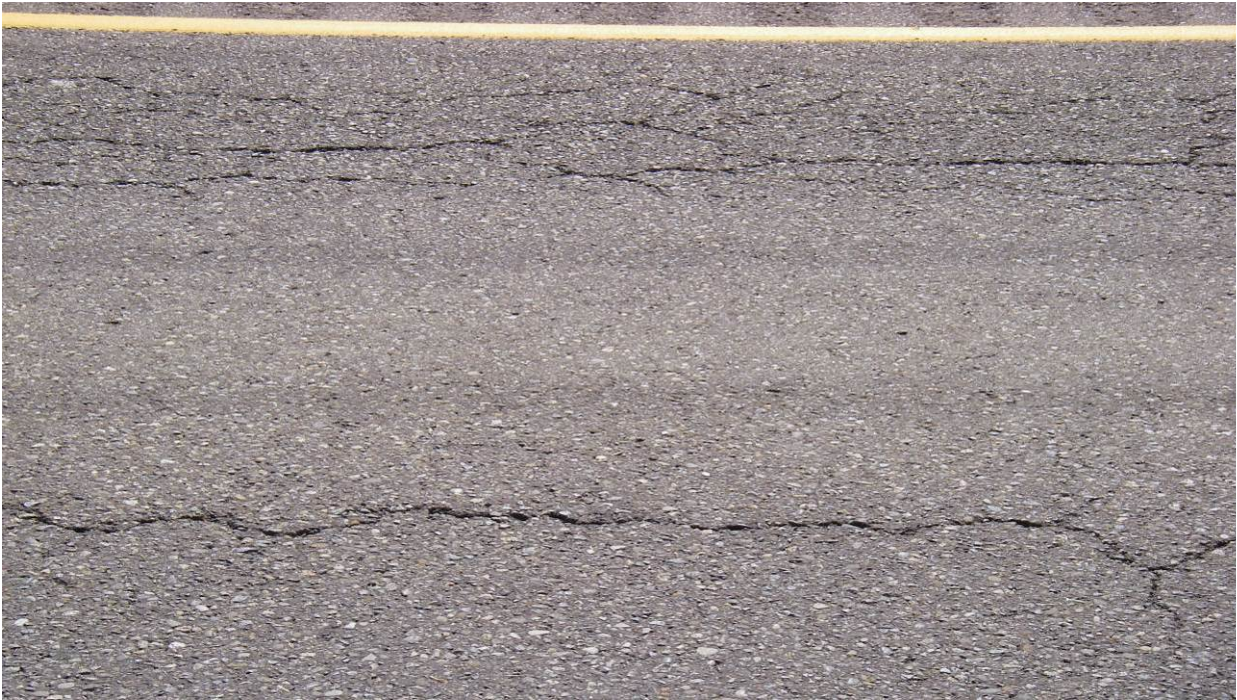
Figure 14. OR1, SR101, prior to treatment. Cracks exceed 1/4 inch in width in places.

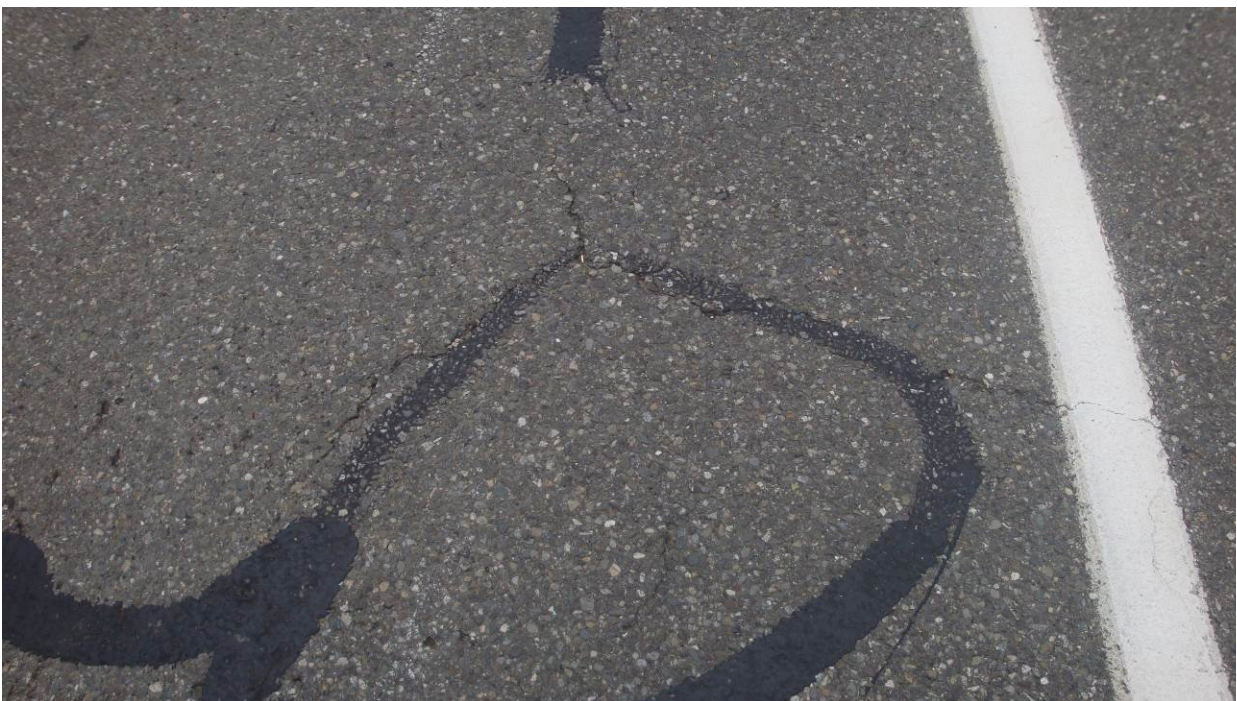
Figure 15. OR1, SR101, one year after installation. Slight wear of sealant over banding.

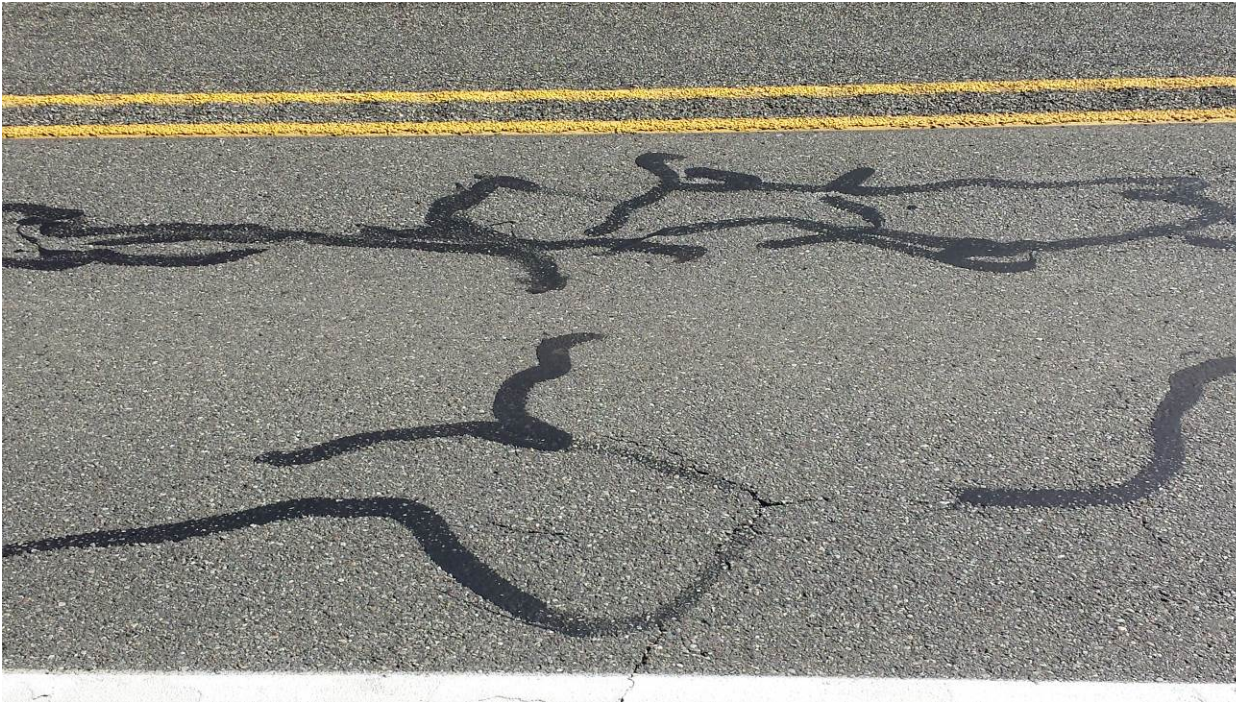
Figure 16. OR1, SR101, two years after installation. There is not much change from year one.

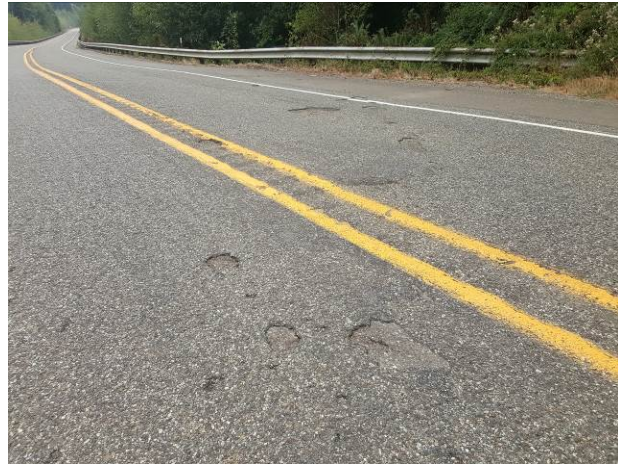
Figure 21. OR3b, SR101, Poor, age 62 months. Delamination and spalling noted.

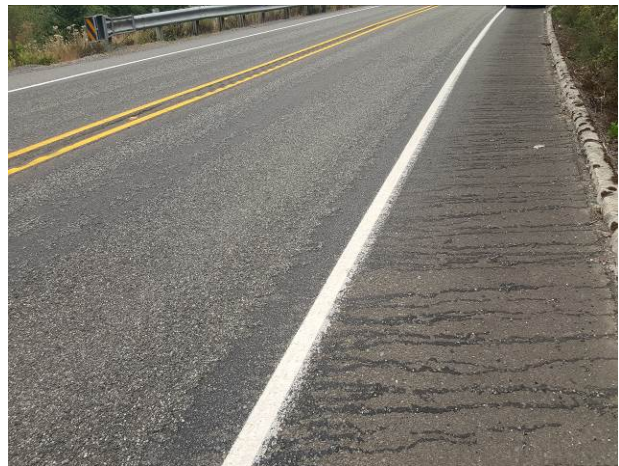
Figure 23. OR22, SR101, Good, age 26 months. Loss of aggregate at bottom of super elevation.

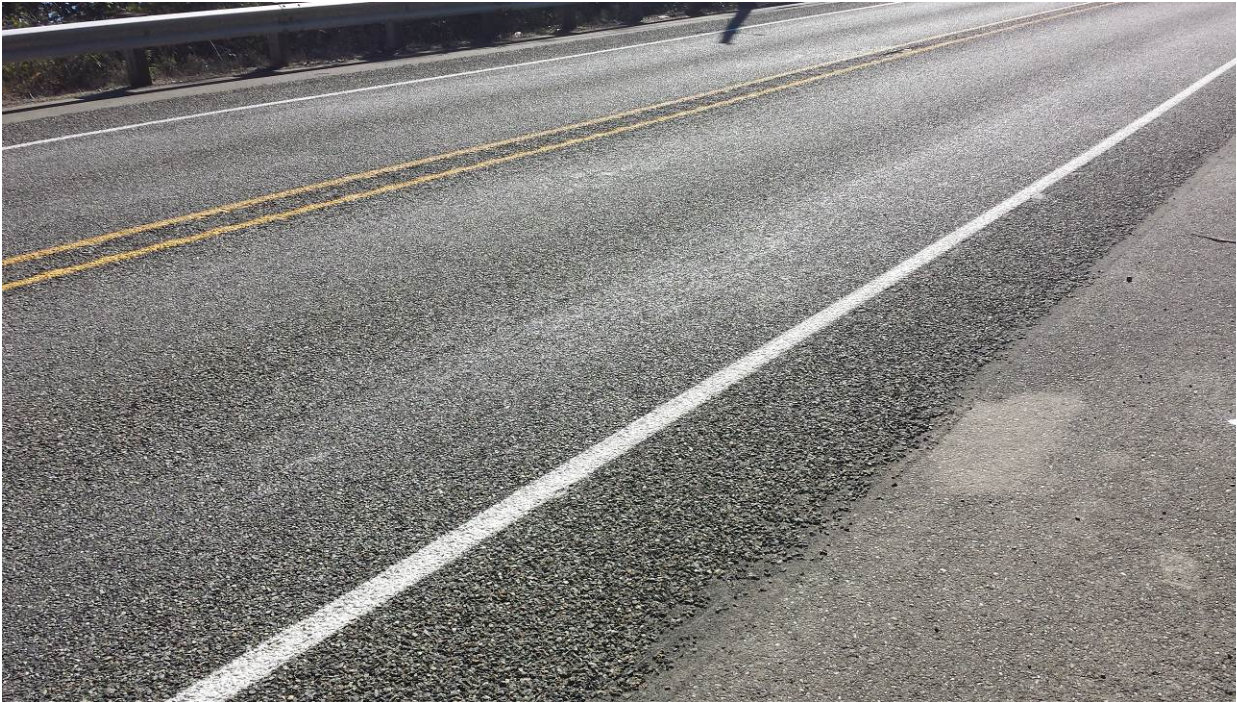
Figure 26. OR1b, SR101, two years after installation. Longitudinal crack appears to have “healed”. Slight flushing in the wheel paths.

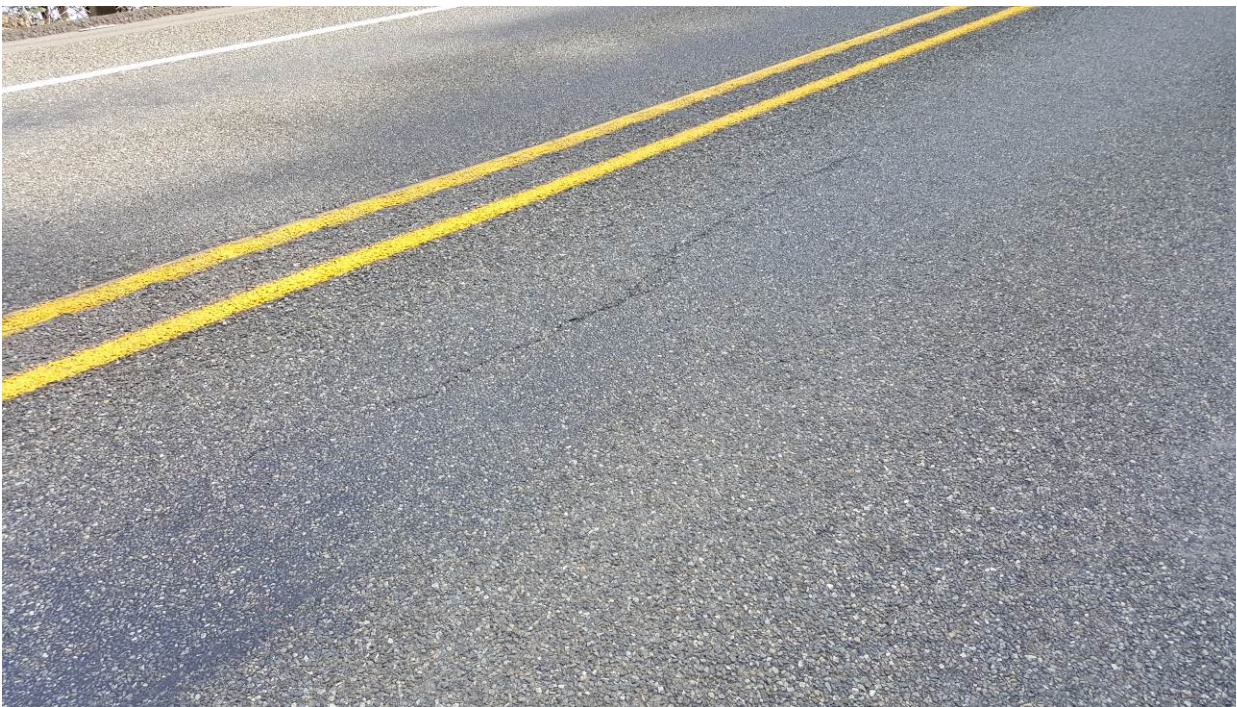
Figure 27. OR1b, SR101, three years after installation. Longitudinal crack is getting longer and wider. Flushing in the wheel paths is about the same.

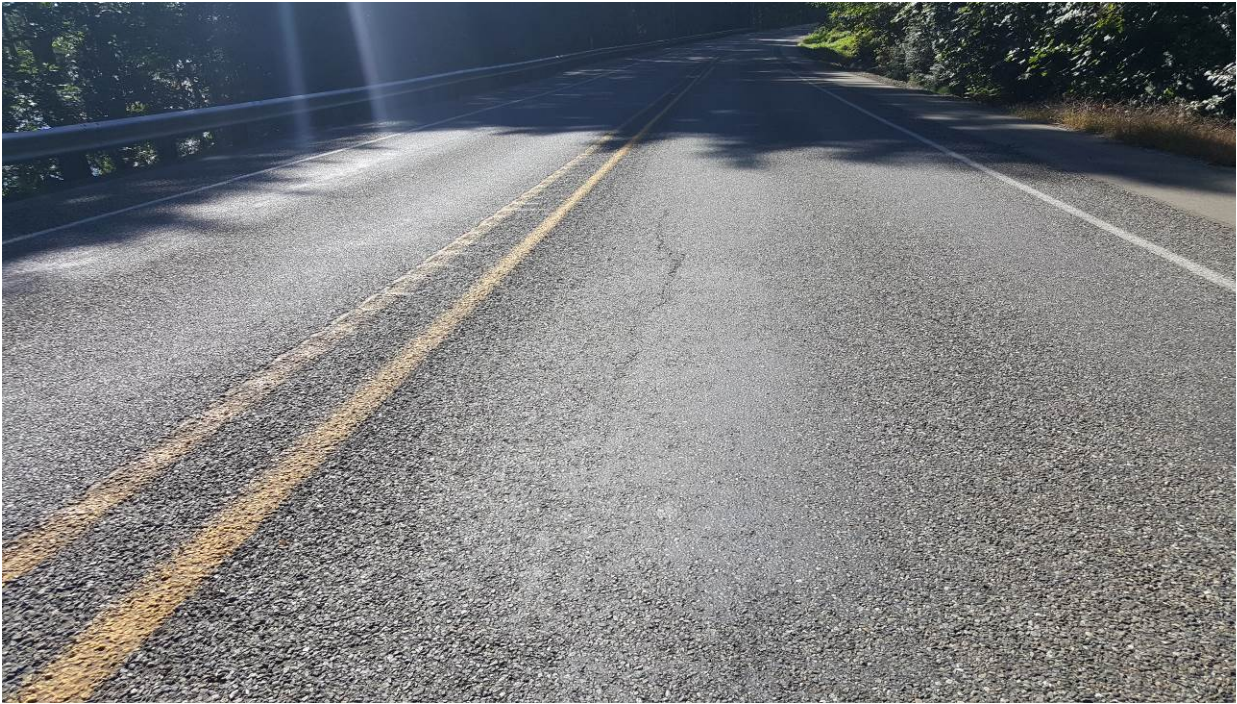
Figure 28. OR1b, SR101, four years after installation. Longitudinal crack condition is about the same, slight rutting and flushing in the wheel paths.

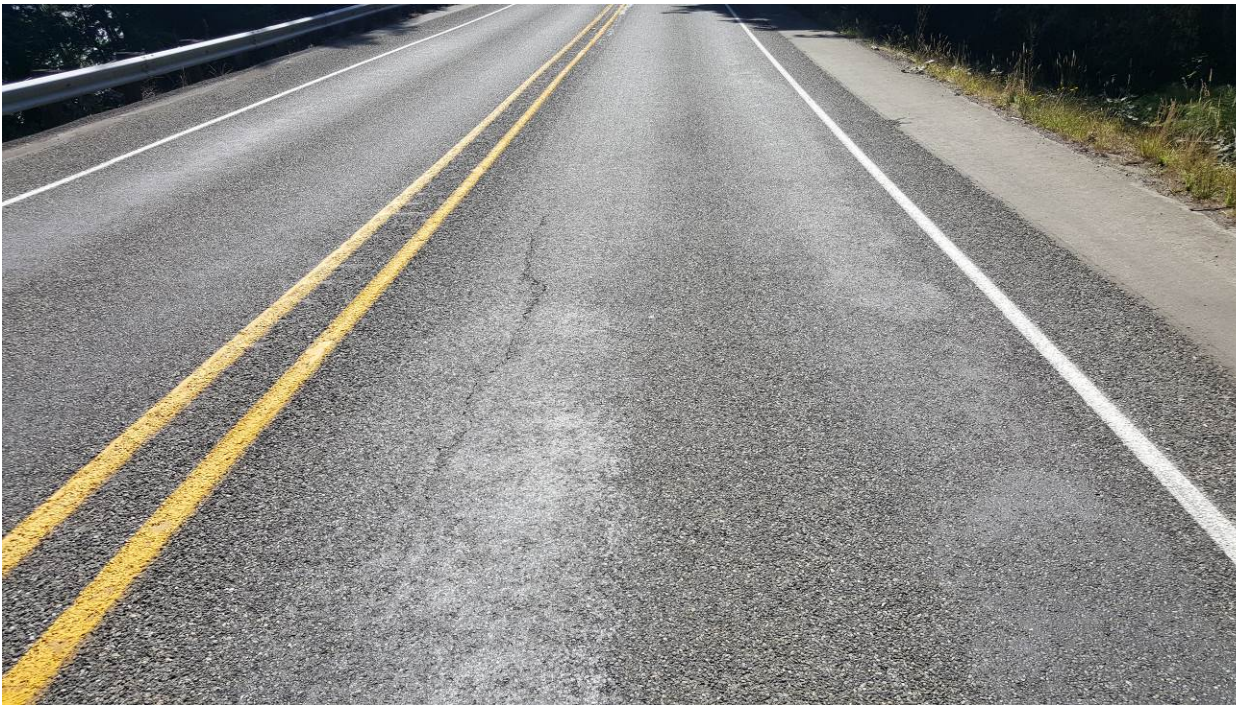
Figure 29. OR1b, SR101, five years after installation. Longitudinal crack condition is about the same, slight rutting and flushing in the wheel paths.

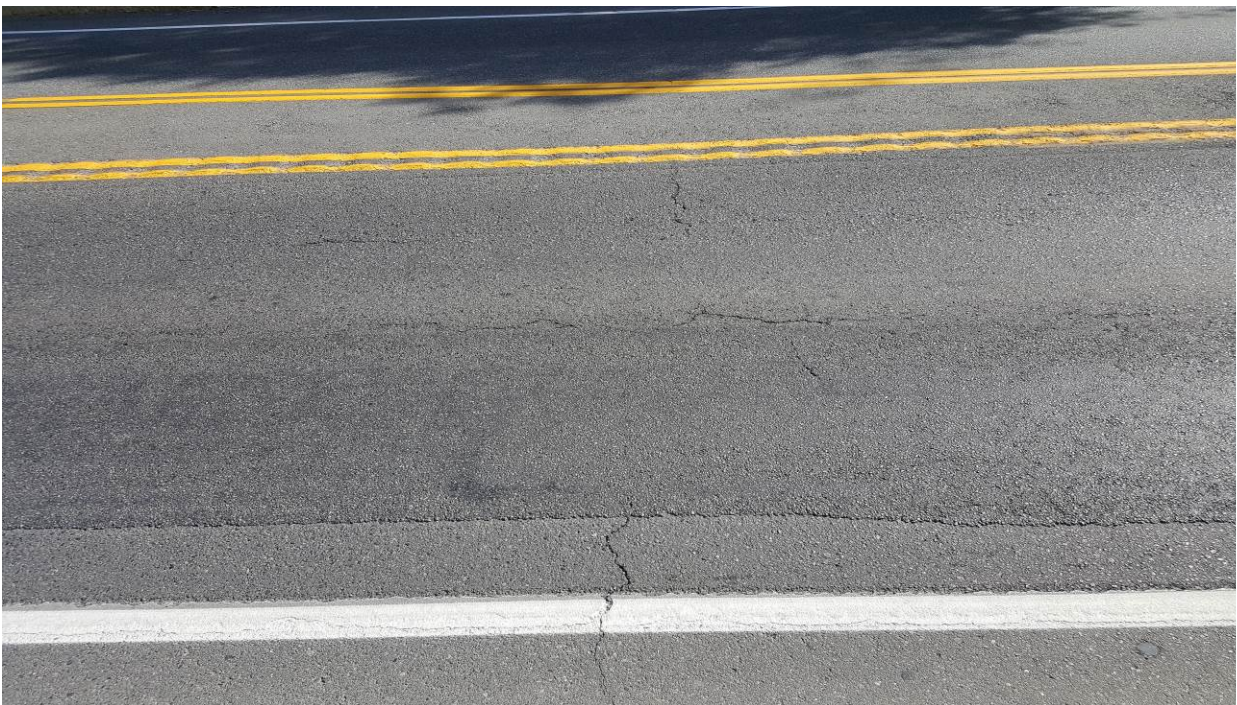
Figure 37. OR12, SR20, four years after installation. Some loss of aggregate and lots of reflection cracking through the wheel path chip seal.

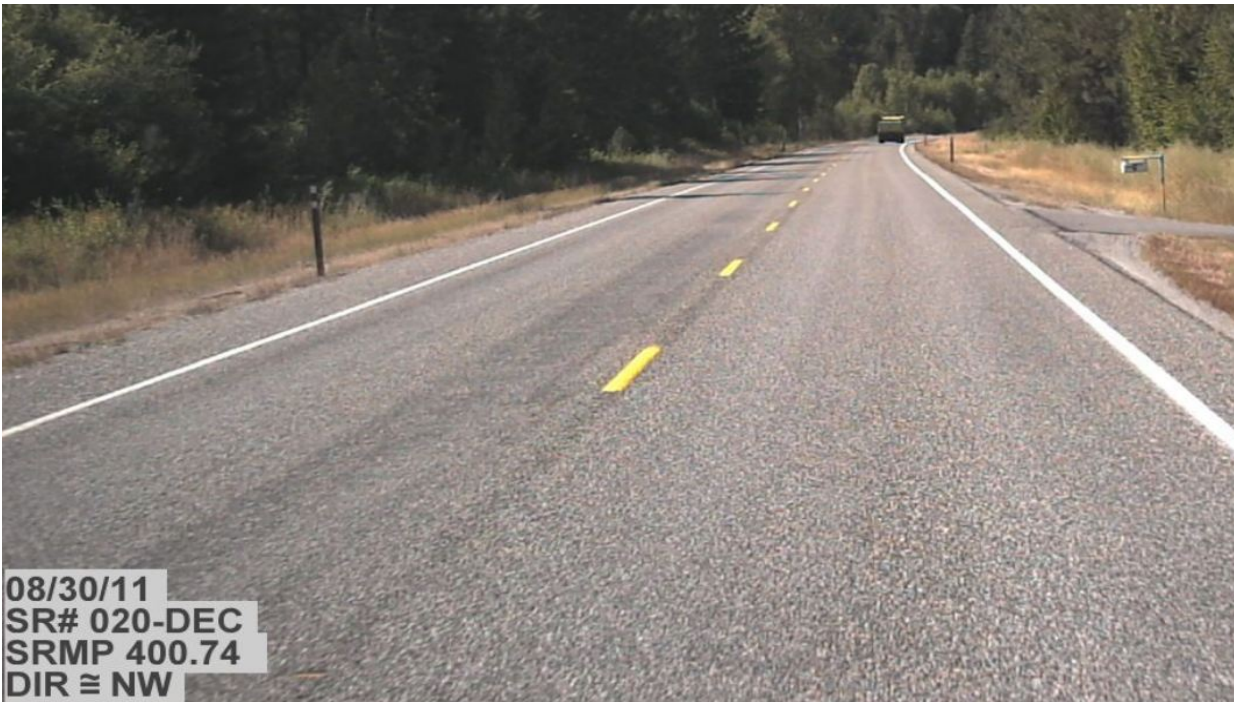
Figure 43. ER7, SR20, prior to treatment. Rutting is visible in the wheel paths.

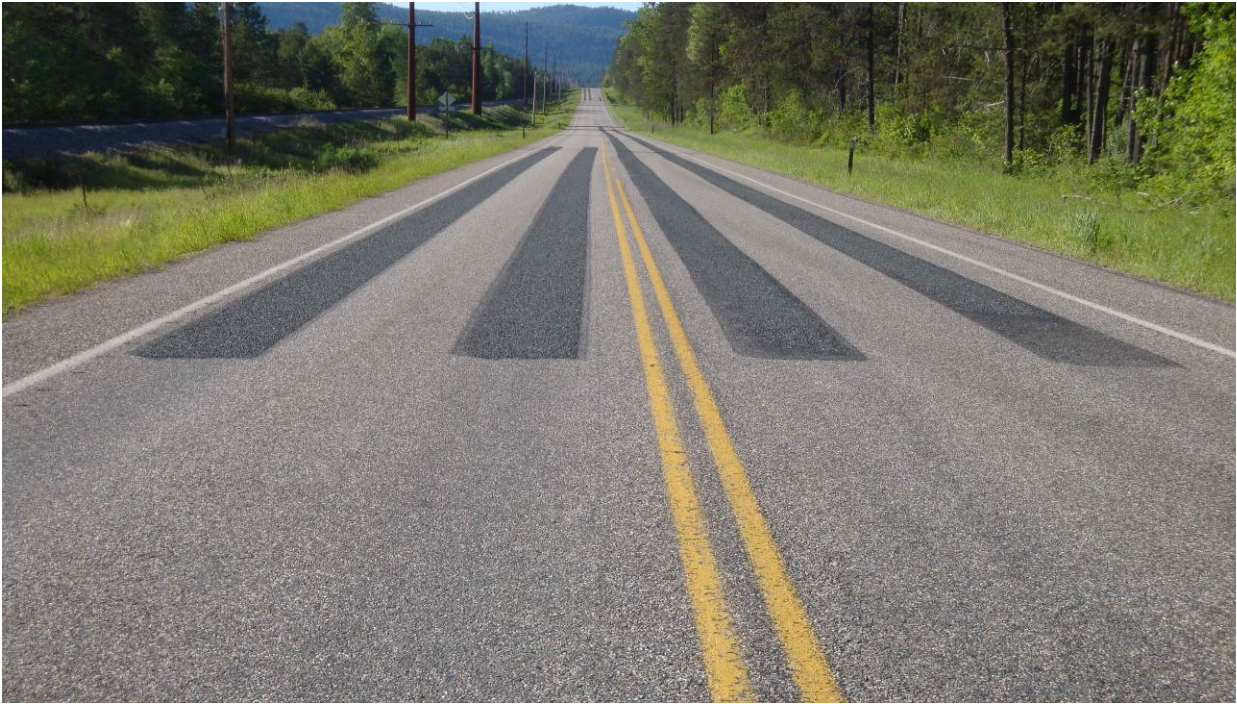
Figure 45. ER7, SR20, one year after installation. Wheel path chip seal rut fills are in excellent condition.

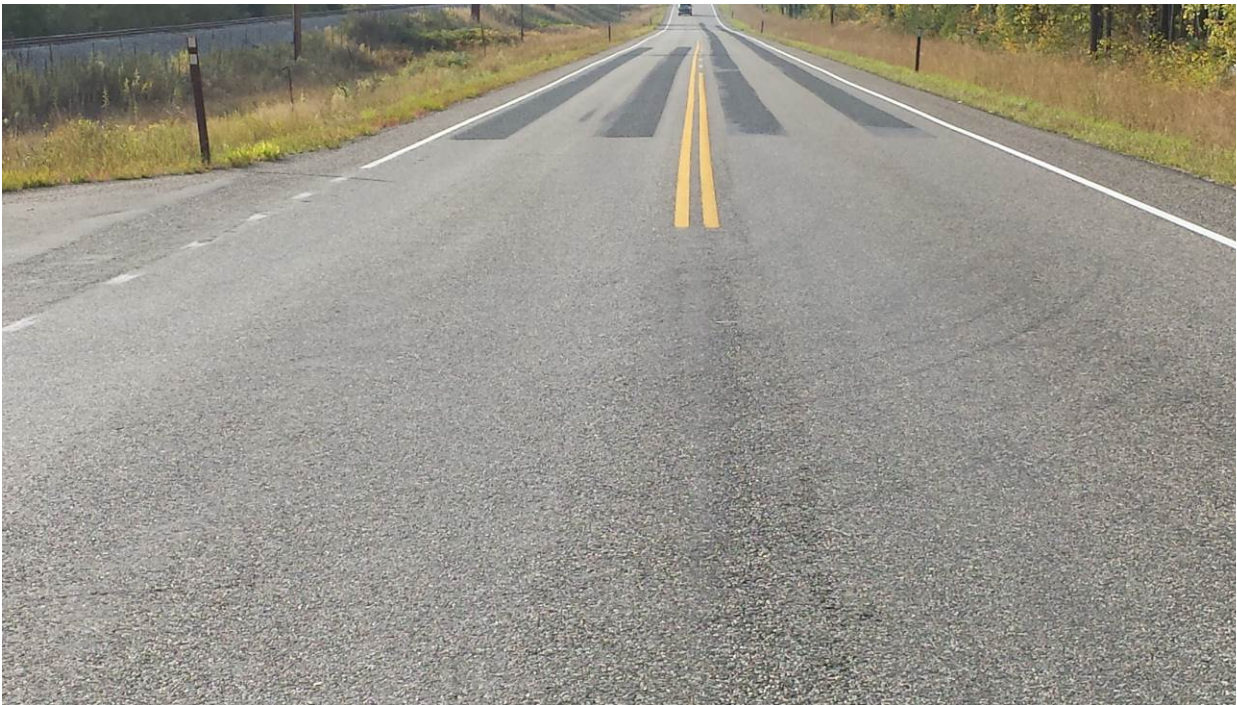
Figure 46. ER7, SR20, two years after installation. No change in chip seal.

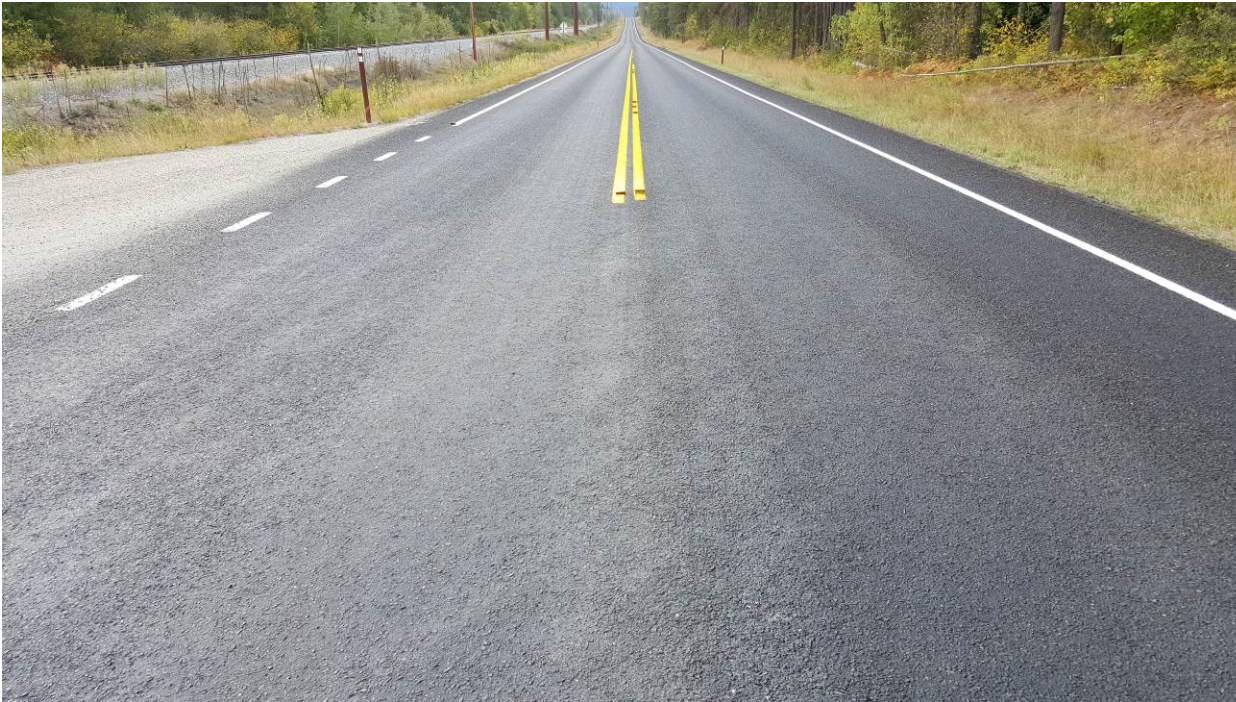
Figure 47. ER7, SR20, three years after installation. Full lane chip seal installed under Contract 8728, US 2 ET AL 2015 Eastern Region Chip Seal.

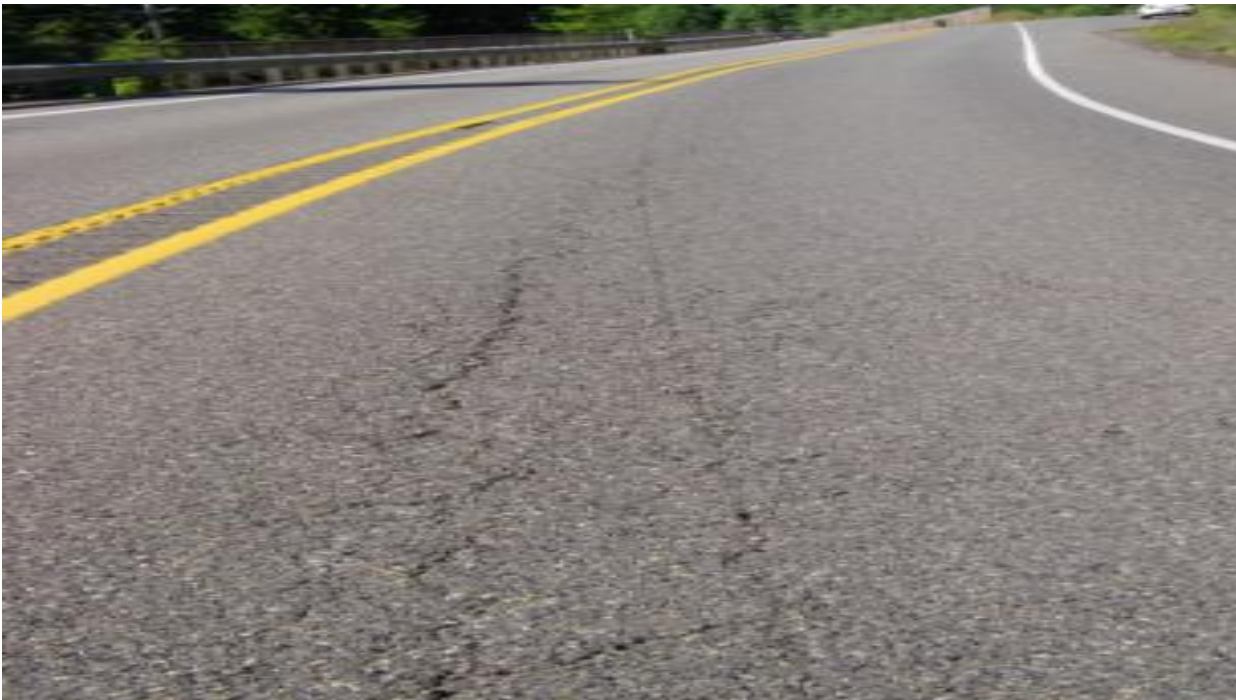
Figure 50. OR1a, SR101, prior to treatment. Alligator and longitudinal cracking noted.

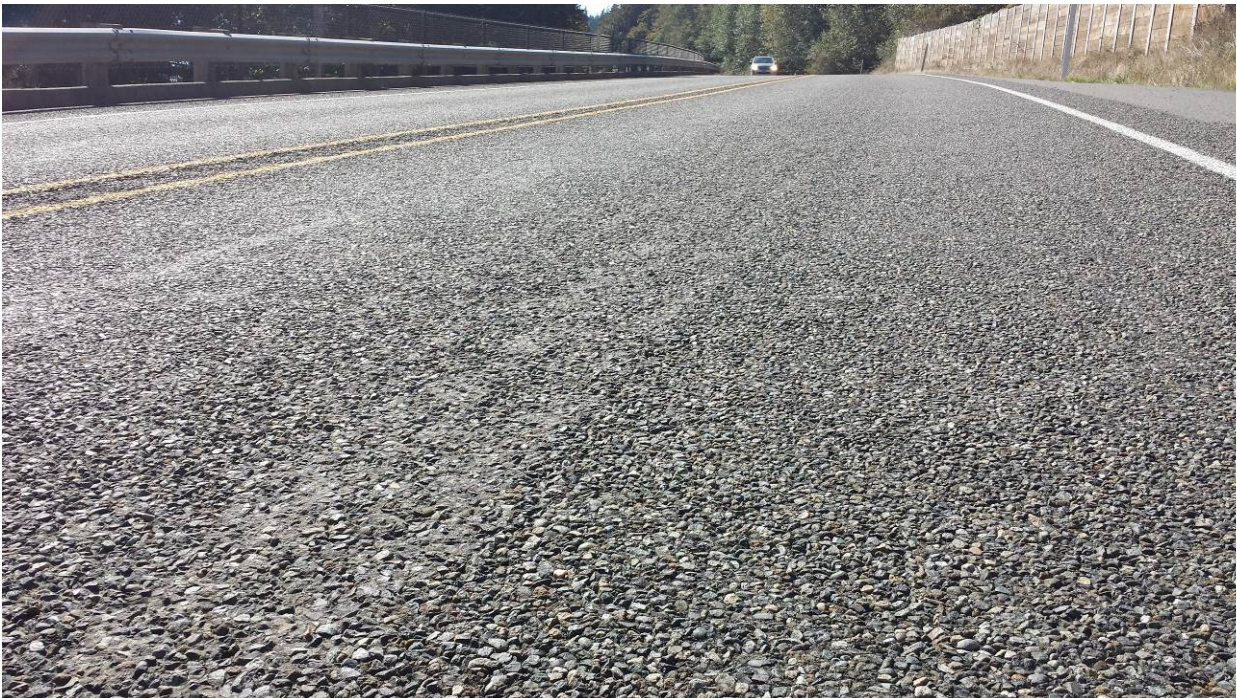
Figure 52. OR1a, SR101, two years after installation. Shadowing of the sealed cracks visible.

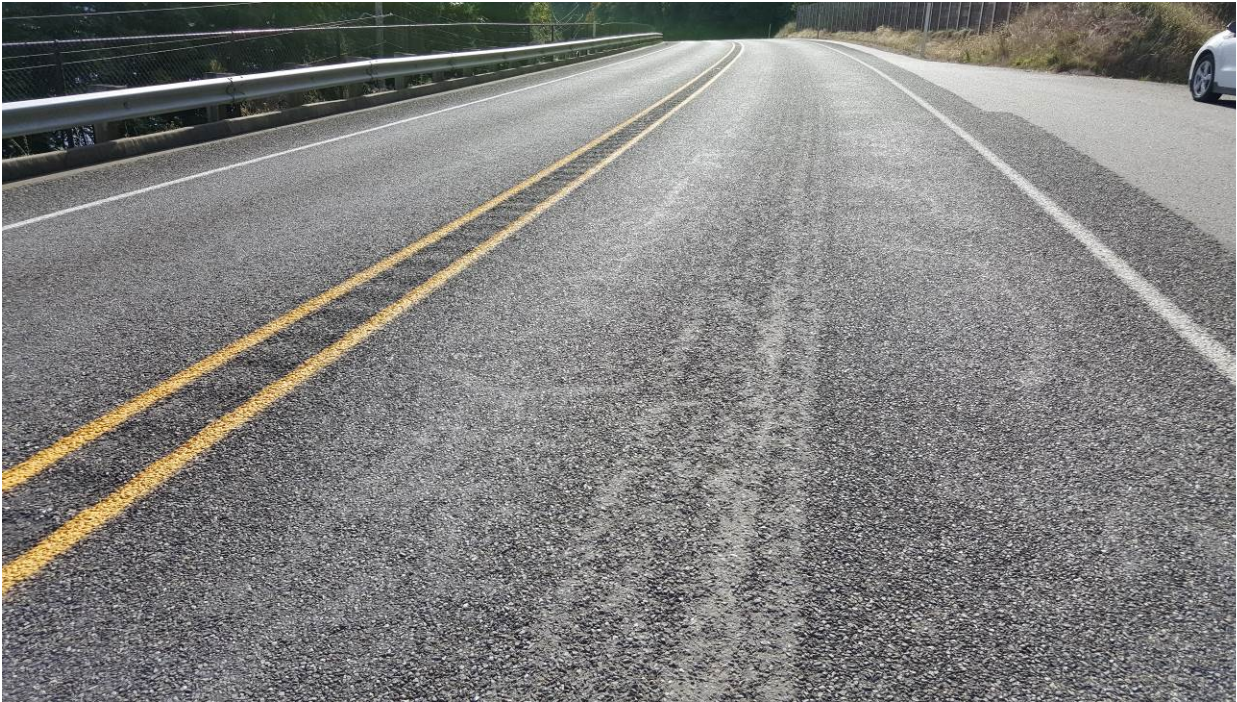
Figure 53. OR1a, SR101, three years after installation. Very slight flushing and shadowing of the sealed cracks.

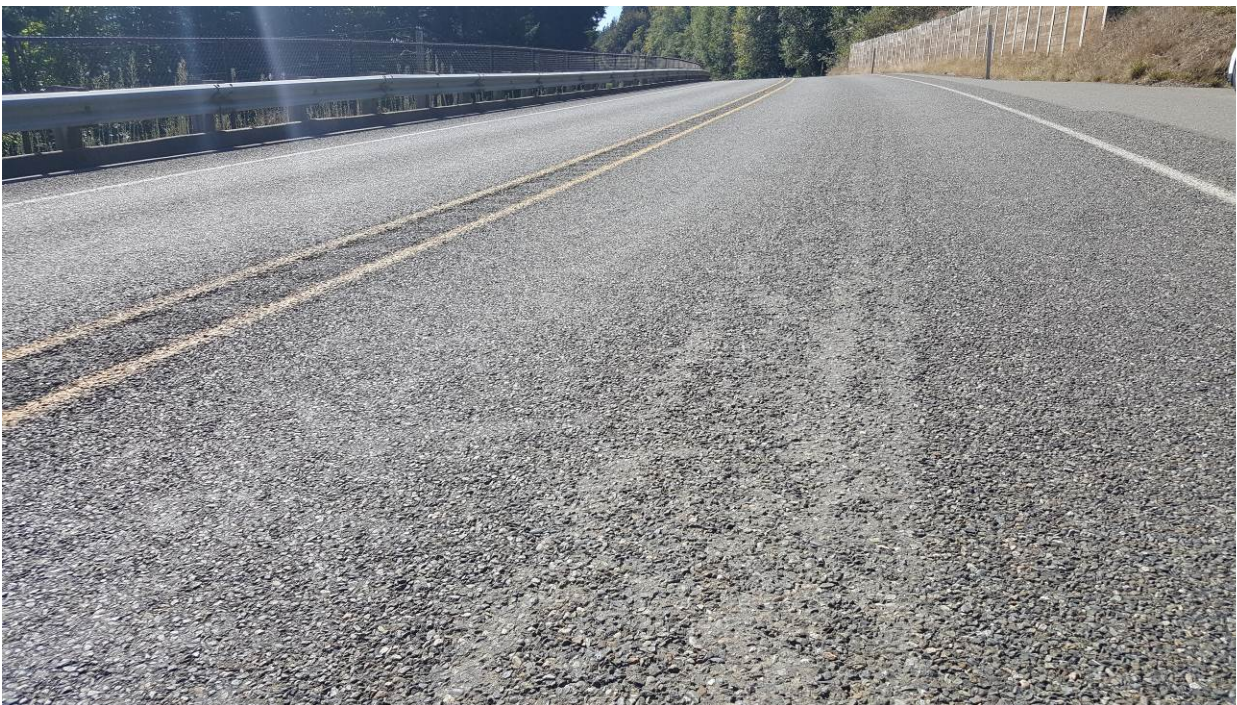
Figure 54. OR1a, SR101, four years after installation. Slight amount of rutting beginning to appear. Flushing does not seem to be a big issue.

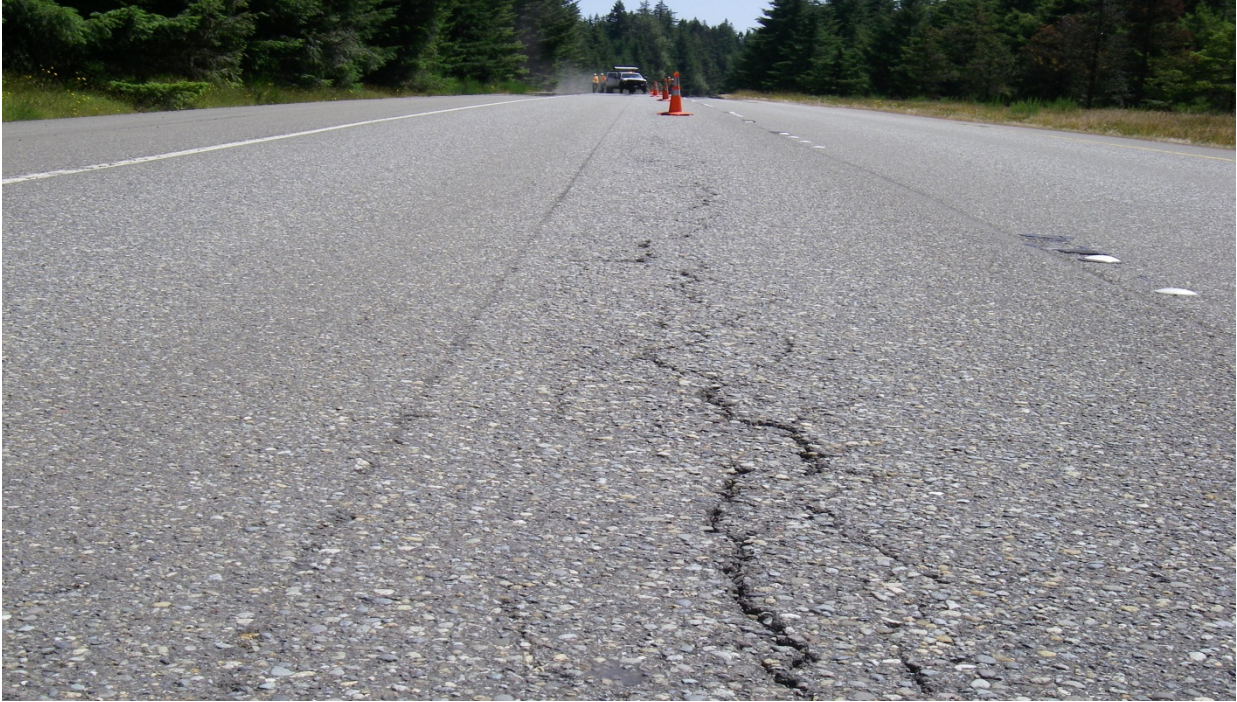
Figure 78. OR2, SR8, prior to treatment. Alligator cracking in the left wheel path. This is not the same location as the following photos which had alligator cracking in both wheel paths.

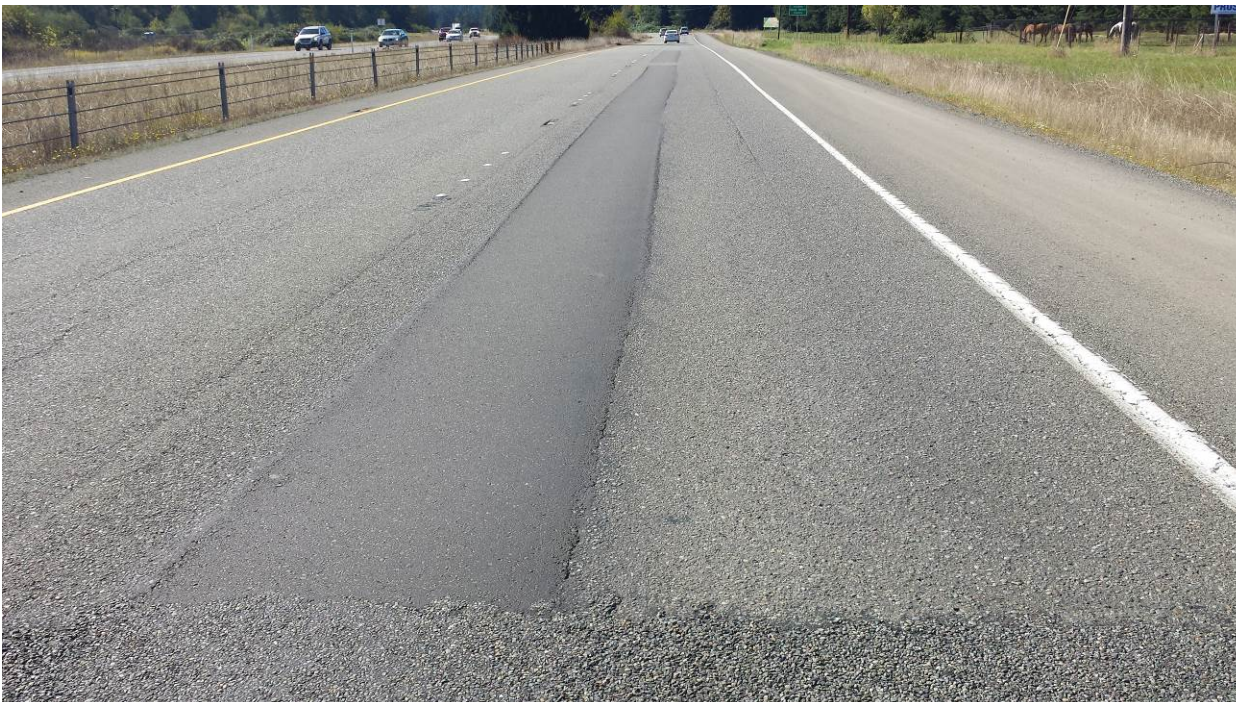
Figure 80. OR2, SR8, two years after installation. No change in condition of patch.

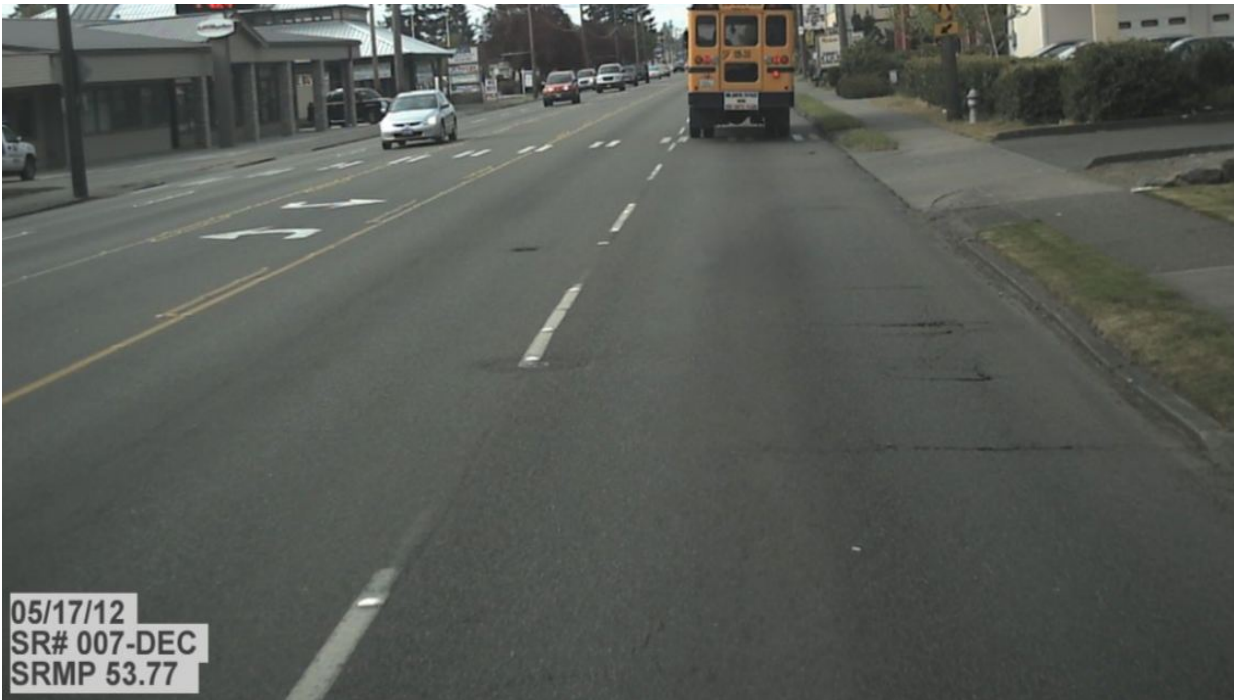
Figure 84. OR5, SR7, prior to treatment. Not at same location as following photos.

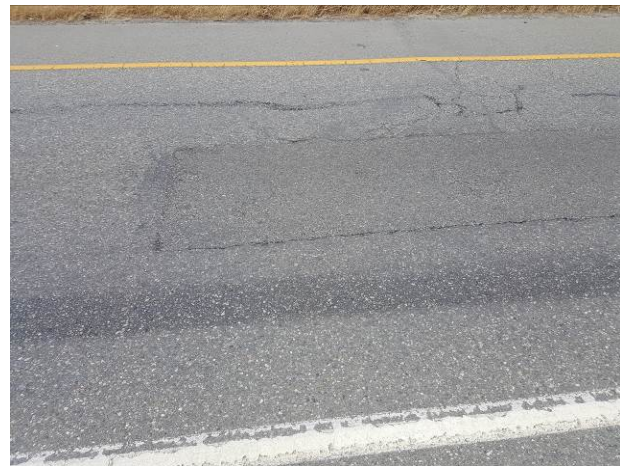
Figure 91. OR4, SR3, Good, age 50 months. Dig out patches and crack sealing in excellent condition.

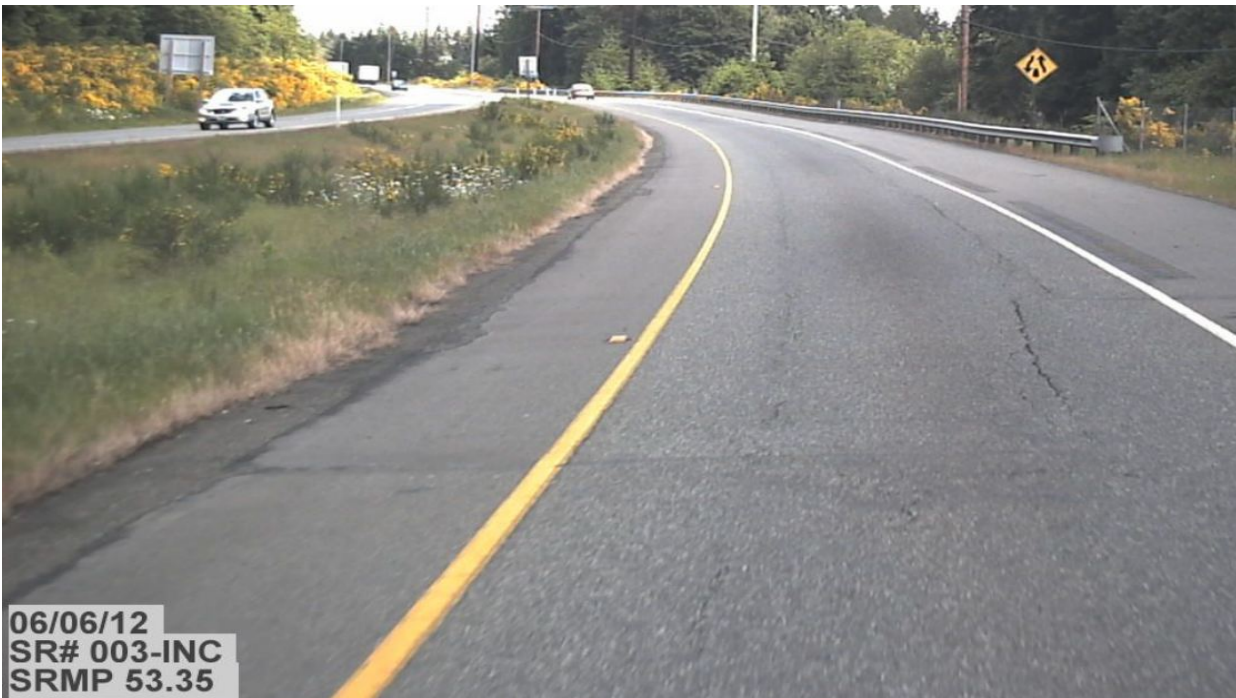
Figure 94. OR4, SR3, prior to treatment. Longitudinal, transverse and alligator cracking.

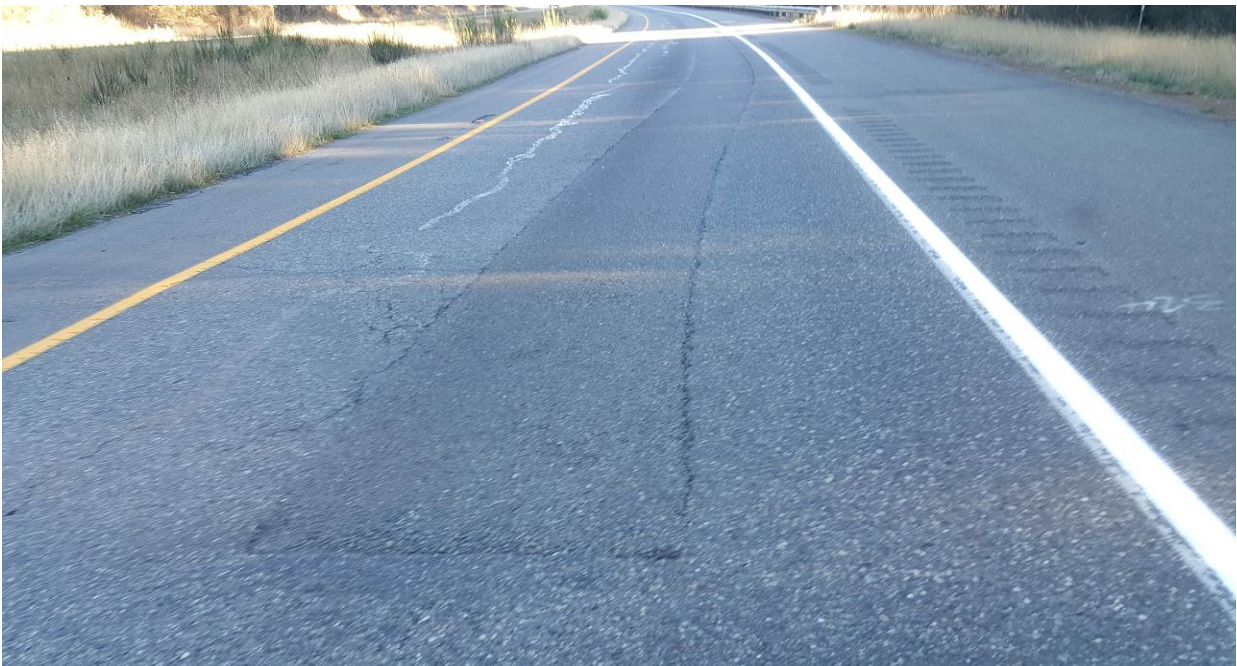
Figure 98. OR4, SR3, three years after installation. No change in dig out patch or crack sealing.

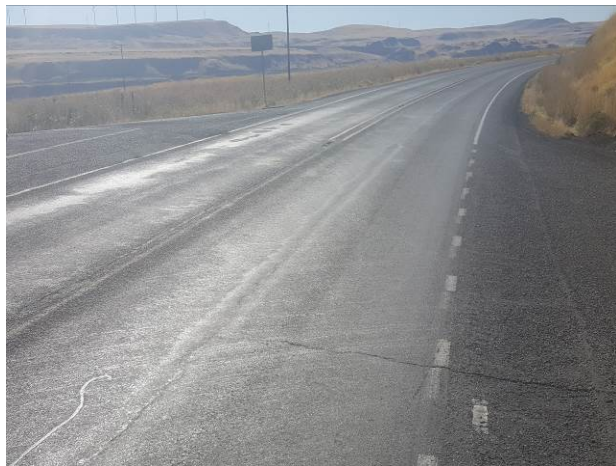
Figure 103. SW1a, SR14, Poor, age 62 months. Transverse and longitudinal reflection cracking and flushing noted at 12 months after installation. Potholes developed at 50 months.

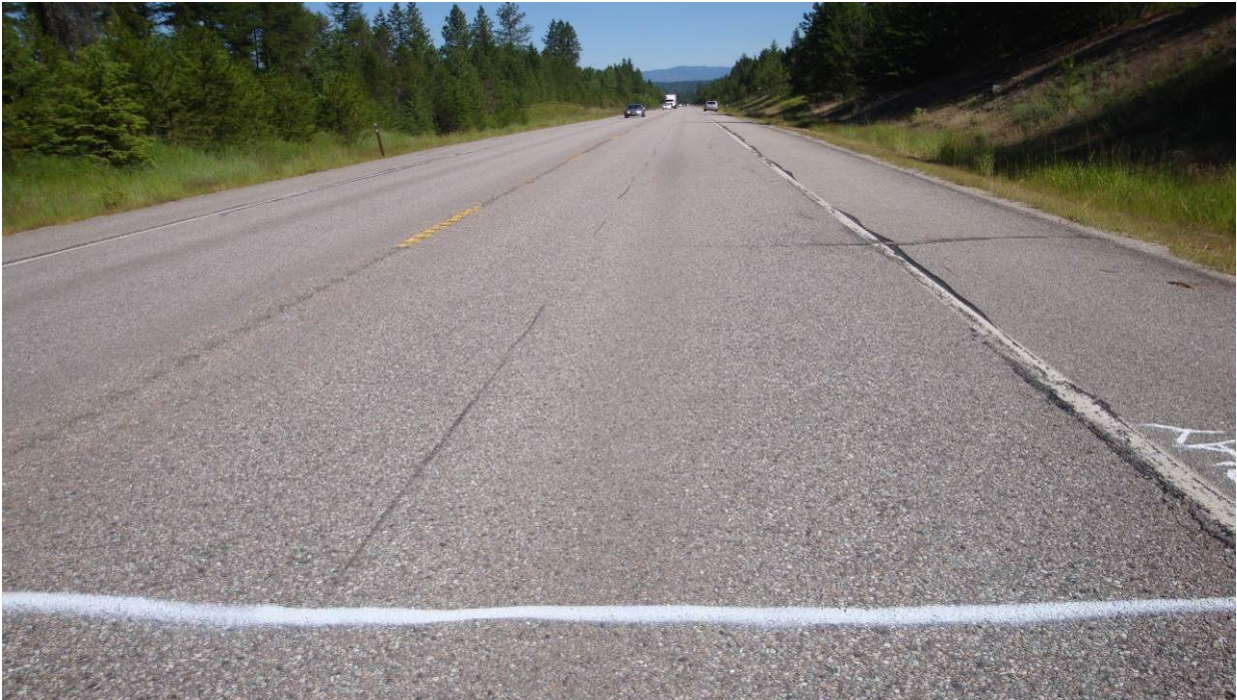
Figure 120. ER9a, SR395, prior to treatment. Longitudinal, transverse and alligator cracking.

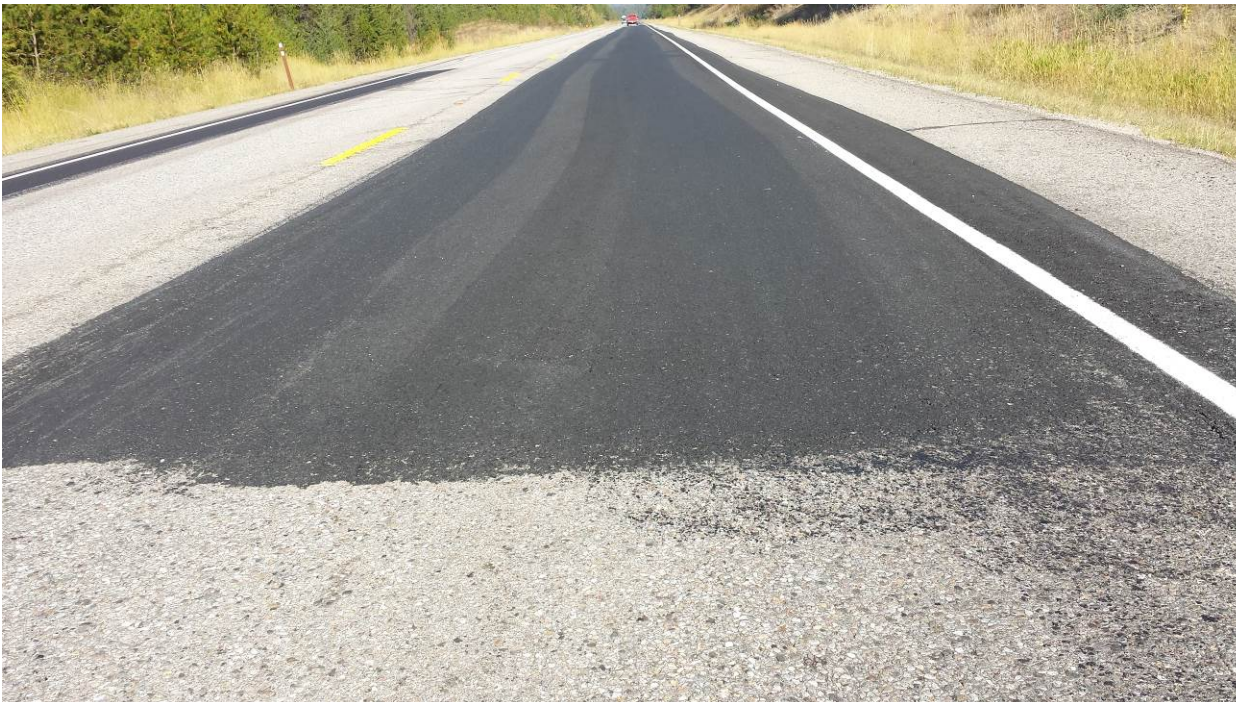
Figure 121. ER9a, SR395, a few months after installation. Blade patch looks excellent.

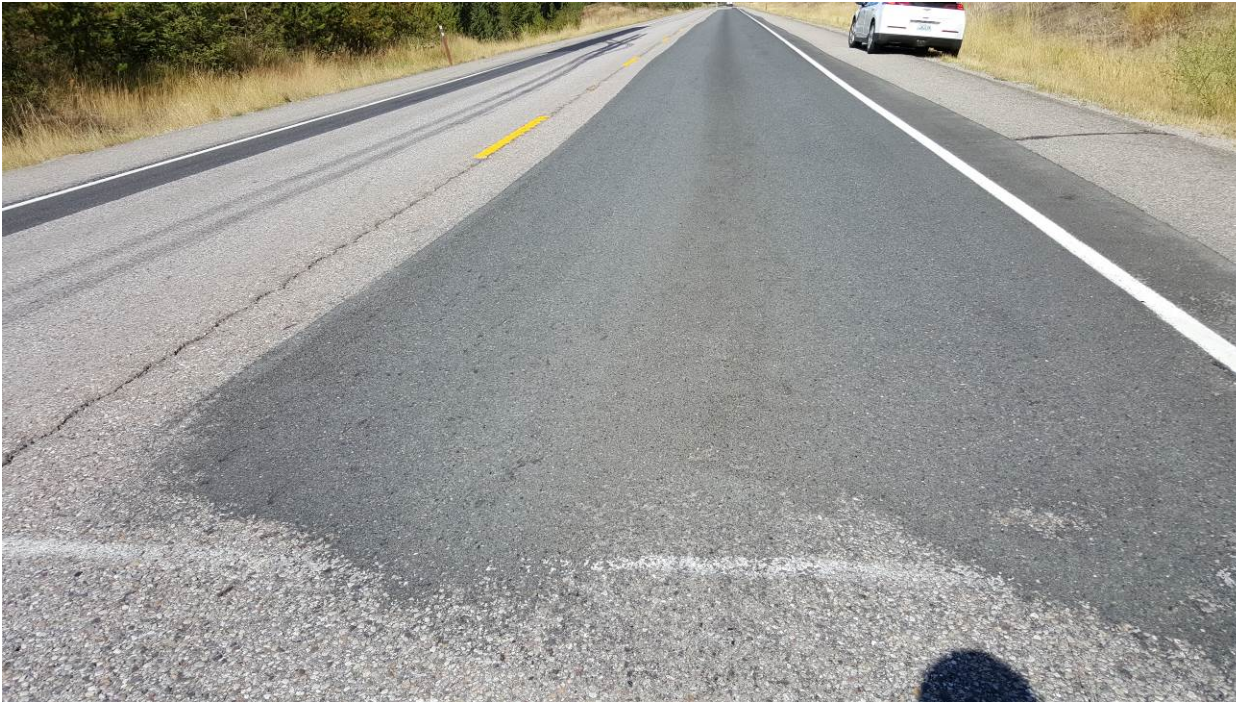
Figure 122. ER9a, SR395, one year after installation in 2014. Some wear of the blade patch at each end. Transverse cracks reflected through the blade patch after only one year.
